**As-built report for the Brigmon
Mitigation Site, Paint Fork Creek,
Madison County**

North Carolina Wildlife Resources Commission

October 31, 2000

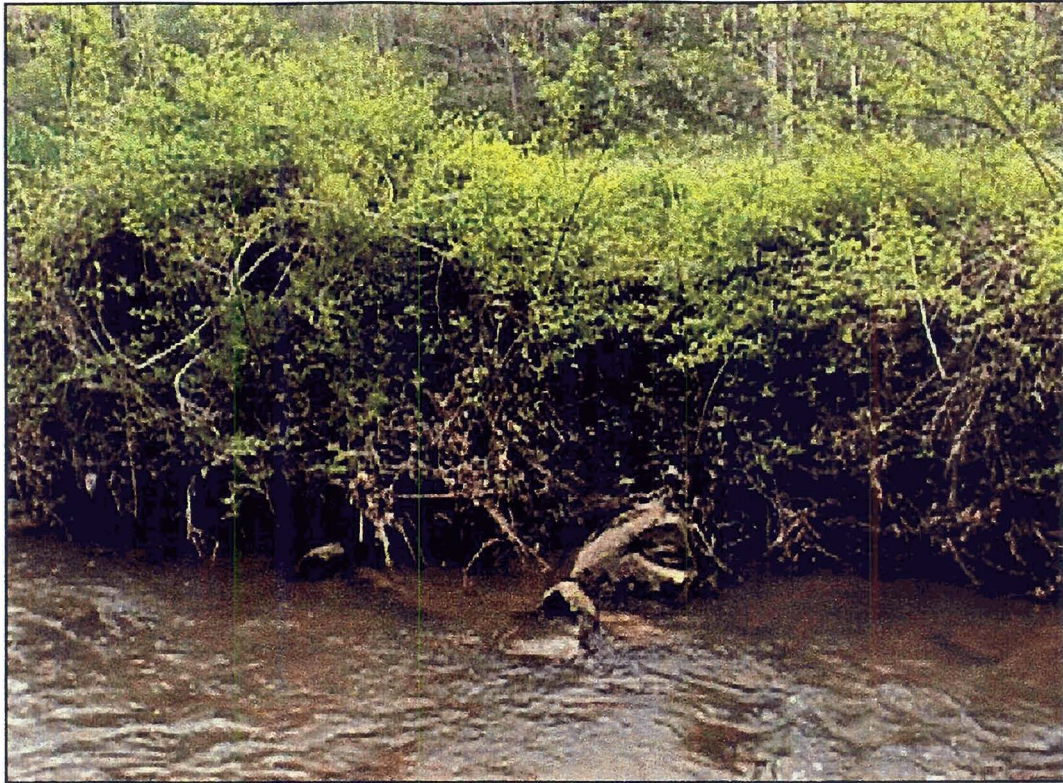
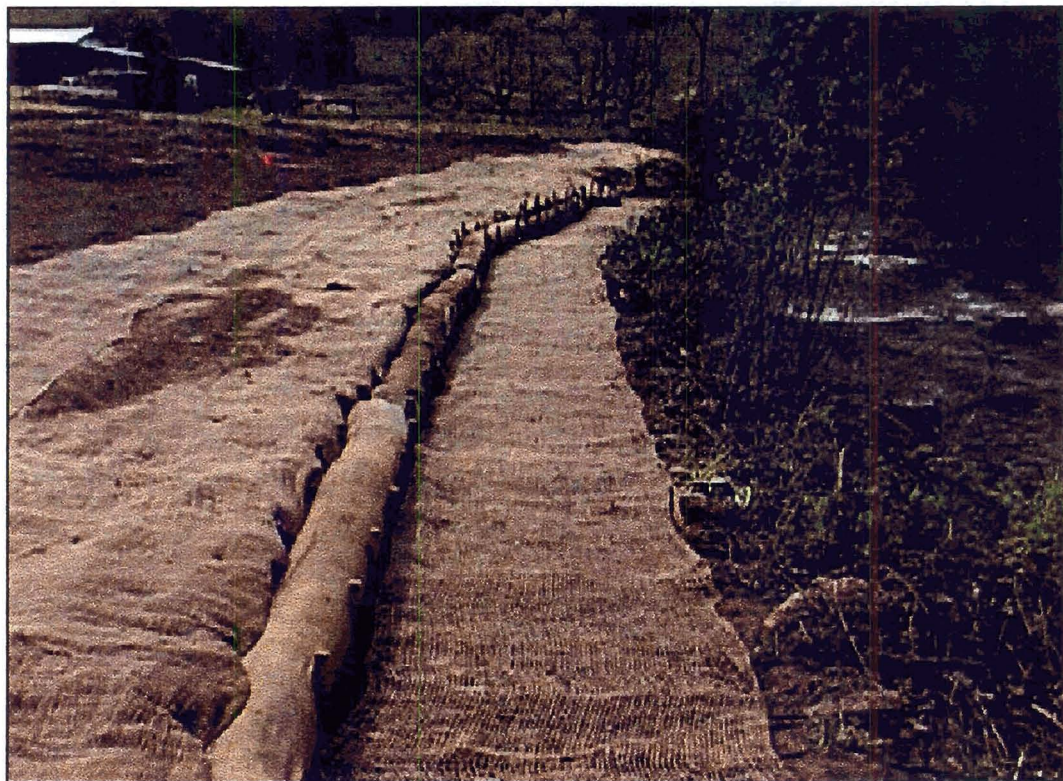
Top photo shows typical condition of stream banks at this site prior to construction. Bottom photo shows typical construction methods used to address vertical bank conditions. Banks are sloped, fertilized, limed, seeded and erosion matting installed. Coir logs are pinned at the bankfull elevation and trees are planted behind this log to provide long-term stability.

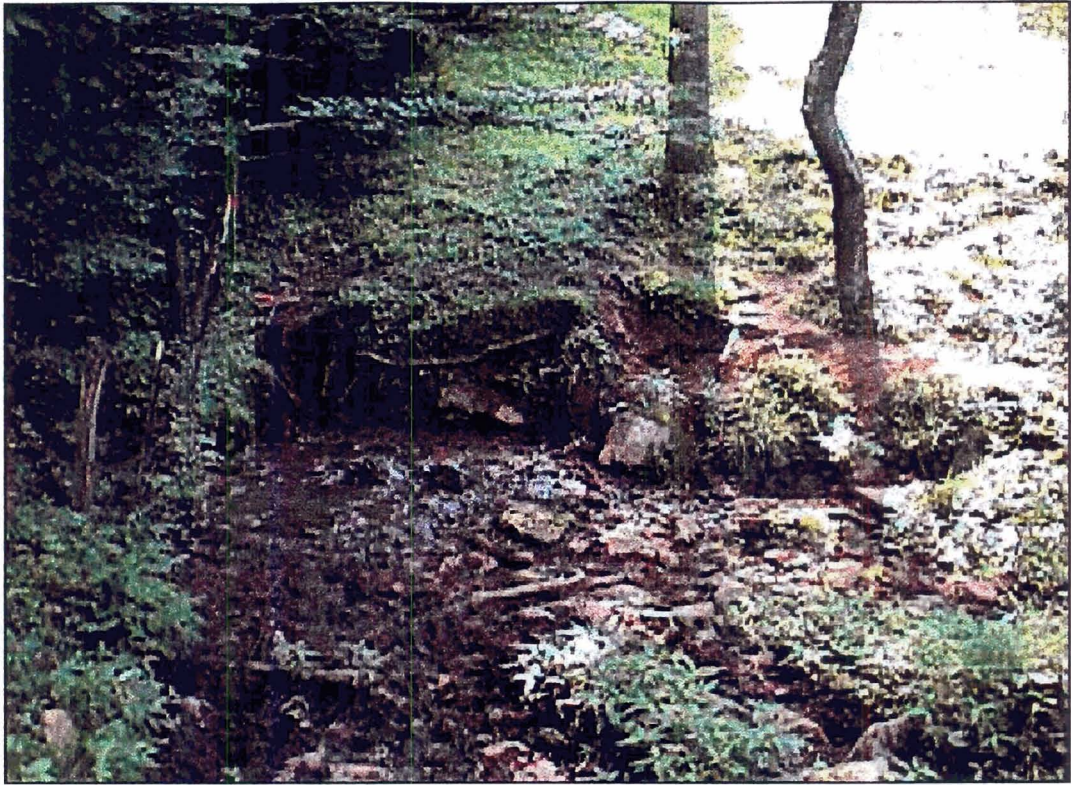
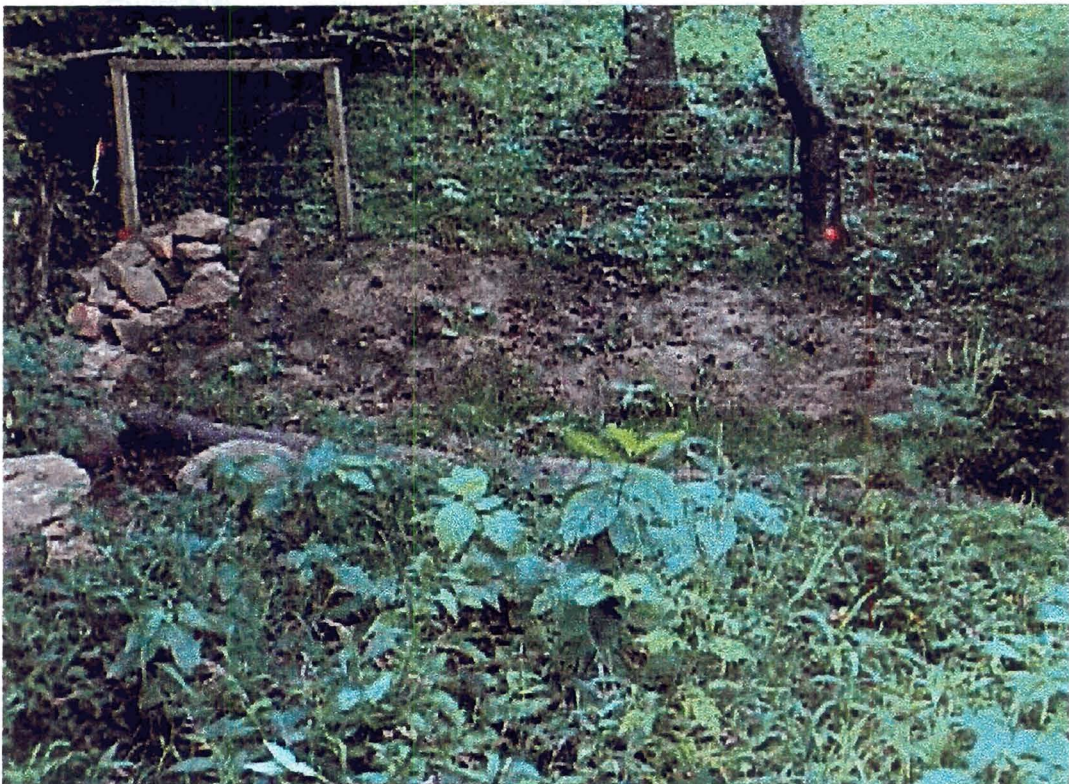
Top photo shows condition of a site that livestock were using to water and cross the stream. Bottom photo shows the same site after coir logs were used to define the channel and the banks were filled and sloped up to the logs. The site was seeded and protected with erosion control blankets. Trees were planted and the stream fenced.

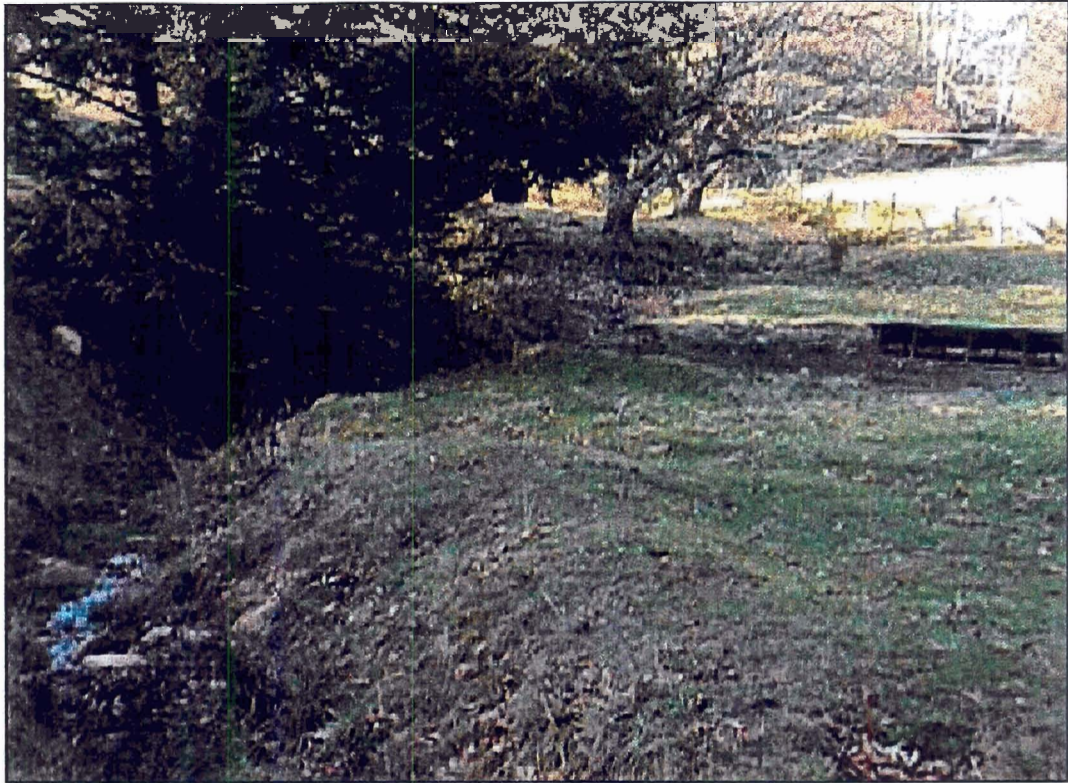
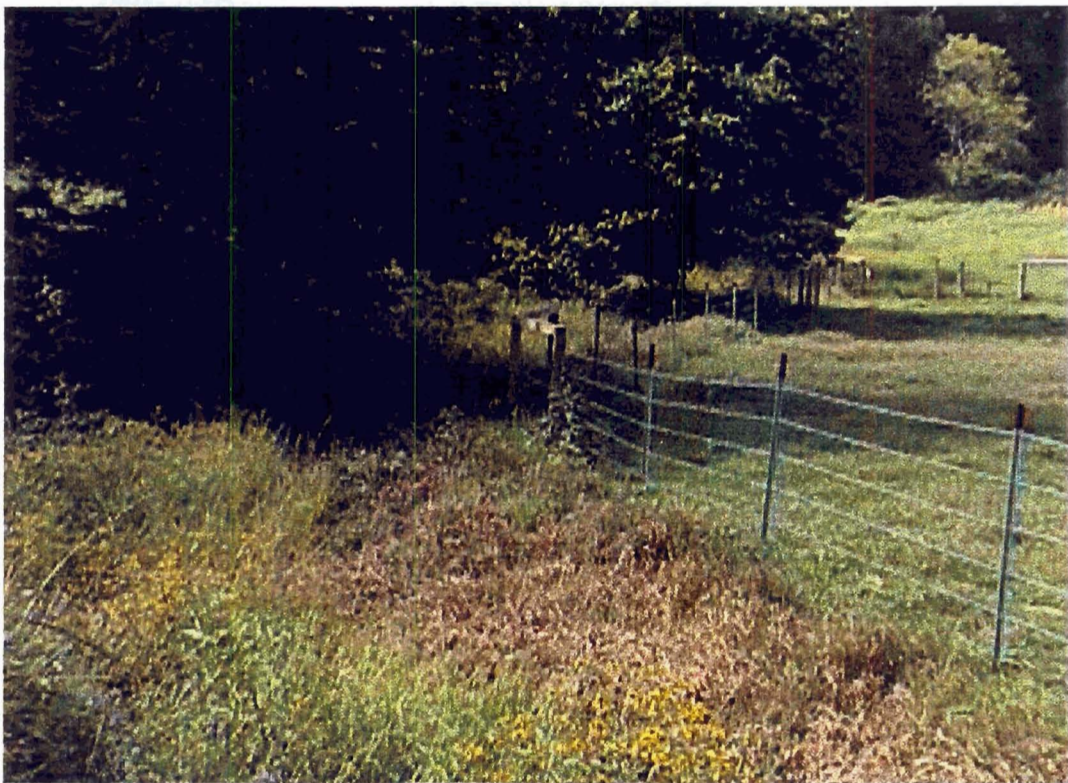
Top photo shows the lower end of the upper, unnamed tributary prior to construction. Bottom photo shows the same site after construction. Banks were sloped and seeded and livestock were fenced out of the site. Prior to construction, the two small unnamed tributaries at this site were major sources of sediment during high water periods.

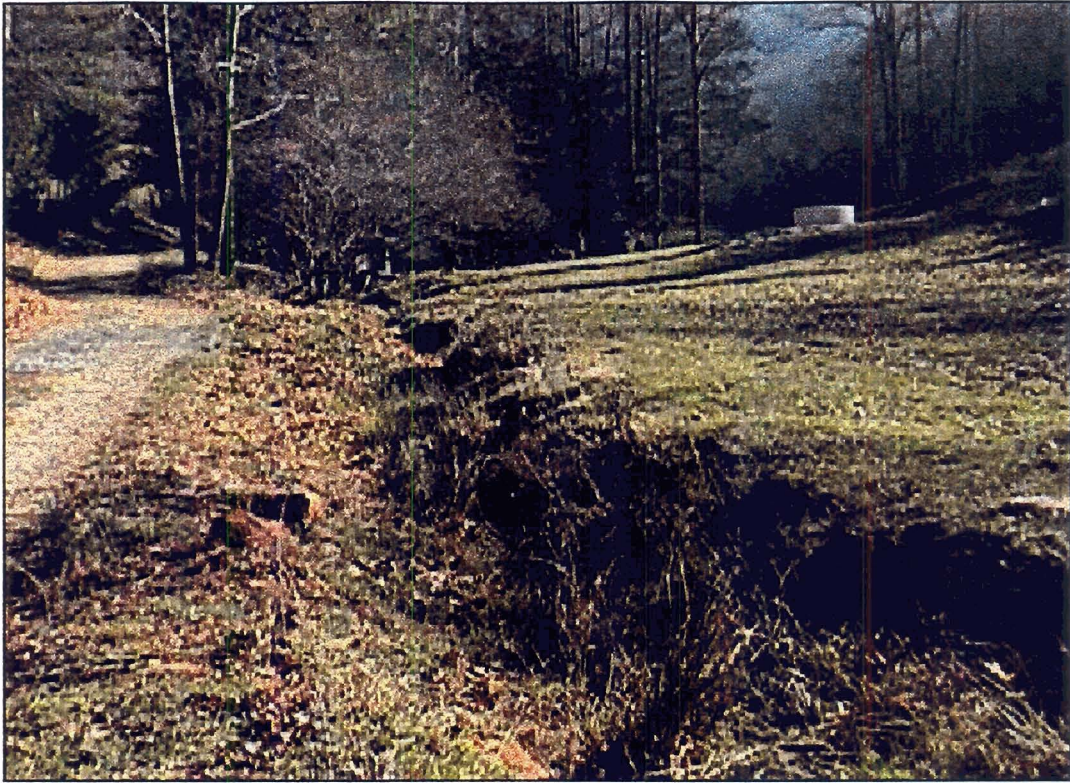
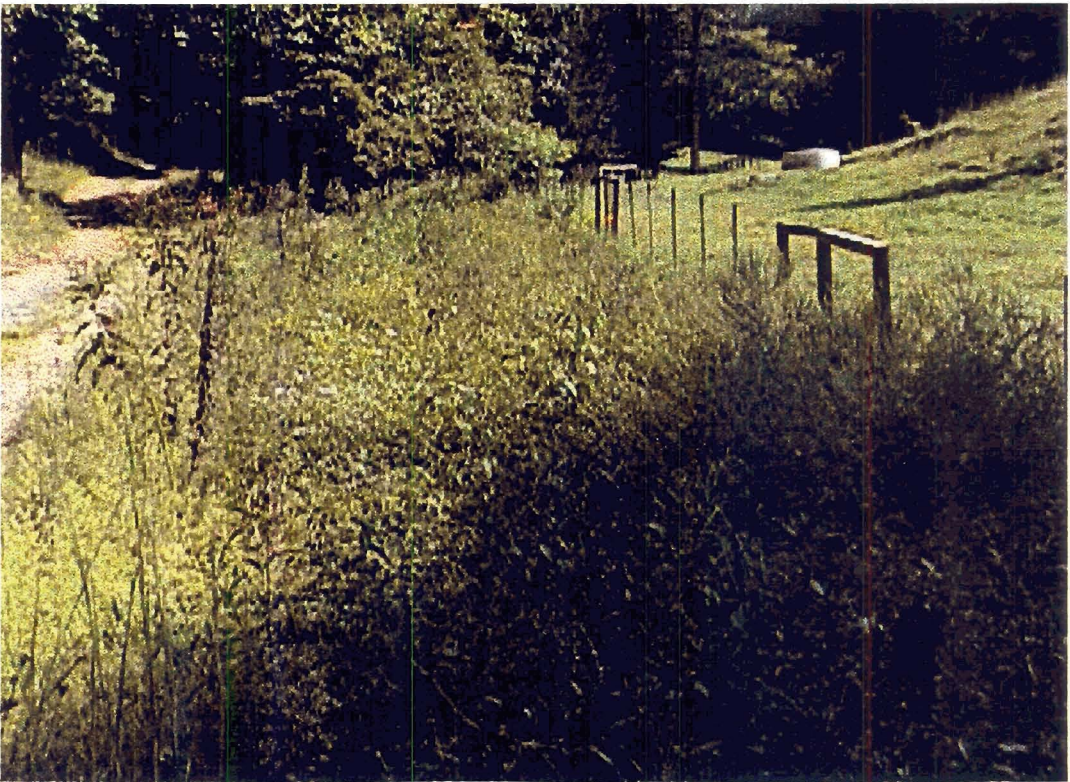
Top photo is along the lower, unnamed tributary looking up stream from the bottom of the reach. Bottom photo is the same site after construction. Vegetation has grown thick on the banks. Livestock were fenced out of this site and one of the water tanks installed at this site can be seen in the background. A covey of quail was flushed at this site when taking this photo.

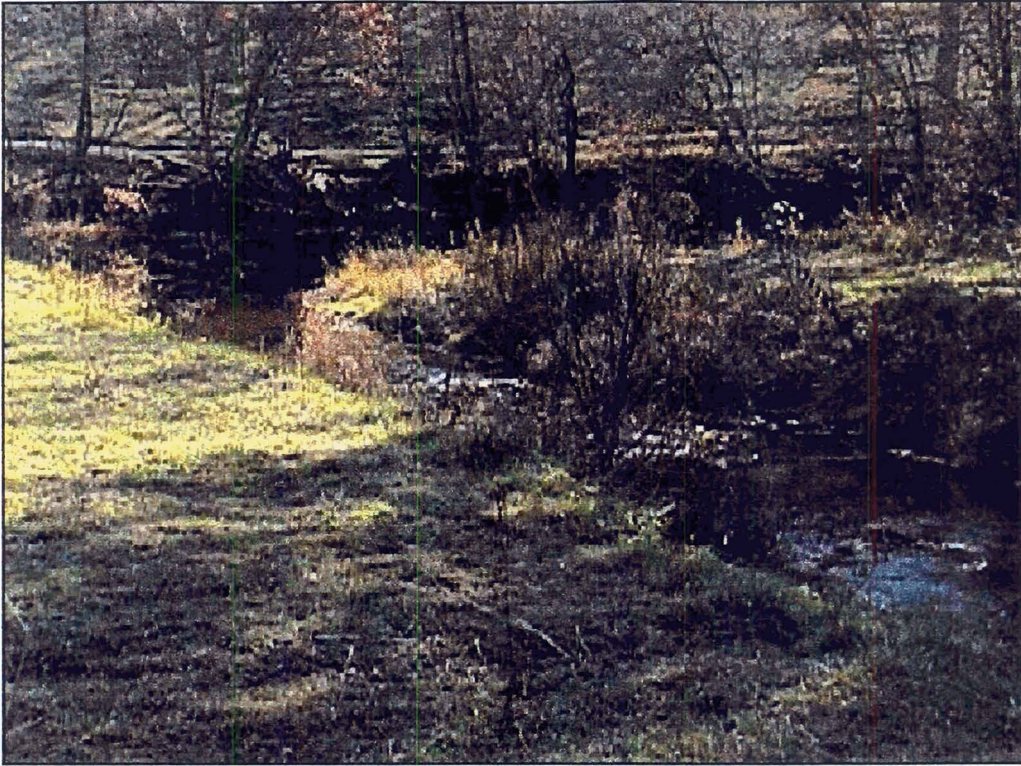
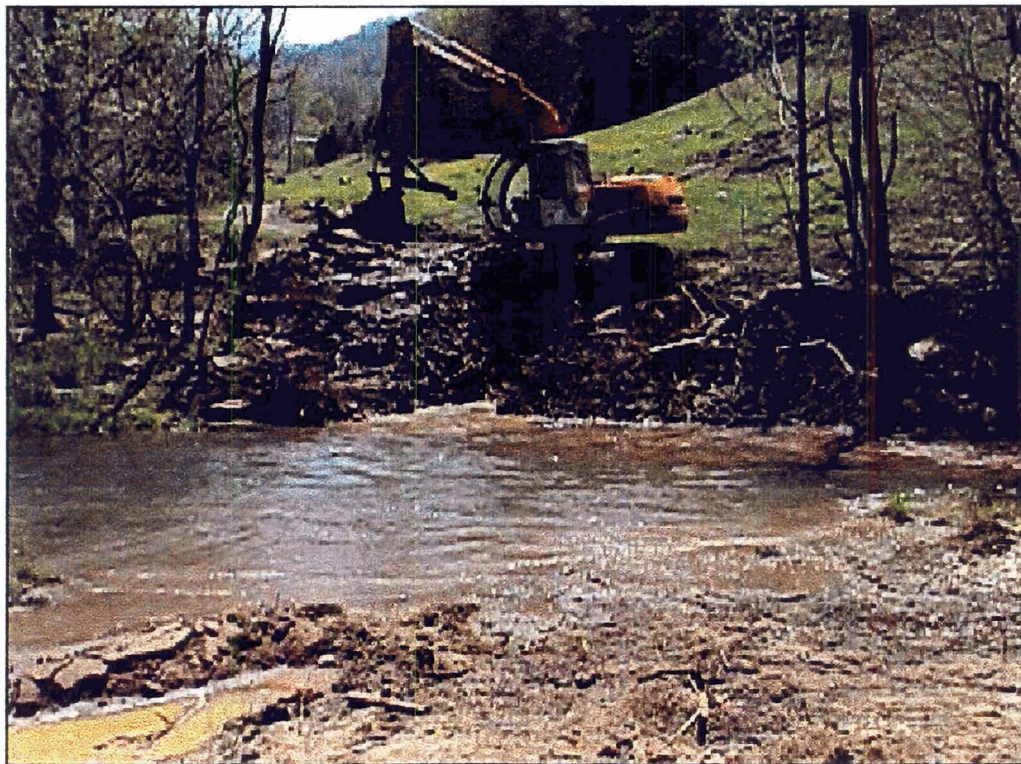
Big bend below driveway bridge. Top photo shows the existing conditions with erosion and auto parts as stabilizing material. Bottom photo shows removing auto parts and trash and installing root-wads and creating floodplain to match existing bench upstream.

4. Install J-hook vanes along eroding sections of Paint Fork Creek to reduce erosion and provide fish habitat.
5. Stabilize the "big bend" in Paint Fork Creek by removing the auto parts presently used and constructing a bankfull bench with boulders and a rootwad revetment.

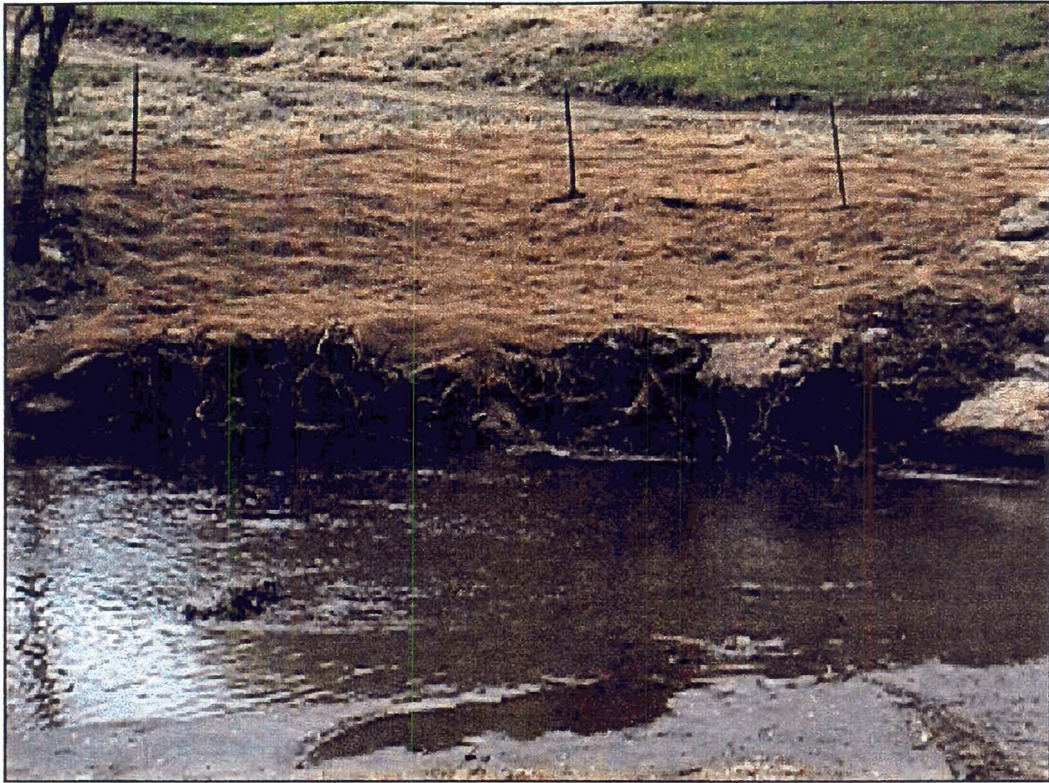
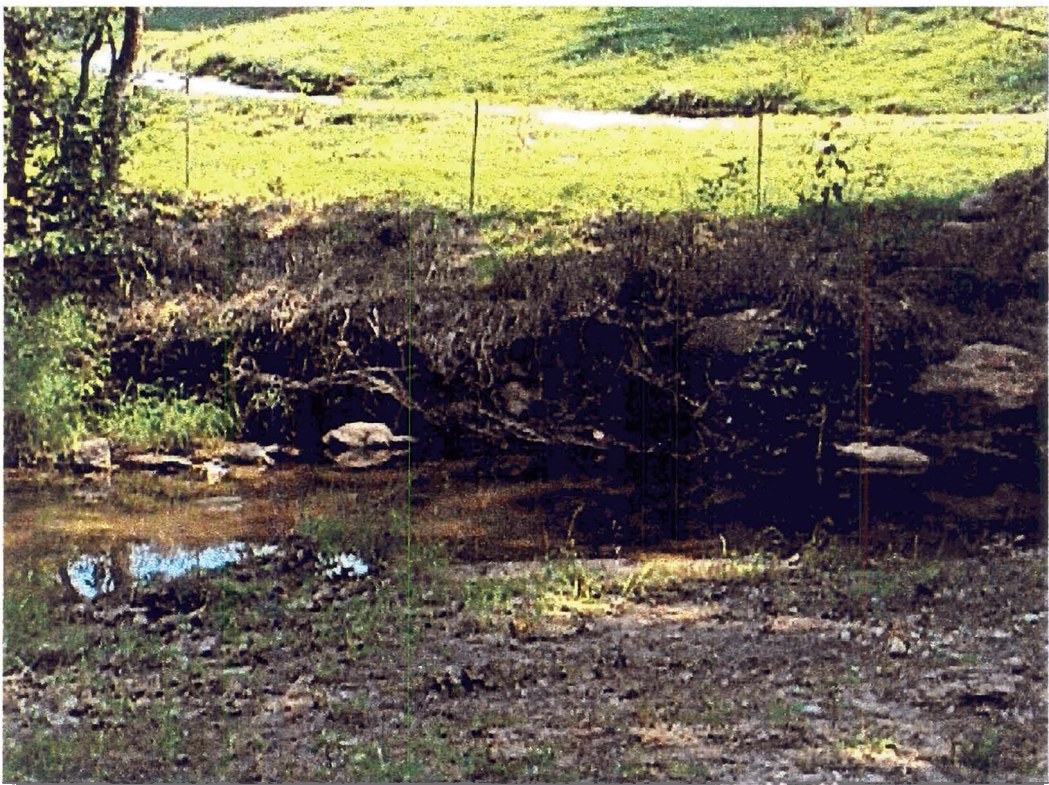
Top photo shows concave side of meander after construction and installation of erosion control material and root-wads. Bottom photo shows flood-plain bench matching the upstream bank with cover crop vegetation, trees and fence 3 months after construction.
