**ANNUAL REPORT FOR 2003**

**Paint Fork Creek Stream Mitigation Site (Brigmon Site)  
Madison County  
WBS Element 32573.4.1  
TIP No. A-10WM**

Prepared By:  
Office of Natural Environment & Roadside Environmental Unit  
North Carolina Department of Transportation  
December 2003

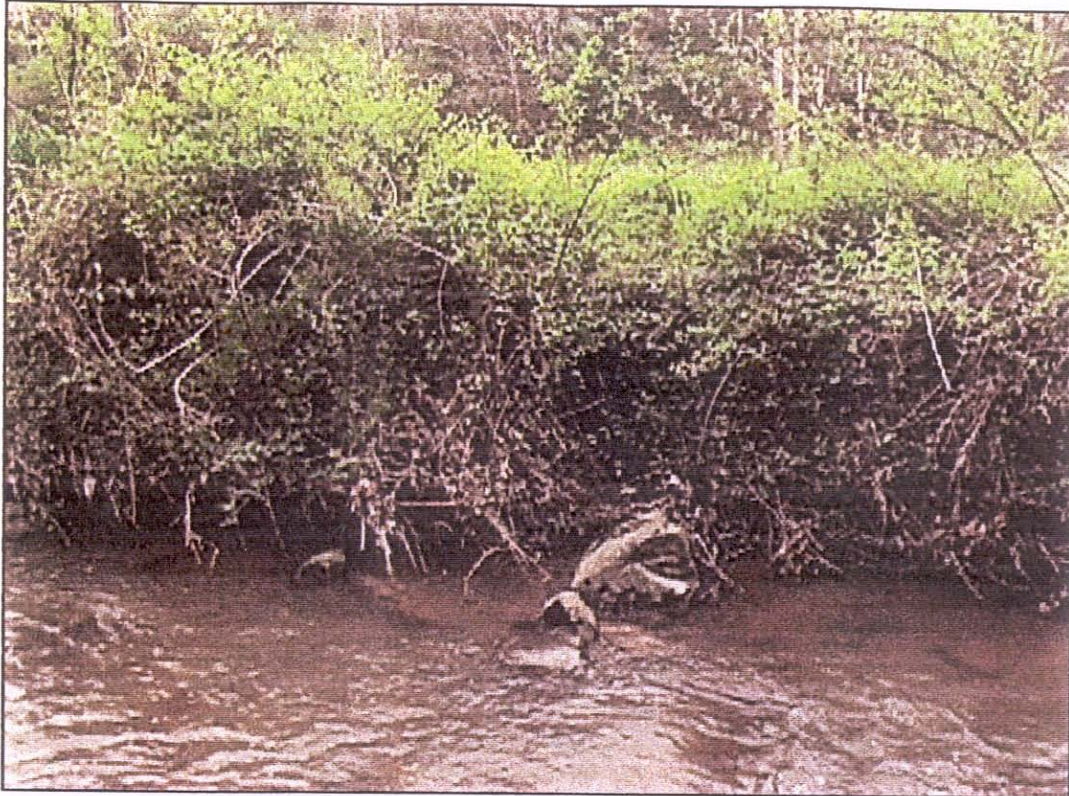
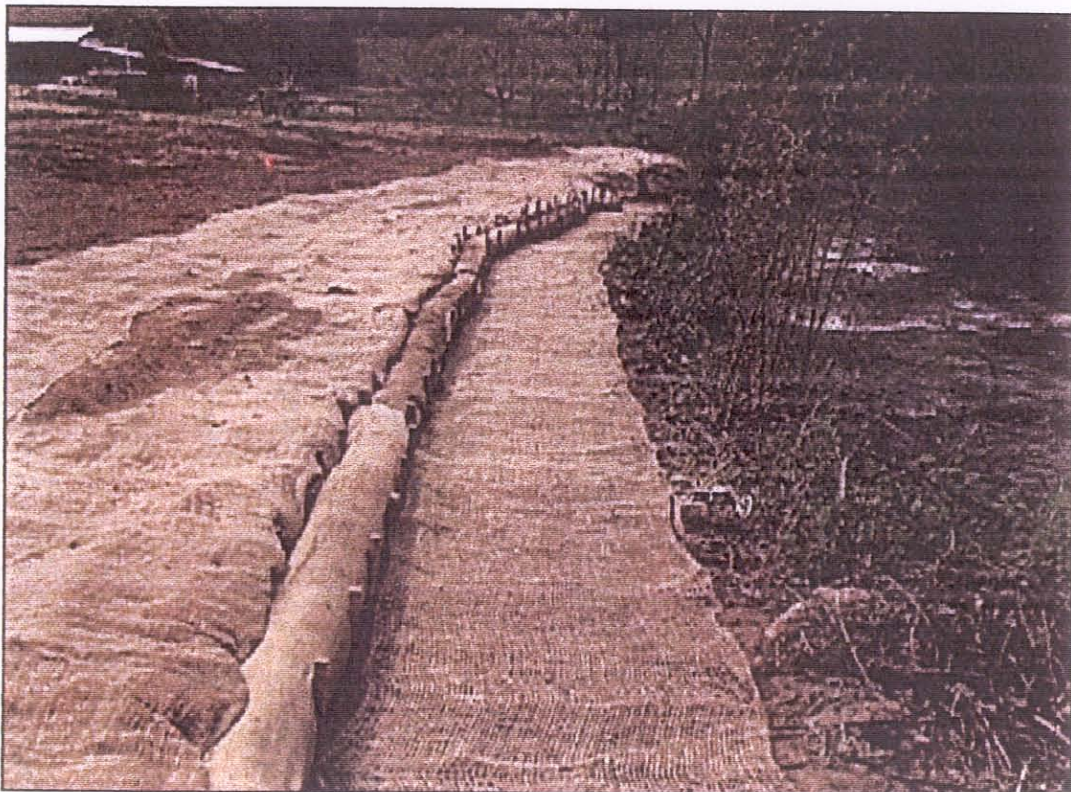
Top photo shows typical condition of stream banks at this site prior to construction. Bottom photo shows typical construction methods used to address vertical bank conditions. Banks are sloped, fertilized, limed, seeded and erosion matting installed. Coir logs are pinned at the bankfull elevation and trees are planted behind this log to provide long-term stability.

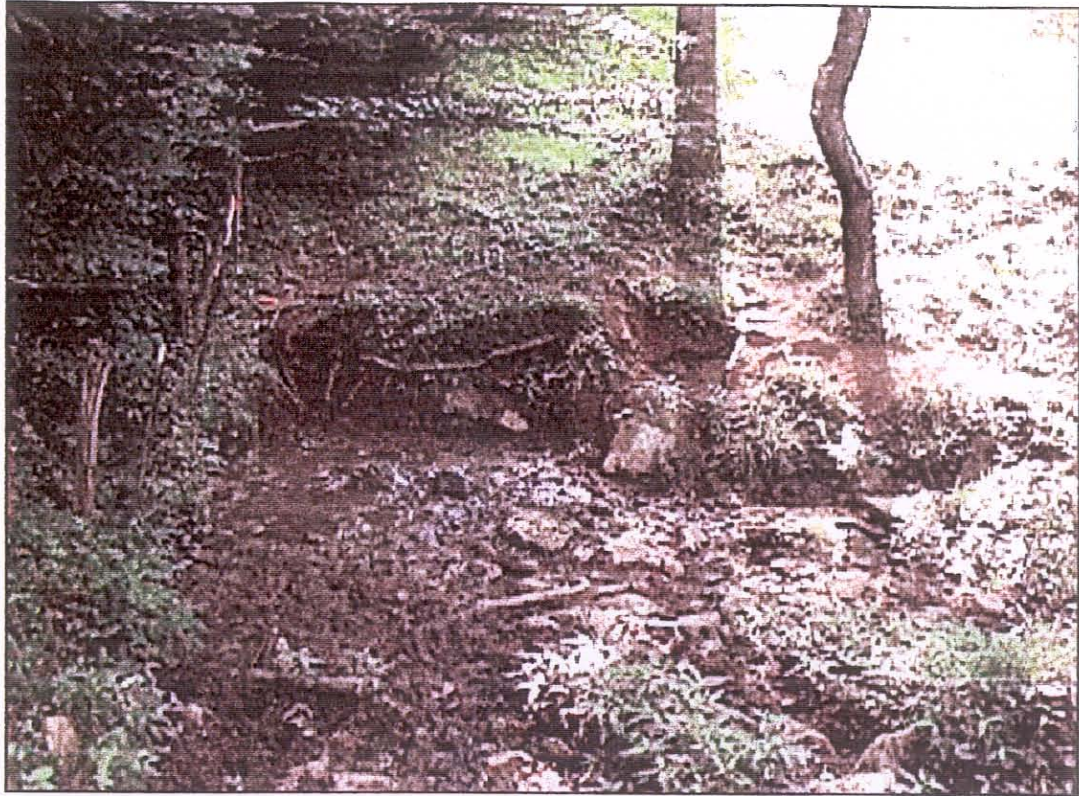
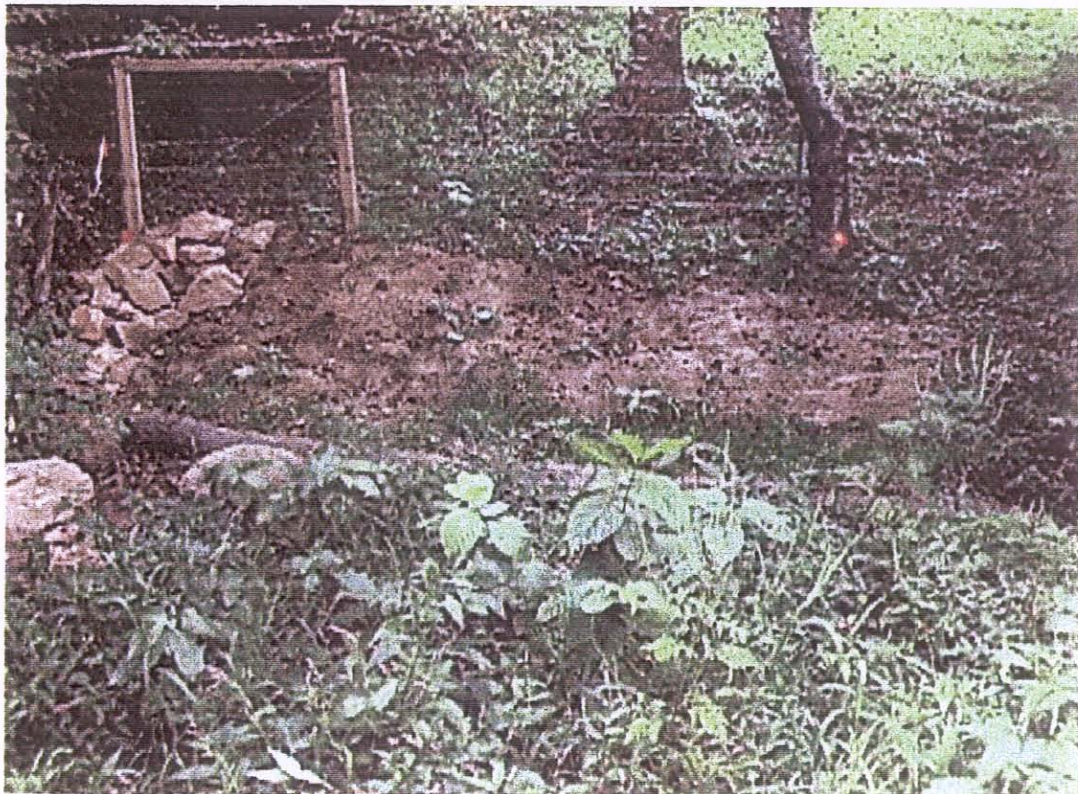
Top photo shows condition of a site that livestock were using to water and cross the stream. Bottom photo shows the same site after coir logs were used to define the channel and the banks were filled and sloped up to the logs. The site was seeded and protected with erosion control blankets. Trees were planted and the stream fenced.

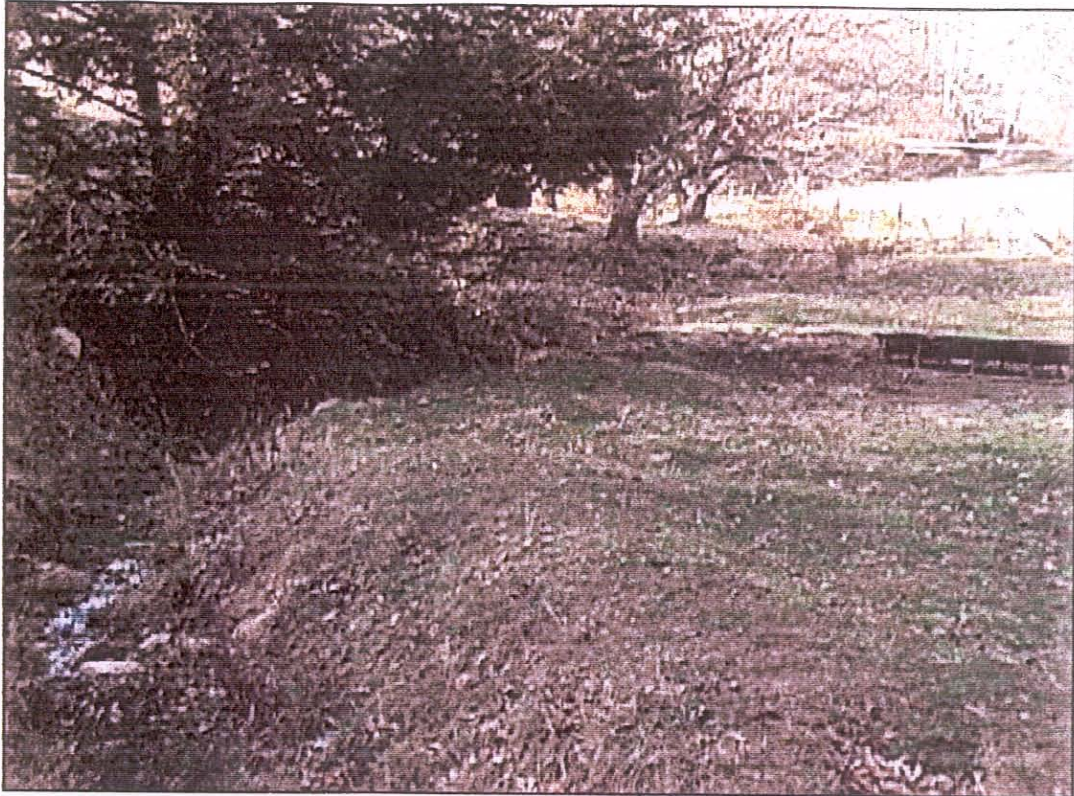
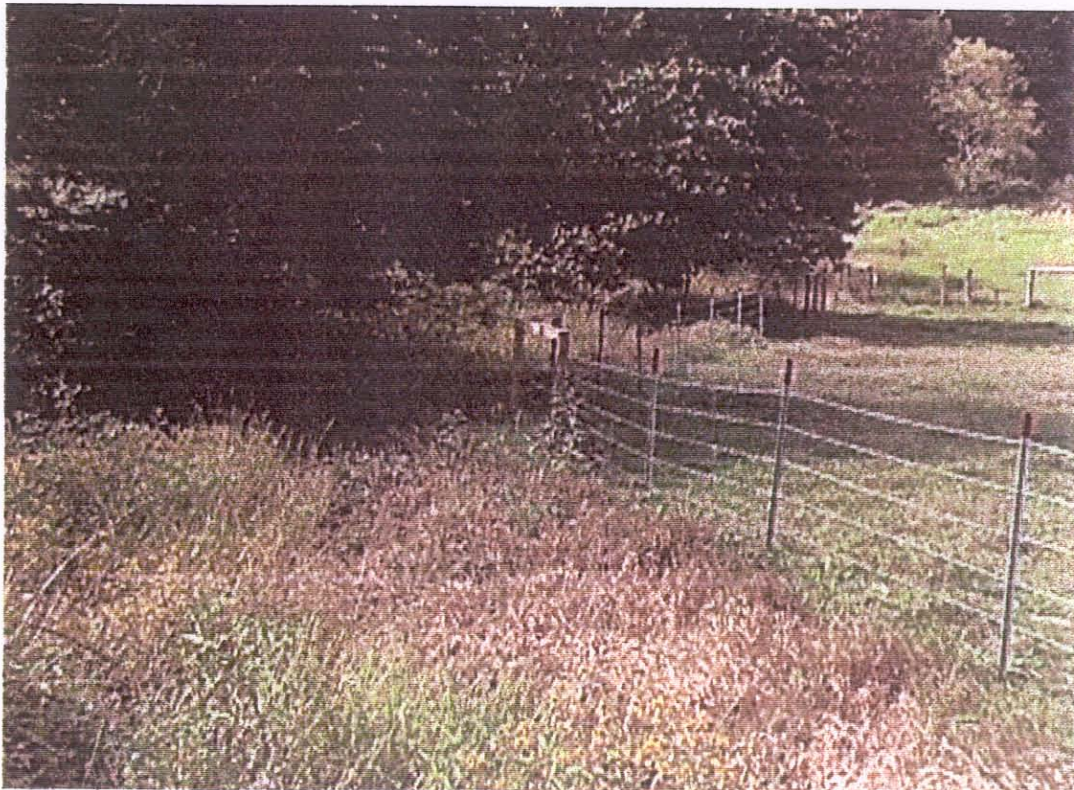
Top photo shows the lower end of the upper, unnamed tributary prior to construction. Bottom photo shows the same site after construction. Banks were sloped and seeded and livestock were fenced out of the site. Prior to construction, the two small unnamed tributaries at this site were major sources of sediment during high water periods.

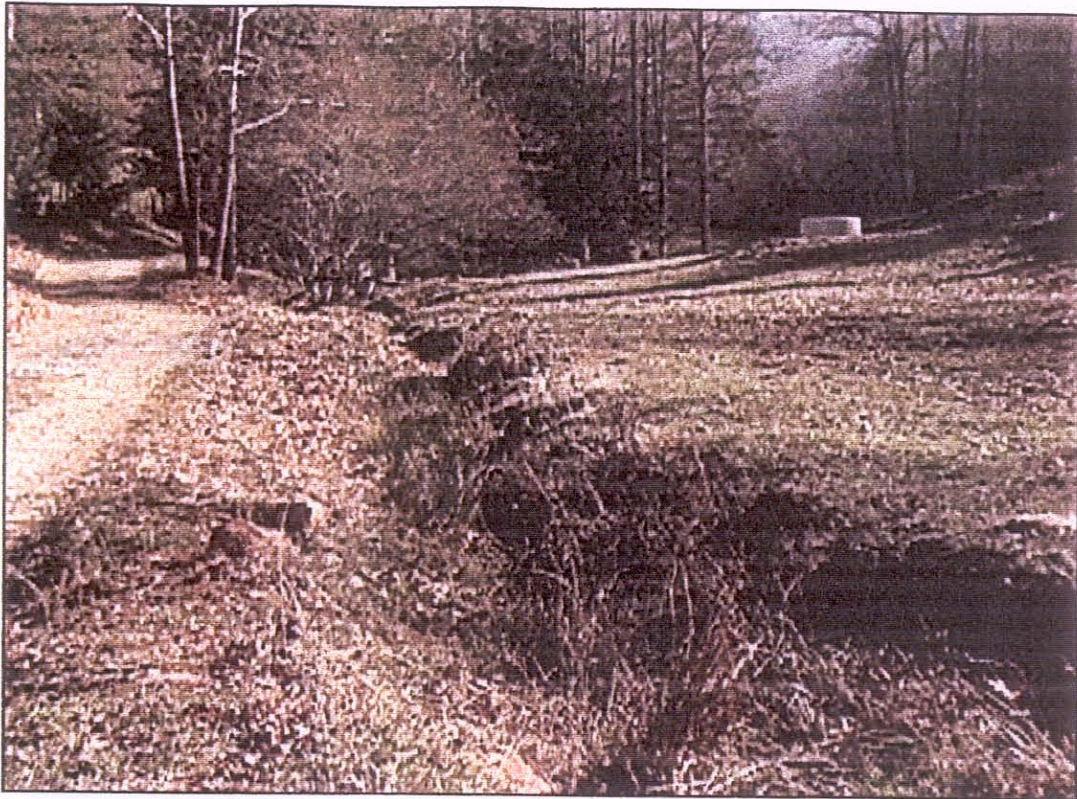
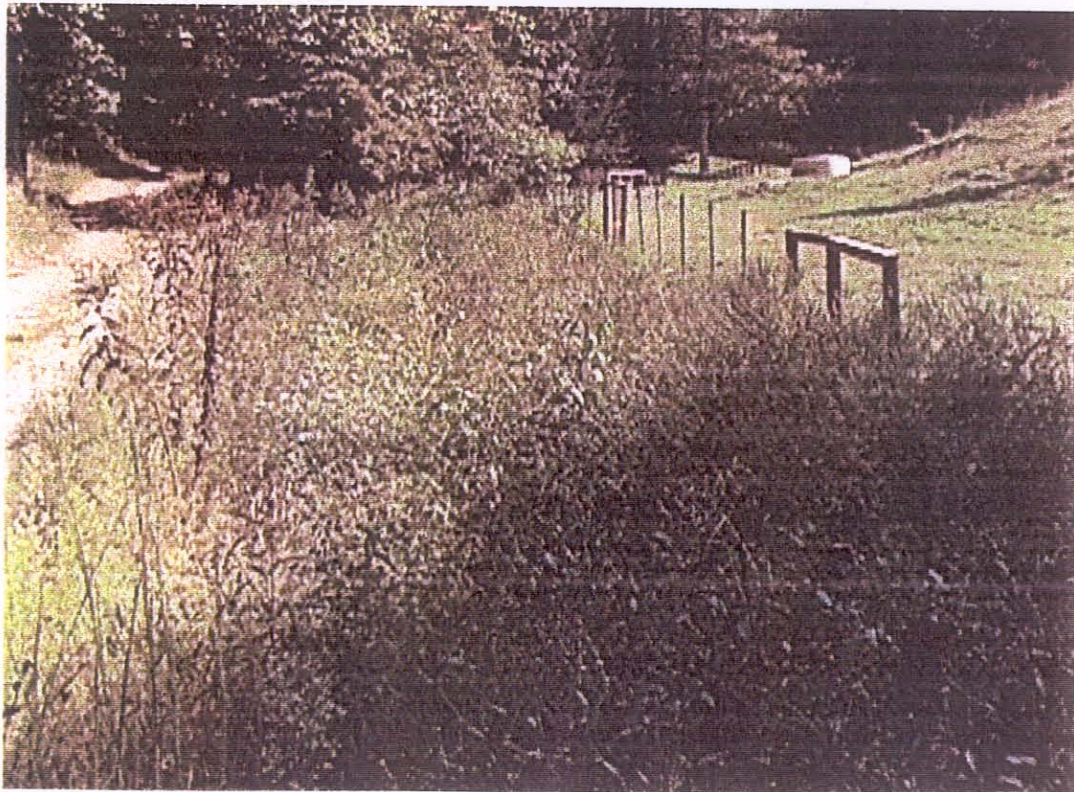
Top photo is along the lower, unnamed tributary looking up stream from the bottom of the reach. Bottom photo is the same site after construction. Vegetation has grown thick on the banks. Livestock were fenced out of this site and one of the water tanks installed at this site can be seen in the background. A covey of quail was flushed at this site when taking this photo.

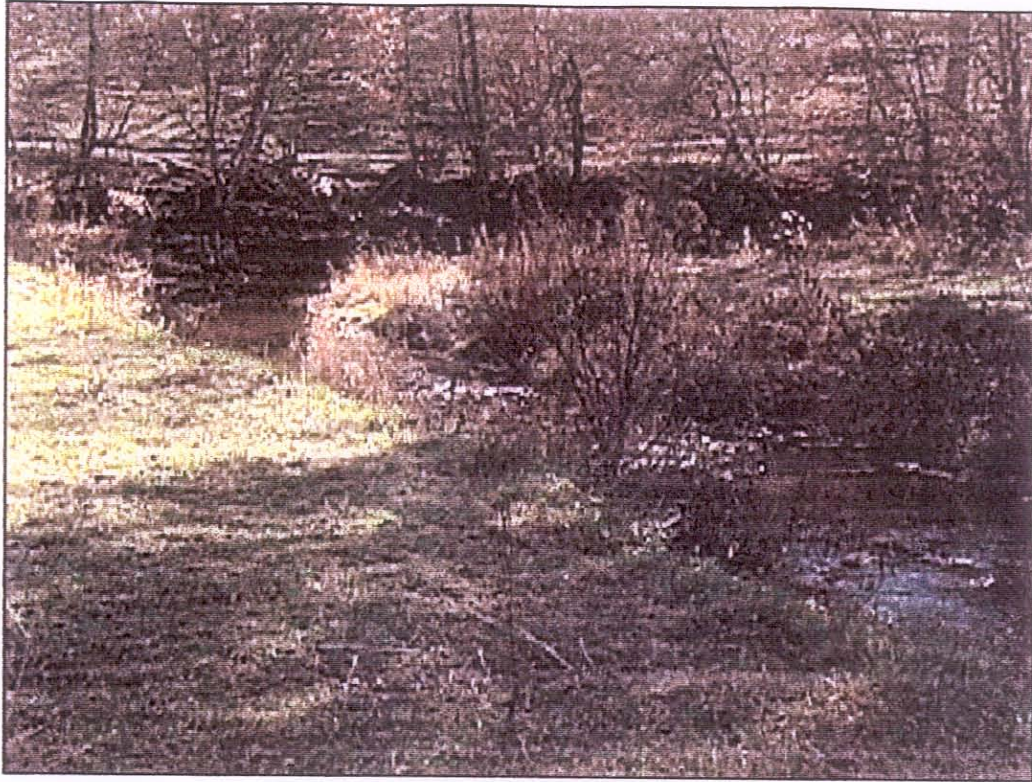
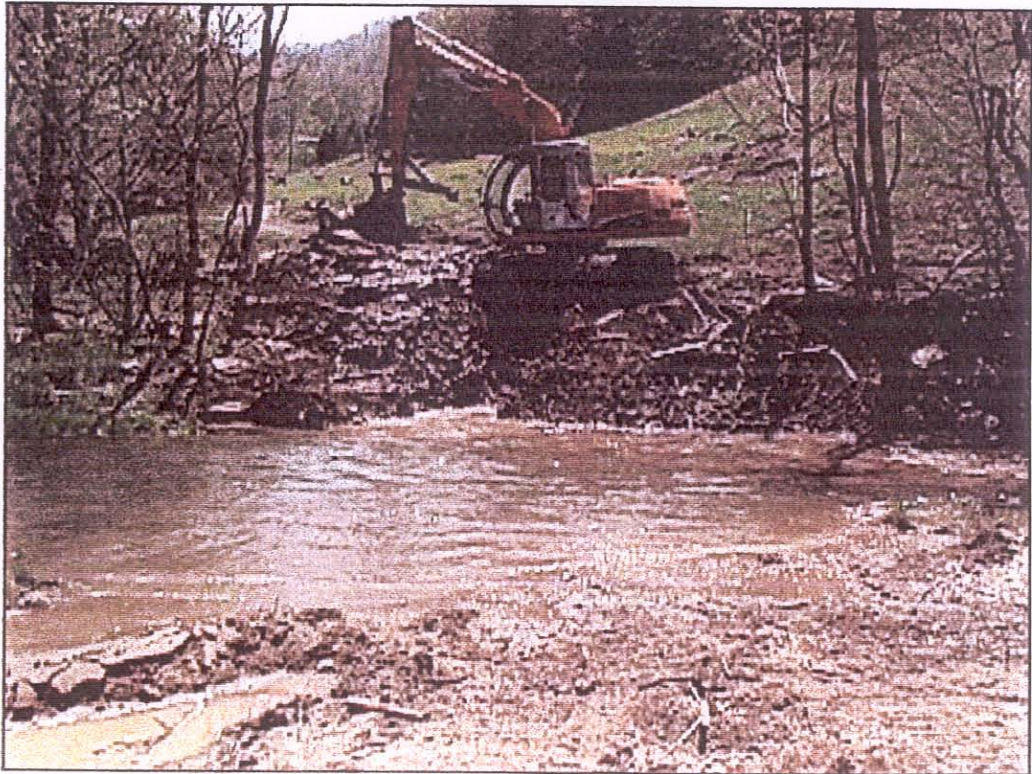
Big bend below driveway bridge. Top photo shows the existing conditions with erosion and auto parts as stabilizing material. Bottom photo shows removing auto parts and trash and installing root-wads and creating floodplain to match existing bench upstream.

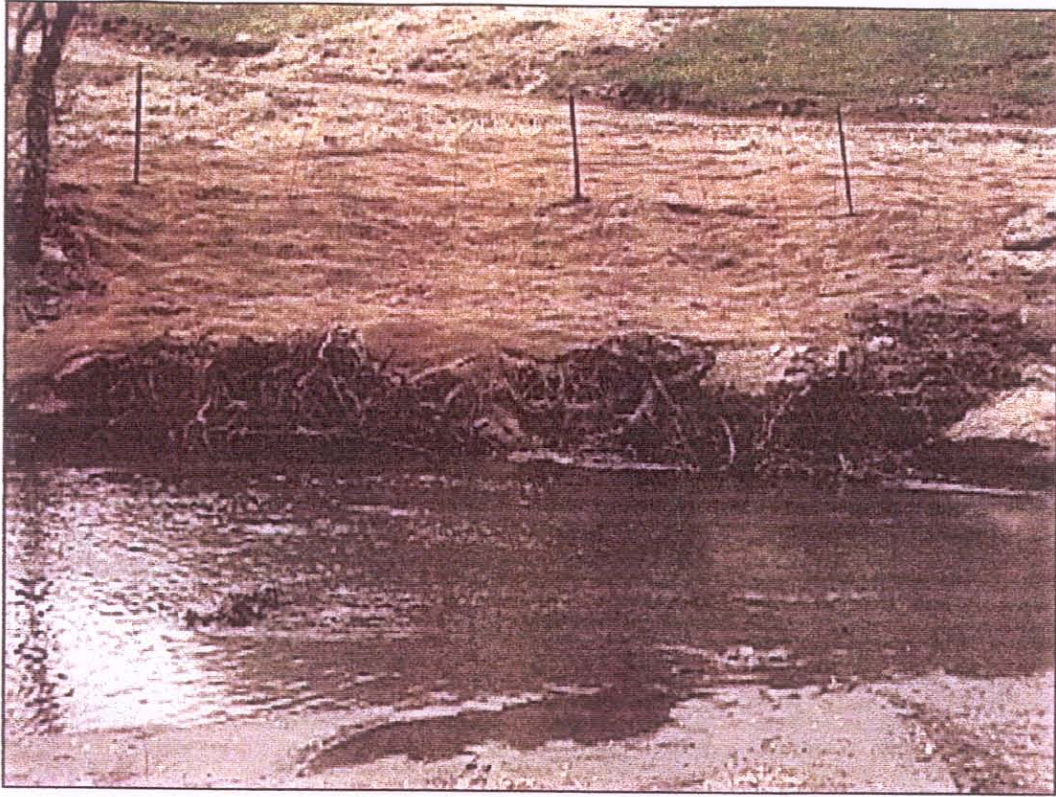
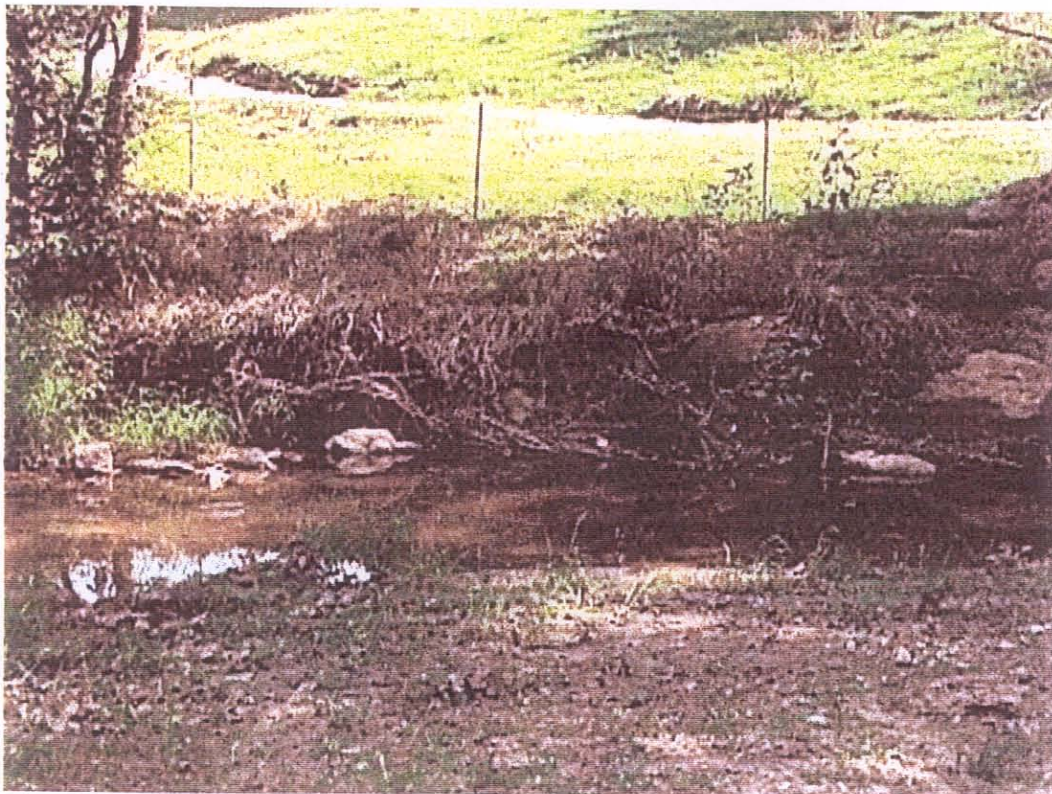
Top photo shows concave side of meander after construction and installation of erosion control material and root-wads. Bottom photo shows flood-plain bench matching the upstream bank with cover crop vegetation, trees and fence 3 months after construction.
