ANNUAL REPORT FOR 2004

Paint Fork Creek Stream Mitigation Site (Brigmon Site)
Madison County
WBS Element 32573.4.1
TIP No. A-10WM

Prepared By:
Office of Natural Environment & Roadside Environmental Unit
North Carolina Department of Transportation
March 2005

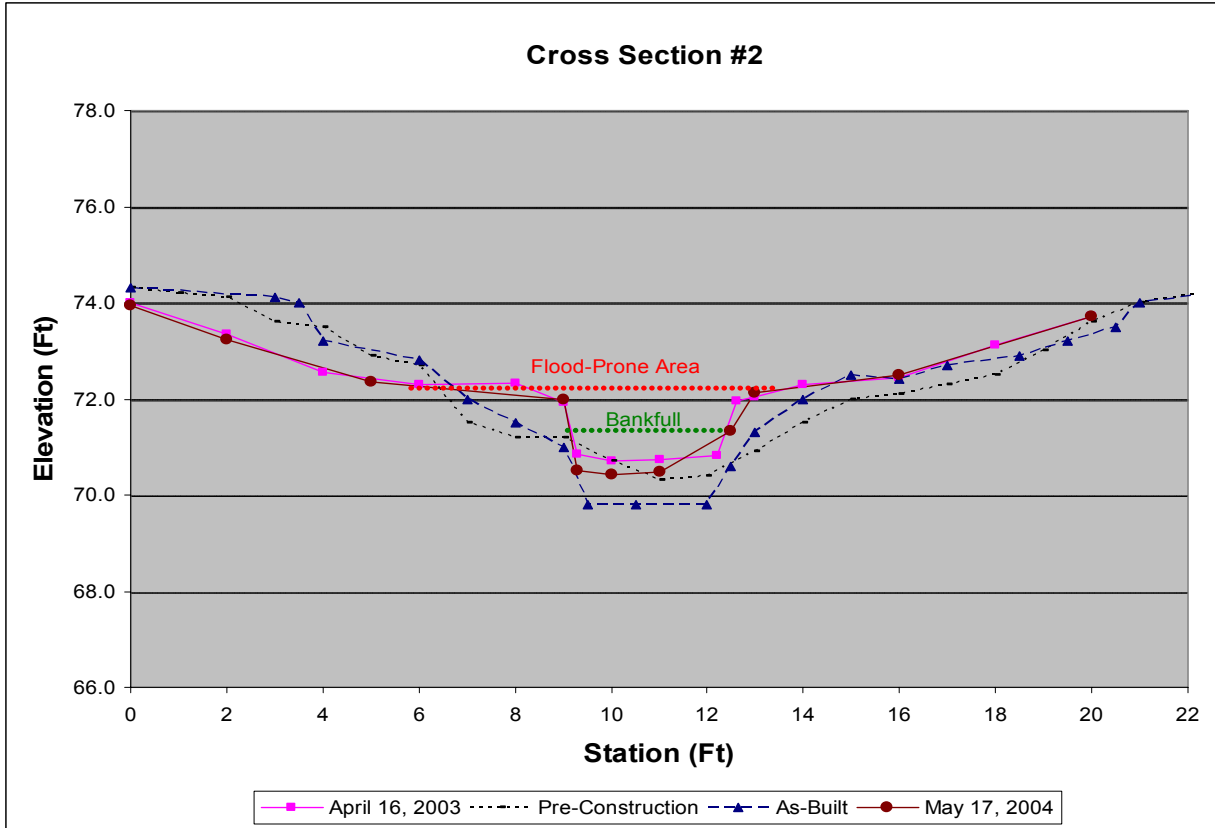
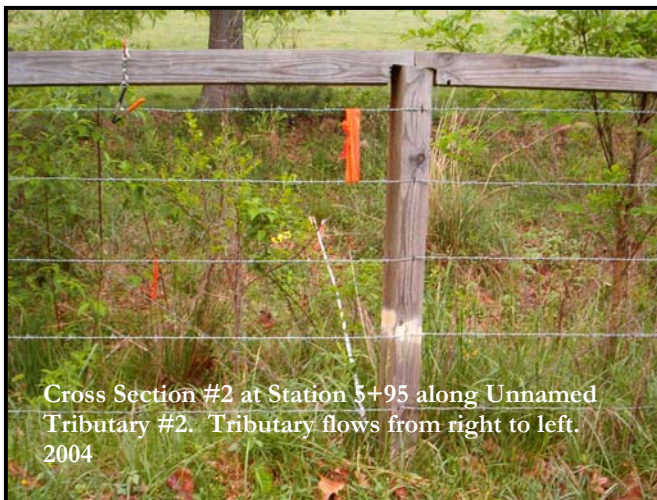
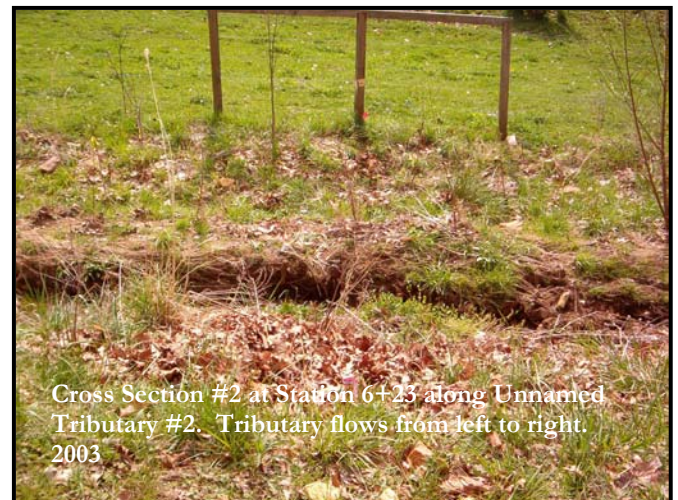
Cross-Section #2 Abbreviated Morphological Summary		
	2003	2004
Bankfull Cross Sectional Area (ft ²)	4.1	2.2
Maximum Bankfull Depth (ft)	1.3	0.9
Bankfull Mean Depth (ft)	1	0.7
Width/Depth Ratio	4.4	5.1
Entrenchment Ratio	4	3
Bankfull Width (ft)	4.2	3.4

The majority of the cross sections along all three reaches remain intact. Cross Sections #2, #10, and #12 appeared to be slightly aggrading based on the comparison of 2004 data to 2003 data. Cross Section #11 appears to be slightly degrading. It is anticipated that the channel will continue to aggrade and degrade over the course of time due to overall changes in the watershed.

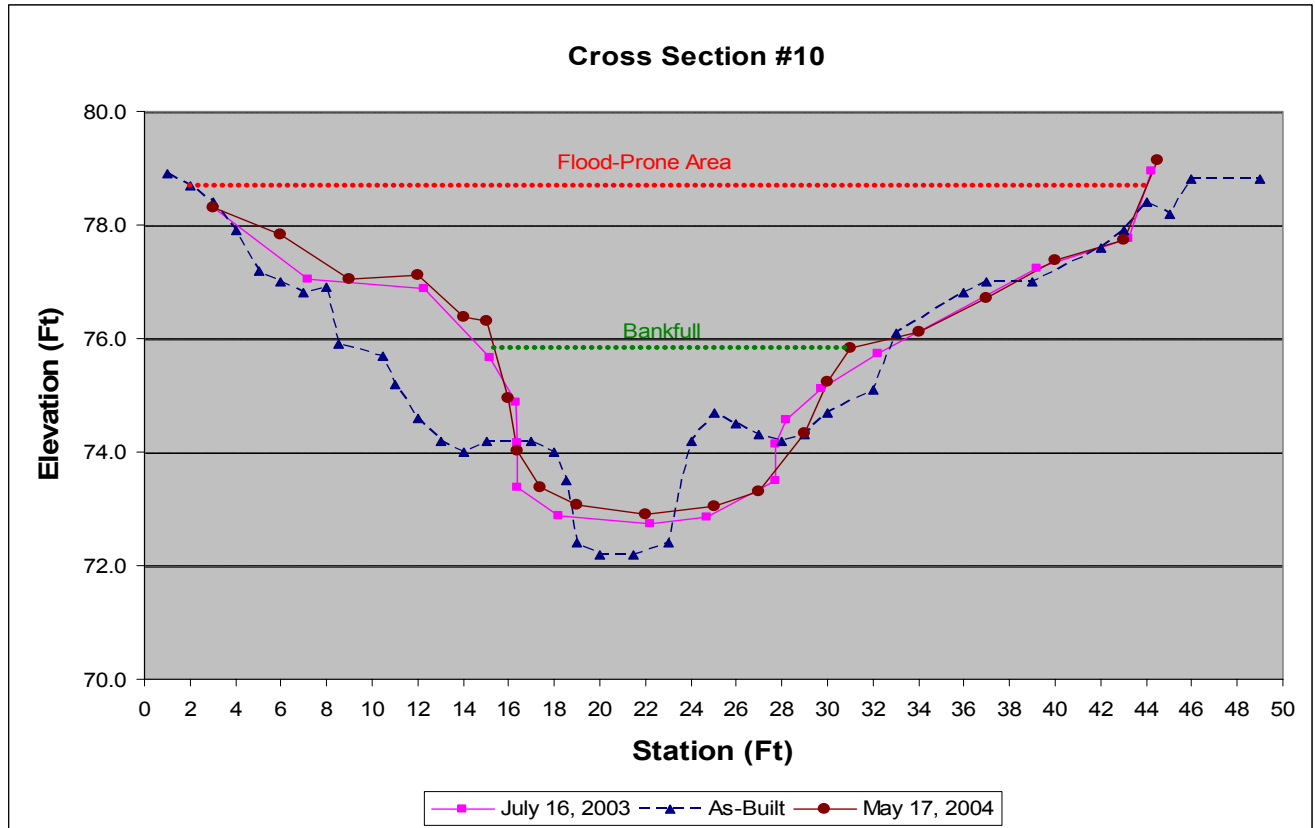
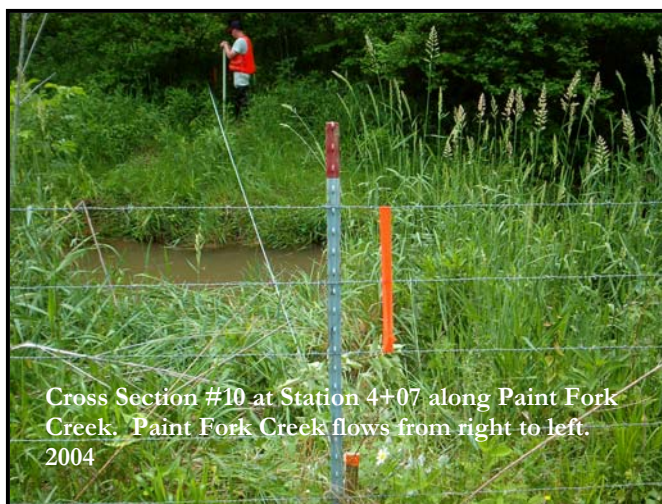
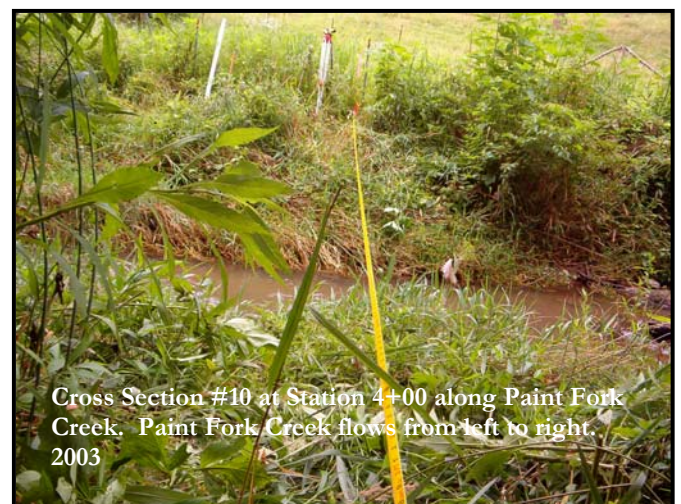
Cross-Section #10 Abbreviated Morphological Summary		
	2003	2004
Bankfull Cross Sectional Area (ft ²)	33.8	35
Maximum Bankfull Depth (ft)	2.9	2.9
Bankfull Mean Depth (ft)	2	2.2
Width/Depth Ratio	8.3	7
Entrenchment Ratio	3	3.2
Bankfull Width (ft)	16.7	15.6

- ◆ Cross Section #10 at Station 4+70. Active erosion was noted along left side of cross vane arm in 2003. This area remained stable in 2004.
- ◆ Cross Section #11 at Station 6+16. Active erosion was noted along cross vane arms on both sides of channel in 2003. This erosion has led to undercutting of the vane arms; however, the cross vane continues to maintain the thalweg in the middle of the channel through this section. This area remained stable in 2004.

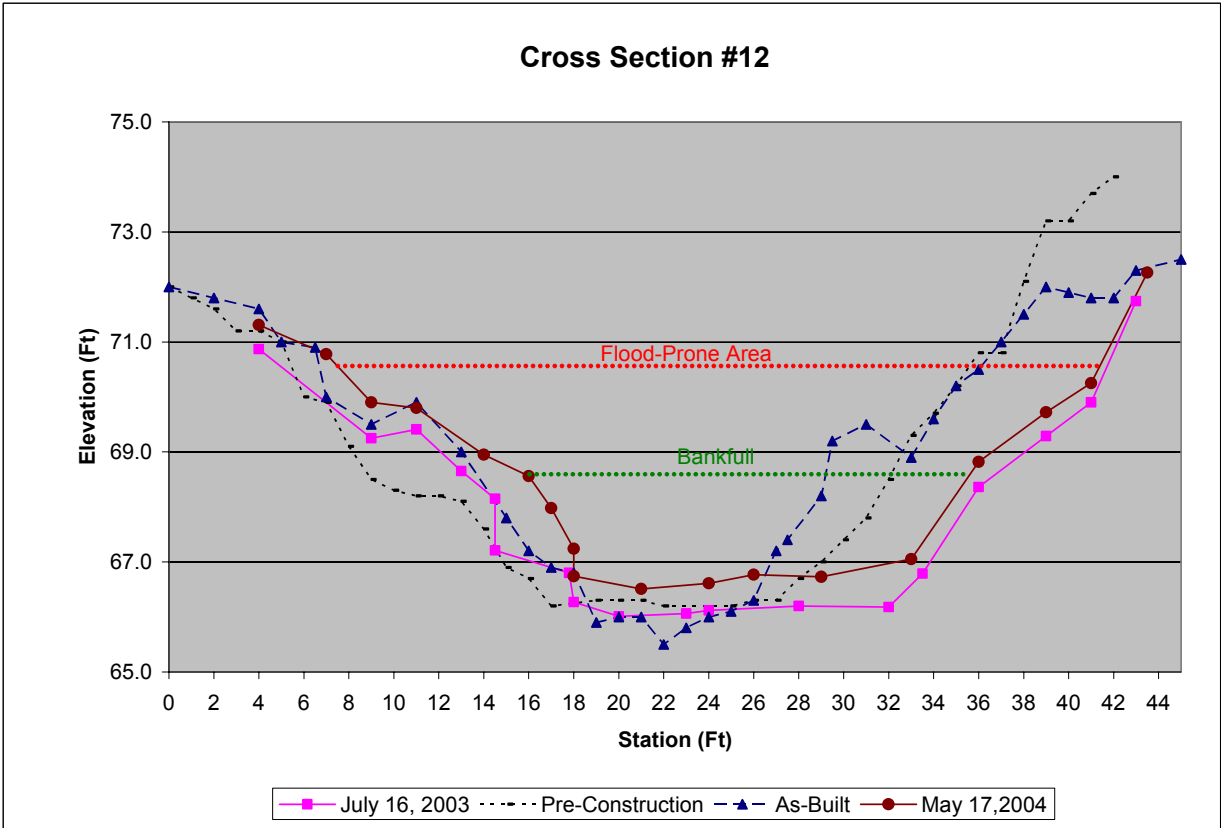
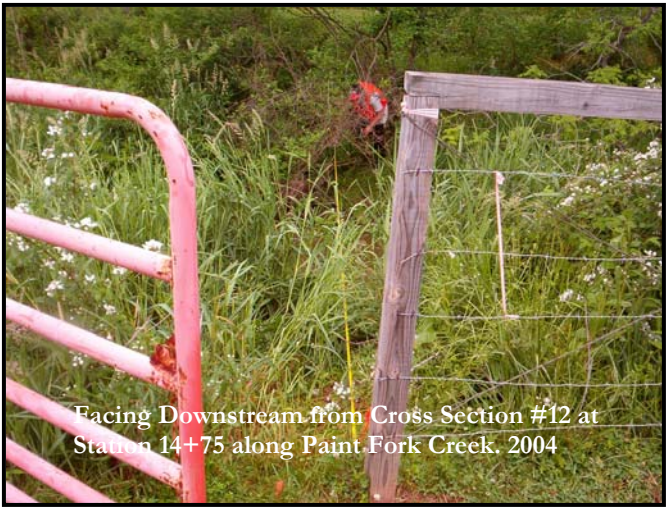
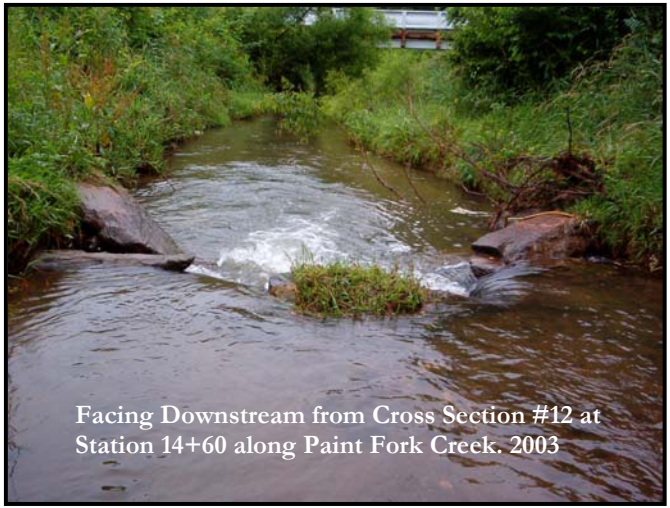
Cross-Section #12 Abbreviated Morphological Summary		
	2003	2004
Bankfull Cross Sectional Area (ft ²)	36.4	30.8
Maximum Bankfull Depth (ft)	2.1	2.1
Bankfull Mean Depth (ft)	1.7	1.6
Width/Depth Ratio	12.3	12.4
Entrenchment Ratio	1.7	1.8
Bankfull Width (ft)	21.2	19.6

- ◆ Station 14+67. The existing elevation of the header rock at a cross vane immediately downstream of Cross Section #12 is higher than the adjacent vane arms, which has resulted in the formation of a center bar immediately upstream of the vane. Active erosion was noted along both arms of the vane in 2003. Vegetation has stabilized this area in 2004. It was observed in 2004 that one of the boulders along the left arm has failed, though it does
