**YEAR 3 MONITORING and CLOSEOUT REPORT**  
**for the**  
**BRIGMON MITIGATION SITE**  
**PAINFORK CREEK,**  
**MADISON COUNTY, NORTH CAROLINA**  
**EEP PROJECT NUMBER 92700**

Prepared in Partnership with the  
North Carolina Ecosystem Enhancement Program  
1652 Mail Service Center  
Raleigh, N.C. 27699-1652

North Carolina Wildlife Resources Commission  
Watershed Enhancement Group  
December 2008

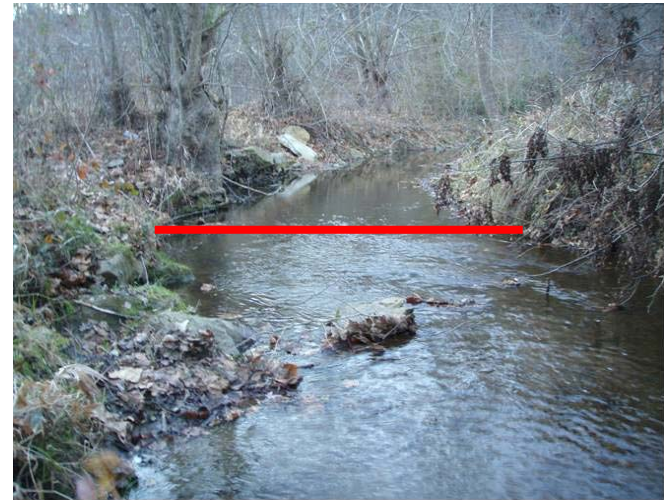
*Cross-section 7 (Run; Appendix Table A.1.).*—The left channel bank has degraded slightly ( $\approx 1.0$  ft) and the right channel bank has aggraded  $>0.5$  ft since project construction. However, during the MY3 survey both channel banks at this cross-section appeared stable. The thalweg degraded  $\approx 1.0$  ft following the as-built survey, as revealed during MY1 and MY2, but was found to be at the same elevation as the as-built thalweg elevation during the MY3. Although minor changes in channel bank location and thalweg elevation have been observed over the course of monitoring, this cross-section appeared stable with no areas of active erosion observed in MY3. The width/depth ratio for this cross-section was below 12.0 for MY2 and MY3, and the entrenchment ratio was 2.2 (slightly entrenched), making this cross-section an E stream type. Adjustments were not made to the right bank during construction because of the proximity to SR 1350.

Cross-section 7, facing downstream, December 2007.

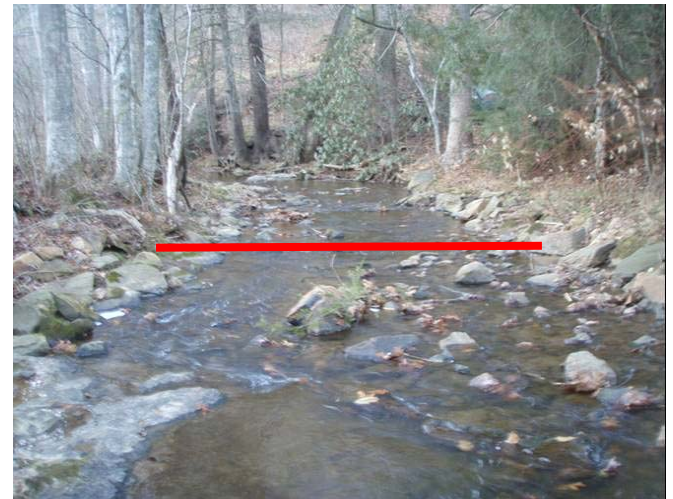
Cross-section 9, facing downstream, December 2007.

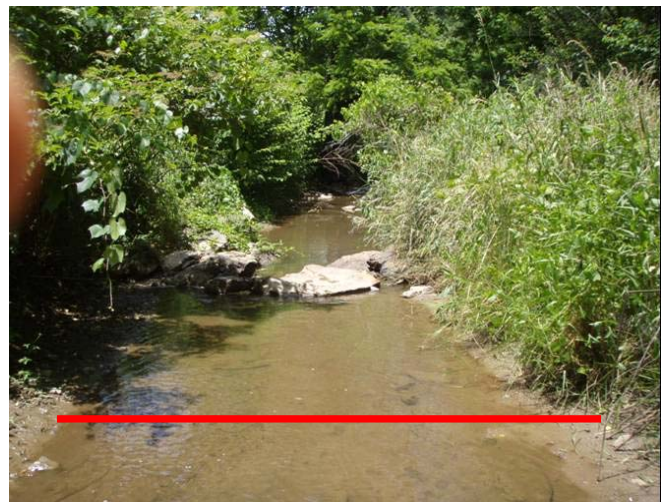
*Cross-section 10 (Run; Appendix Table A.4.).*—Channel dimensions at this cross-section have changed since the as-built survey in 2000. The left and right channel banks aggraded between the as-built survey and MY1, but the left bank then degraded  $\approx 1.5$  ft during the three years between the MY2 and MY3 surveys, although not to the contour found in the as-built survey. The thalweg elevation aggraded  $\approx 1.0$  ft following the as-built survey, but has remained at the same elevation during each of the three monitoring surveys. Vegetation observed along both channel banks was dominated by multiflora rose and various herbaceous species. Although the channel banks appeared stable with no active erosion during MY3, the reestablishment of woody

Cross-section 10, facing downstream, June 2008.

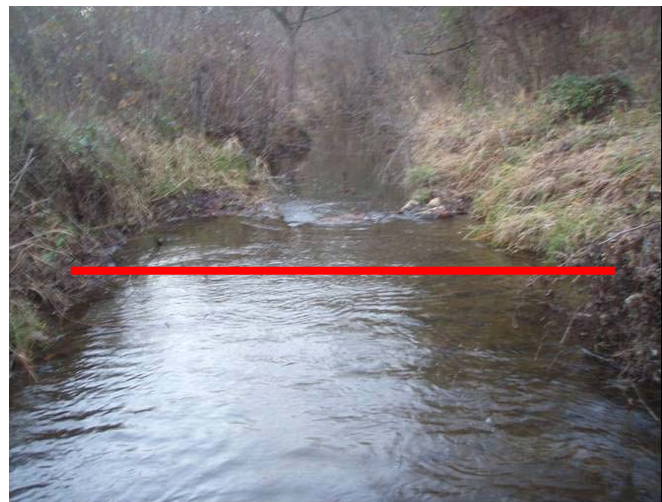
*Cross-section 11 (Glide; Appendix Table A.5).*—Channel dimensions at this cross-section have changed since the as-built survey in 2000. The left and right channel banks degraded between the as-built survey and the MY1 survey. Both channel banks have remained stable since the MY1 survey. Although the thalweg aggraded  $\approx 1.0$  ft following the as-built survey, it remained at the same elevation during each of the three monitoring years. The riparian vegetation primarily consists of multiflora rose and various herbaceous species. The channel banks appeared stable with no active erosion observed during the MY3 survey.

Cross-section 11, facing downstream, December 2007.

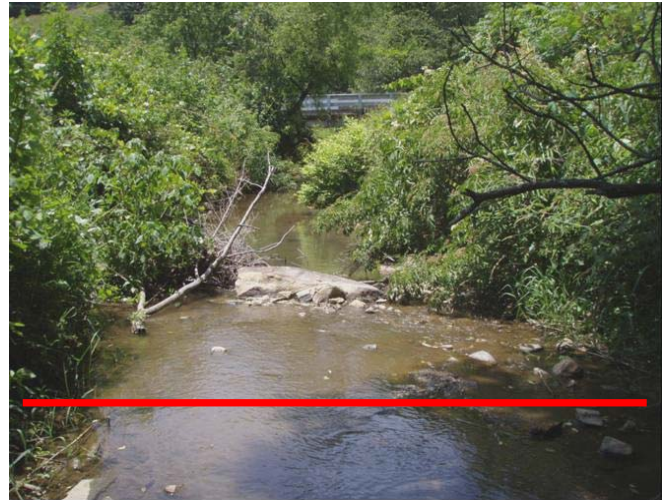
*Cross-section 12 (Run; Appendix Table A.6).*—The channel banks at this cross-section are stable with only minimal aggradation observed over the seven years since project completion. The thalweg aggraded  $>1.0$  ft between the as-built survey and MY1; however, no change in thalweg elevation has been observed during the three monitoring surveys. The observed aggradation may be the result of the in-stream structure (rock cross vane) directly below this cross-section contributing to the accumulation of bed material. In fact, the channel bed surface at this location was observed to be flat and dominated by finer particle sizes. This was observed at the two previous cross-sections as well, all of which are just upstream of in-stream structures. Otherwise, channel adjustments made following the as-built survey appeared to have stabilized and no areas of active erosion were observed during MY3.

Cross-section 12, facing downstream, June 2008.

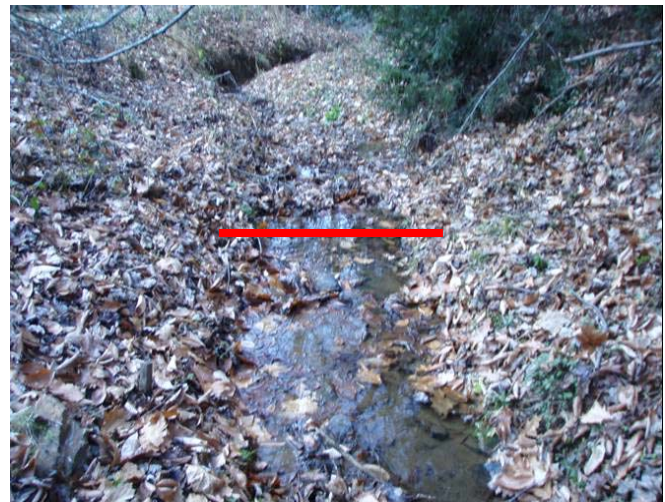
*Cross-section 4 (Riffle; Appendix Table A.7).*—The channel banks and thalweg at cross-section 4 have shown little evidence of change over the seven years since project completion. Minor aggradation on the left channel bank was noted between the as-built survey and the MY1 survey. Thalweg elevation has not changed since the MY1 survey. Variation in morphological values was noted during each of the three monitoring years (Appendix Table A.4.). Morphological values varied the most for MY1 when compared to MY2 and MY3. This variation is likely the result of a bankfull determination that was higher in elevation for MY1 than for MY2-3. Although the channel was moderately entrenched (1.9) in MY3, the left and right channel banks are stable.

Cross-section 4, facing downstream, December 2007.

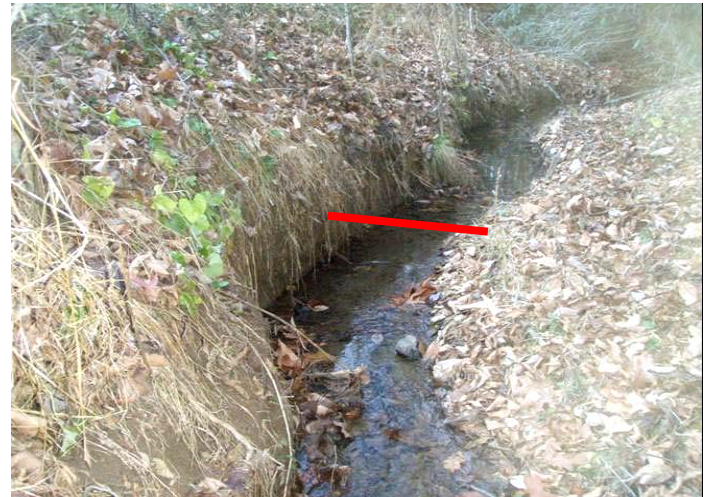
Although the upper unnamed tributary was largely stable, one area of concern was observed. In the vicinity of cross-section 5 (sta. 5+25 to 5+75), the left channel bank has moved laterally and is now  $\approx 3.0$  ft from the fence line delineating the conservation easement boundary. At a minimum, installation of woody plant material or rock toe protection should be considered at this location to provide long-term protection to the left channel bank and fence line.

Cross-section 5, facing downstream, December 2007.

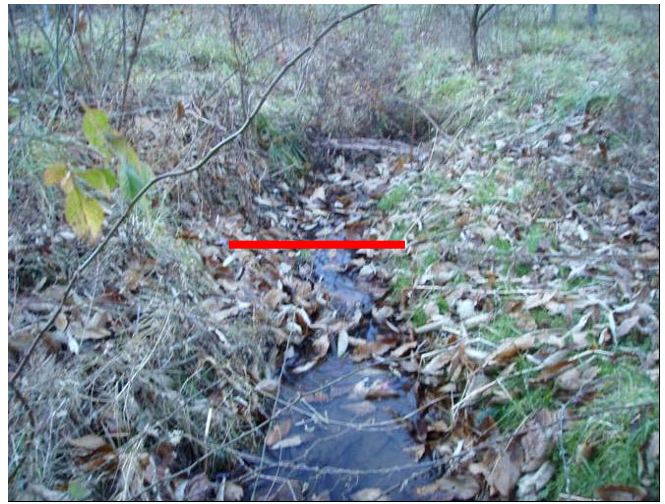
*Cross-section 6 (Riffle; Appendix Table A.9).*—The channel banks and thalweg have remained stable with very little lateral movement or change in elevation in the seven years since construction. Planted vegetation was noted along both channel banks; instability at this cross-section was not observed.

Cross-section 6, facing downstream, December 2007.

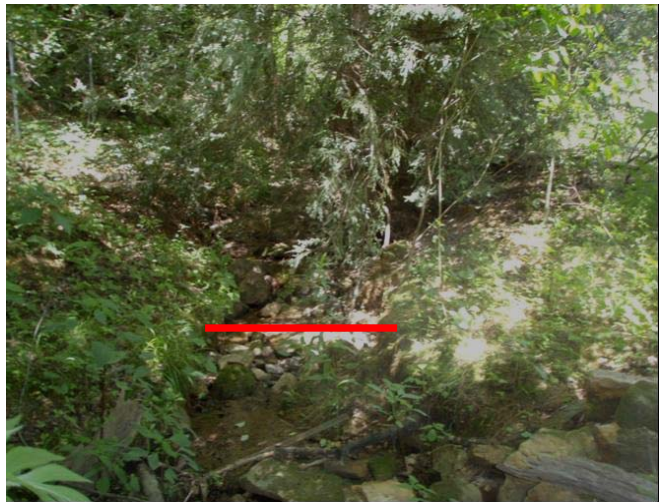
*Cross-section 1 (Riffle; Appendix Table A.10).*—This location was used as a livestock crossing before project construction and establishment of the conservation easement. Since project completion, the thalweg has decreased in elevation  $\approx 0.6$  ft and moved laterally towards the left bank. Although the left channel bank is slightly under-cut, both channel banks appeared stable, and vegetation has become well established. Overall, the channel is in far better condition at this location compared to the pre-project form.

Cross-section 1, facing downstream, June 2008.

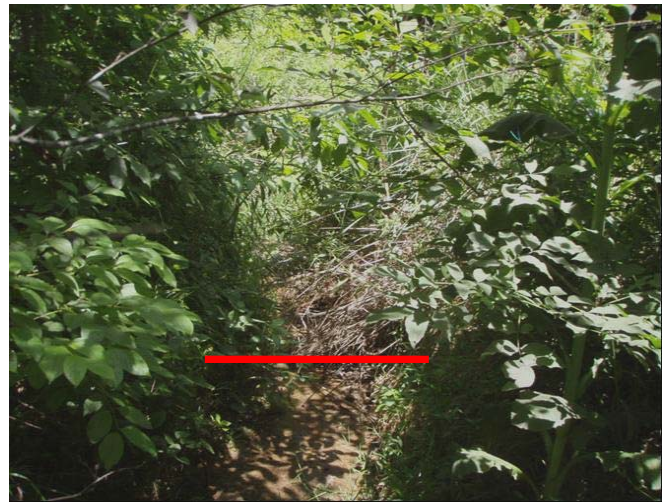
*Cross-section 2 (Riffle; Appendix Table A.11).*—The thalweg has experienced only minor aggradation ( $\approx 0.2$  ft) in the four years since MY1; more aggradation was noted between the as-built condition and the observations made in MY1 ( $\approx 1.0$  ft). Aggradation of the channel bed in MY1 may have resulted from substrate movement during several high water events that occurred following construction. Degradation of the left bank and aggradation to the right bank was noted between MY2 and MY3. Nonetheless, the channel bed and channel banks appeared stable and functioning as desired seven years post-construction. Vegetation is very dense on both banks and is performing as desired.

Cross-section 2, facing downstream, June 2008.

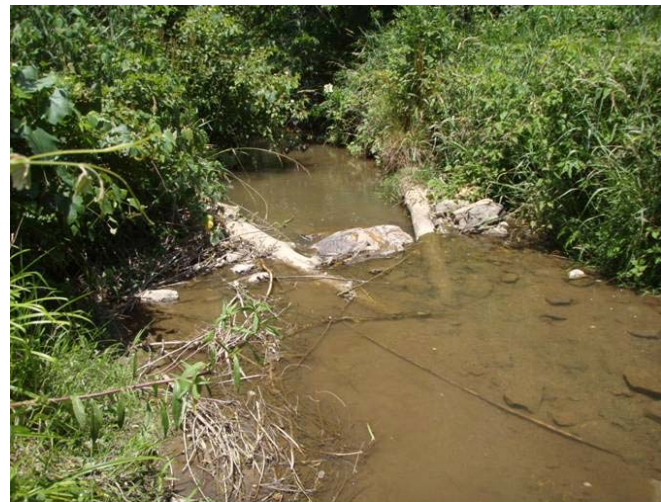
Photo sta. 4, hemlock vane facing downstream, June 2008.

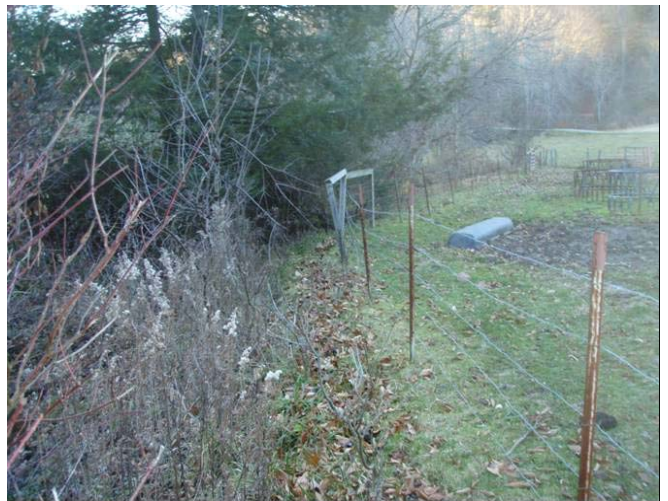
Photo sta. 5, upper tributary facing downstream, December 2007.
