# **Final Monitoring Report/Closeout Report**

Monitoring Year 7 of 7

Pee Dee Stream Restoration Project  
NCDMS Contract No.: 004644  
NCDMS Project No.: 95350  
USACE Action ID: SAW-2012-01077  
DWR #: 13-1140

Montgomery County, NC  
Data Collected: May and October 2021  
Date Submitted: December 2021

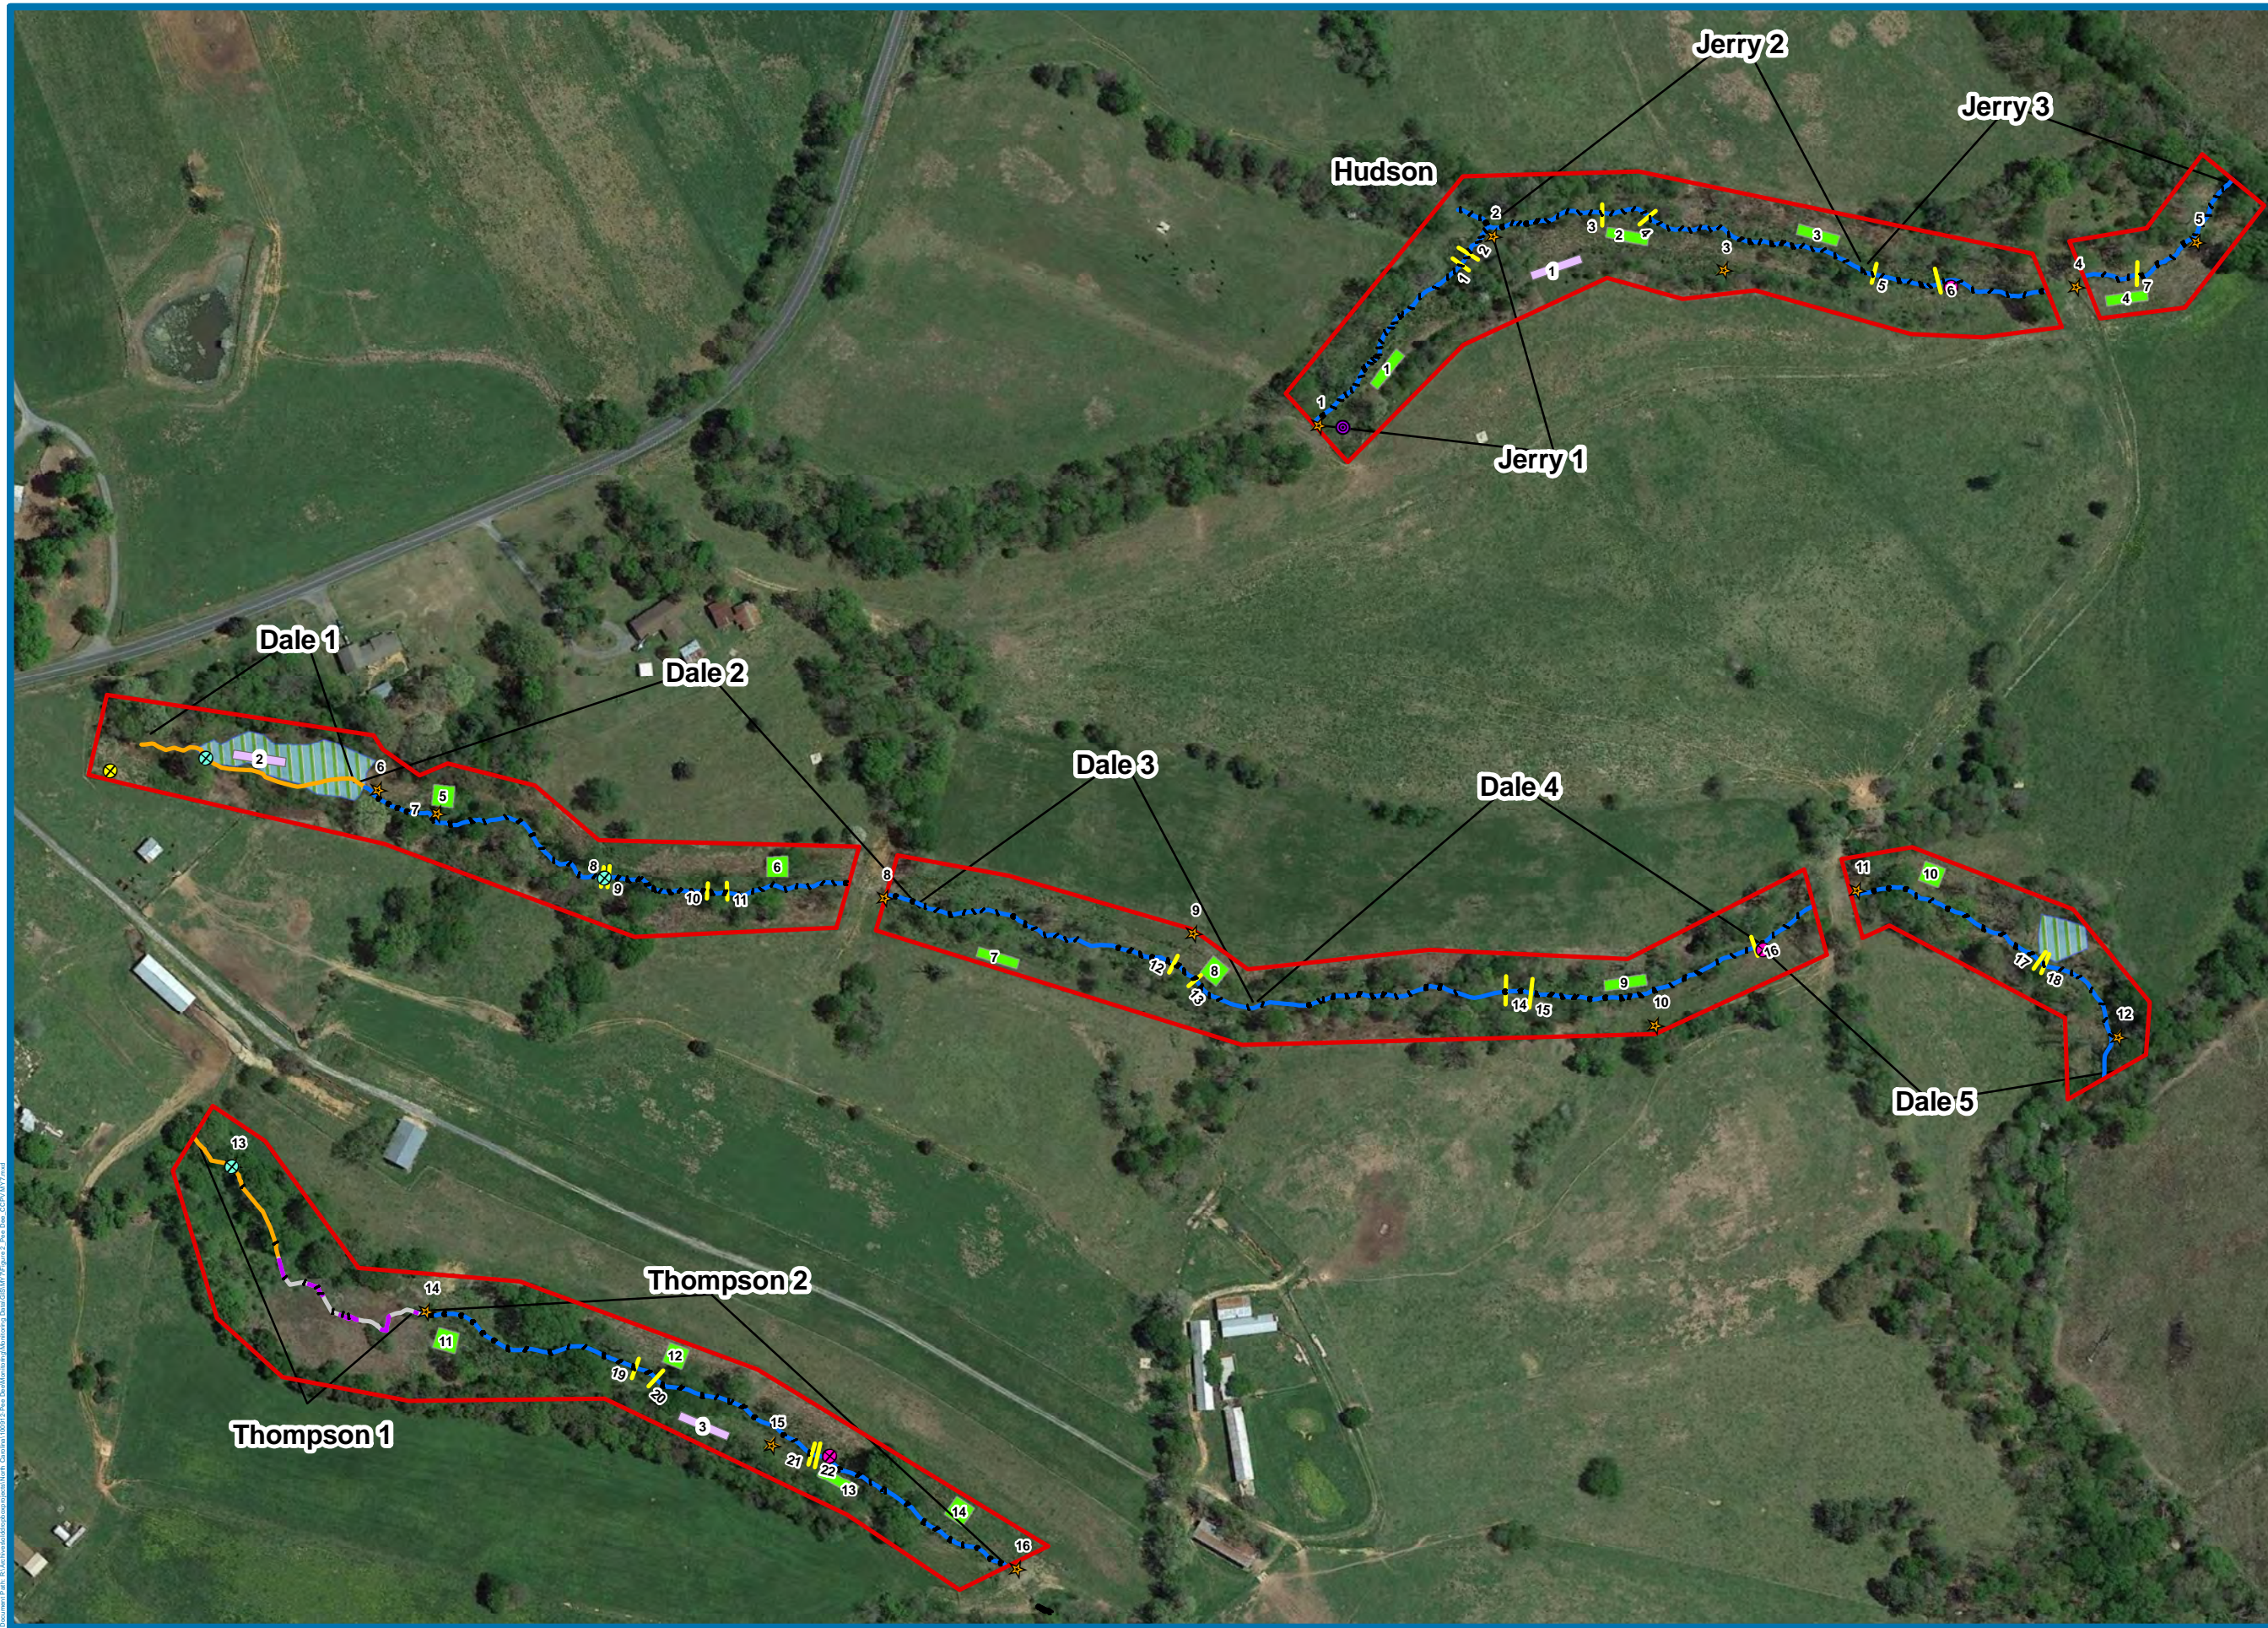
**Figure 2**  
**Pee Dee Stream**  
**Restoration Project**  
**MY7 2021**  
**Current Conditions**  
**Plan View**

Visual assessment of the stream was performed to document signs of channel instability, such as eroding banks, structural instability, or excessive sedimentation. There was no indication of instability was observed during the visual assessment (**Table 5 and Figure 2**). Structures are intact and performing as designed.
