Annual Monitoring Report

Monitoring Year 5 of 7

Pee Dee Stream Restoration Project

NCDMS Project No.: 95350

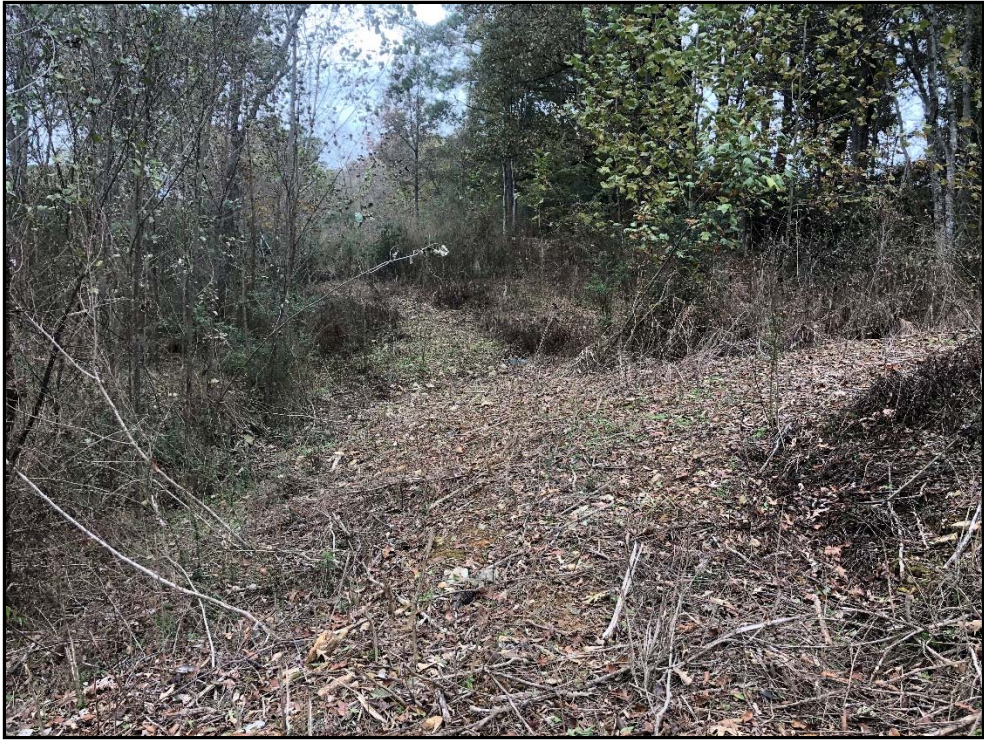
Dale Branch – Privet Mulching Strip

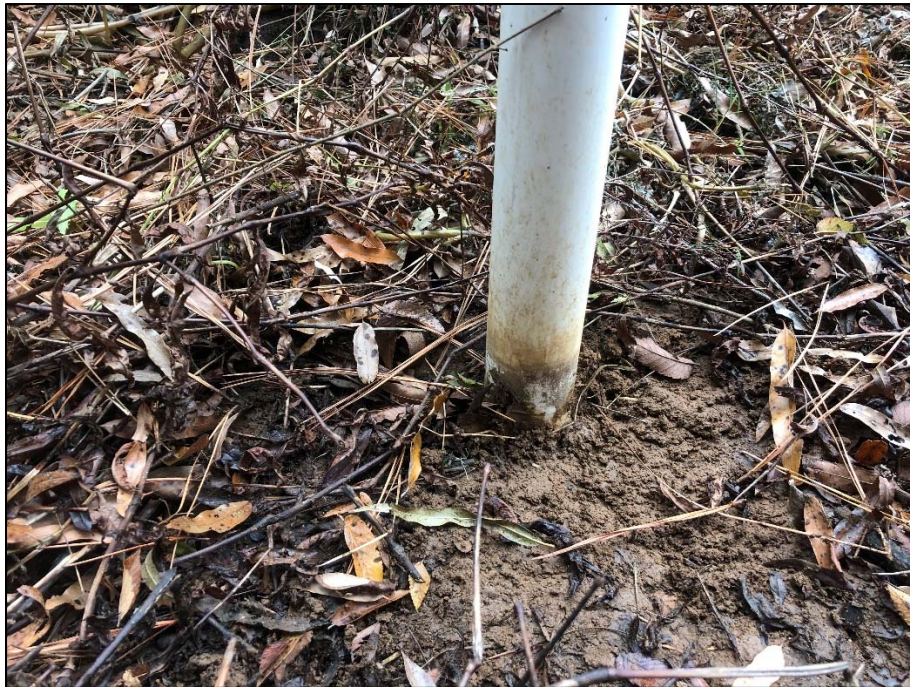
Water stain on FG Dale 1

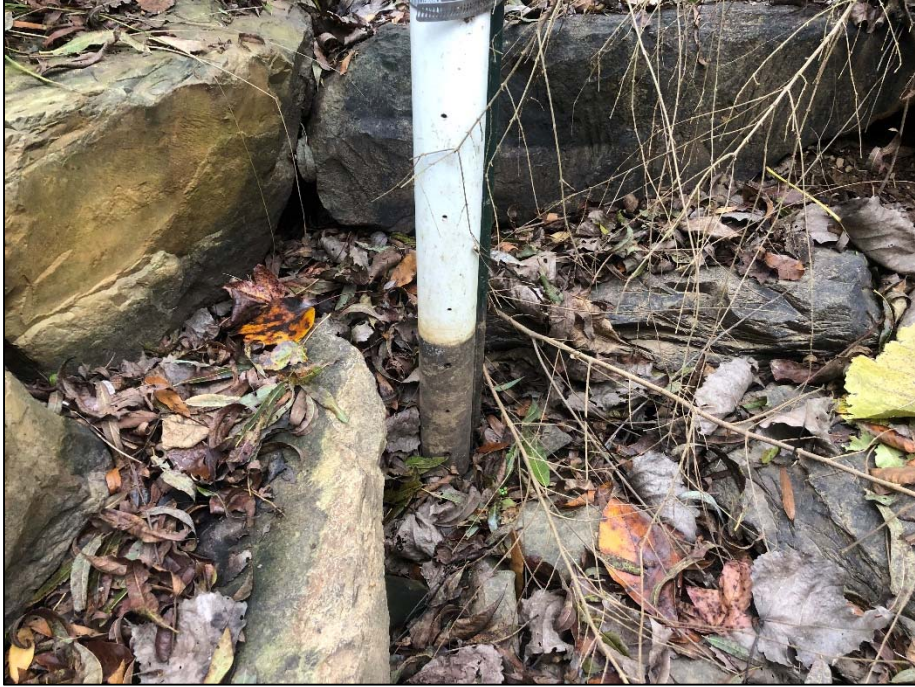
Water stain on FG Dale 2

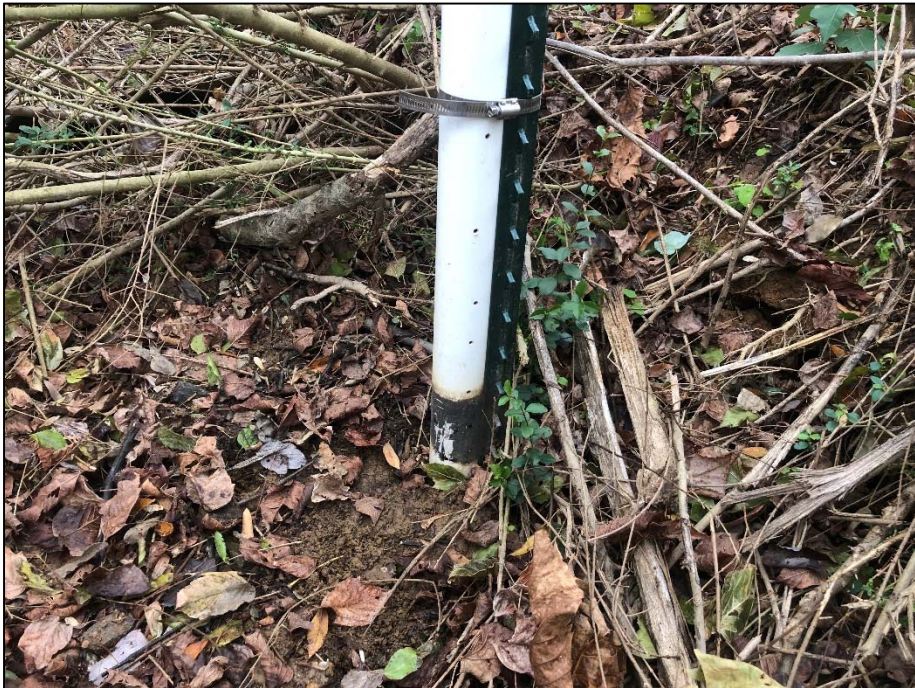
Water stain on FG Thompson 1

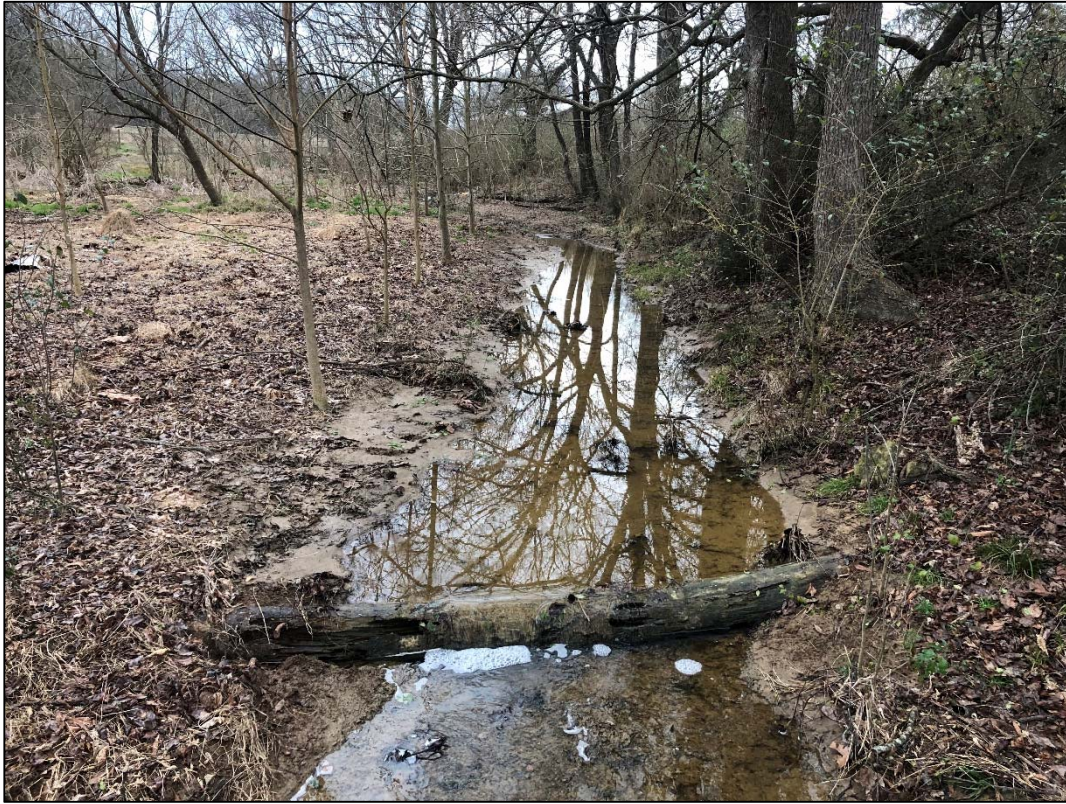
During the July 2018 site visit, the IRT noted that this reach had a defined flow path but the lack of sorting in the bed material and the uniform bedform was characteristic of a stream with less than intermittent flow. In January 2019, RES installed a flow gauge above the old pond bottom to document at least intermittent flow. RES will report consecutive and cumulative flow days in the annual monitoring reports. To further assess perenniality, RES completed NCDWR Stream Forms above the old pond bed and in the pasture upstream of the easement. The reach above the old pond bottom in the easement scored 27.5 and the reach above the old pond bottom in the pasture scored 25. The completed NCDWR Stream Forms are attached. Additionally, the new crossing (constructed in 2017) directly upstream of the easement was inspected to confirm it was not blocking flow.

Thompson 1 above old pond looking upstream

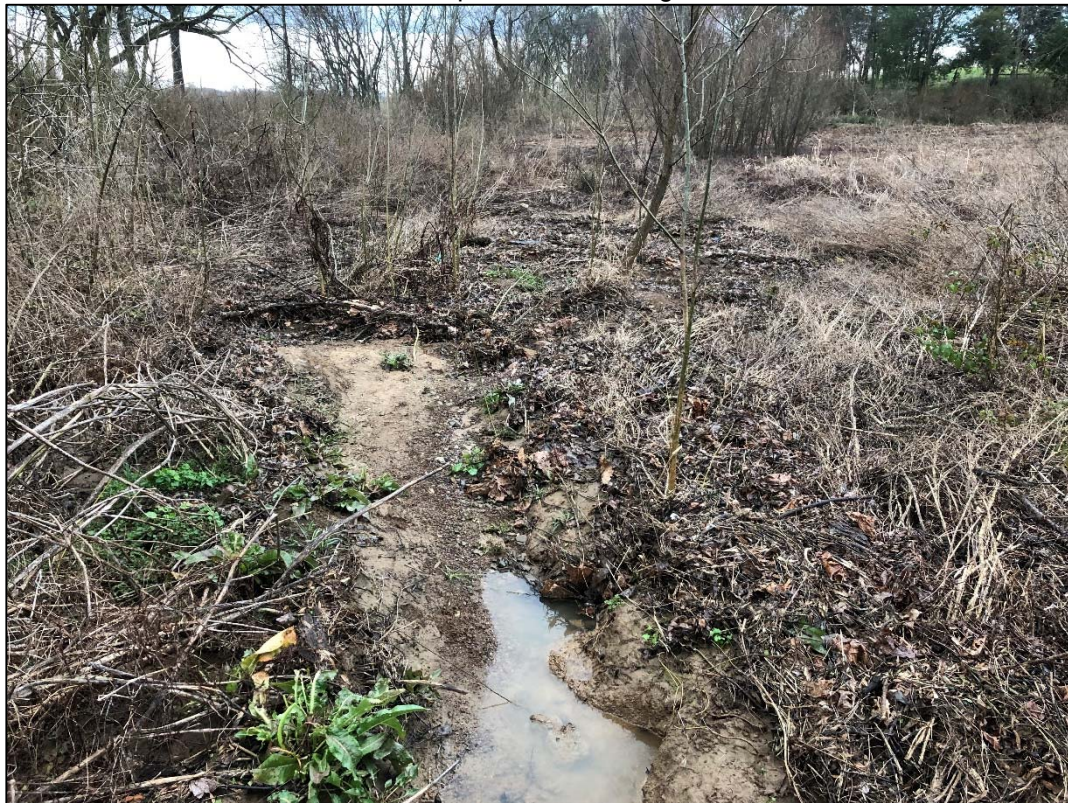
Following dam removal, the pond bottom cracked as it was drained. The cracks in the soil are up to a few feet deep. Any surface water that enters the pond bottom is lost into the cracks and a single-thread flow path is difficult to locate. Due to risk and budgetary constraints, RES does not plan on doing any work in this area.

Thompson 1 above old pond looking downstream into pond bottom

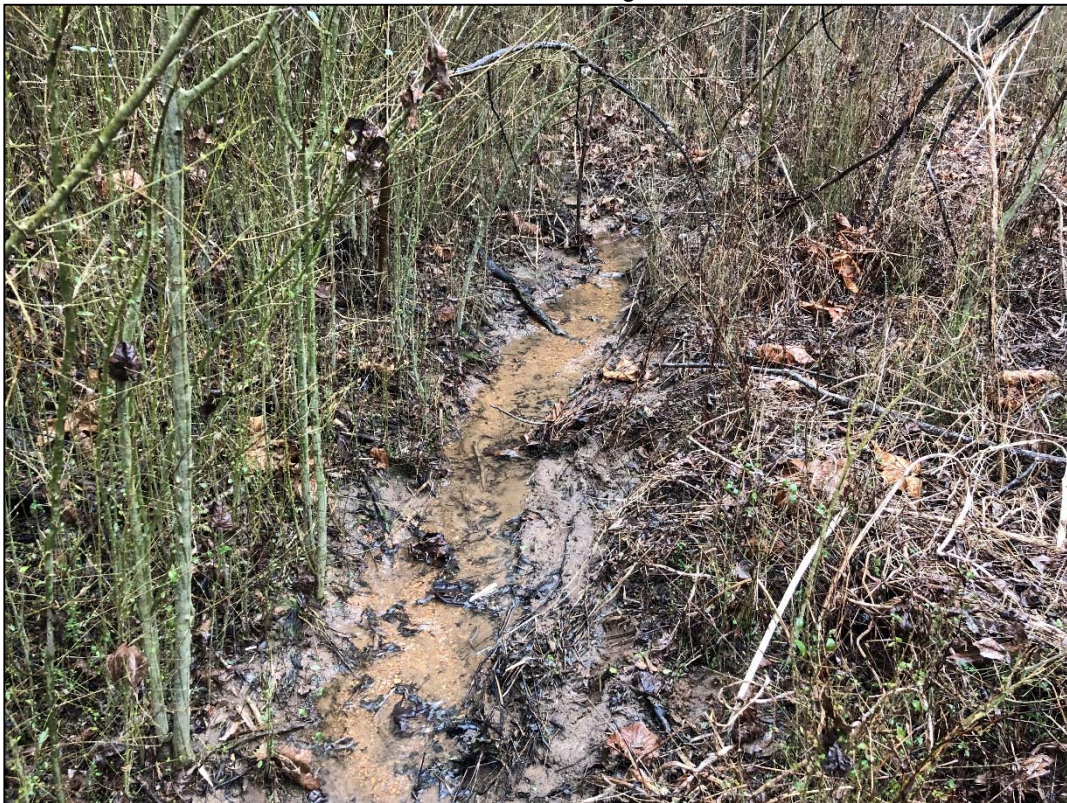
Dale 1 in old pond looking upstream

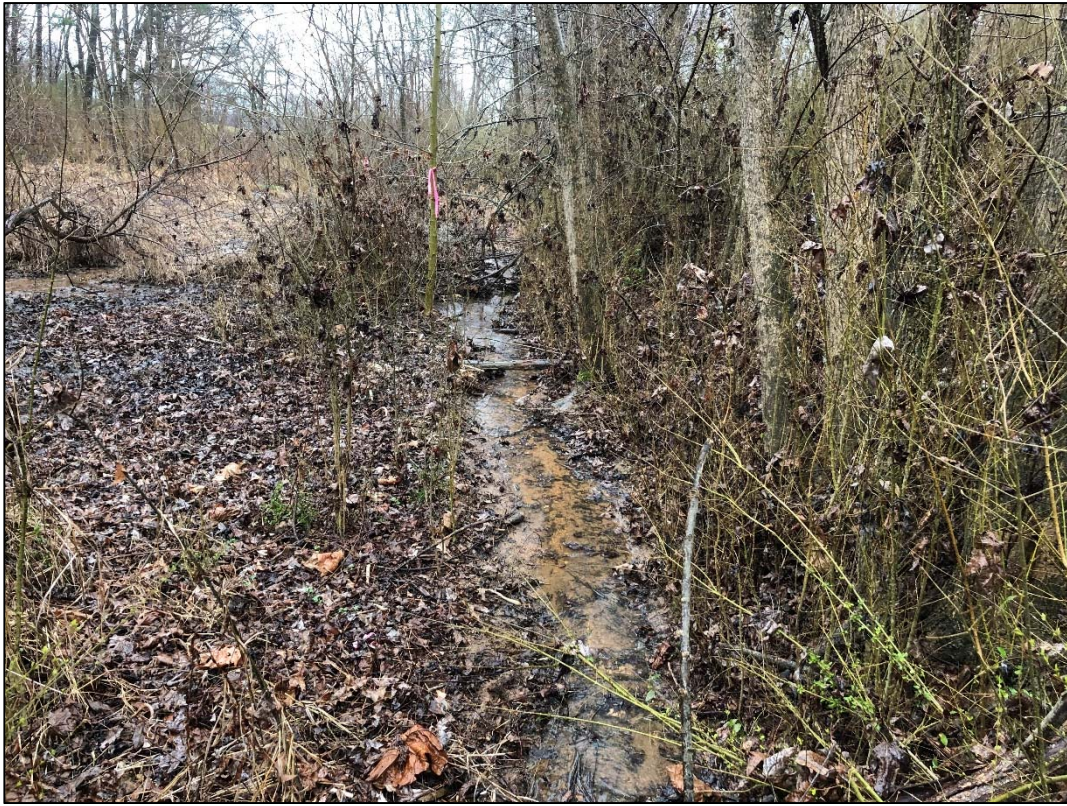
Dale 1 in old pond looking downstream
