Annual Monitoring Report

Monitoring Year 6 of 7

Pee Dee Stream Restoration Project
NCDMS Contract No.: 004644
NCDMS Project No.: 95350
USACE Action ID: SAW-2012-01077
DWR #: 13-1140

Montgomery County, NC
Data Collected: November 2020
Date Submitted: January 2021

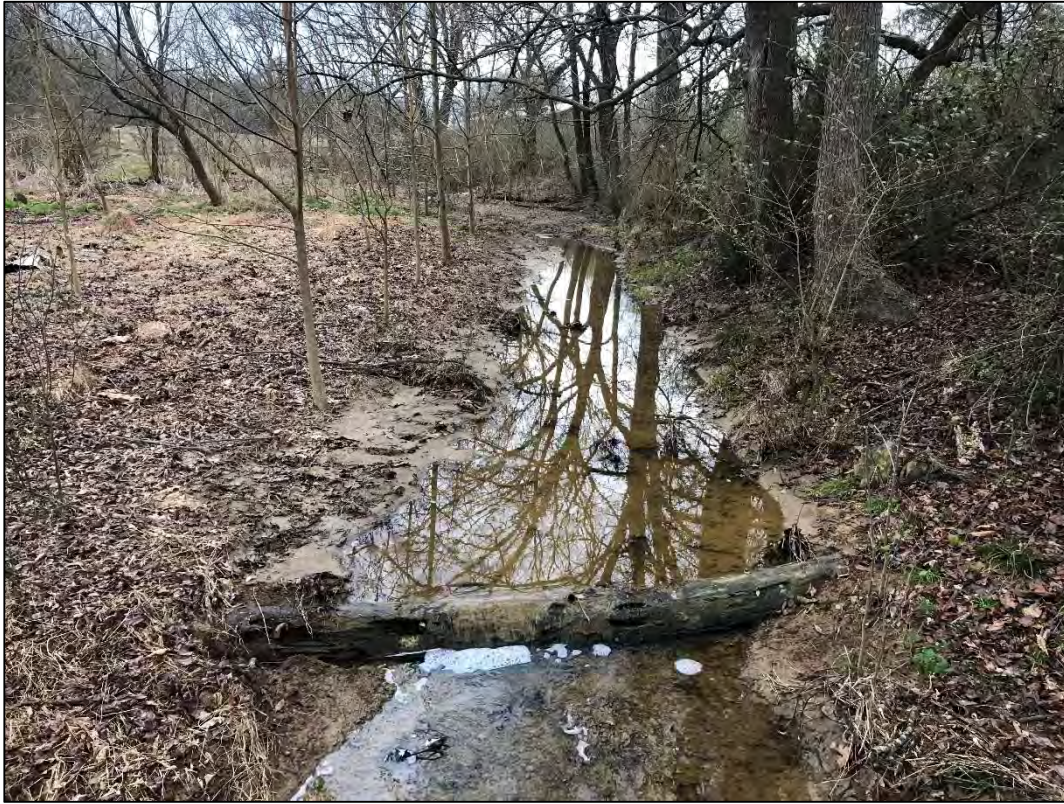
- Flow, bed and bank, and riffle/pool sequences were observed above the pond area on Thompson 1. A hydrologic connection to Thompson Reach 2 through the pond area was also observed.

Thompson 1 above old pond looking upstream

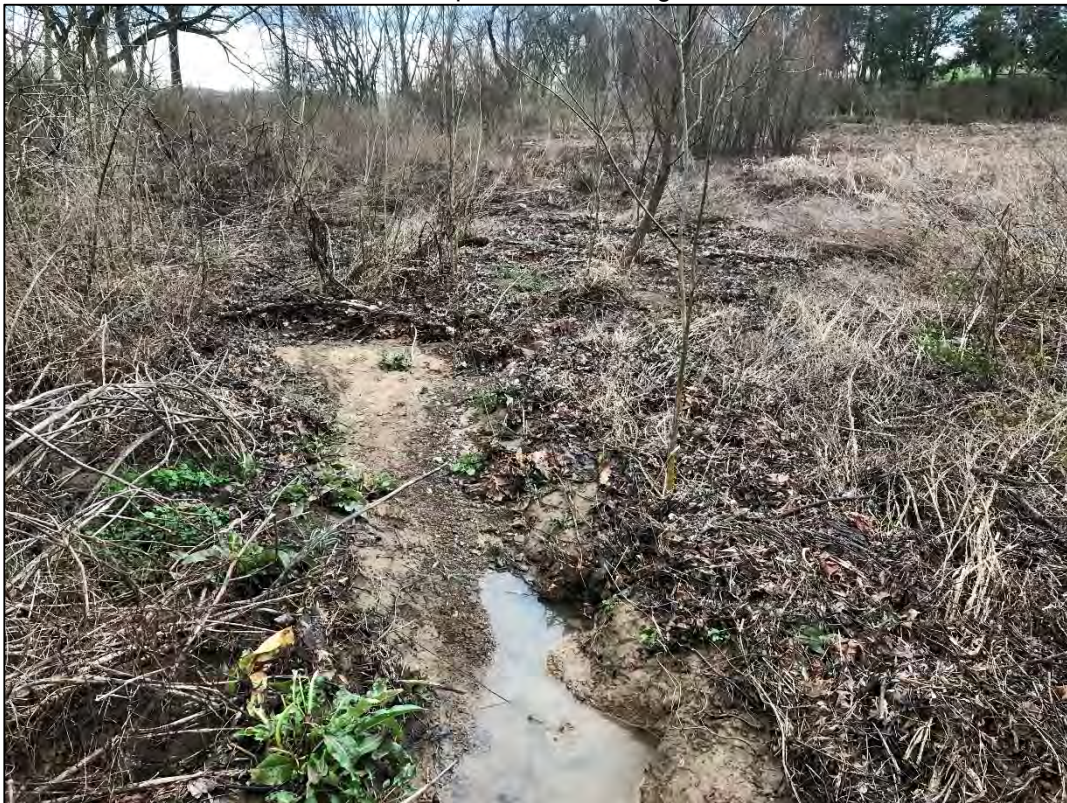
Following dam removal, the pond bottom cracked as it was drained. The cracks in the soil are up to a few feet deep. Any surface water that enters the pond bottom is lost into the cracks and a single-thread flow path is difficult to locate. Due to risk and budgetary constraints, RES does not plan on doing any work in this area.

Thompson 1 above old pond looking downstream into pond bottom

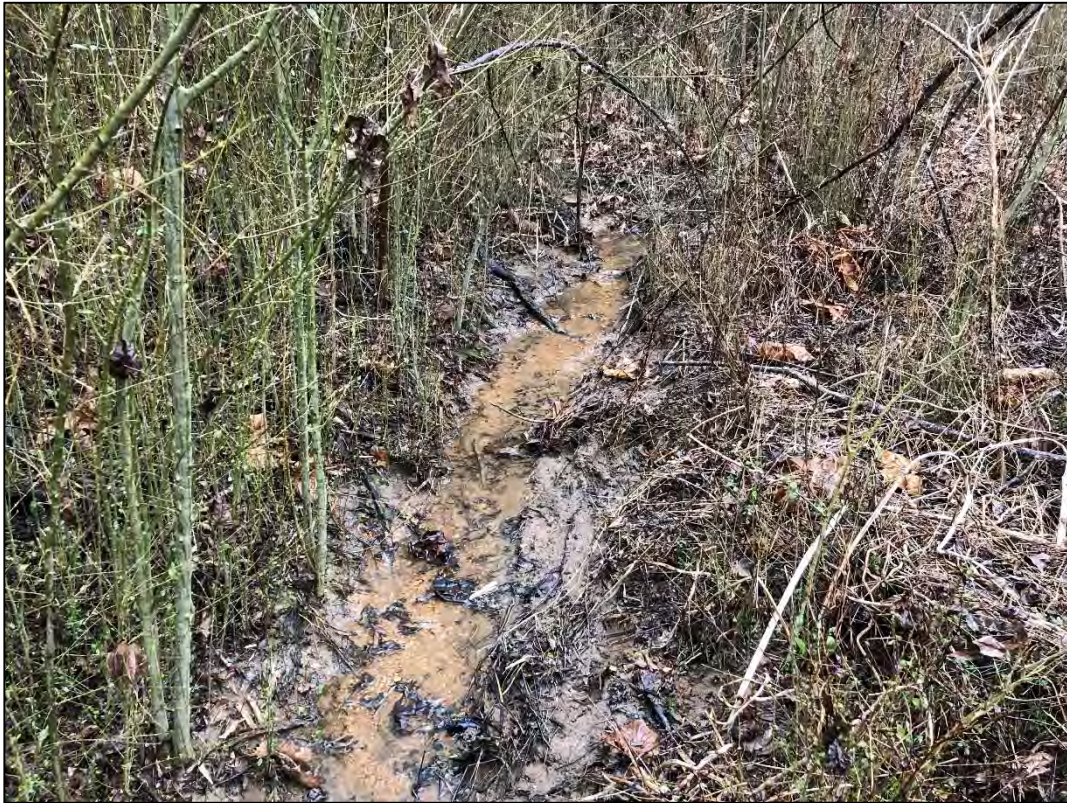
- Despite the hand work RES performed on the channel through the wetland area on Dale 1, the area resembled more of a braided system. DWR recommended using valley length for all of Dale 1. Valley length for Dale 1 would reduce the credits from 250 SMUs to 240 SMUs.

Dale 1 in old pond looking upstream

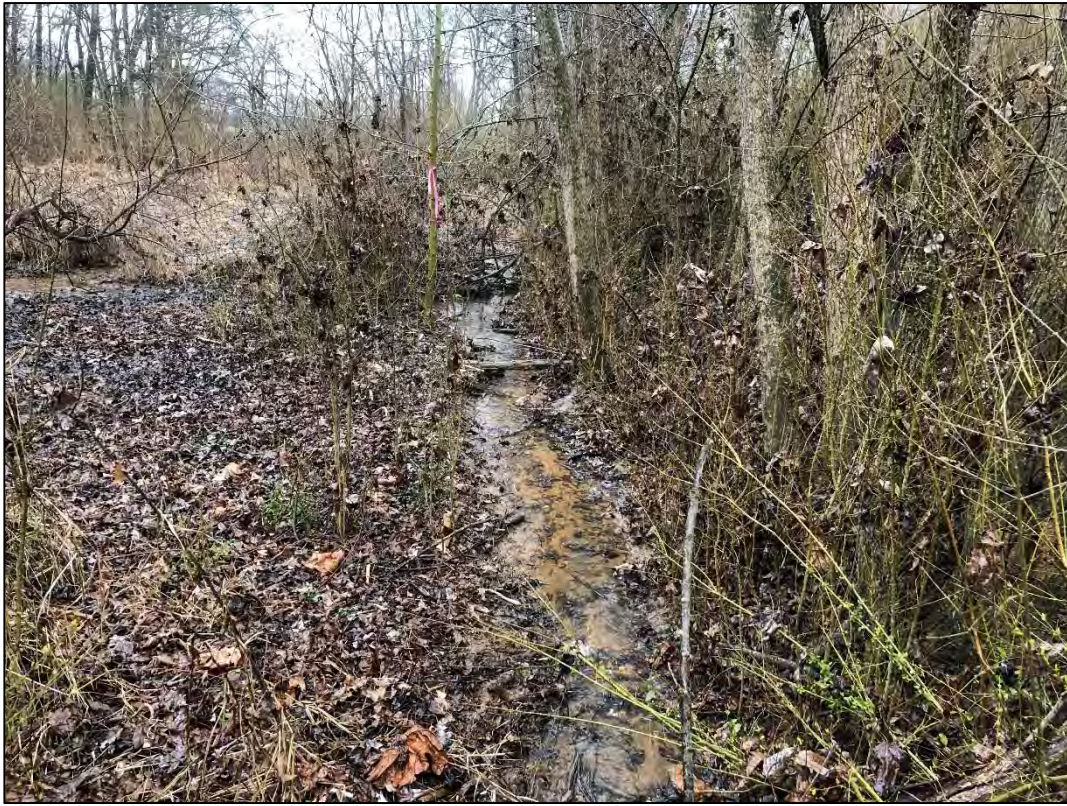
Dale 1 in old pond looking downstream
