Monitoring Report- Year 5  
FINAL VERSION  
Pen Dell Mitigation Project  
Calendar Year of Data Collection: 2022

NCDEQ DMS Project Identification # 97079  
NCDEQ DMS Contract # 6824  
Neuse River Basin (Cataloging Unit 03020201)  
USACE Action ID Number: SAW-2016-00885  
NCDEQ DWR Project # 2016-0403 V2  
Johnston County, NC  
Contracted Under RFP # 16-006477  
Data Collection Period: March and September 2022  
Submission Date: November 30<sup>th</sup>, 2022

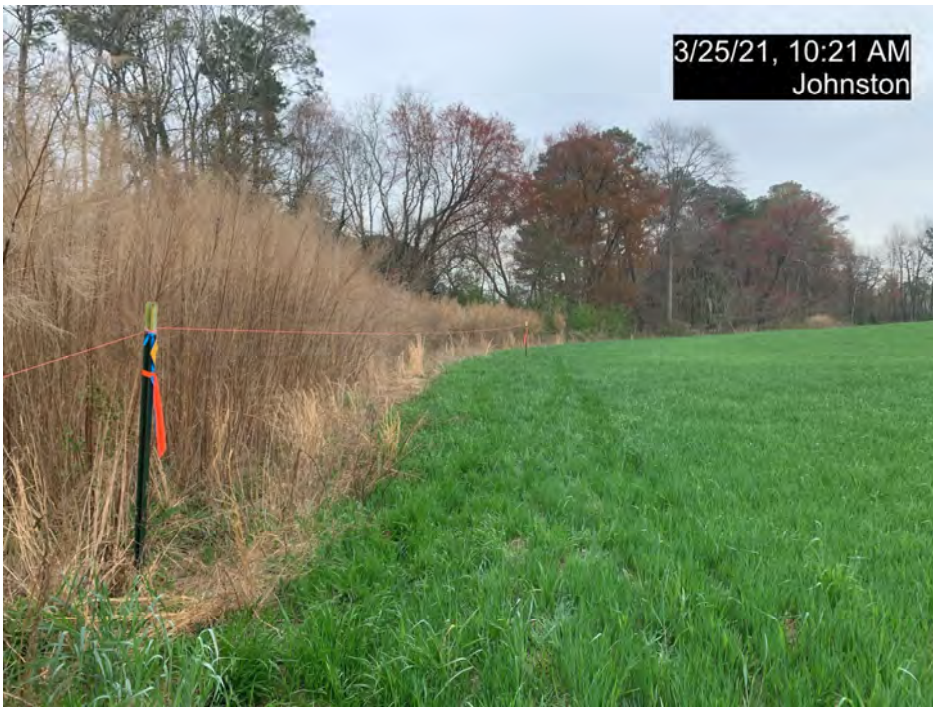
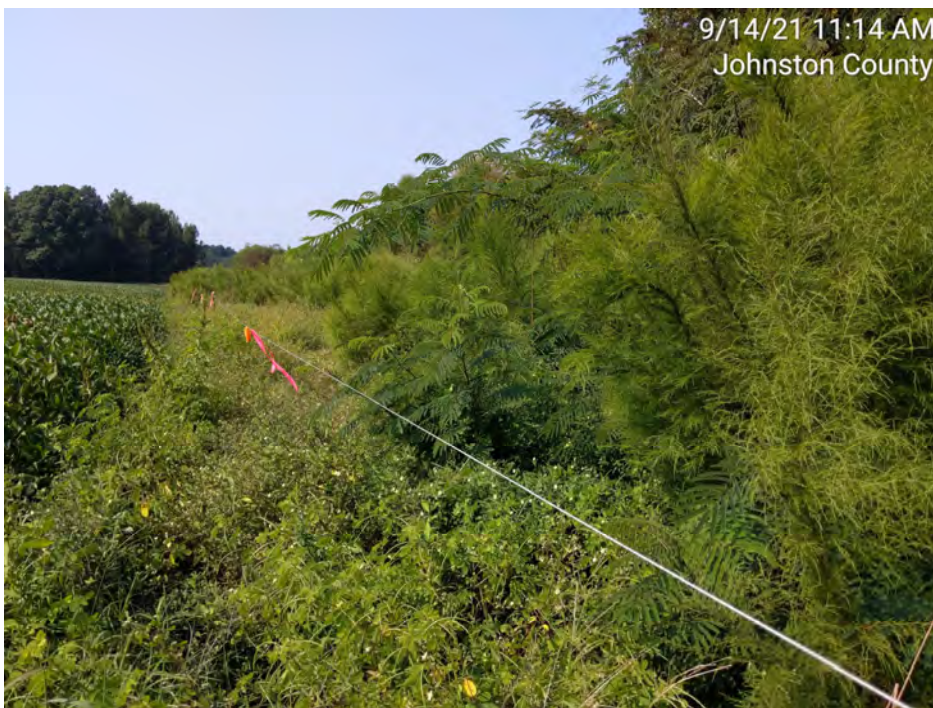
The MY5 vegetation monitoring was also conducted utilizing visual assessment throughout the easement. A small encroachment area (VPA1) of approximately 0.05 acres was found along R1 left floodplain during a spring MY4 site visit. No trees were damaged due to mowing, only herbaceous vegetation. During MY5, encroachment in this area has stopped. Three additional encroachments were discovered during MY5. VPA2 (0.006 acres) and VPA3 (0.012 acres) are small encroachments due to mowing along the farm field of the right floodplain of R1. VPA4 (0.003 acres) is a small encroachment caused by mowing along the driveway adjacent to the easement near R2. All encroachments have been marked with additional t-posts and horse tape. These areas will be monitored closely in MY6 to ensure encroachments have ceased.

Encroachment (VPA1), R1 Left Floodplain, March 17, 2021 (MY-04)

Encroachment (VPA1) R1 Left Floodplain, September 14, 2021 (MY-04)

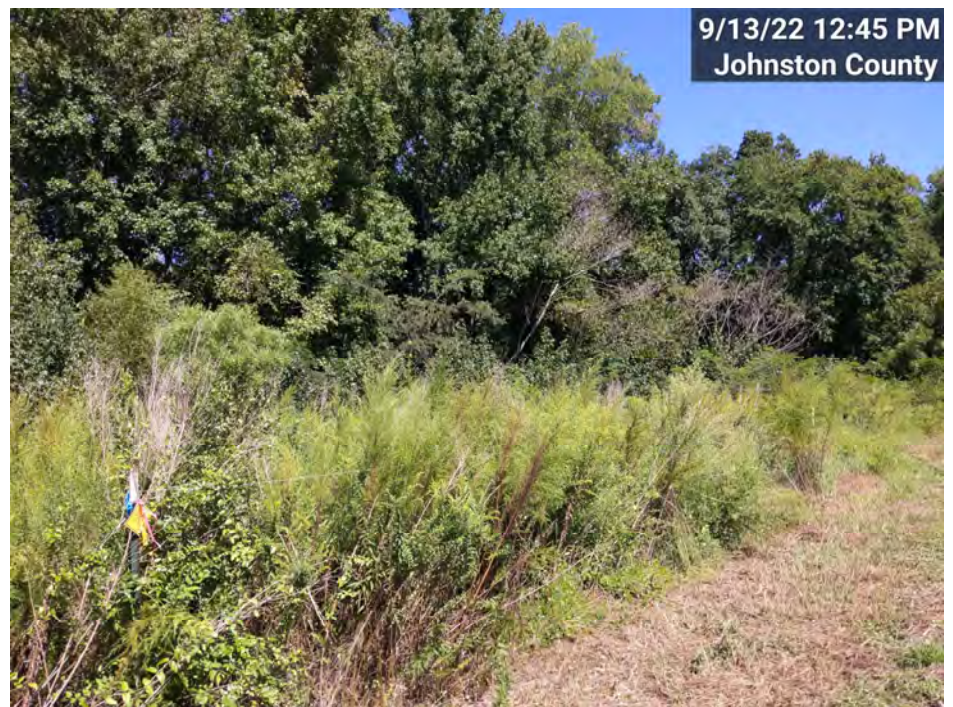
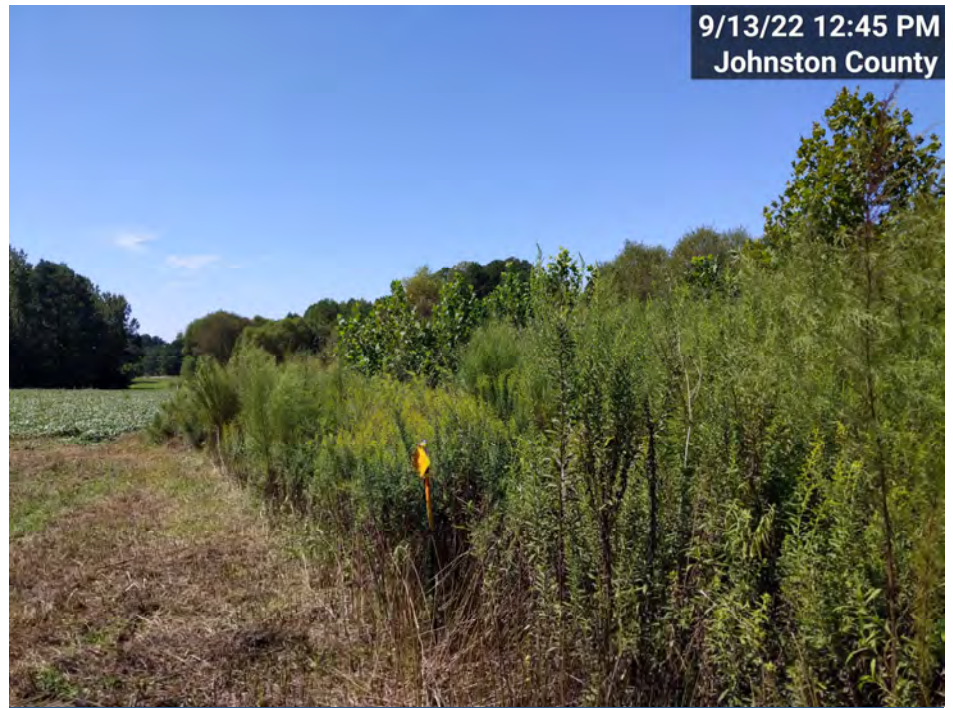
Encroachment (VPA1), R1 Left Floodplain, September 13, 2022 (MY-05)

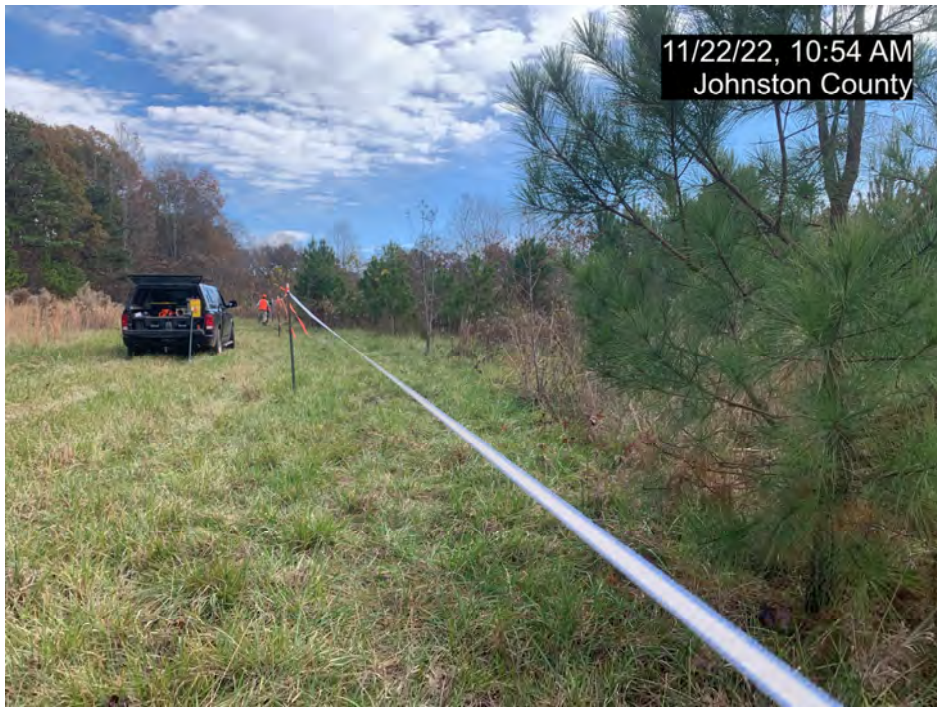
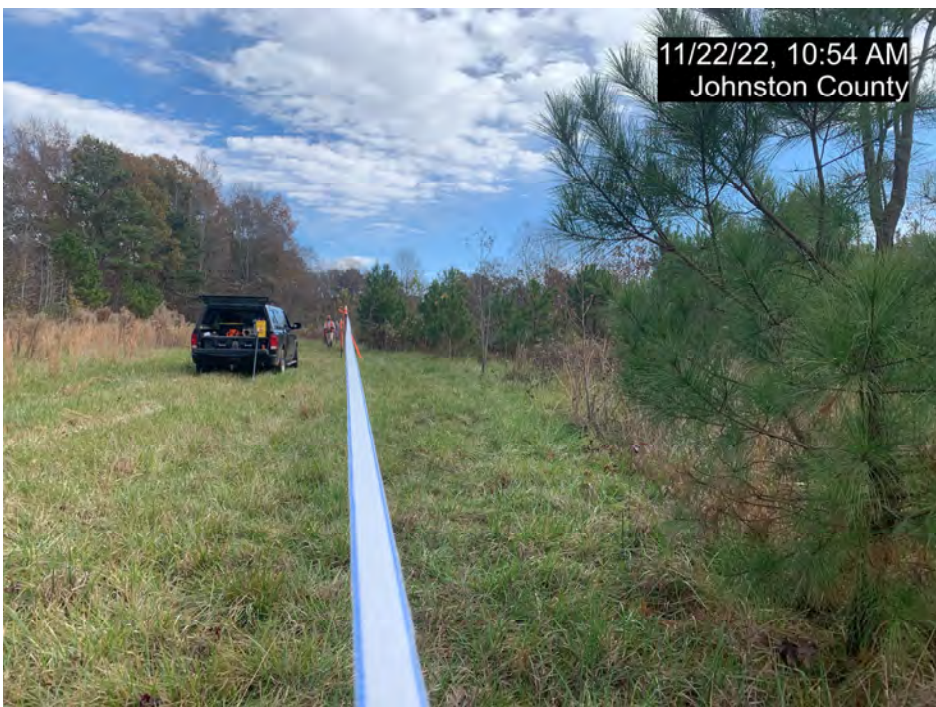
Encroachment (VPA2), R1 Right Floodplain (MY-05)

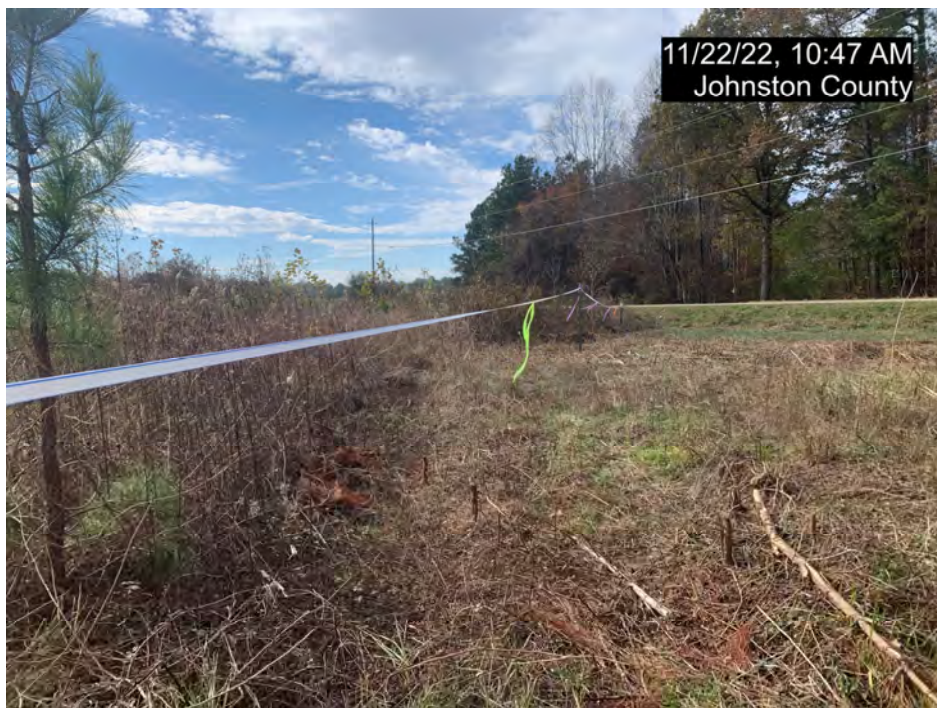
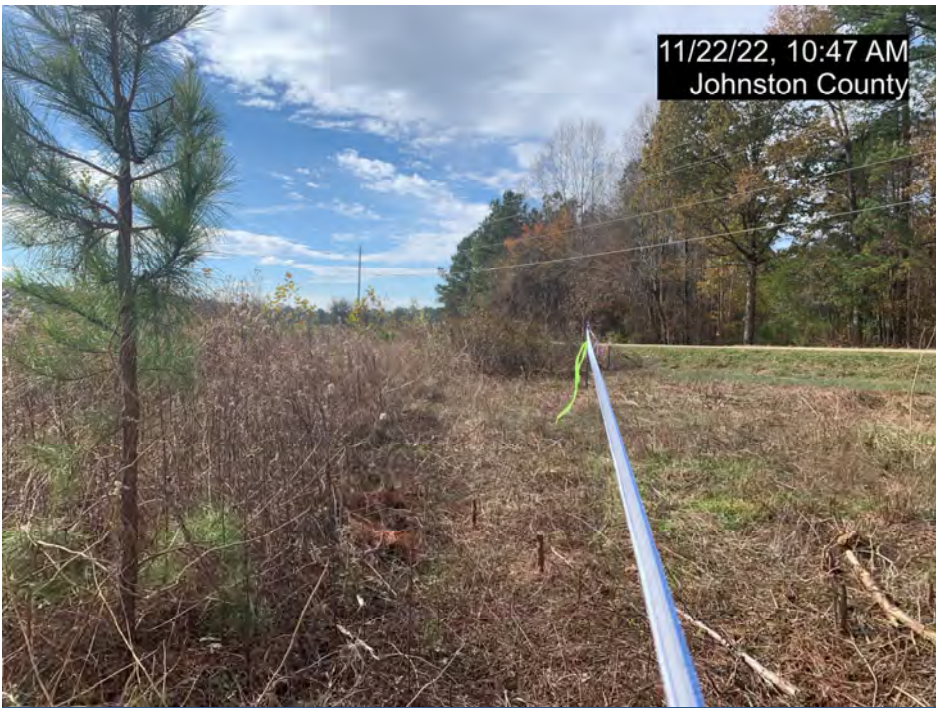
Encroachment (VPA3) R1 Right Floodplain (MY-05)

Encroachment (VPA3), R1 Right Floodplain (MY-05)

- 2. DMS Comment: Examine any pine treatment that WLS may elect to do in the thicker area of R1. Locate irons and determine if there is a boundary issue with R1 mowing. Suggest additional signage and horse tape to help landowner visualize and/or planting larger trees there if necessary.** WLS Response: Pine management along R1 will occur early in MY6. During field inspection it was found that mowing had occurred in two spots along the easement boundary of R1. The encroachment is approximately 0.018 acres. Additional t-posts, signs, and horse tape were added to this area.

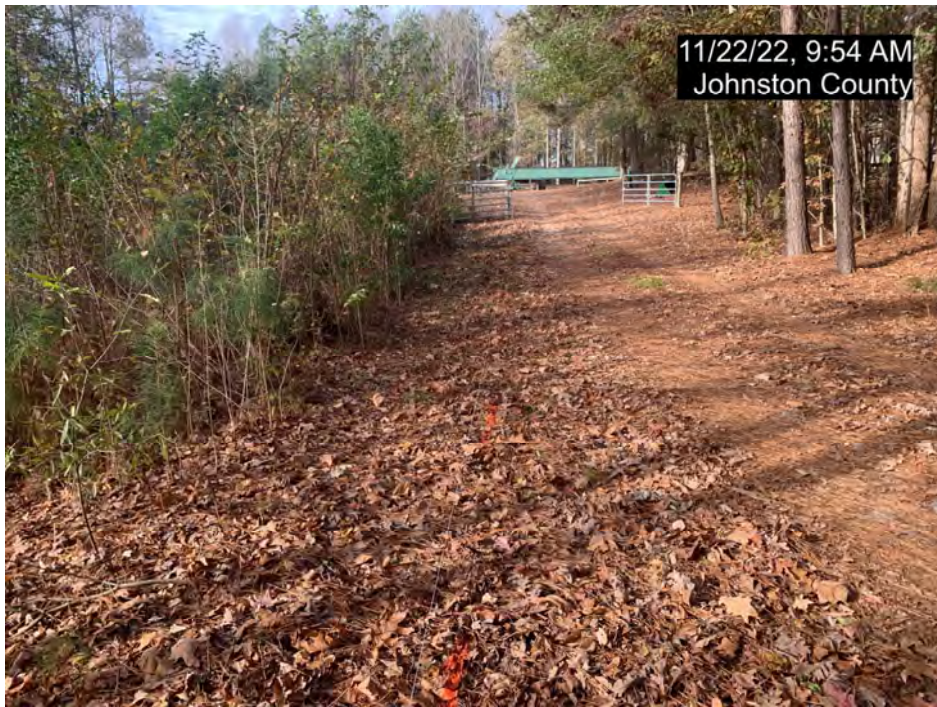
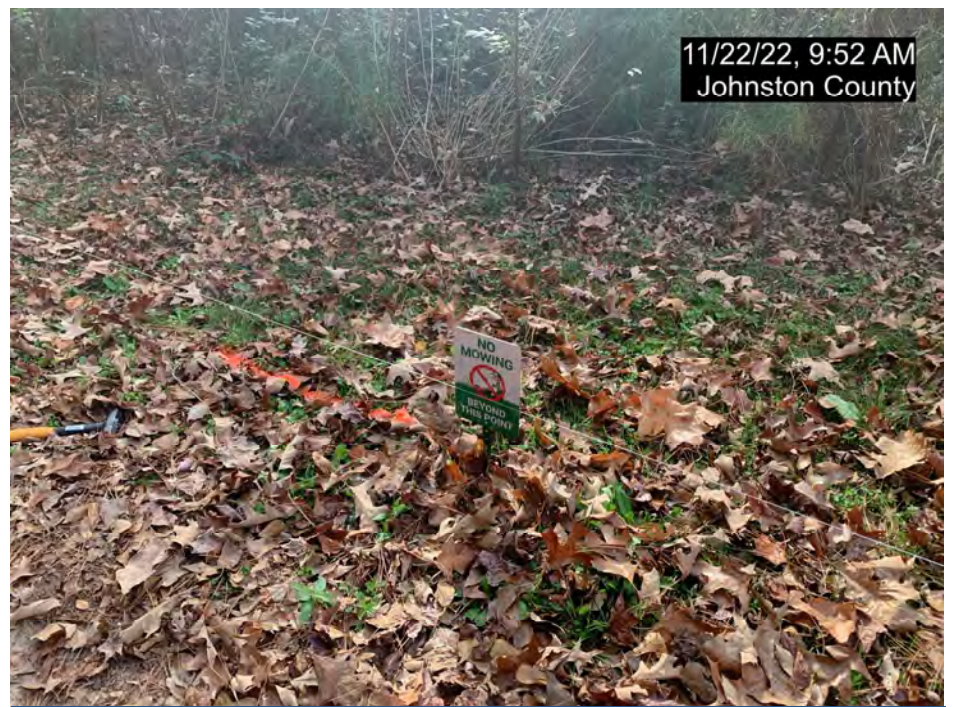
Encroachment (VPA4), R2 adjacent driveway, (MY-05)

- 1. DMS Comment: Locate irons and determine if there is boundary issue along R2 on the west side of Wendell Road. This area may need additional signage, fencing, or discussions with DMS Property there.** WLS Response: There is a small encroachment along the driveway near R2 of approximately 0.003 acres. This area was marked with string and signage. A gate at the corner of the easement currently swings into the easement and will be fixed in MY6.

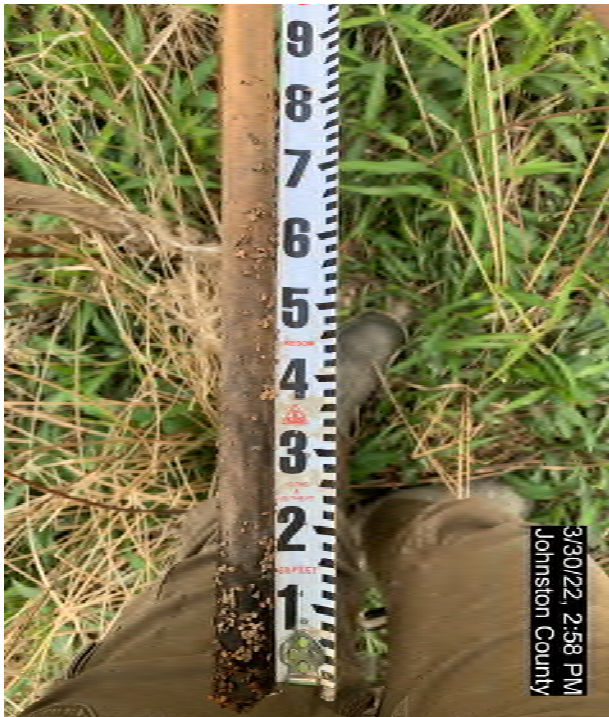
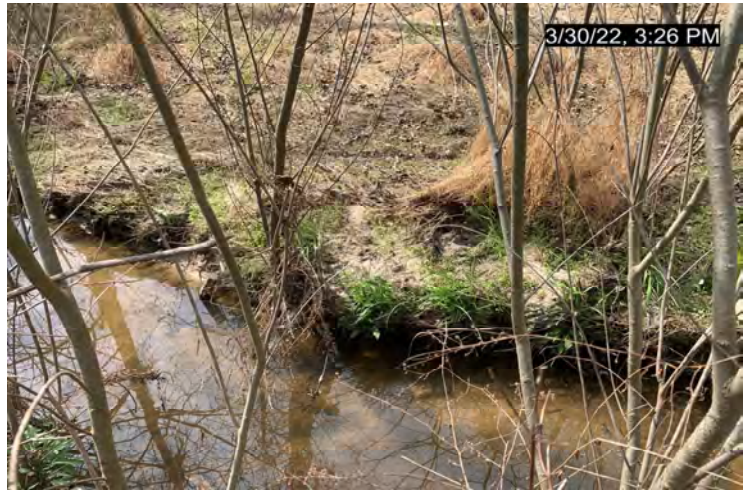
| Table 8. Verification of Flow Events | | | | | | |
|---|---|---|--|---|---|---|
| MY5 | 3/30/2022 | Unknown | Crest Gauge and observed recent alluvial deposits | Bkf | Photos | 0.80 ft |
