Monitoring Report- Year 6  
FINAL VERSION  
Pen Dell Mitigation Project  
Calendar Year of Data Collection: 2023

NCDEQ DMS Project Identification # 97079  
NCDEQ DMS Contract # 6824  
Neuse River Basin (Cataloging Unit 03020201)  
USACE Action ID Number: SAW-2016-00885  
NCDEQ DWR Project # 2016-0403 V2  
Johnston County, NC  
Contracted Under RFP # 16-006477  
Data Collection Period: March and October  
2023 Submission Date: December 29, 2023

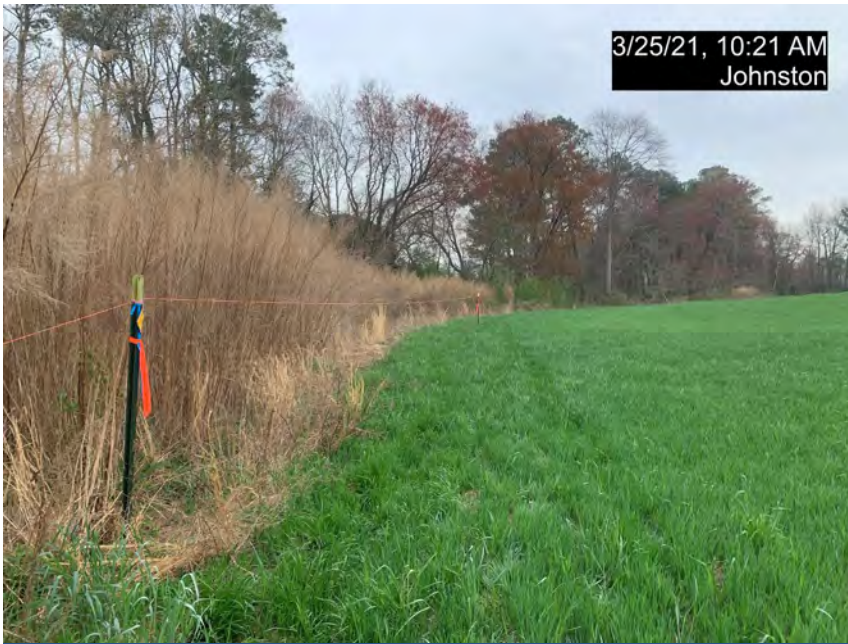
easement. A small encroachment area (VPA1) of approximately 0.05 acres was found along the left floodplain of R1 during a spring MY4 site visit. No trees were damaged due to mowing, only herbaceous vegetation. During MY5 & MY6, encroachment in this area has stopped. Three additional encroachments were discovered during MY5. VPA2 (0.006 acres) and VPA3 (0.012 acres) are small encroachments due to mowing along the farm field of the right floodplain of R1. VPA4 (0.003 acres) is a small encroachment caused by mowing along the driveway adjacent to the easement near R2. All encroachments have been marked with additional t-posts and horse tape and the landowners were informed of the encroachments. These areas were monitored closely in MY6, and no further encroachments were observed. In addition to adding t-posts, supplemental planting in VP4 occurred in MY6 (see table below for planting list). During the Buffer Close-Out meeting on July 19, 2023, removal of pines and sweetgum and supplemental planting in VPA1 was requested (See Appendix E for Buffer Close-Out Correspondence). Pine and sweetgum management was completed in August 2023 and supplemental planting in VPA1 will occur in the dormant season of prior to MY7. Species planted and any additional vegetative management will be included in the MY7 report.

Encroachment (VPA1), R1 Left Floodplain, March 17, 2021 (MY-04)

- WLS Remedial Action Plan for Pen Dell Buffer:
- **Add horse tape to R1 where missing.**
  - WLS will add horse tape to boundary posts to make a continuous boundary barrier.
- **Remove pines and sweetgum from VPA1.**
- **Complete additional planting in VPA1.**
  - WLS will remove pines and sweetgum from VPA1 in the dormant season of 2023/2024.
  - WLS will add supplemental planting within this area during the dormant season of 2023/2024. The planting will include 15 containerized trees of the following species\*:
    - *Plantanus occidentalis* – Sycamore
    - *Quercus Phellos* – Willow Oak
    - *Quercus nigra* – Water Oak
    - *Betula nigra* – River Birch
    - *Quercus michauxii* – Swamp Chestnut Oak
  - \*Amount and species dependent on species availability.
  - Species removal and supplemental planting will be included in MY7 report.

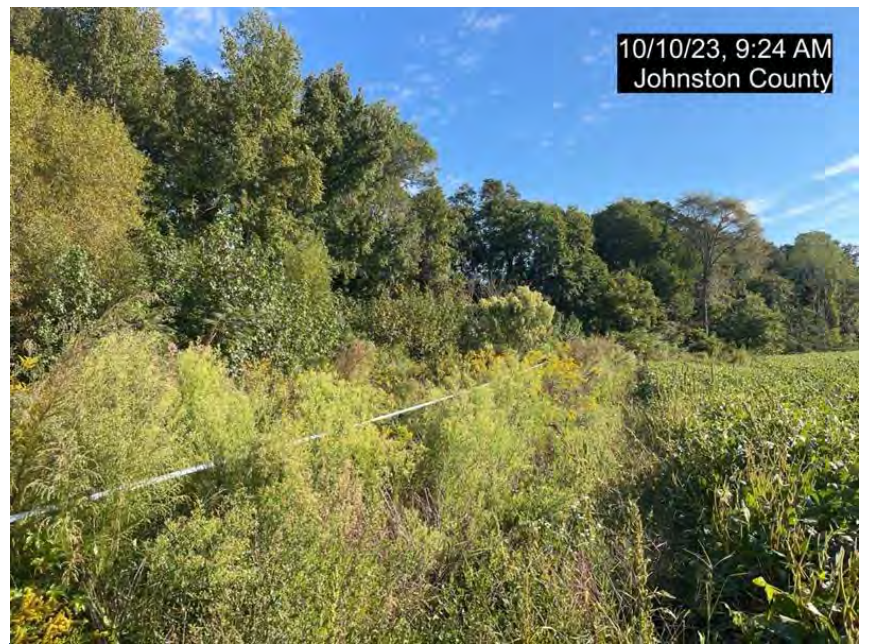
Encroachment (VPA1), R1 Left Floodplain, October 10, 2023 (MY-06)

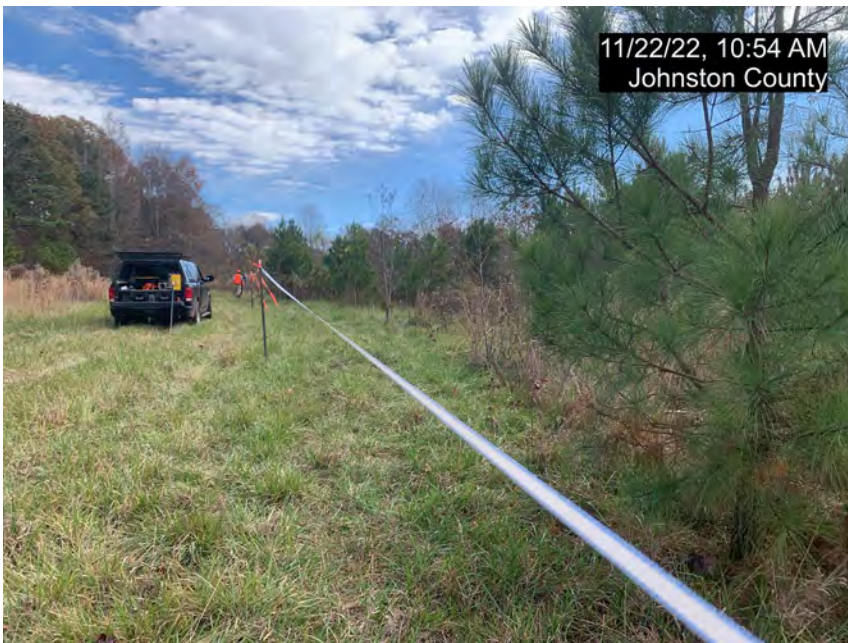
Encroachment (VPA2), R1 Right Floodplain (MY-05)

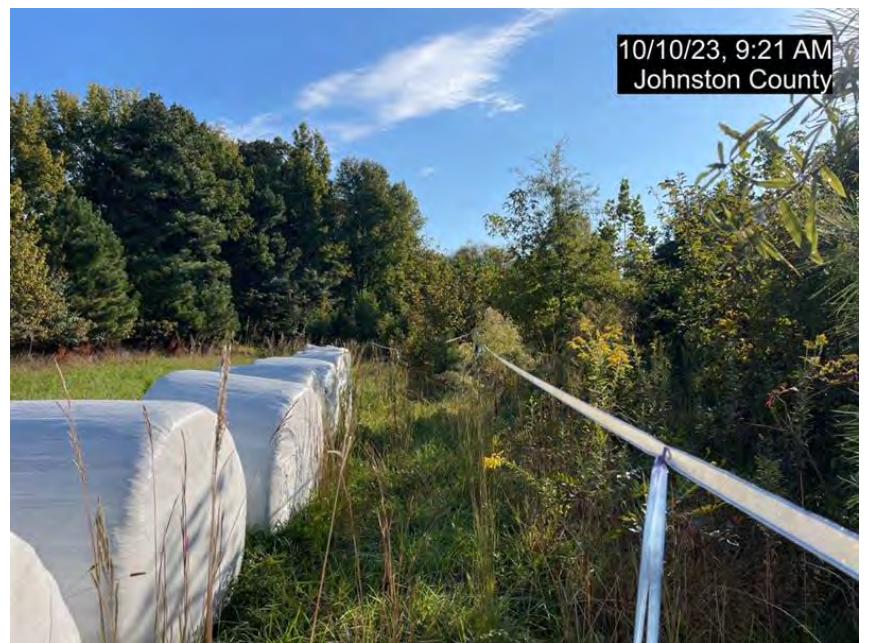
Encroachment (VPA2), R1 Right Floodplain (MY-06)

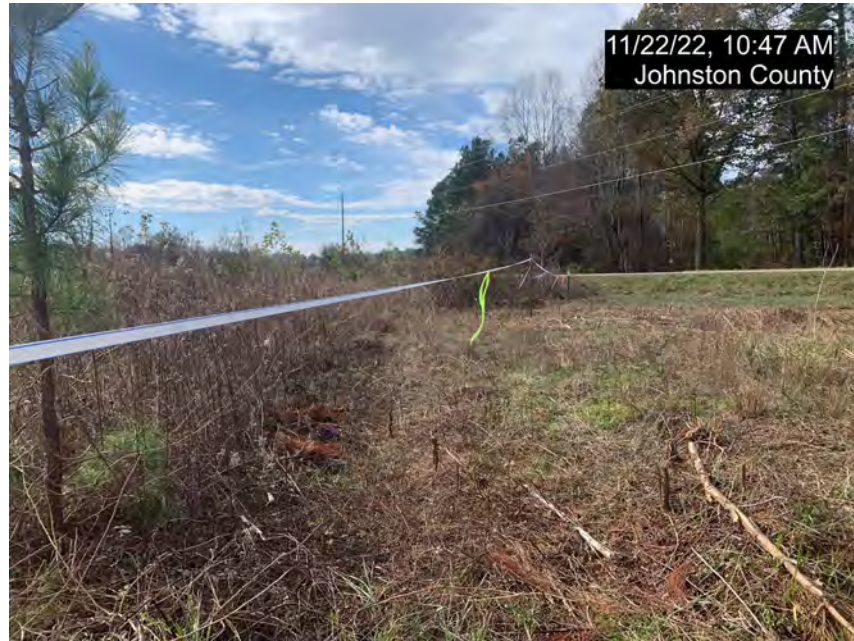
Encroachment (VPA3) R1 Right Floodplain (MY-05)

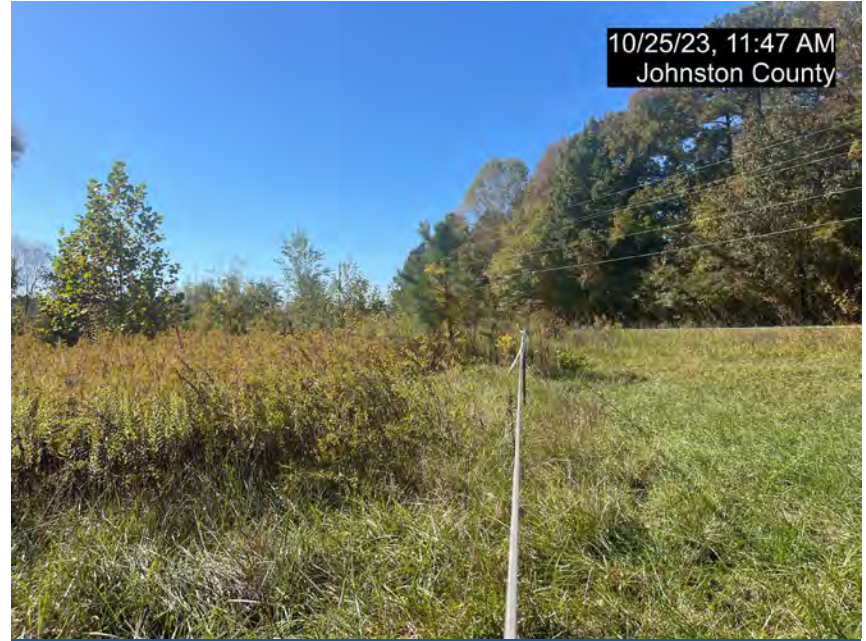
Encroachment (VPA3), R1 Right Floodplain (MY-06)

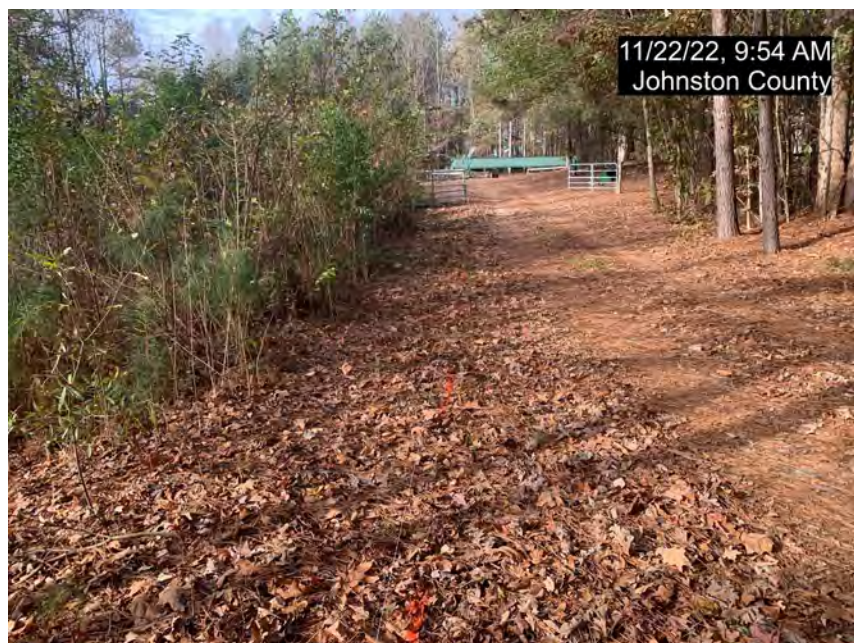
Encroachment (VPA4), R2 adjacent driveway, (MY-05)

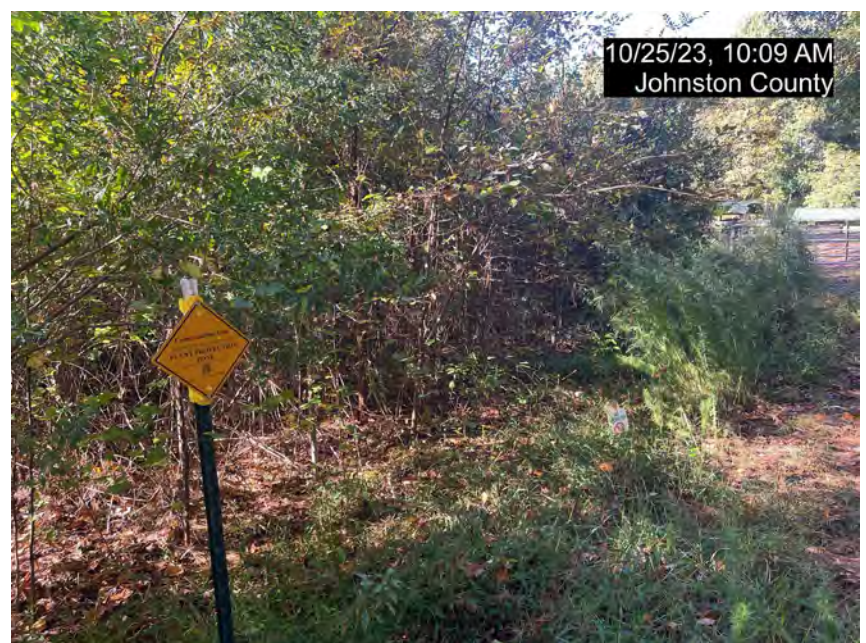
Encroachment (VPA4), R2 adjacent driveway, (MY-06)

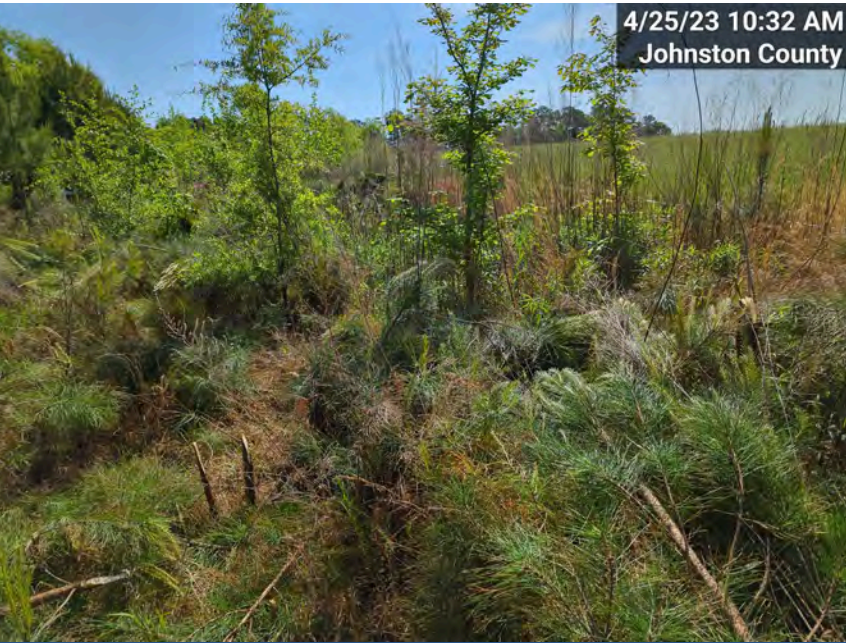
Pine management area along R1, (MY-06)

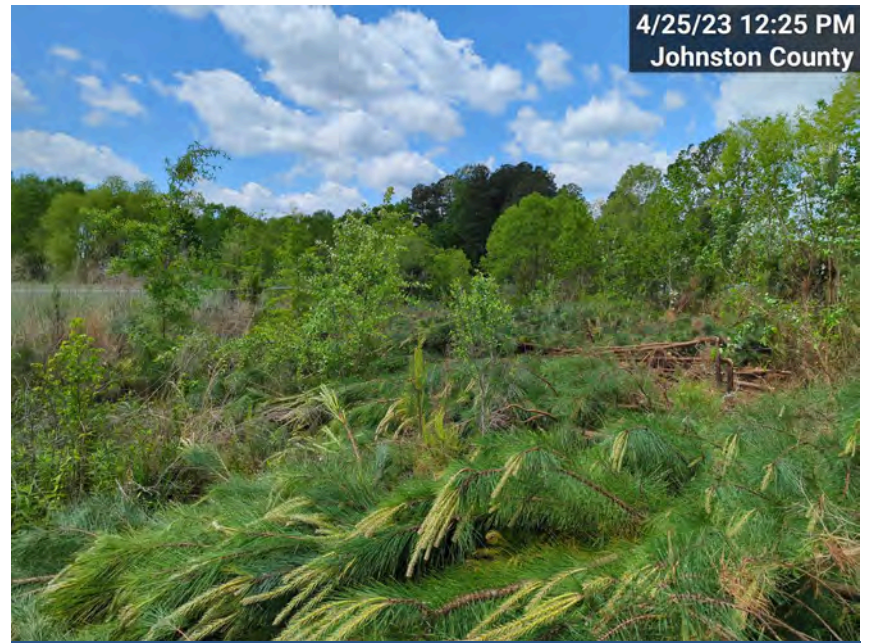
Pine management area along R1, (MY-06)
