Monitoring Report- Year 4
FINAL VERSION
Pen Dell Mitigation Project
Calendar Year of Data Collection: 2021

NCDEQ DMS Project Identification # 97079
NCDEQ DMS Contract # 6824
Neuse River Basin (Cataloging Unit 03020201)
USACE Action ID Number: SAW-2016-00885
NCDEQ DWR Project # 2016-0403 V2
Johnston County, NC
Contracted Under RFP # 16-006477
Data Collection Period: September 2020
Submission Date: October 20th, 2021

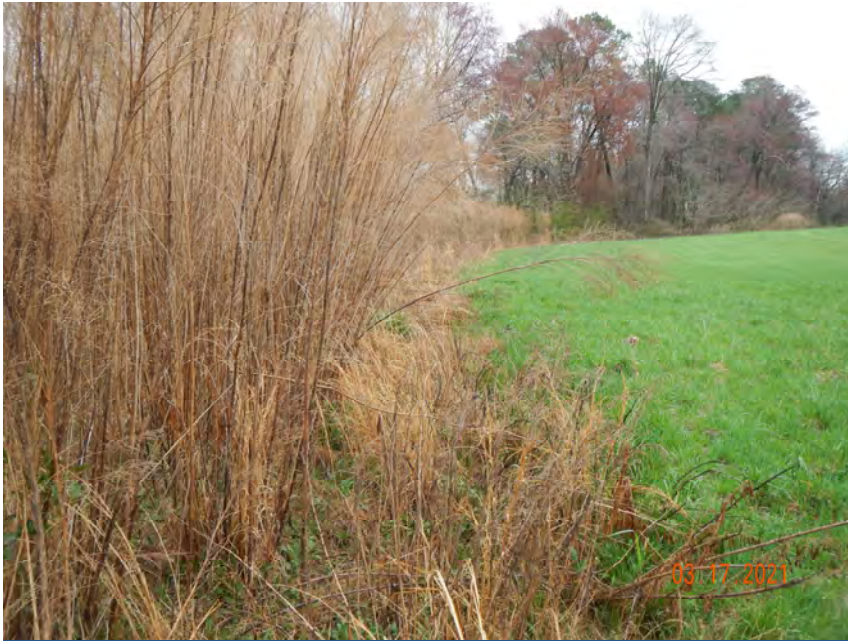
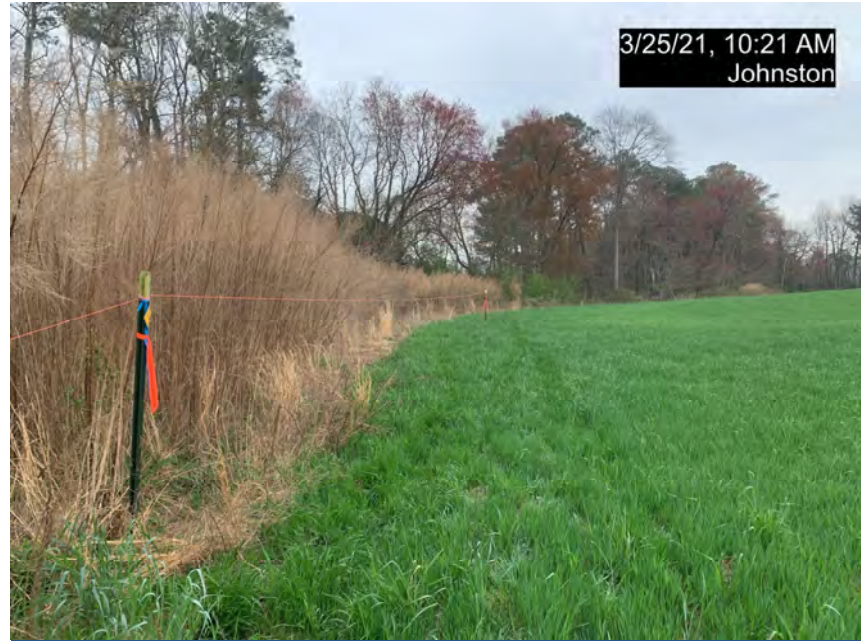
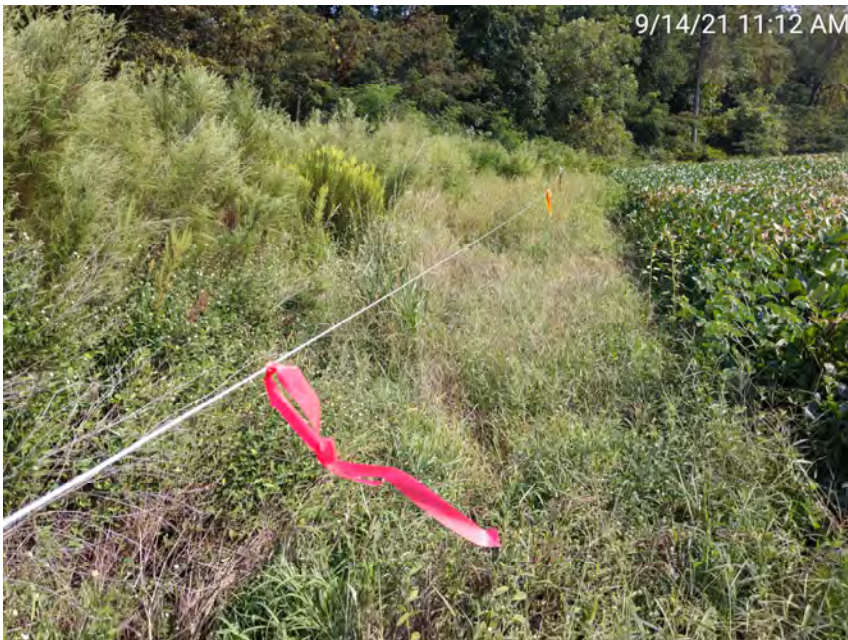
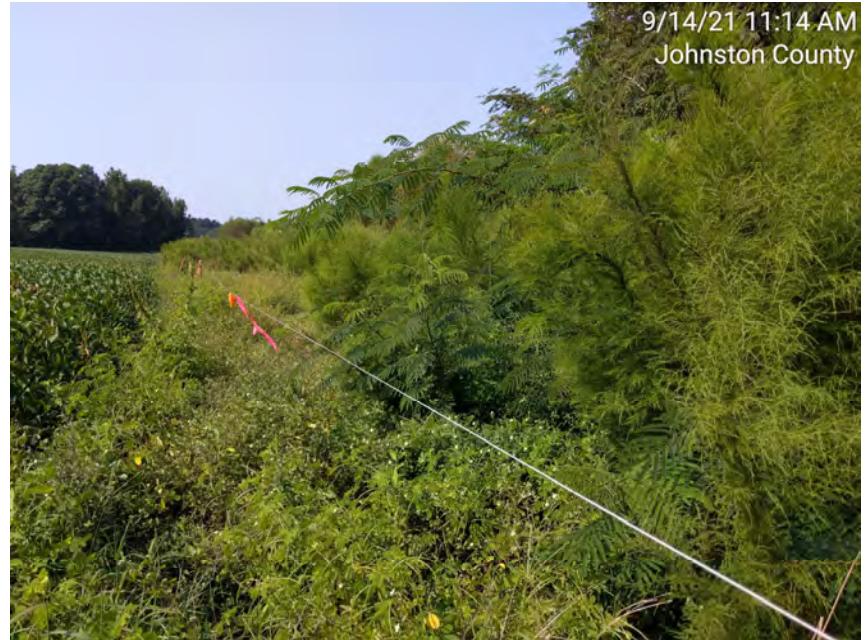
The MY4 vegetation monitoring was also conducted utilizing visual assessment throughout the easement. A small area of encroachment (VPA1) of approximately 0.05 acres was found along R1 left floodplain during a spring 2021 site visit. Encroachment was a result of mowing along the field edge and has been more clearly marked to prevent further encroachment. The results of the visual assessment did not indicate any additional significant negative changes to the existing vegetation community.

Encroachment (VPA1), R1 Left Floodplain, March 17, 2021 (MY-04)

Encroachment (VPA1), R1 Left Floodplain, March 25, 2021 (MY-04)

Encroachment (VPA1) R1 Left Floodplain, September 14, 2021 (MY-04)

Encroachment (VPA1), R1 Left Floodplain, September 14, 2021 (MY-04)

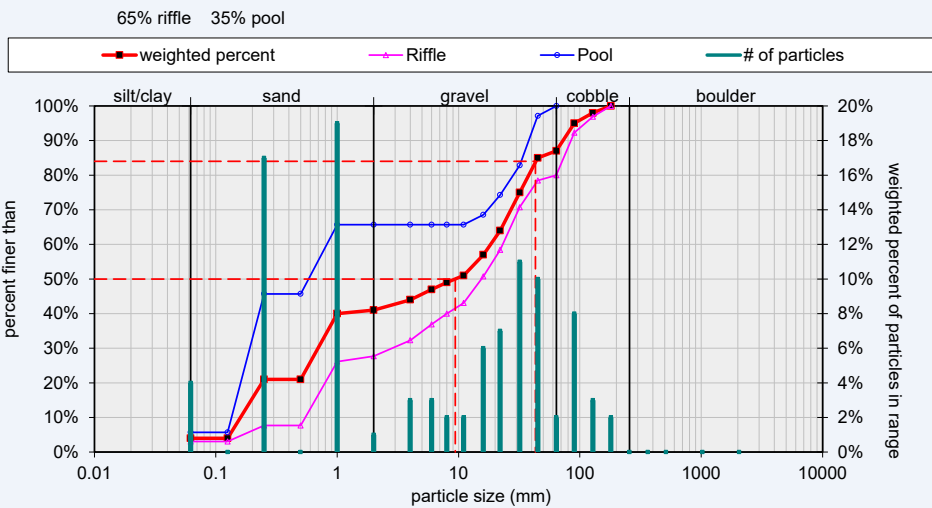
Weighted pebble count by bed features Pen Dell Mitigation Project

A representative sediment sample was collected in R4, near station 51+00, at a constructed riffle and pool to assess streambed material condition and stability. The dominant substrate for the project was verified as coarse sand. The post-construction riffle substrate sampling indicated no significant change in streambed material condition or stability for MY4.

MY4	Riffle		Pool	
	Channel materials		Channel materials	
	D16 =	0.68	D16 =	0.15
	D35 =	5.1	D35 =	0.21
	D50 =	15	D50 =	0.58
	D65 =	27	D65 =	0.98
	D84 =	71	D84 =	33
	D95 =	110	D95 =	43

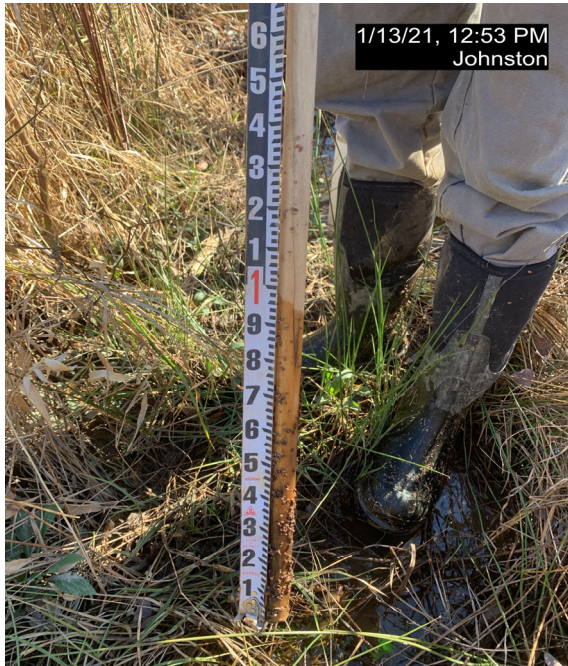
Monitoring Year	Date of Data Collection	Date of Occurrence	Method	Greater than Bankfull (Bkf) or Qgs ($Q2^{*0.66} = 36.64$ CFS) Stage?	Photo/ Notes	Measurement above bankfull
MY1	9/17/2018	9/16-9/17/2018	Observed indicators of stage (wrack lines) after sotrm event	Bkf	Photos	NA
	11/21/2018	9/16-9/17/2018	Crest Gauge	Bkf	Photos	
MY2	7/26/2019	7/24/2019	Crest Gauge	Bkf	Photos	.11 ft
MY3	2/7/2020	Unknown	Crest Gauge	Bkf & Qgs	Photos	.85 ft
	10/13/2020	Unknown	Crest Gauge	Bkf	Photos	.13 ft
MY4	1/13/2021	Unknown	Crest Gauge	Bkf	Photos	1.35 ft
	7/13/2021	Unknown	Crest Gauge	Bkf	Photos	1.03 ft

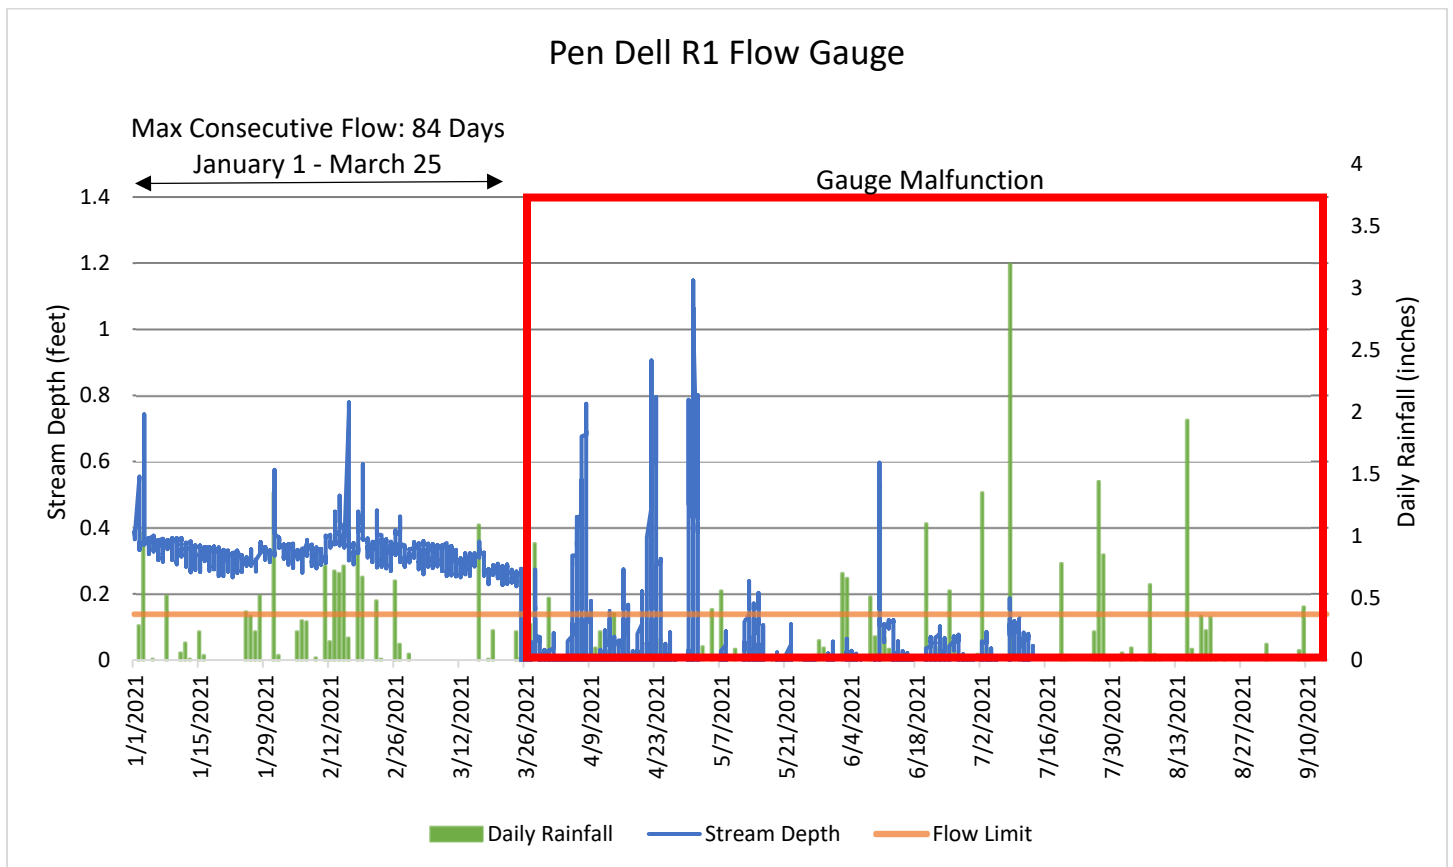
Figure 4a:

Jurisdictional stream flow documentation and monitoring of restored intermittent reaches is achieved using a flow gauge (pressure transducer) within the thalweg of the channel towards the middle portion of enhanced Reach R1 (Figure 1). Additionally, to determine if rainfall amounts are normal for the given year, precipitation data was obtained from CLAY Central Crops Research Station in Johnston County, approximately nine miles southwest of the site. A flow gauge malfunction resulted in the loss of data from March 26th, 2021, to September 14th, 2021. The malfunctioning gauge was repaired on September 14th, 2021. The flow gauge documented that the stream exhibited surface flow for 84 consecutive days from January 1st to March 25th, 2021 (see Figure 4).

*Longest consecutive days of flow: 84 days, January 1, 2021 - March 25, 2021.

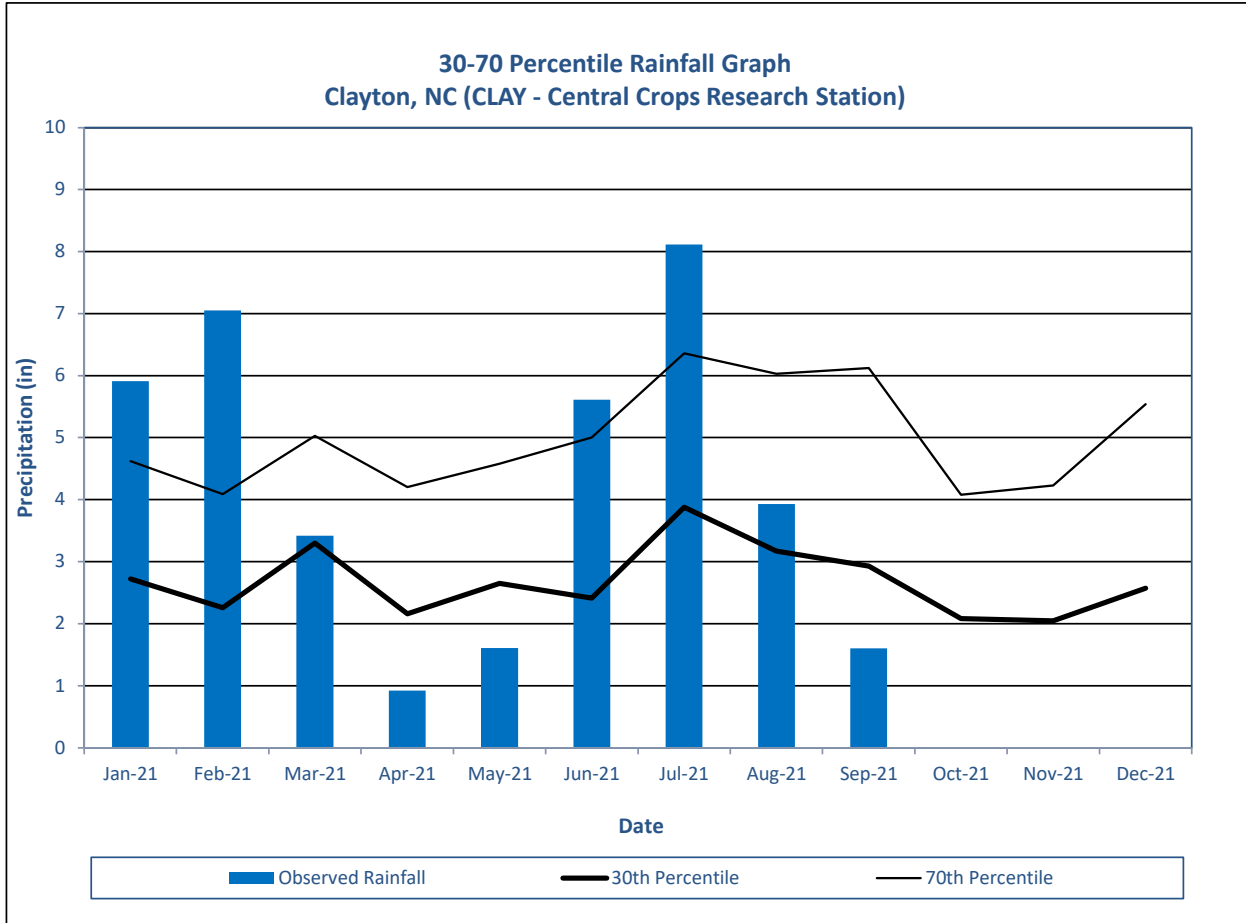
Figure 5: Monthly Rainfall Data
Pen Dell Mitigation Project (NCDEQ DMS Project ID# 97079)
MY4 2021

Month	30%	70%	Observed
Jan-21	2.72	4.62	5.91
Feb-21	2.26	4.09	7.05
Mar-21	3.30	5.03	3.42
Apr-21	2.16	4.20	0.92
May-21	2.65	4.58	1.61
Jun-21	2.41	5.00	5.61
Jul-21	3.88	6.36	8.11
Aug-21	3.17	6.03	3.93
Sep-21	2.93	6.12	1.6
Oct-21	2.08	4.08	**
Nov-21	2.05	4.23	**
Dec-21	2.57	5.54	**
