**YEAR 4 (2017) ANNUAL MONITORING REPORT**

**PEPPERWOOD FARM RIPARIAN BUFFER MITIGATION SITE**

Wake County, North Carolina

DMS Project ID: 95713

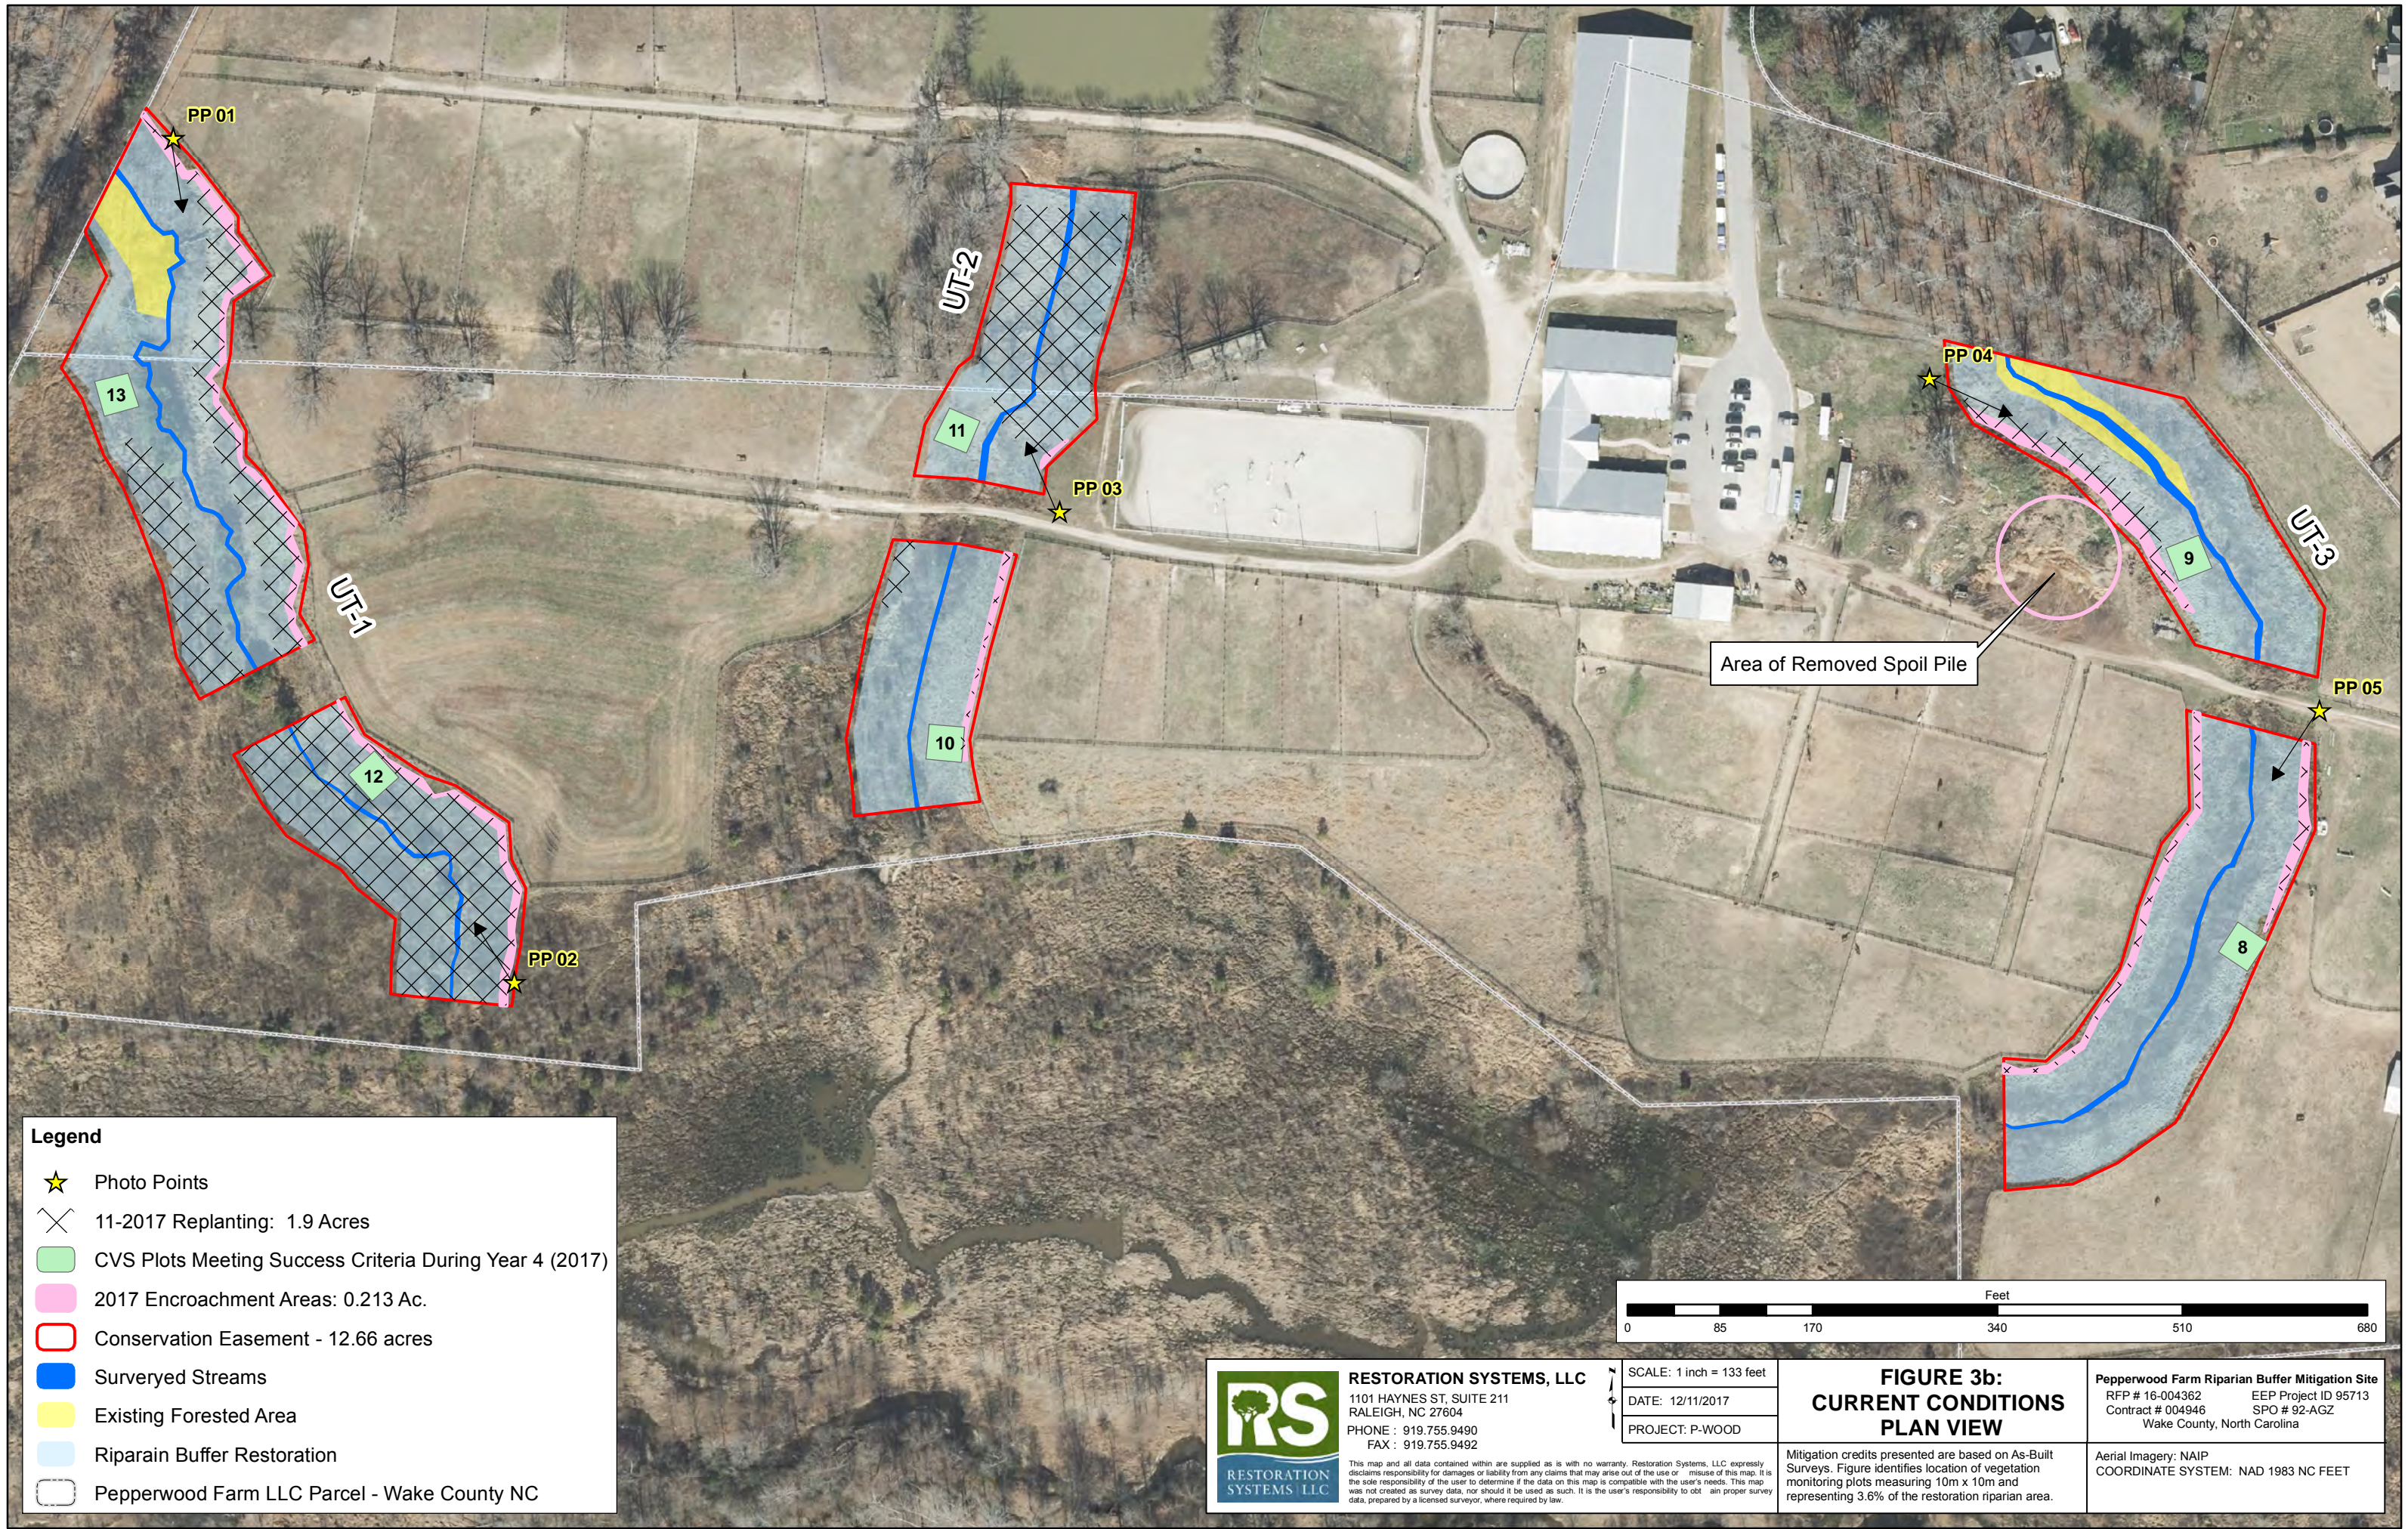
**FIGURE 3b:  
 CURRENT CONDITIONS  
 PLAN VIEW**

Previous to 2017, Pepperwood Farm had done an excellent job staying within their 5-foot allowance around fencing. For reasons unknown to Restoration Systems, Pepperwood Farm infringed into credit-generating areas along easement boundaries UT-1, 2, and 3 (shown in Figure 3b). Encroachment totaled 0.213 acres or 1.9% of the credit-generating area. Encroachment was not severe, and ranged from 2-5 feet along the edge of the easement. Included in the encroachment acreage, is the impact from the removal of a large spoil pile that abutted the conservation easement along UT-3. Pepperwood Farm moved the pile during the summer of 2017 and efforts cause slight encroachment, approximately 10 feet x 30 feet, see Figure 3b.

Vegetation Category	Definitions	Mapping Threshold	CCPV Depiction	Number of Polygons	Combined Acreage	% of Easement Acreage
4. Invasive Areas of Concern <sup>4</sup>	None	1000 SF	N/A	0	0.00	0.0%
5. Easement Encroachment Areas <sup>3</sup>	Yes, 0.213 acs.	0.1	Bright Pink	7	0.21	1.7%

Although site density was still above success criteria standards, Restoration Systems (RS) believed it would be best to replant the boundary of the conservation easement, at the 50’ offset line from the top of stream banks where encroachment took place. This would offset the loss to any planted stems from mowing activities, and would act as a visual barrier to protect the site in subsequent years from encroachment. RS had the easement boundary re-surveyed and marked the 5-foot maintenance offset with wood stakes and ribbon. Working with Carolina Silvics, RS planted 300, 3-gallon species with an average height of 5 feet along 3,000 feet of the 5-foot maintenance line (one tree about every 10-feet). Ribbon was placed on these trees to enhance the visual barrier further.

Restoration Systems also observed some areas of the Site which seemed not-to-be meeting success criteria including areas within the UT-1 easement and the upper portion of UT-2. RS did not conduct additional vegetation surveys in these areas and instead added 200, 3-gallon species as needed. No planting occurred within monitoring plots.

Planting occurred during the week of November 27<sup>th</sup> and included 500 3-gallon trees (Figure 3b). Species included, green ash (*Fraxinus pennsylvanica*), Sycamore (*platanus occidentalis*), willow oak (*Quercus phellos*), northern red oak (*Quercus ruba*), and swamp chestnut oak (*Quercus michauxii*).
