MONITORING YEAR 2 ANNUAL REPORT FINAL

PERRY HILL MITIGATION SITE

Orange County, NC
Neuse River Basin
HUC 03020201

DMS Project No. 100093
DMS Contract No. 7744
DMS RFP No. 16-007576
USACE Action ID No. 2019-00125
DWR Project No. 2019-0157

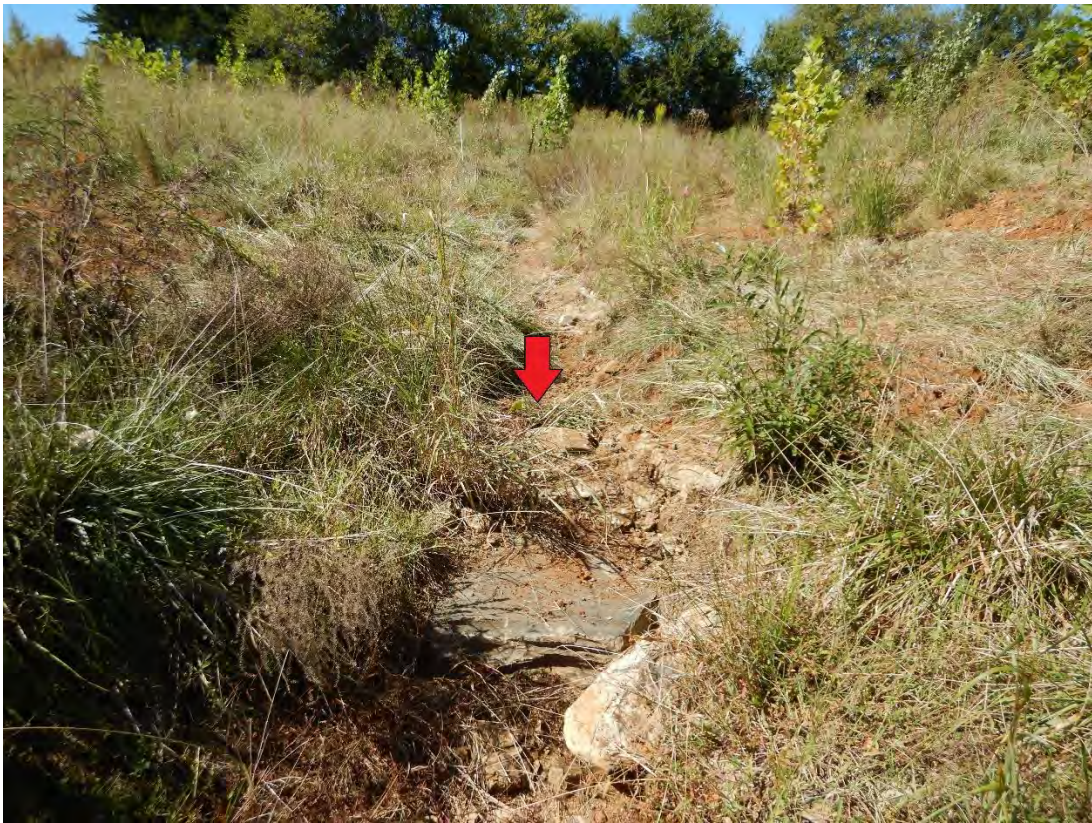
UT1 R1 US – Repair just above rock sill in foreground (9/27/2022)

Wildlands continued to observe the lack of flow in the short stretch of UT1 Reach 1 through the winter and spring of 2022. When gauge data and observations did not show an increase in flow throughout the wettest part of the year (see Section 2.5 Hydrology Assessment Section below), it was decided that repairs were necessary. In September 2022, a rock sill was repaired by reinstalling filter fabric and backfill material on the upstream face. The original fabric and backfill material are believed to have failed to seal this structure, resulting in stream flow going subsurface. The repair was completed to return the structure to the original design condition. This does not leave much to see on the surface, however pictures with a red arrow pointing to the area of disturbance in the channel are included in Appendix A – Stream Area of Concern Repair Photographs. Approximately five linear feet of channel were impacted (see Figure 1b for location). Wildlands will continue to monitor flow in MY3.

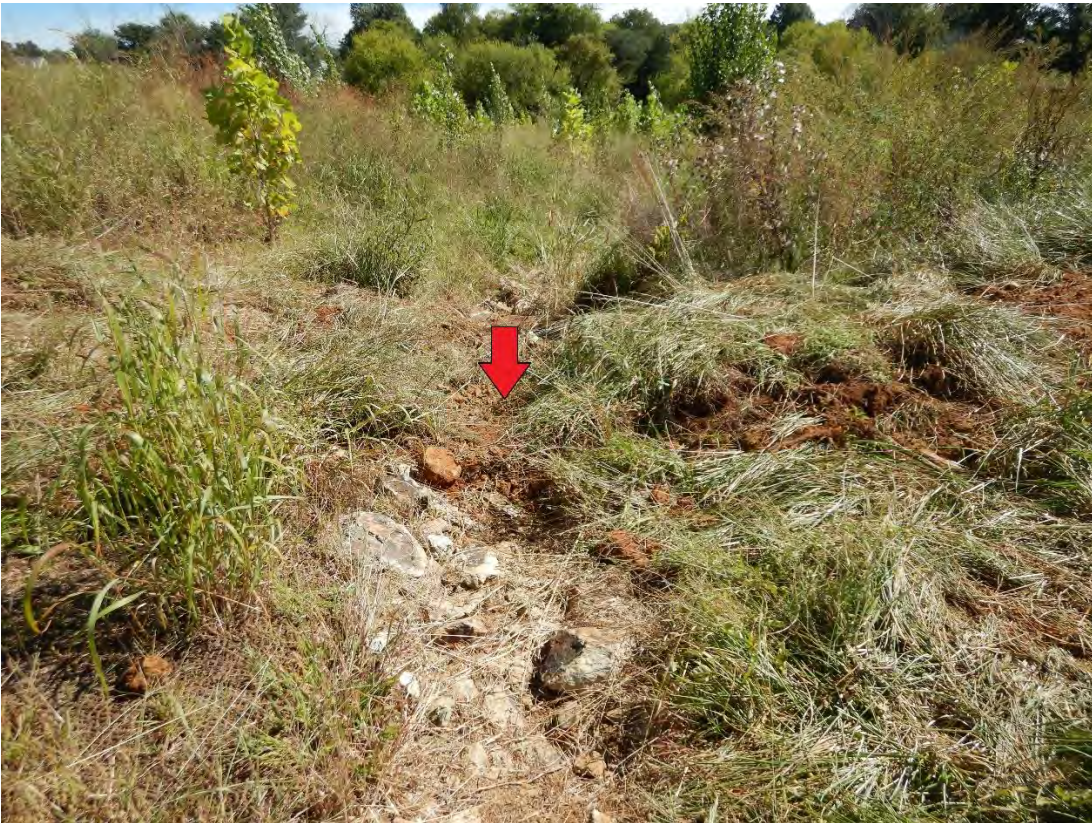
UT1 R1 DS – Repair at end of riffle above rock sill (9/27/2022)

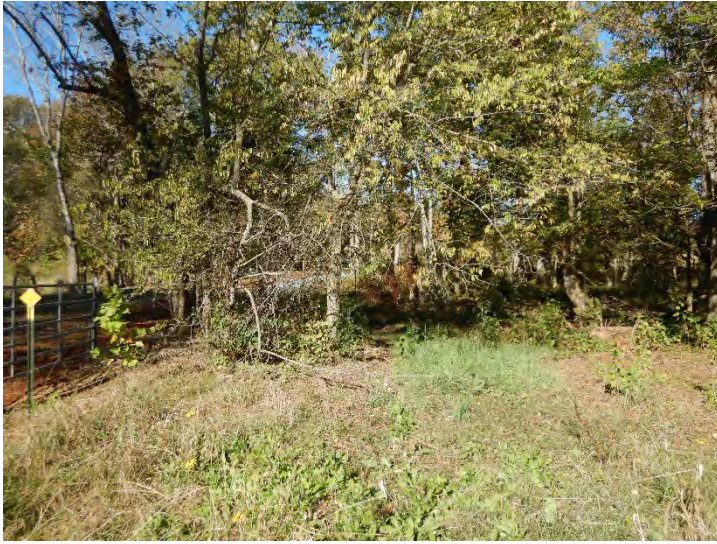
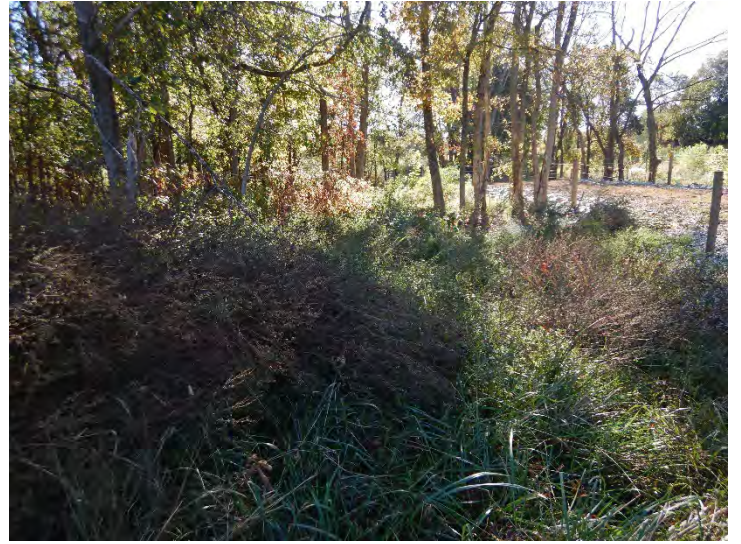
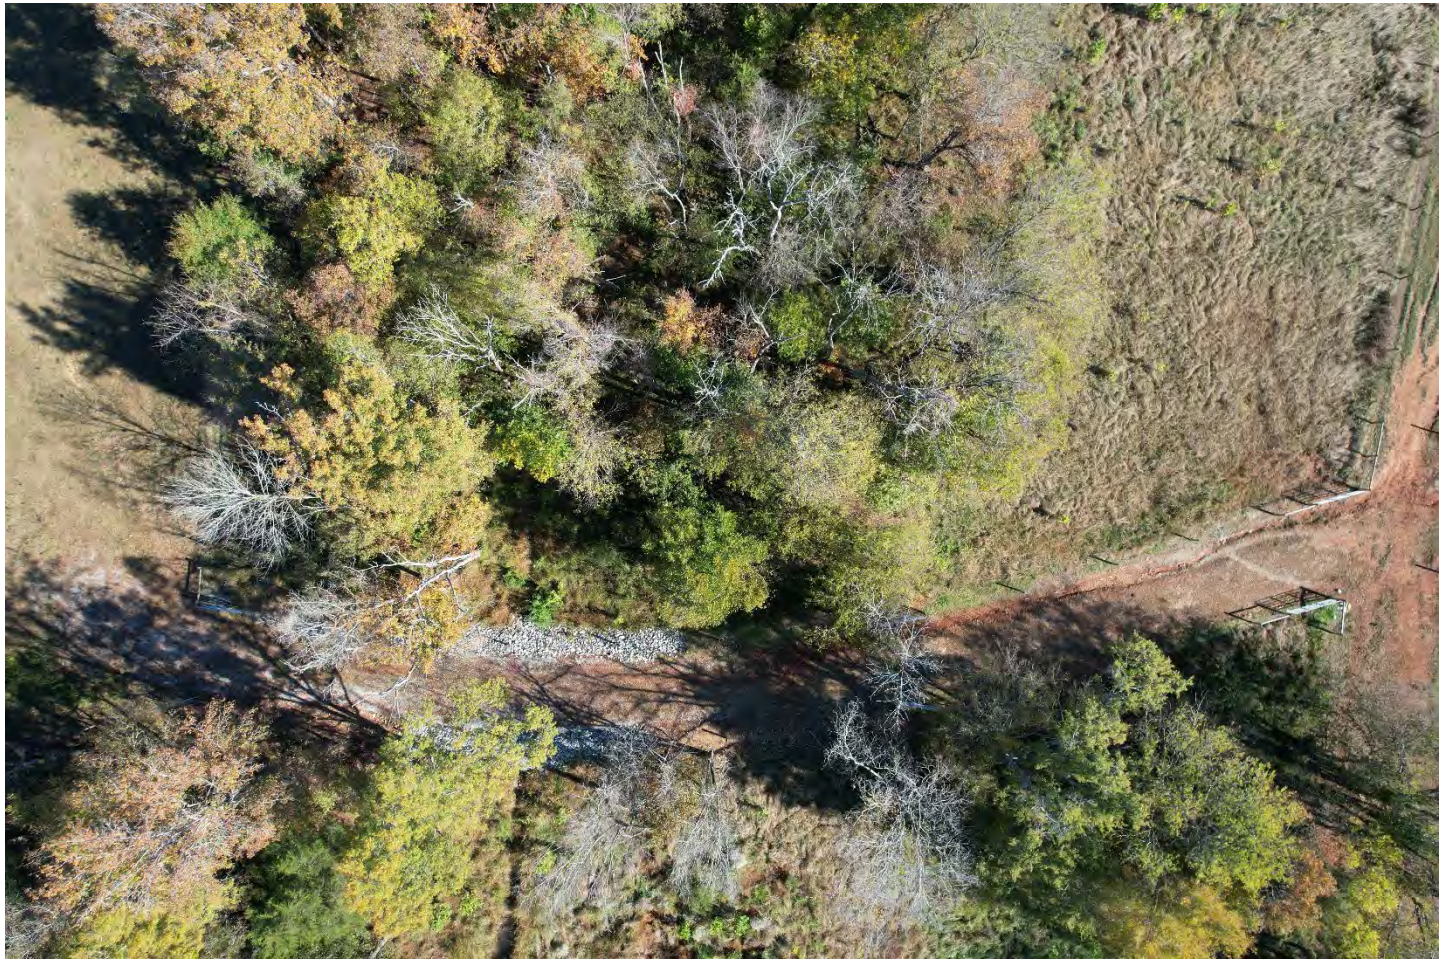
Perry Branch R2 – CE Encroachment Seeded and Stabilized (10/19/2022)

As was discussed above, an additional 20 feet (a total of 0.19 acres) was added alongside both internal crossings as a maintenance area due to the installation of waterlines in October 2021. The affected area was seeded, and herbaceous vegetation has grown over the disturbance. The soil is stabilized, and Wildlands does not anticipate any future problems in these areas. Recent photographs showing vegetation cover are included in Vegetation Areas of Concern Updated Photographs in Appendix A.

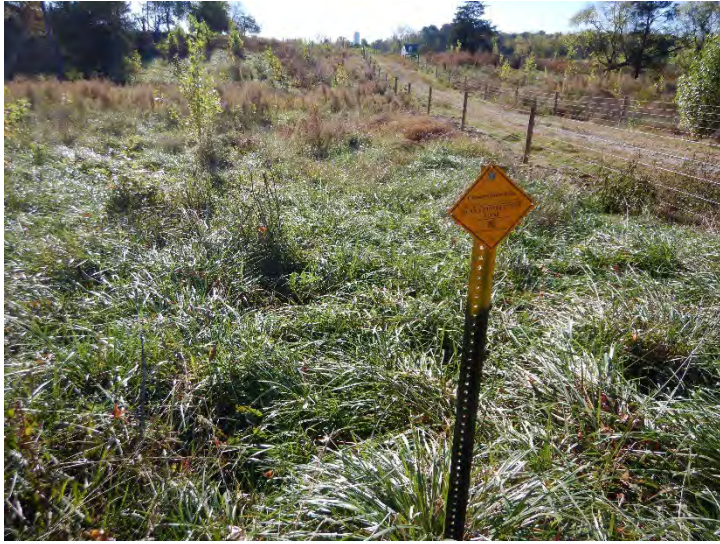
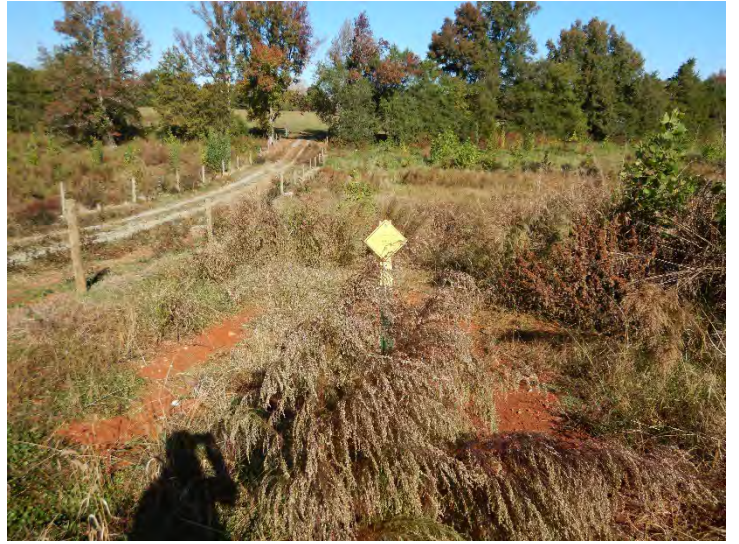
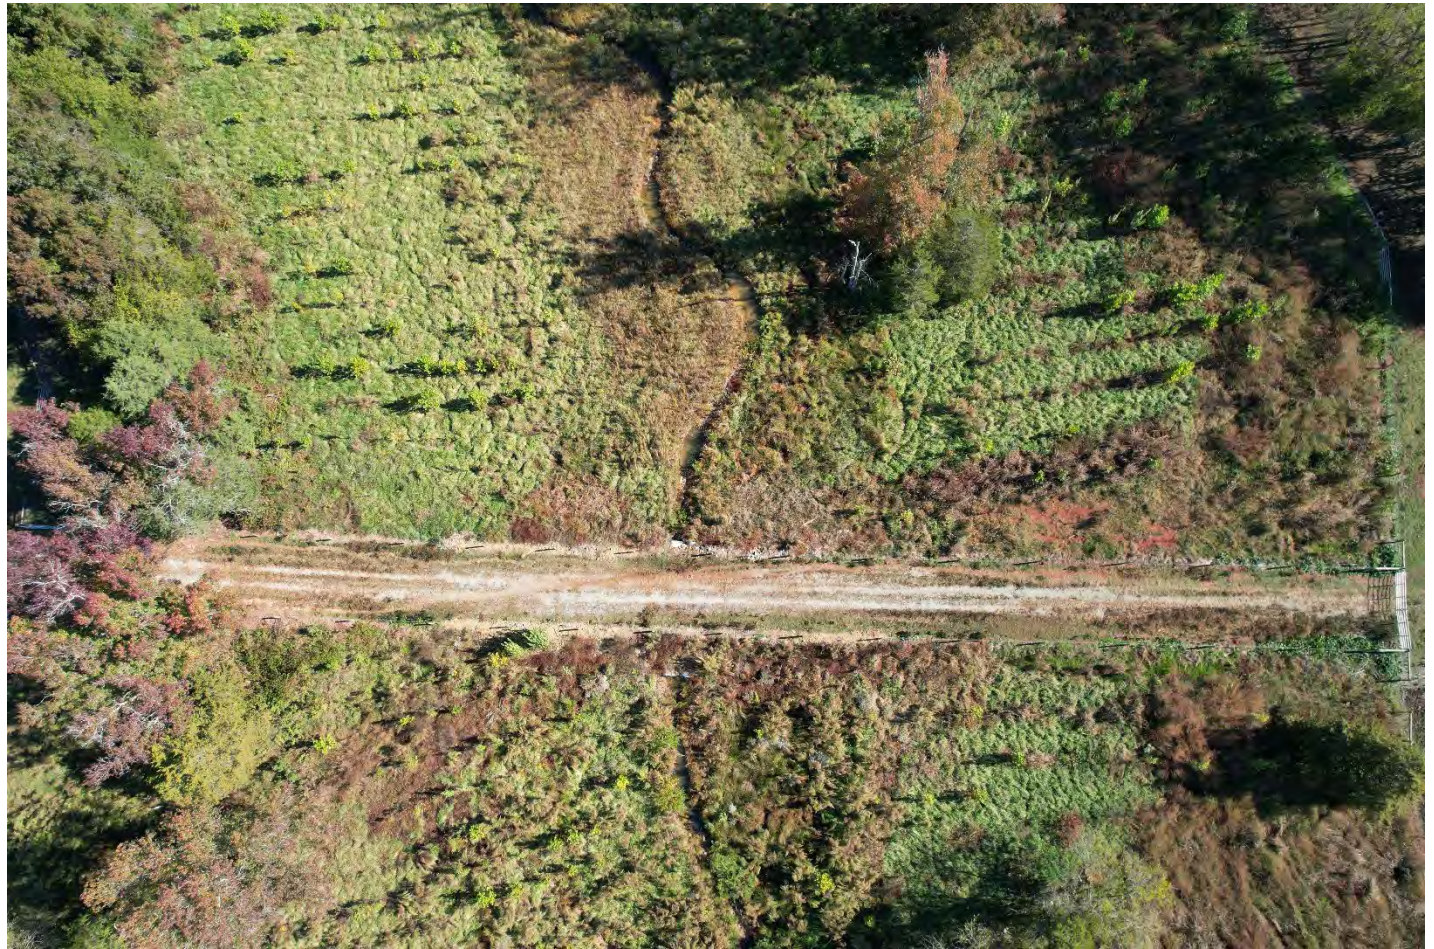
Perry Branch R4 – CE Encroachment Seeded and Stabilized (10/19/2022)
