MYO MONITORING REPORT

PHANTOM MILL

Alamance County, North Carolina
Cape Fear River Basin
Cataloging Unit 03030002

DMS Project No. 100057
Full Delivery Contract No. 7526
DMS RFP No. 16-007330
USACE Action ID No. SAW-2018-01166
DWR Project No. 18-0796

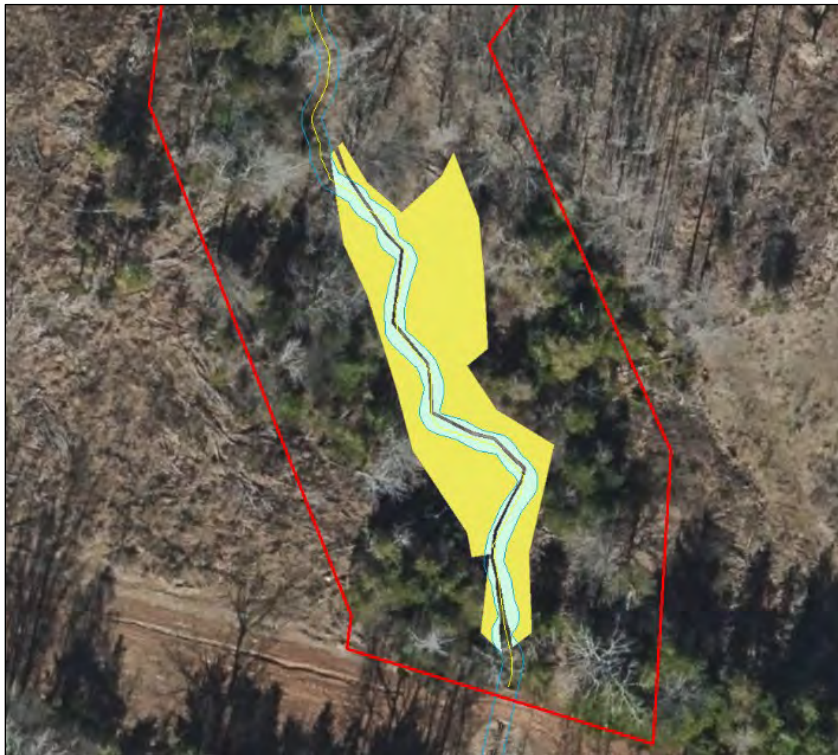
The channel banks on UT-2 were extended into wetland enhancement areas during as-built. These areas total 0.035 acres and were removed from wetland enhancement area calculations during as-built. The as-built wetland enhancement acreage in Table 1 has been updated accordingly. As credit is calculated from the detailed planning phase, wetland credits remain unchanged. See photo below for an explanation of the discrepancy. Blue is the mitigation plan wetland enhancement shapefile (with narrower channel banks), and yellow is the as-built wetlands.

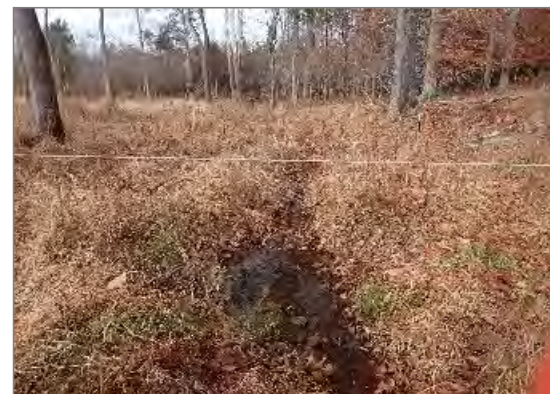
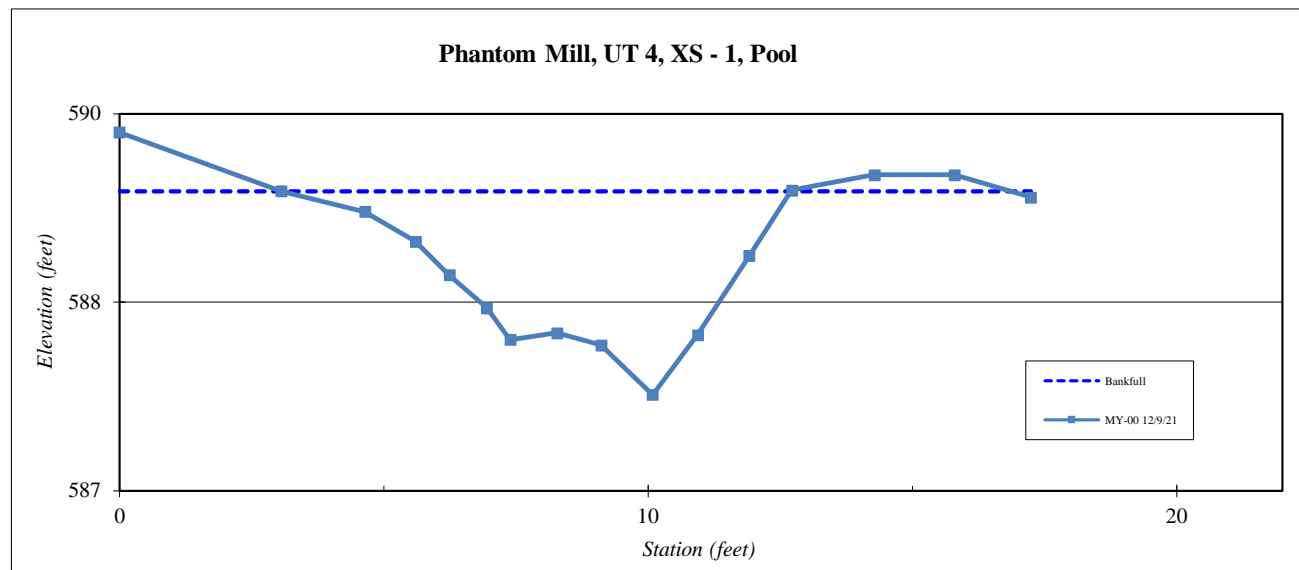
Site	Phantom Mill
Watershed:	Cape Fear River Basin, 03030002
XS ID	UT 4, XS -1, Pool
Feature	Pool
Date:	12/9/2021
Field Crew:	Perkinson, D. Lewis

SUMMARY DATA	
Bankfull Elevation:	589.1
Bank Height Ratio:	1.0
Thalweg Elevation:	587.8
LTOB Elevation:	589.1
LTOB Max Depth:	1.4
LTOB Cross Sectional Area:	6.2

Stream Type E/C 5

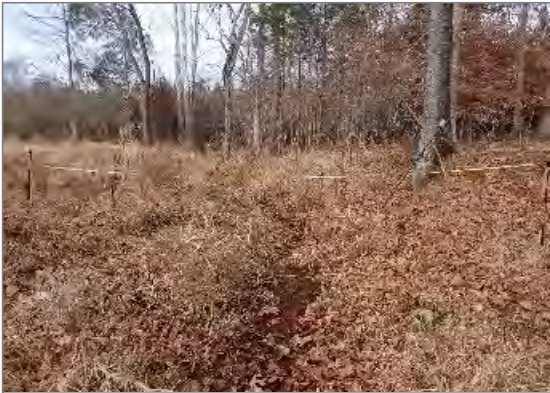
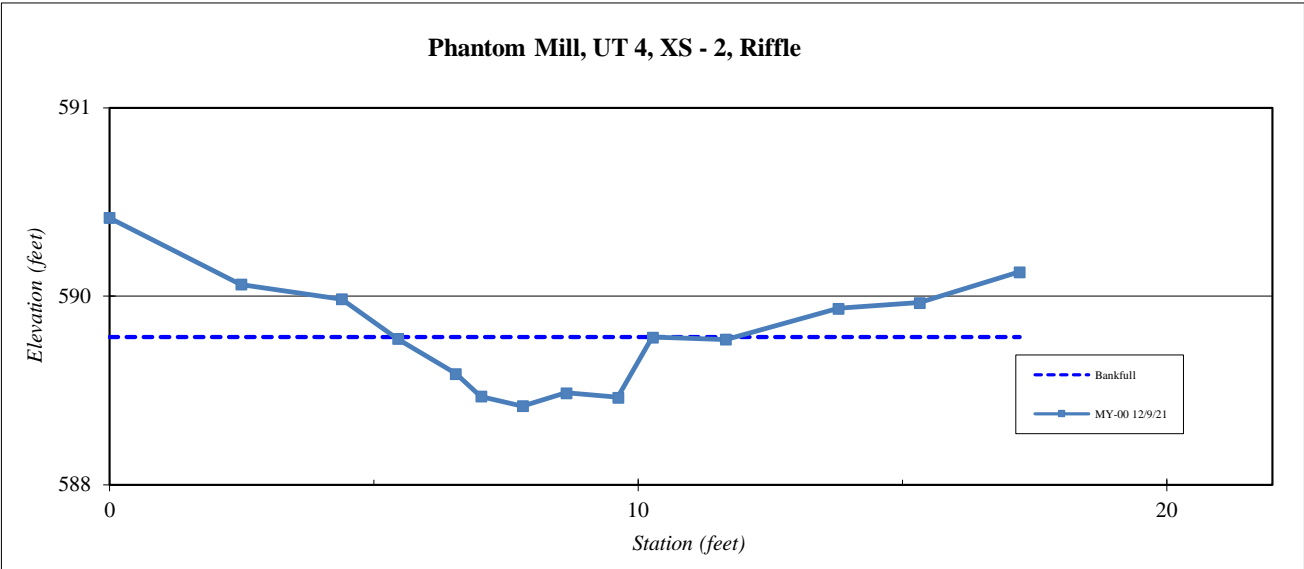
Site	Phantom Mill
Watershed:	Cape Fear River Basin, 03030002
XS ID	UT 4, XS -2, Riffle
Feature	Riffle
Date:	12/9/2021
Field Crew:	Perkinson, D. Lewis

SUMMARY DATA	
Bankfull Elevation:	589.4
Bank Hieght Ratio:	1.0
Thalweg Elevation:	588.9
LTOB Elevation:	589.4
LTOB Max Depth:	0.5
LTOB Cross Sectional Area:	1.5

Stream Type	E/C 5
-------------	-------

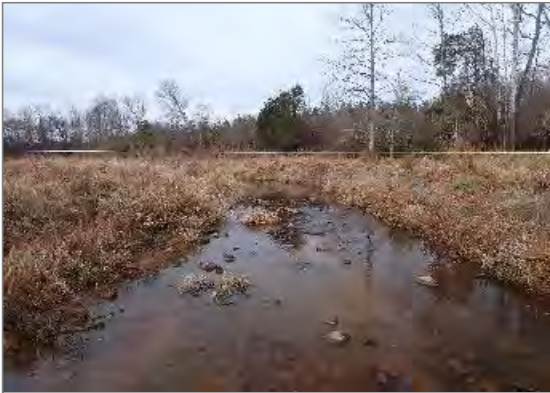
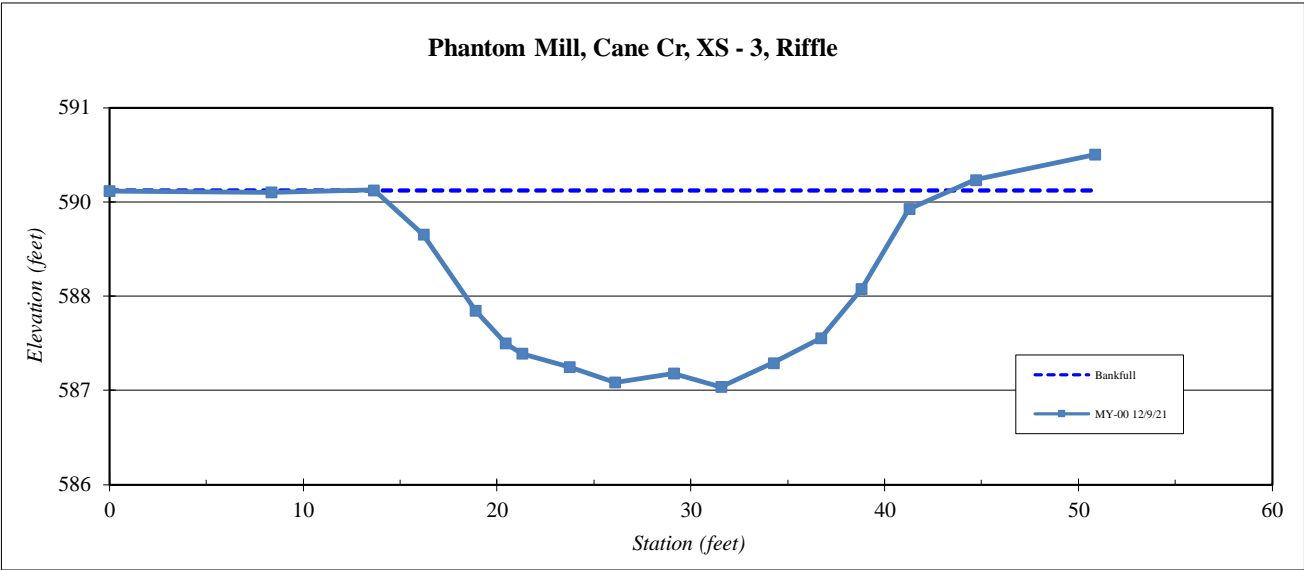
Site	Phantom Mill
Watershed:	Cape Fear River Basin, 03030002
XS ID	Cane Cr, XS -3, Riffle
Feature	Riffle
Date:	12/9/2021
Field Crew:	Perkinson, D. Lewis

SUMMARY DATA	
Bankfull Elevation:	589.8
Bank Height Ratio:	1.0
Thalweg Elevation:	587.2
LTOB Elevation:	589.8
LTOB Max Depth:	2.6
LTOB Cross Sectional Area:	50.9

Stream Type	E/C 5
-------------	-------

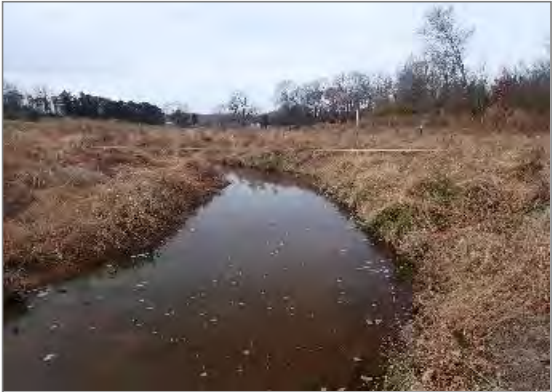
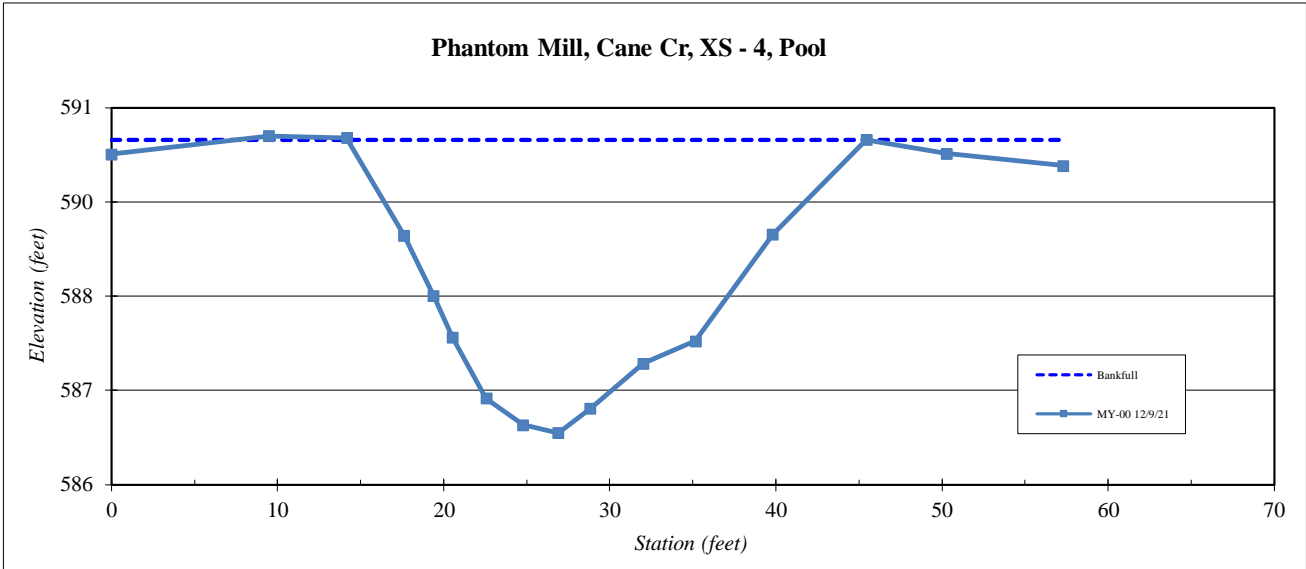
Site	Phantom Mill
Watershed:	Cape Fear River Basin, 03030002
XS ID	Cane Cr, XS -4, Pool
Feature	Pool
Date:	12/9/2021
Field Crew:	Perkinson, D. Lewis

SUMMARY DATA	
Bankfull Elevation:	590.5
Bank Hieght Ratio:	1.0
Thalweg Elevation:	586.6
LTOB Elevation:	590.5
LTOB Max Depth:	3.9
LTOB Cross Sectional Area:	69.4

Stream Type	E/C 5
--------------------	-------

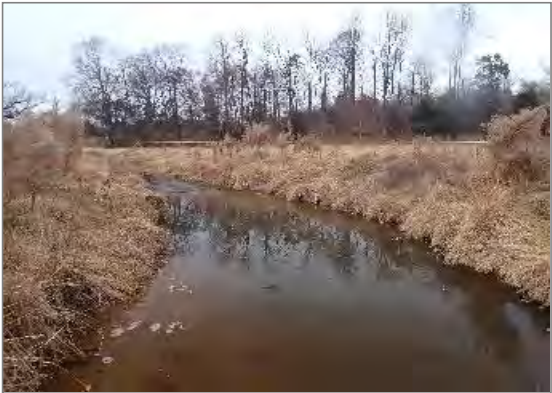
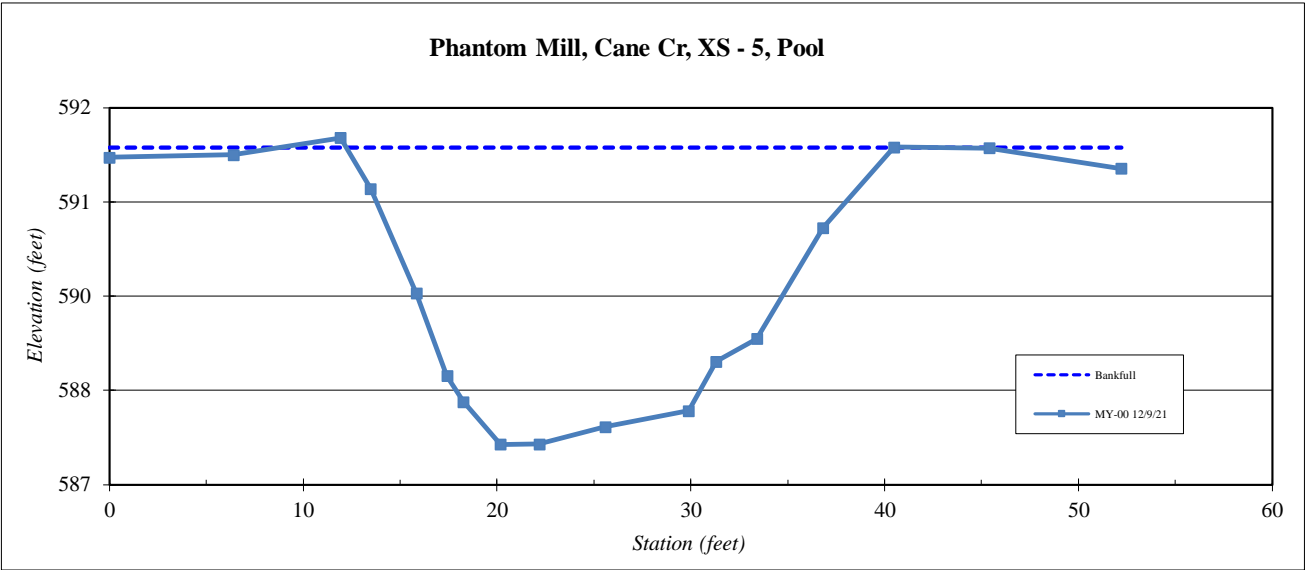
Site	Phantom Mill
Watershed:	Cape Fear River Basin, 03030002
XS ID	Cane Cr, XS -5, Pool
Feature	Pool
Date:	12/9/2021
Field Crew:	Perkinson, D. Lewis

SUMMARY DATA	
Bankfull Elevation:	591.6
Bank Hieght Ratio:	1.0
Thalweg Elevation:	587.7
LTOB Elevation:	591.6
LTOB Max Depth:	4.0
LTOB Cross Sectional Area:	71.9

Stream Type	E/C 5
--------------------	-------

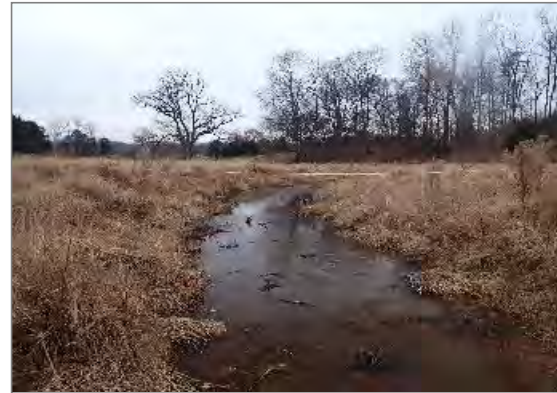
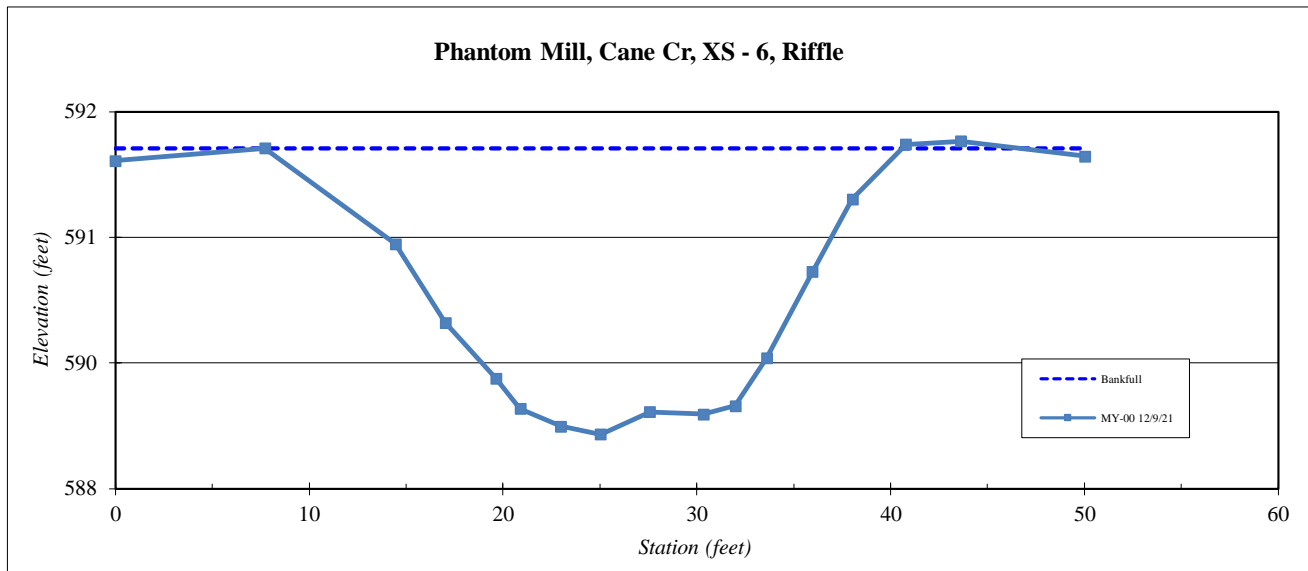
Site	Phantom Mill
Watershed:	Cape Fear River Basin, 03030002
XS ID	Cane Cr, XS - 6, Riffle
Feature	Riffle
Date:	12/9/2021
Field Crew:	Perkinson, D. Lewis

SUMMARY DATA	
Bankfull Elevation:	591.8
Bank Height Ratio:	1.0
Thalweg Elevation:	589.0
LTOB Elevation:	591.8
LTOB Max Depth:	2.9
LTOB Cross Sectional Area:	55.2

Stream Type	E/C 5
--------------------	-------

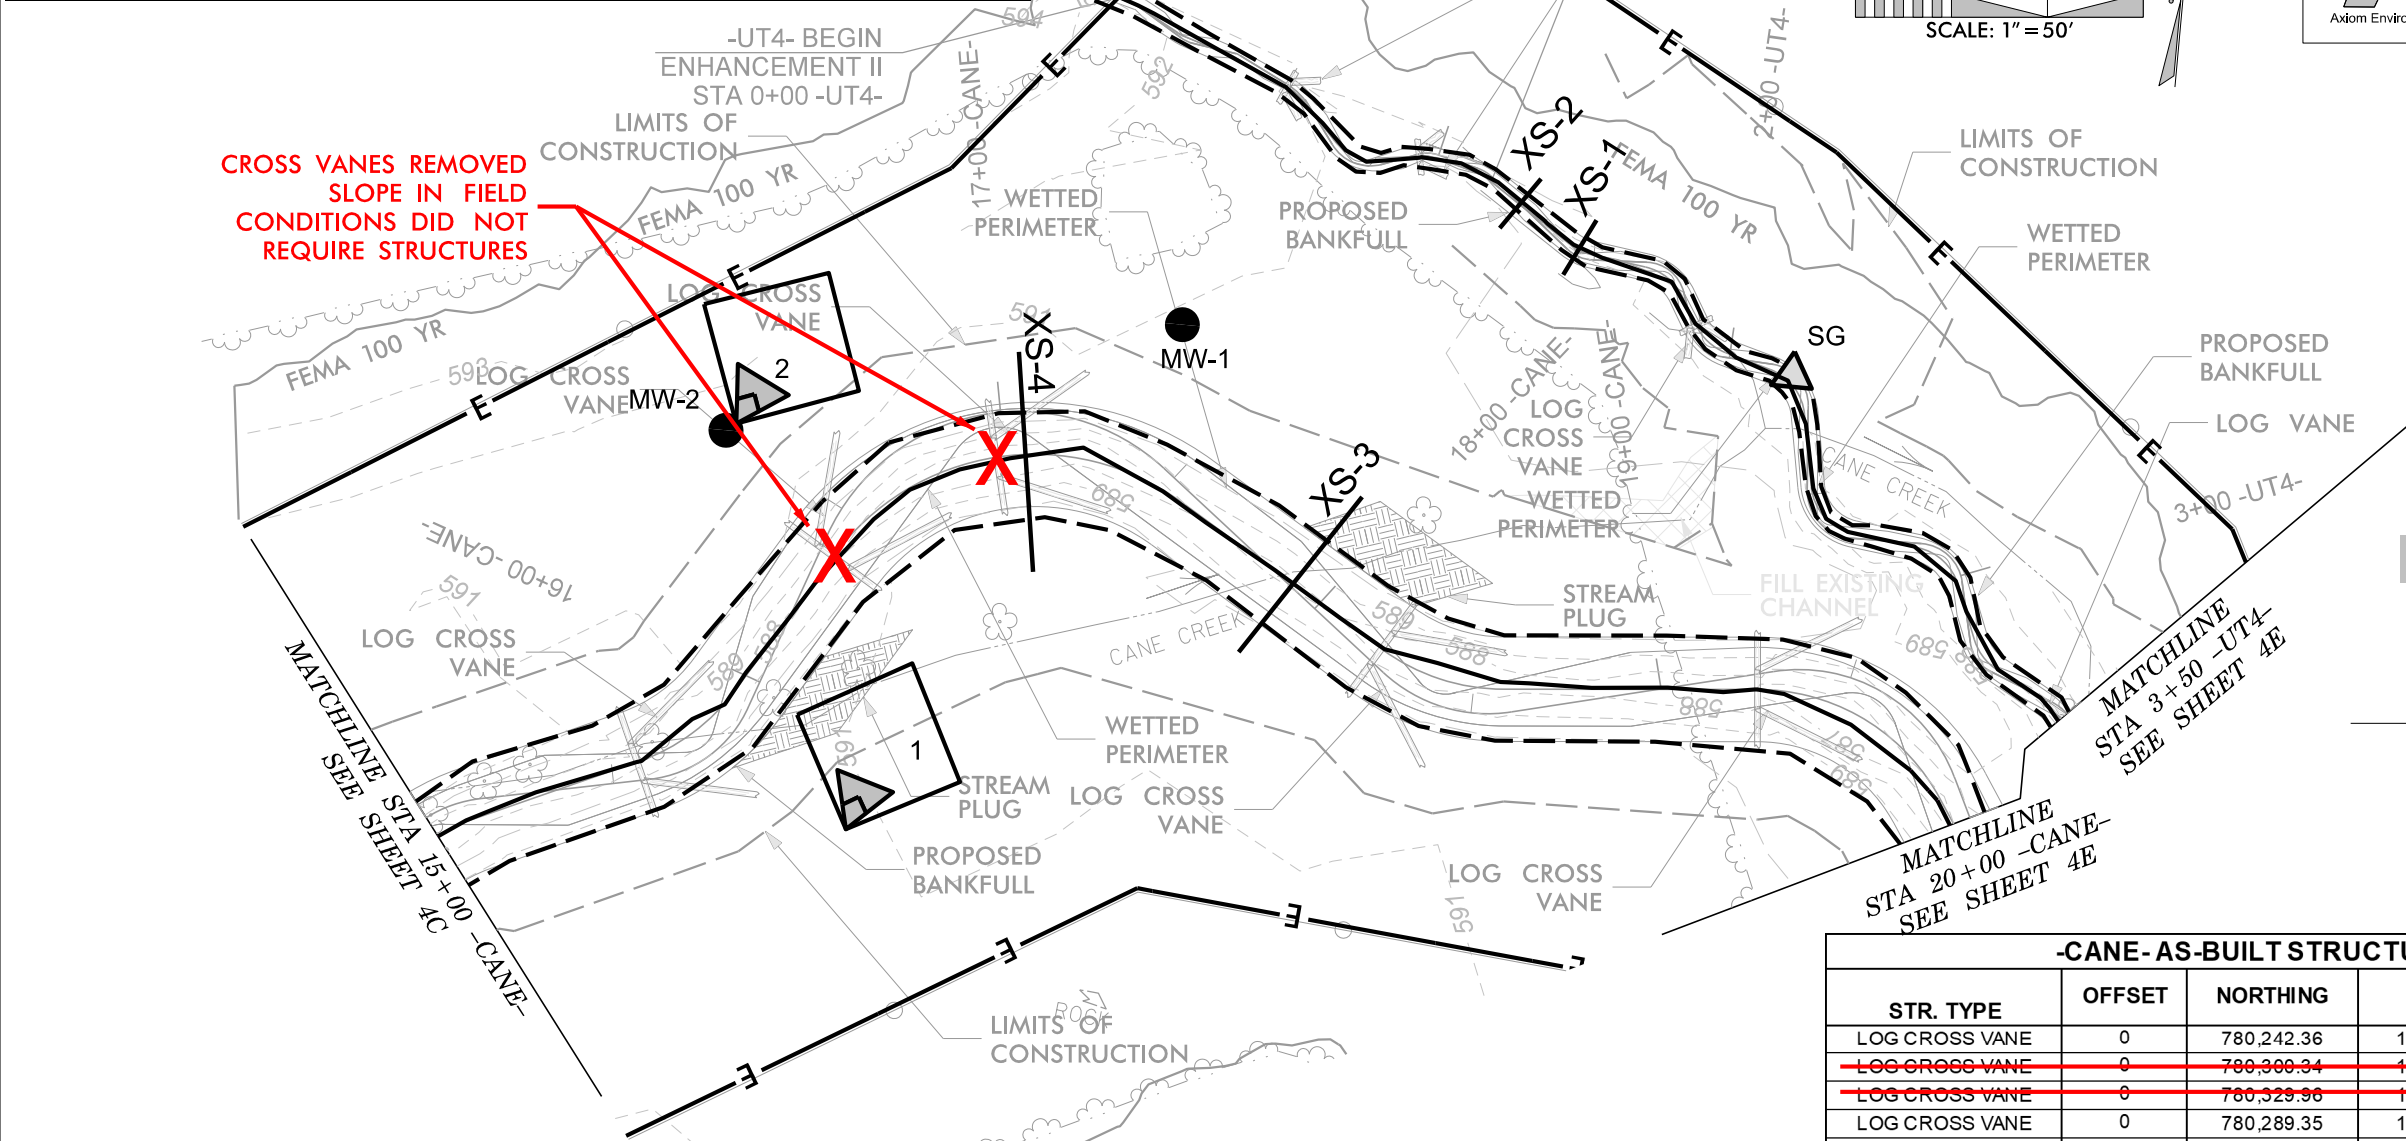
CROSS VANES REMOVED
SLOPE IN FIELD
CONDITIONS DID NOT
REQUIRE STRUCTURES
