**FINAL
MY2 (2023) MONITORING REPORT**

PHANTOM MILL

Alamance County, North Carolina

DMS Project No. 100057

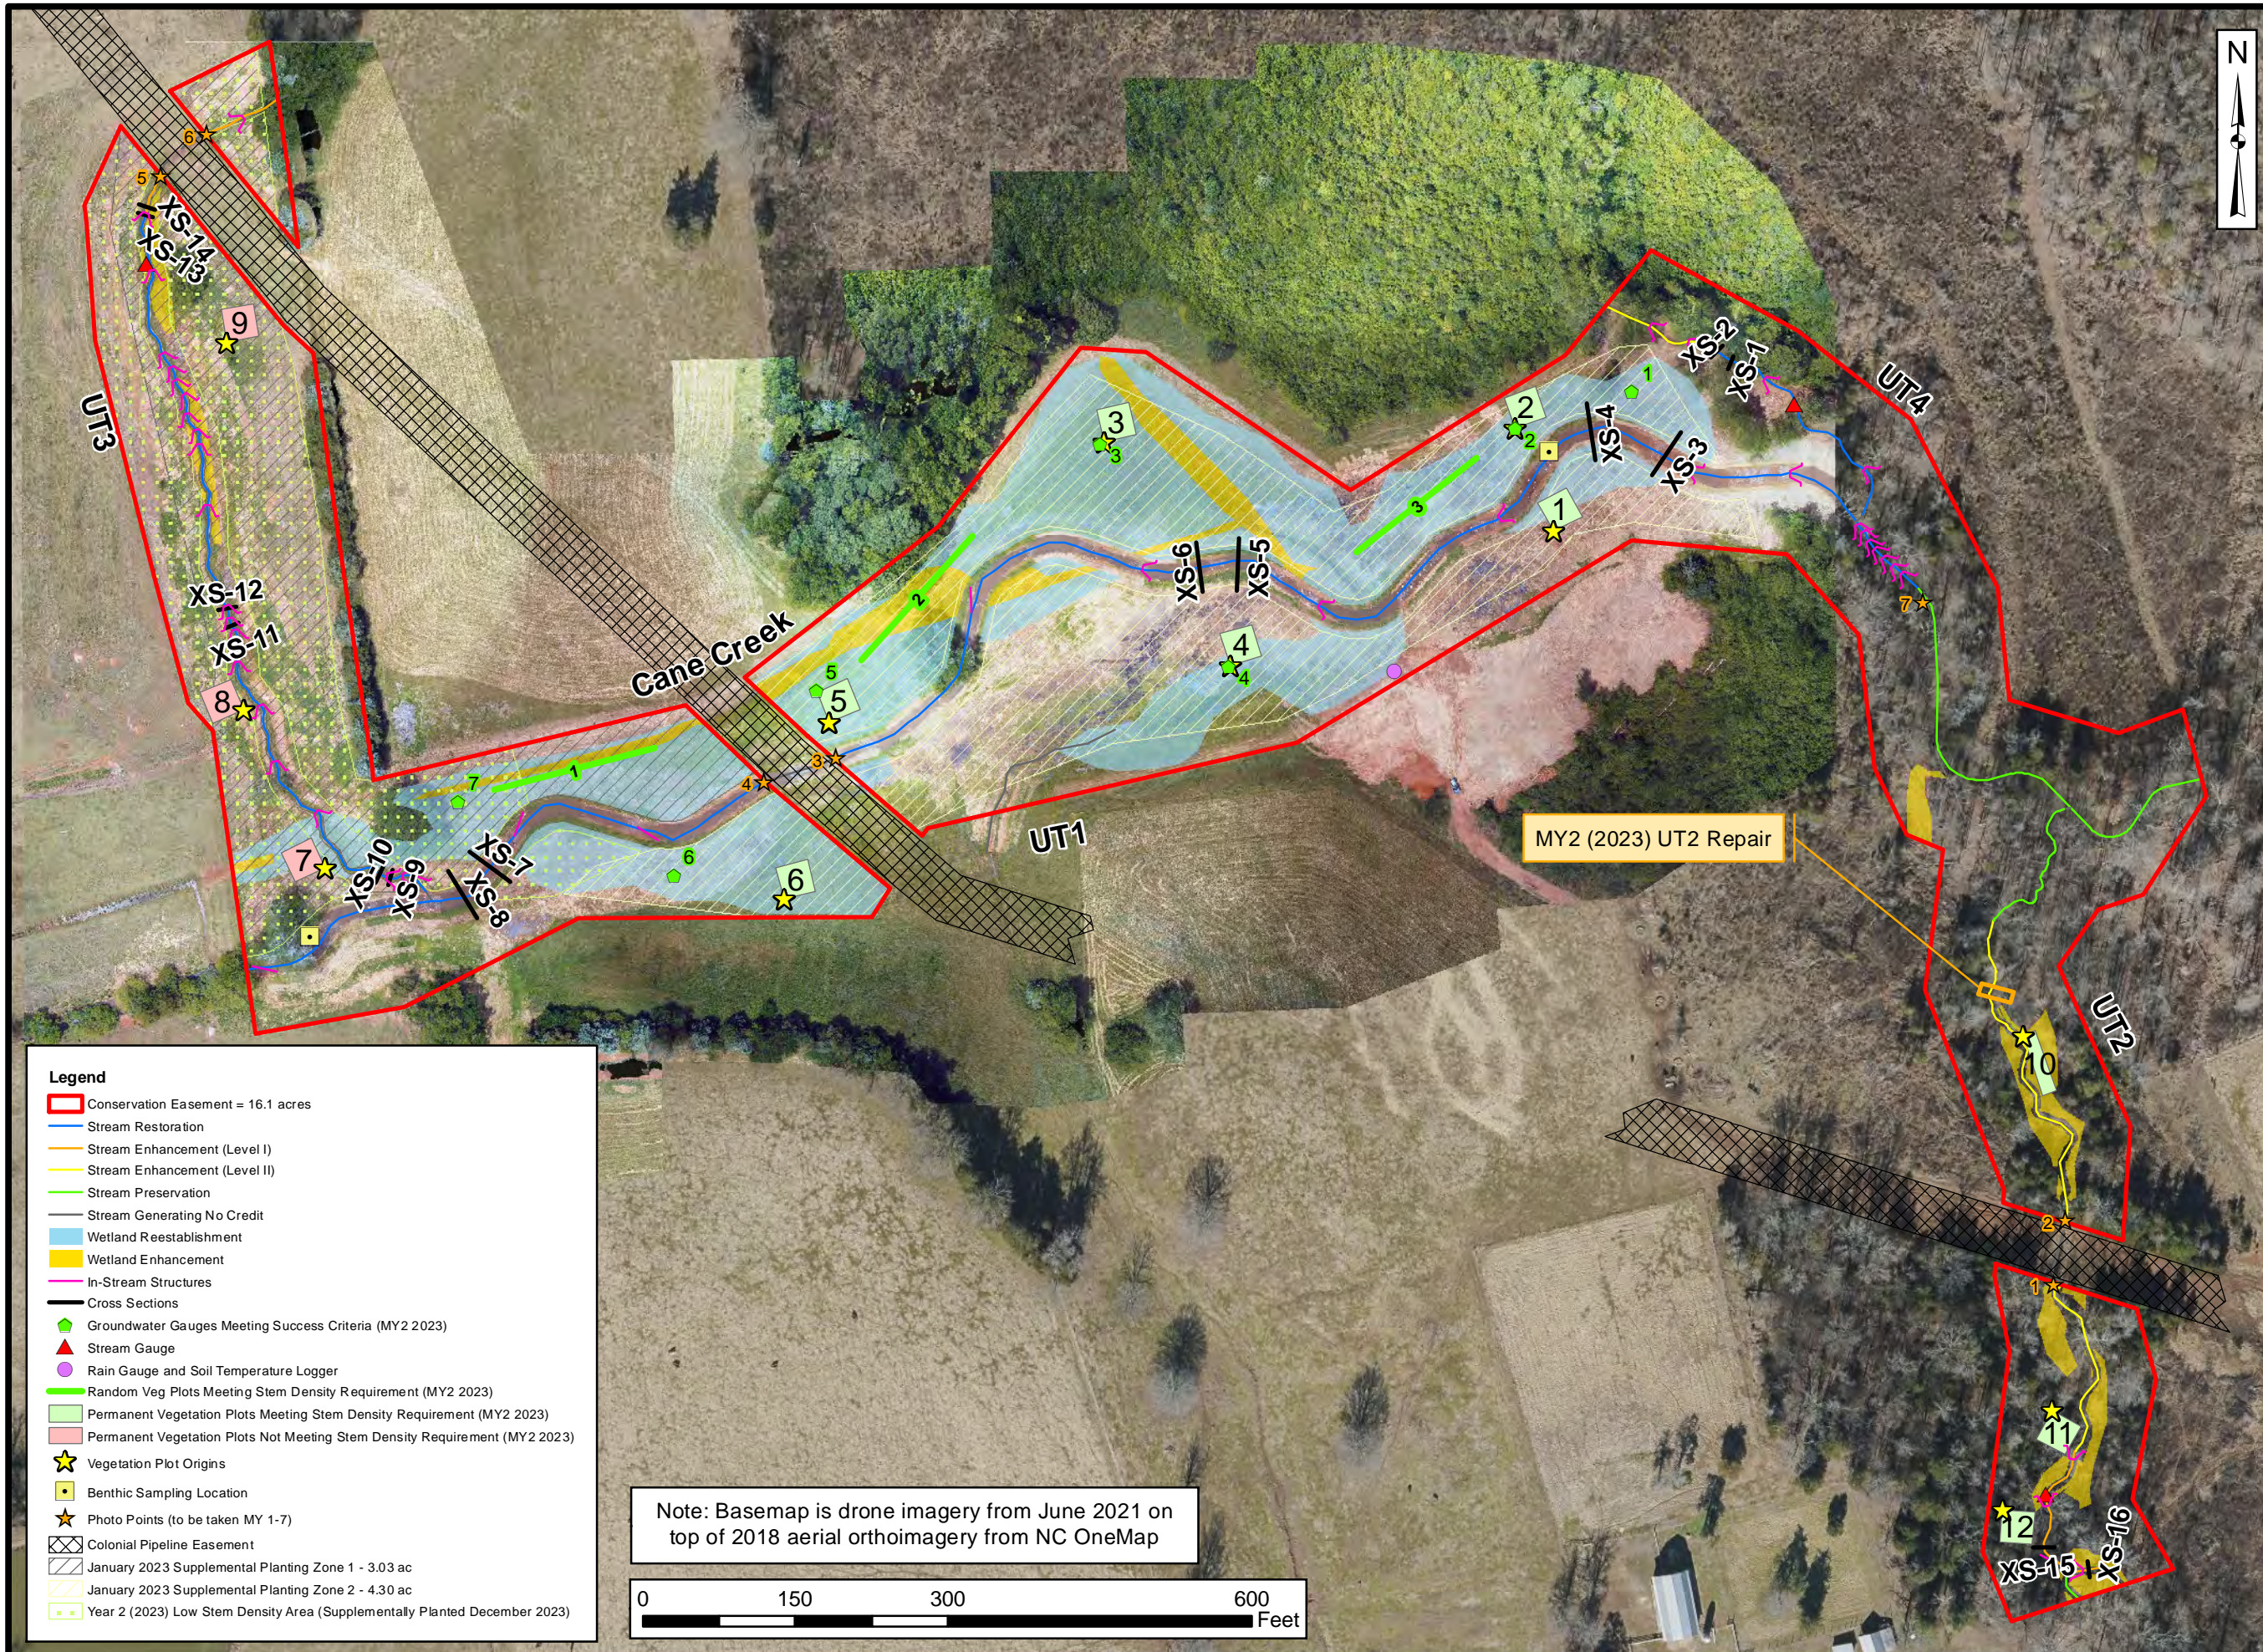
**CURRENT
CONDITIONS
PLAN VIEW**

Based on Year 2 (2023) data and visual assessment, and despite the January 2023 supplemental planting, two areas of low stem density remained. These include the upland areas of UT3, and a portion of the Cane Creek floodplain where herbaceous overtopping was observed during the dormant season of 2023/2024. In response, the upland areas of UT3 was planted on December 22, 2023, with approximately 245, 1- and 3-gallon containerized trees. Species are summarized below. No stems were planted within vegetation plots. RS will conduct random vegetation transects along UT3 in the Spring of 2024 to determine the success of the planting and to better understand the extent of the low stem density area. RS will continue to visually monitor overtop stems within the Cane Creek floodplain and will hand release stems in February 2024. These areas are depicted in Figure 1 and are quantified in Table 5 (Appendix A).

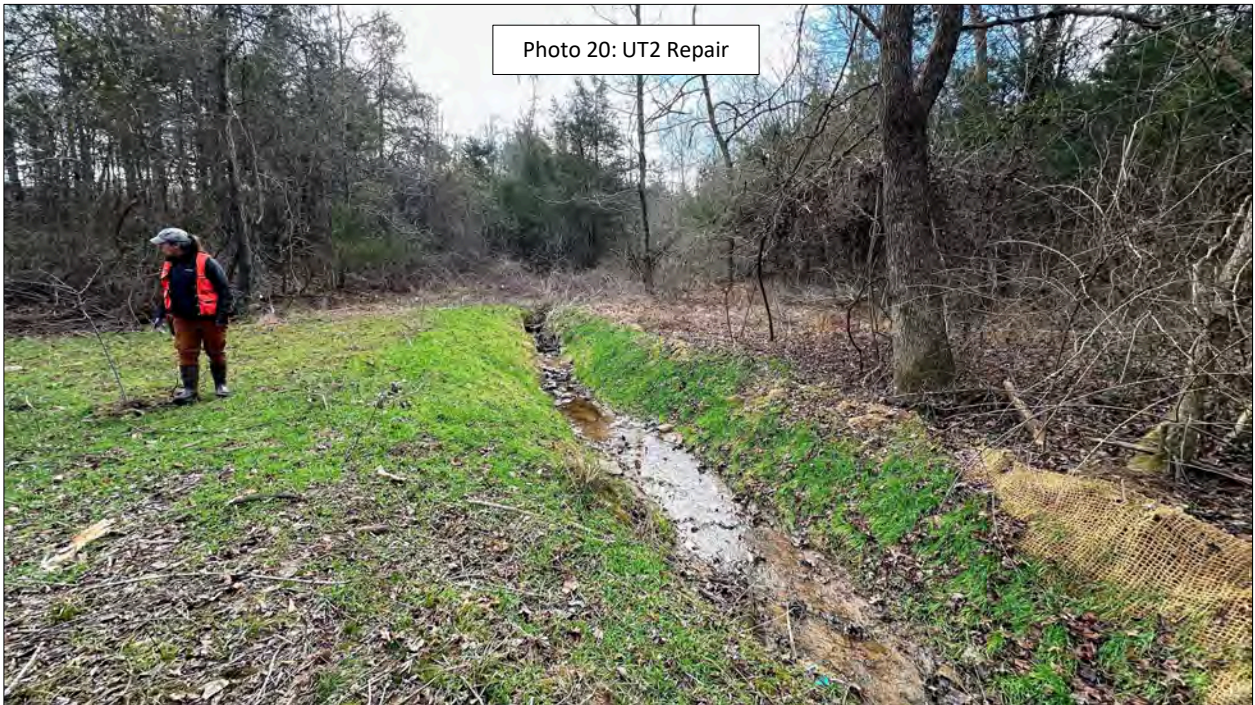
One stream area of concern was observed and repaired during Year 2 (2023) monitoring. At the bottom of the Enhancement II area of UT2, approximately 11 linear feet of the stream was found to be unstable due to piping (Figure 1, Appendix A). In an effort to arrest head cut formation, the area was stabilized with matting and rock found onsite piled outside the easement. The IRT was notified of the maintenance work, which was performed on October 24, 2023. Additionally, five 1- and 3-gallon containerized trees were planted within the footprint of the repair on December 22, 2023. Species included water oak, willow oak, sycamore, and river birch. Live staking of black willow and silky dogwood along the repaired reach is scheduled for mid to late February 2024. See Q4 2023/Q4 2024 Remedial Planting Plan in Vegetation Summary for details. Email correspondence and photos of the repair are in Appendix F. This area will continue to be monitored closely in years 3-7.

Photo 20: UT2 Repair

We have a small area (about 11 linear feet) of piping at Phantom Mill near STA 8 on UT2. This is at the bottom of our enhancement II area. We are planning use some matting and onsite rock that is piled just outside the easement there to correct the issue while it is still minor and arrest the headcut that is forming. We expect to complete the repair in the next 60-90 days.

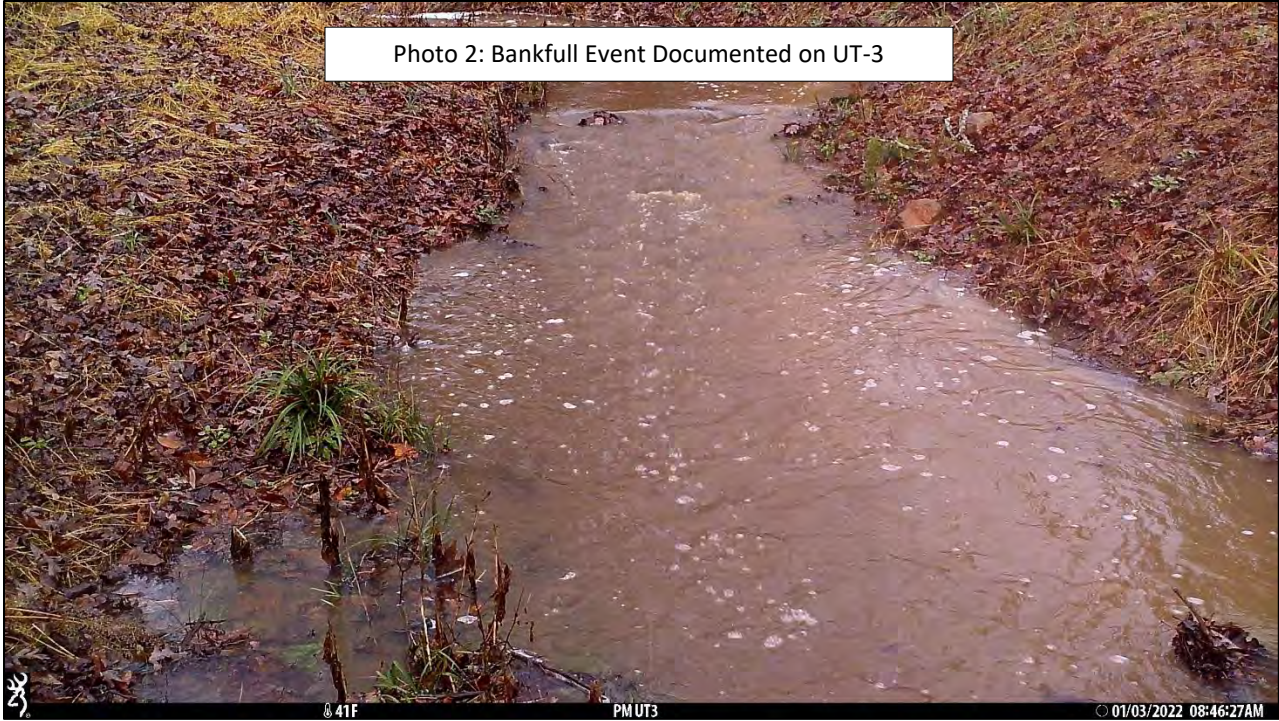
Photo 2: Bankfull Event Documented on UT-3

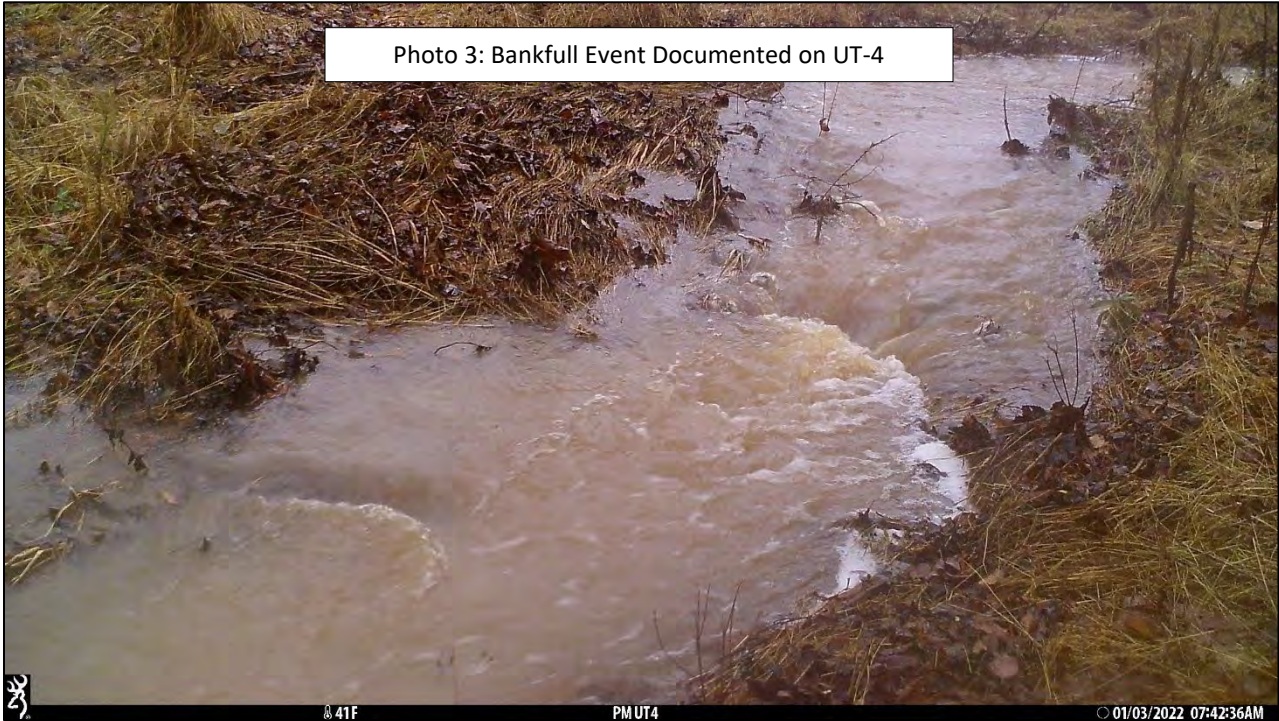
Photo 3: Bankfull Event Documented on UT-4

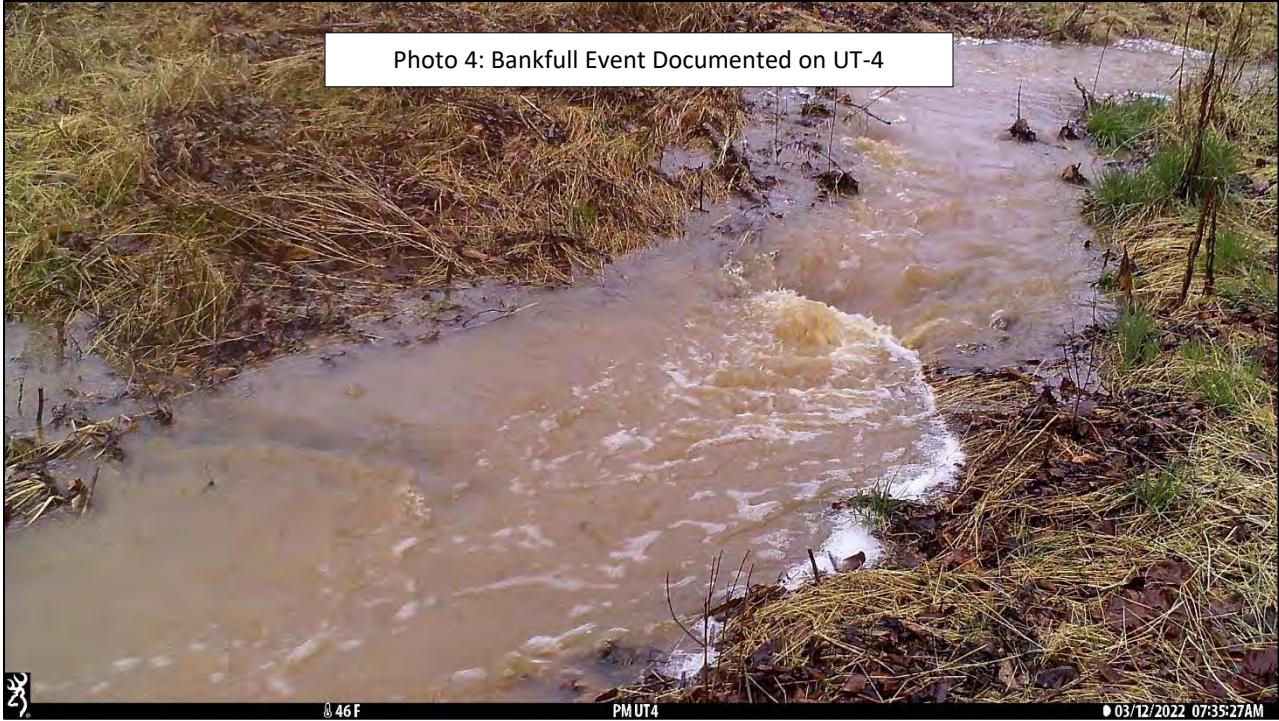
Photo 4: Bankfull Event Documented on UT-4

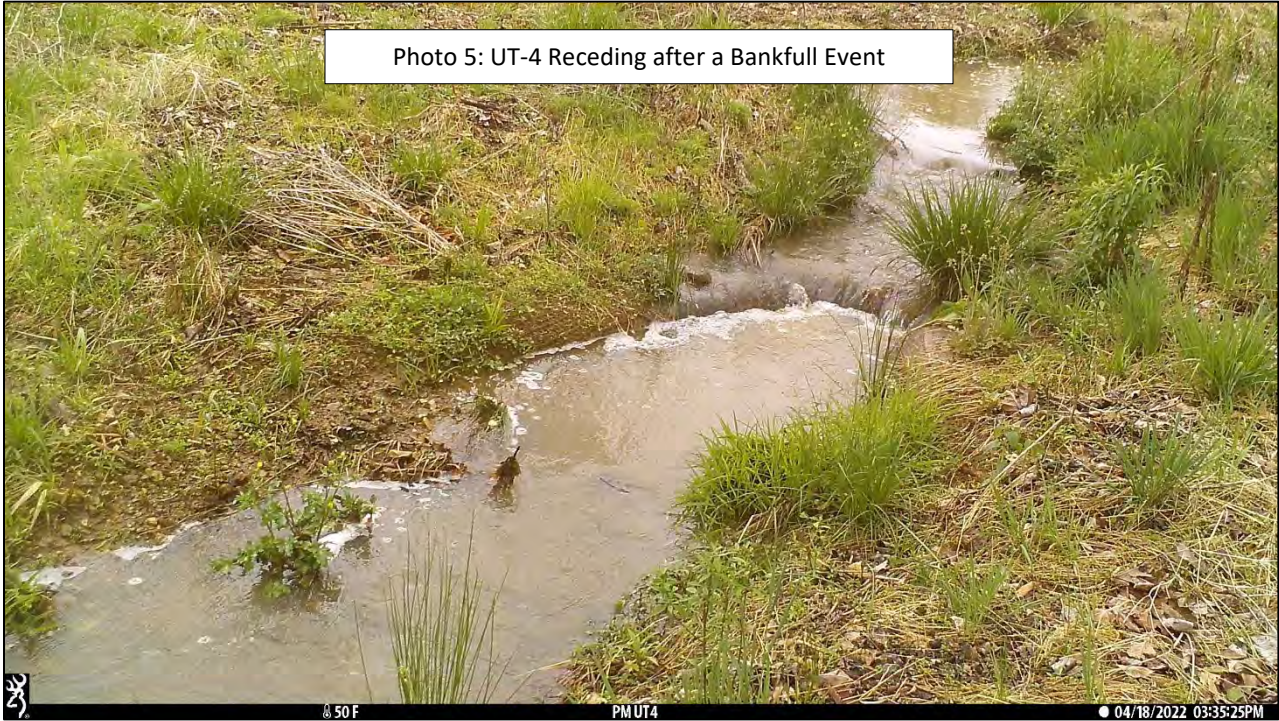
Photo 5: UT-4 Receding after a Bankfull Event

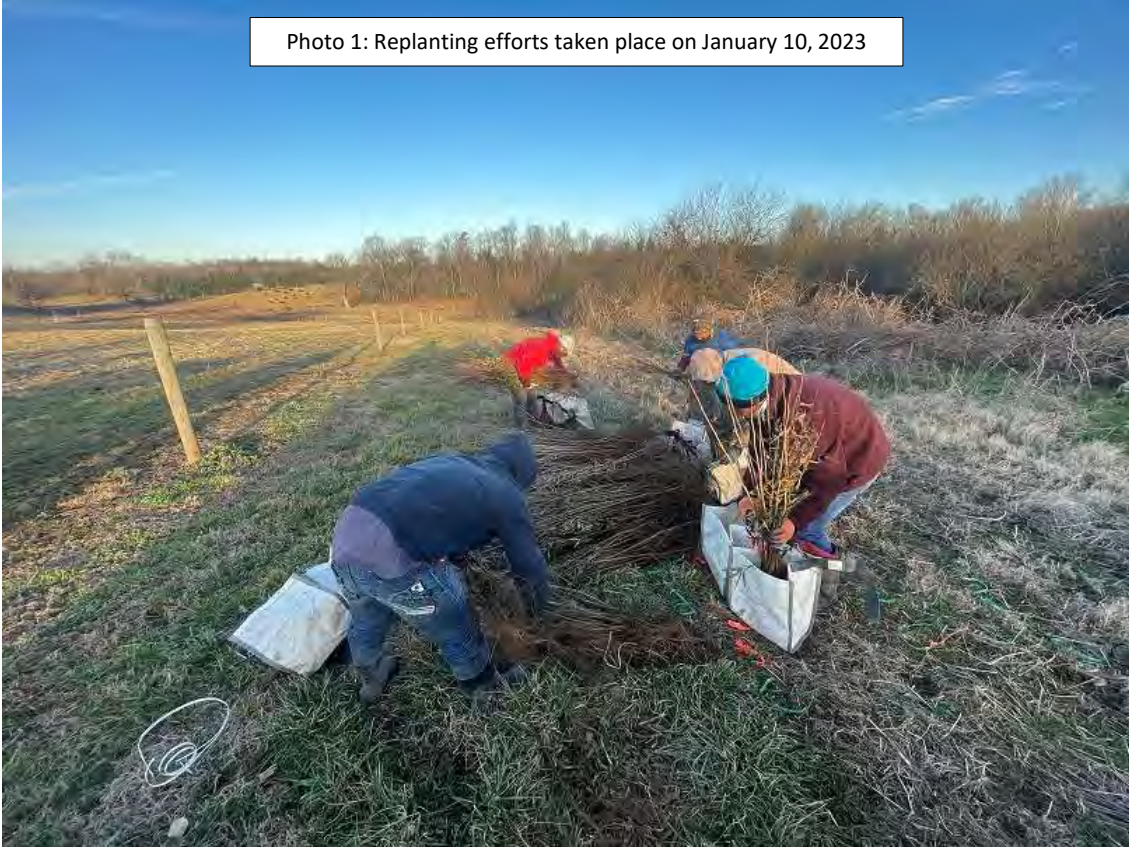
Photo 1: Replanting efforts taken place on January 10, 2023

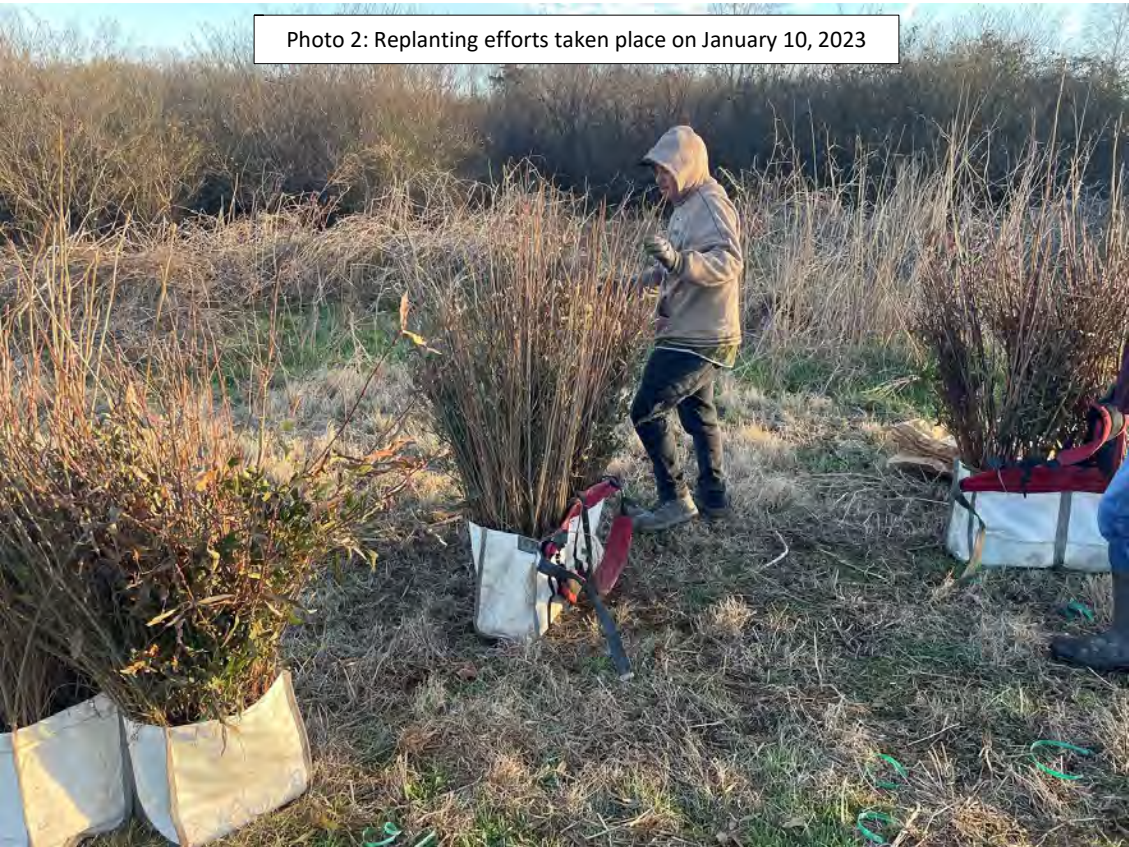
Photo 2: Replanting efforts taken place on January 10, 2023
