# MY1 (2022) MONITORING REPORT

## PHANTOM MILL

DMS Project No. 100057

Data Collection: January 2022-October 2022

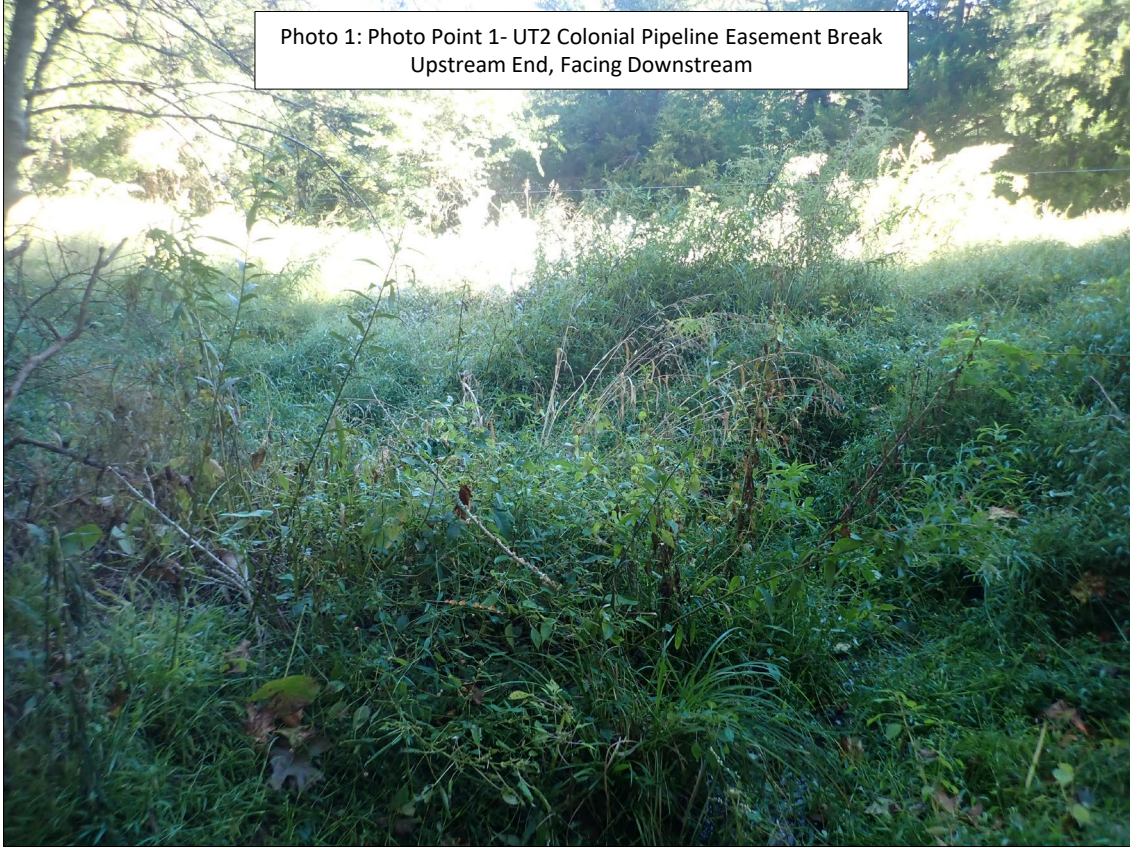
Photo 1: Photo Point 1- UT2 Colonial Pipeline Easement Break  
Upstream End, Facing Downstream

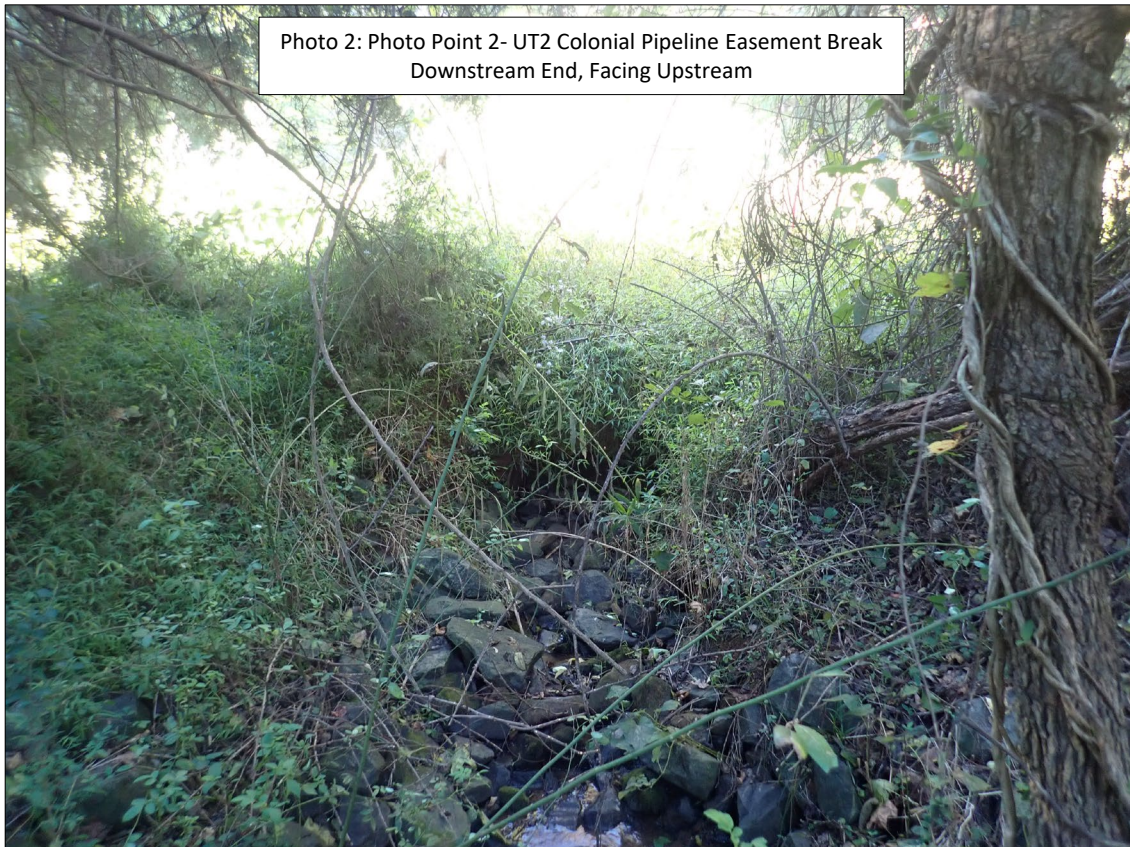
Photo 2: Photo Point 2- UT2 Colonial Pipeline Easement Break  
Downstream End, Facing Upstream

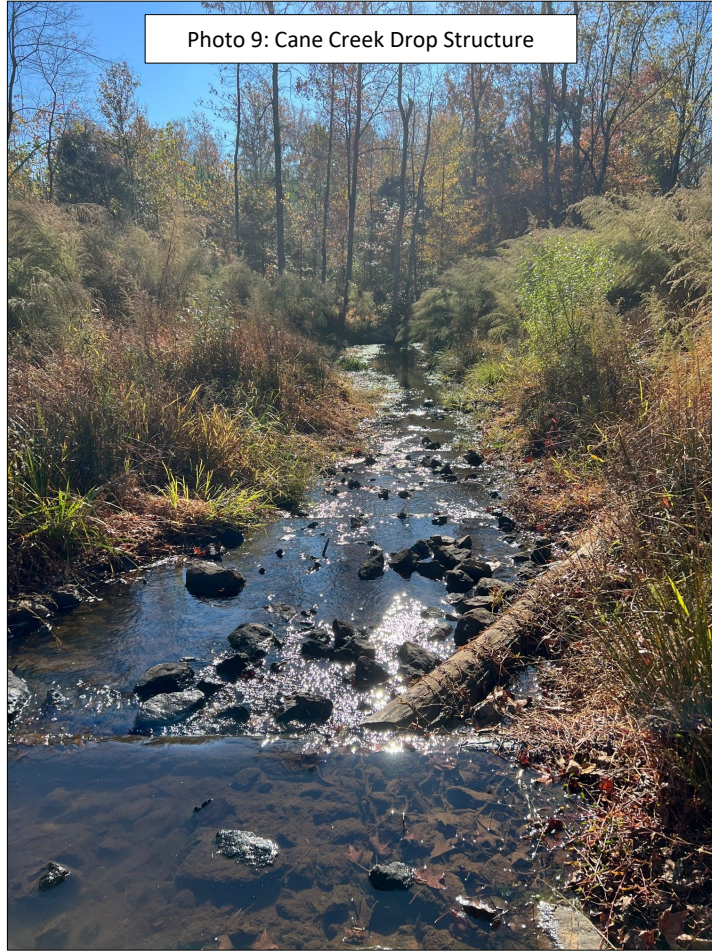
Photo 9: Cane Creek Drop Structure

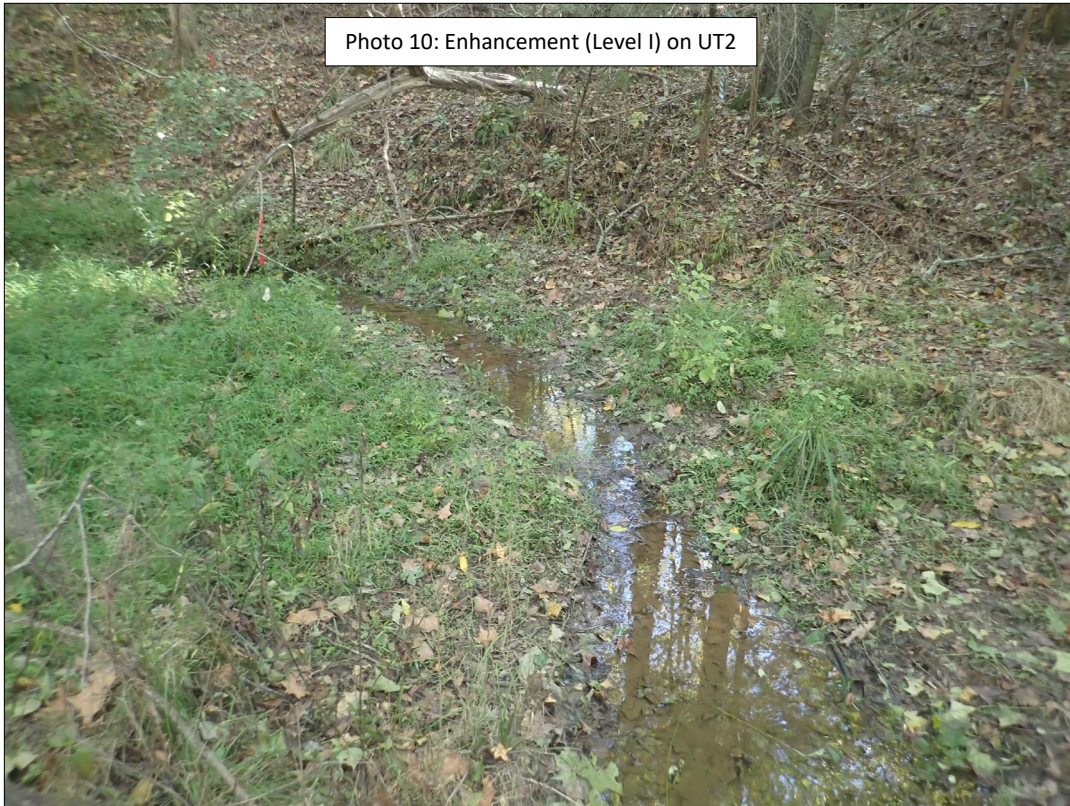
Photo 10: Enhancement (Level I) on UT2

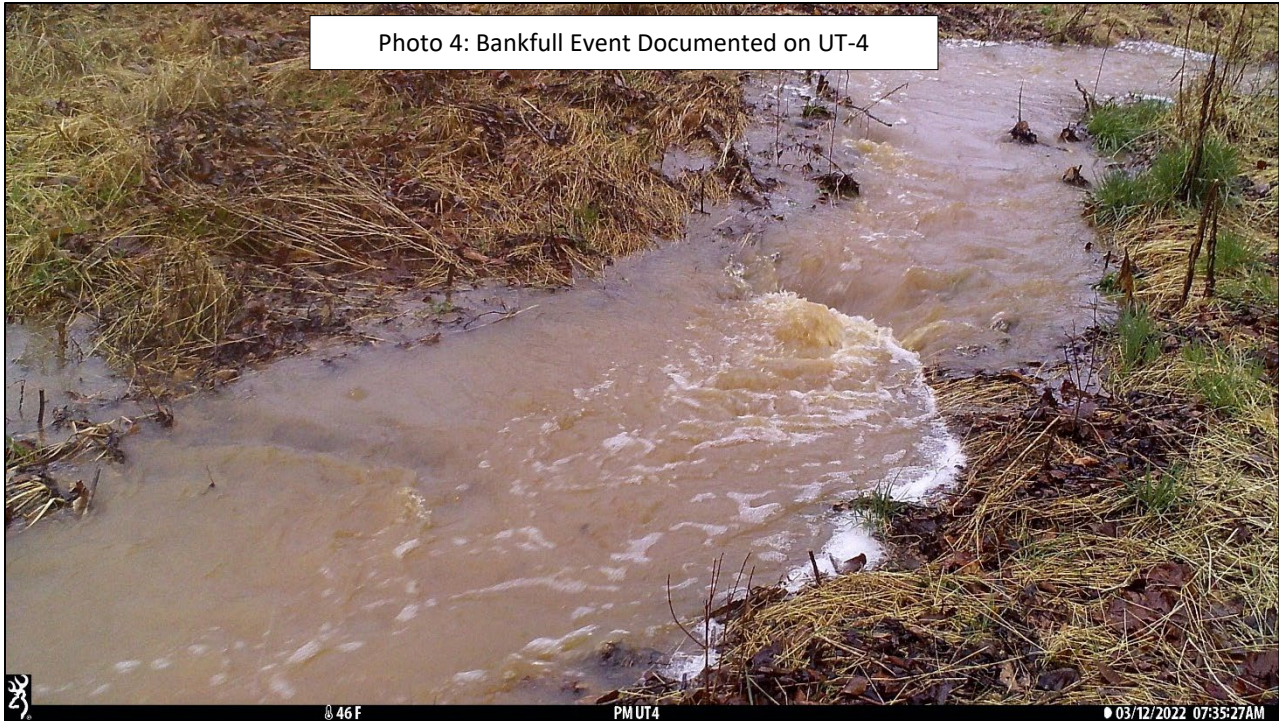
Photo 4: Bankfull Event Documented on UT-4

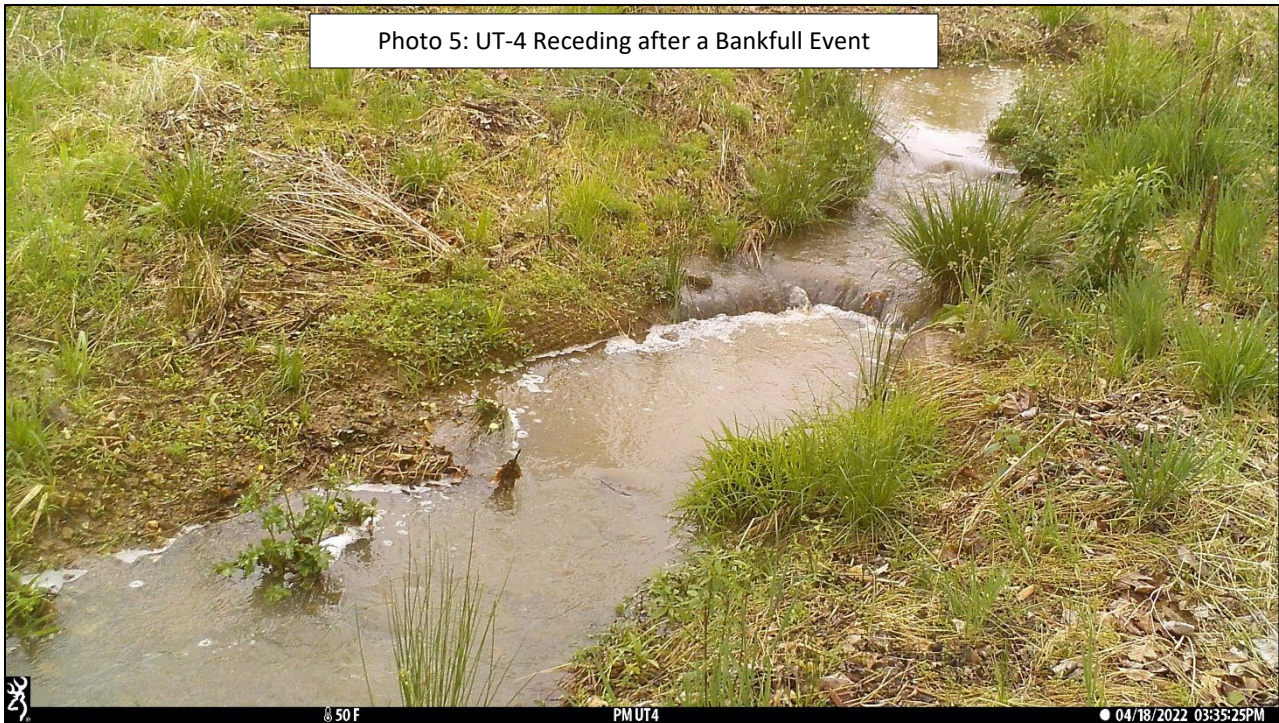
Photo 5: UT-4 Receding after a Bankfull Event
