MONITORING YEAR 3 REPORT

PHILLIPS–WILLIS SITE MIDDLE FORK CREEK

Madison County, North Carolina

EEP Project Number: 92703
Contract Number: D06082; Task Order: 07MON1-11

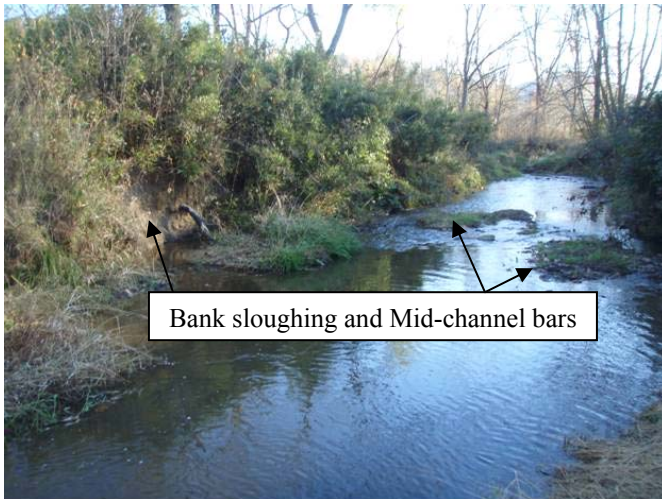
Phillips-Willis Site (EEP project number 92703)			
Feature/Issue	Station numbers	Suspected Cause	Photo number
Aggradation/bar formation	5+50	MFC, beaver dams and bank sloughing	1
	9+25	MFC, beaver dams and bank sloughing	3
Bank scour and sloughing	5+50	MFC, beaver, field drain, and steep bank	1
Beaver dams	1+00	MFC, beaver dam	2
	3+75	Walker Branch, beaver dam	4
Engineered structures – bank or arm scour, etc.

Stream problem area 1, MFC bank sloughing, 4 Dec 2007.

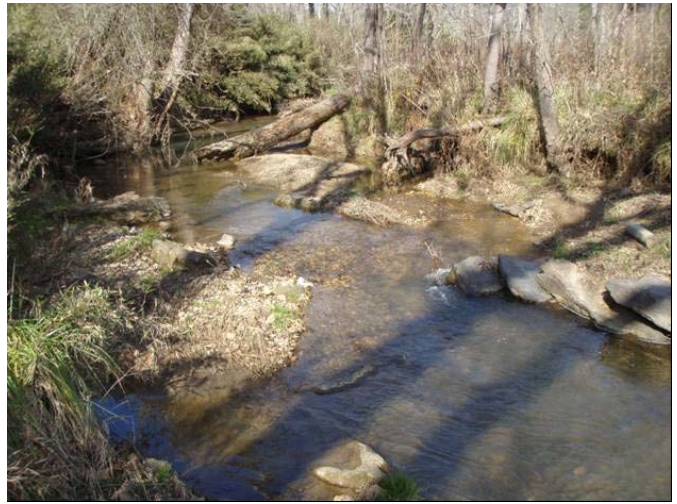
Stream problem area 2, MFC former beaver dam, 25 Nov 2009

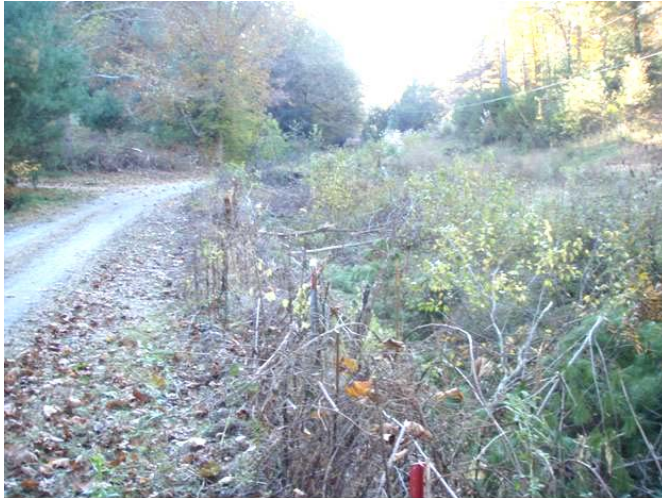
MY1 Vegetation Problem Areas Phillips-Willis Site (EEP project number 92703)			
Feature/Issue	Station Number/Range	Probable Cause	Photo Number
Conservation easement encroachment	MB 0+00, left bank	Long arm mower	1

Veg problem area 1 MB, facing downstream, 15 Oct 2007.

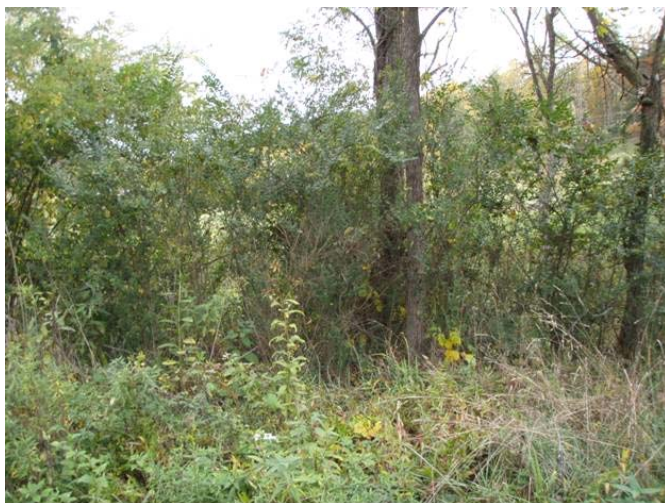
MY2 Vegetation Problem Areas Phillips-Willis Site (EEP project number 92703)			
Feature/Issue	Station Number/Range	Probable Cause	Photo Number
Chinese privet, multiflora rose present	MFC 17+50, left bank	Parent stock	1

Veg problem area 1 MFC, left bank, 14 Aug 2008.

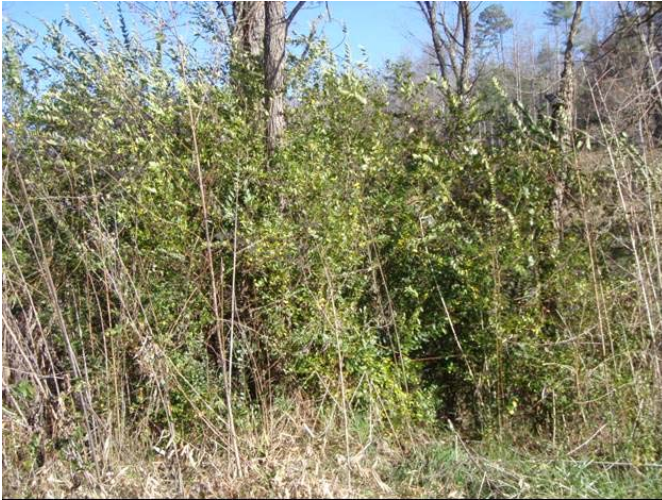
MY3 Vegetation Problem Areas			
Phillips-Willis Site (EEP project number 92703)			
Feature/Issue	Station Number/Range	Probable Cause	Photo Number
Chinese privet, multiflora rose present	MFC 17+50, left bank	Parent stock	1
Chinese privet present	MB 22+25, left bank	Parent stock	2

Veg problem area 1 MFC, left bank, 25 Nov 2009.
