# PINCH GUT CREEK STREAM RESTORATION PROJECT

## ANNUAL MONITORING REPORT FOR 2010 (YEAR 3)

Contract Number D06043-A

**Prepared by:** Michael Baker Engineering, Inc.

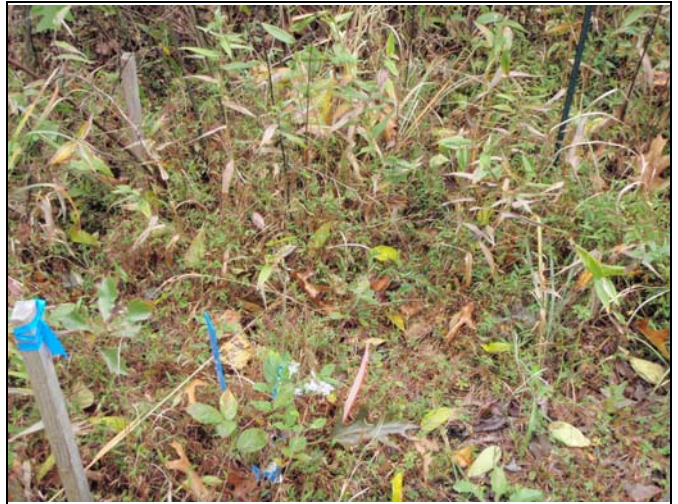
Vegetation Plot 1

It was noted during Year 3 monitoring that vegetation plots 1 and 2 demonstrated densities of 440 and 320 stems per acre, respectively. Although the density of plot 1 shows a density 440 stems per acre, the seven planted stems of spicebush *Lindera benzoin* in plot 1 are very weak and will not likely survive through Year 5. Plot 2 is also of concern due to low stems counts of very weak planted stems of black walnut (*Diospyros virginiana*). Therefore, additional trees will be planted in and around the vicinities of vegetations plots 1 and 2 in winter/spring of 2011.

During Year 3 monitoring, Multiflora rose (*Rosa multiflora*) was observed within vegetation plots 1, 2 and 6. Plots 1 and 2 will have additional stems added in 2011 and plot 6 will be closely observed during Year 4 monitoring. The *rosa multitiflora* observed in these areas will be treated in the summer/fall of 2011.

at this time. A significant presence of Blackberry (*Rubus spp.*) was noted within vegetation Plot 1.

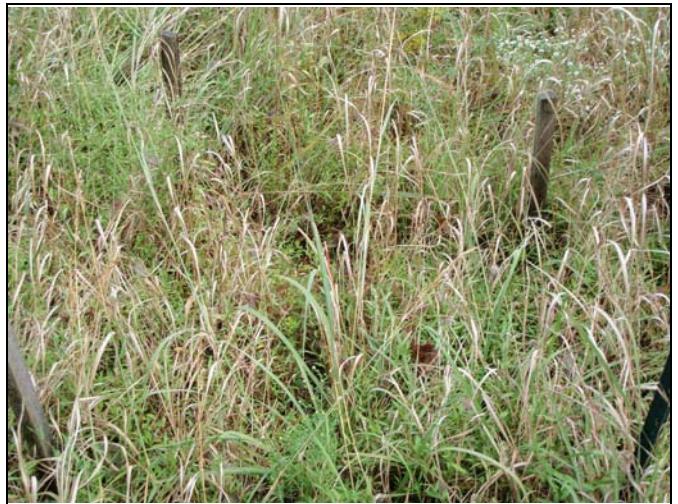
Vegetation Plot 2

Approximately six Tag alders (*Alnus serrulata*), 1 foot to 3 foot in size were observed in vegetation plot 2 following Year 3 monitoring. These volunteer species are native to the area and were also planted as part of the shrub layer for this project. The stems of *Alnus serrulata* did not seem to be posing a threat to the planted stems within the plot. No other significant volunteer woody species were observed in any other vegetation plots. The plots will continue to be assessed during Year 4 monitoring for volunteer species.

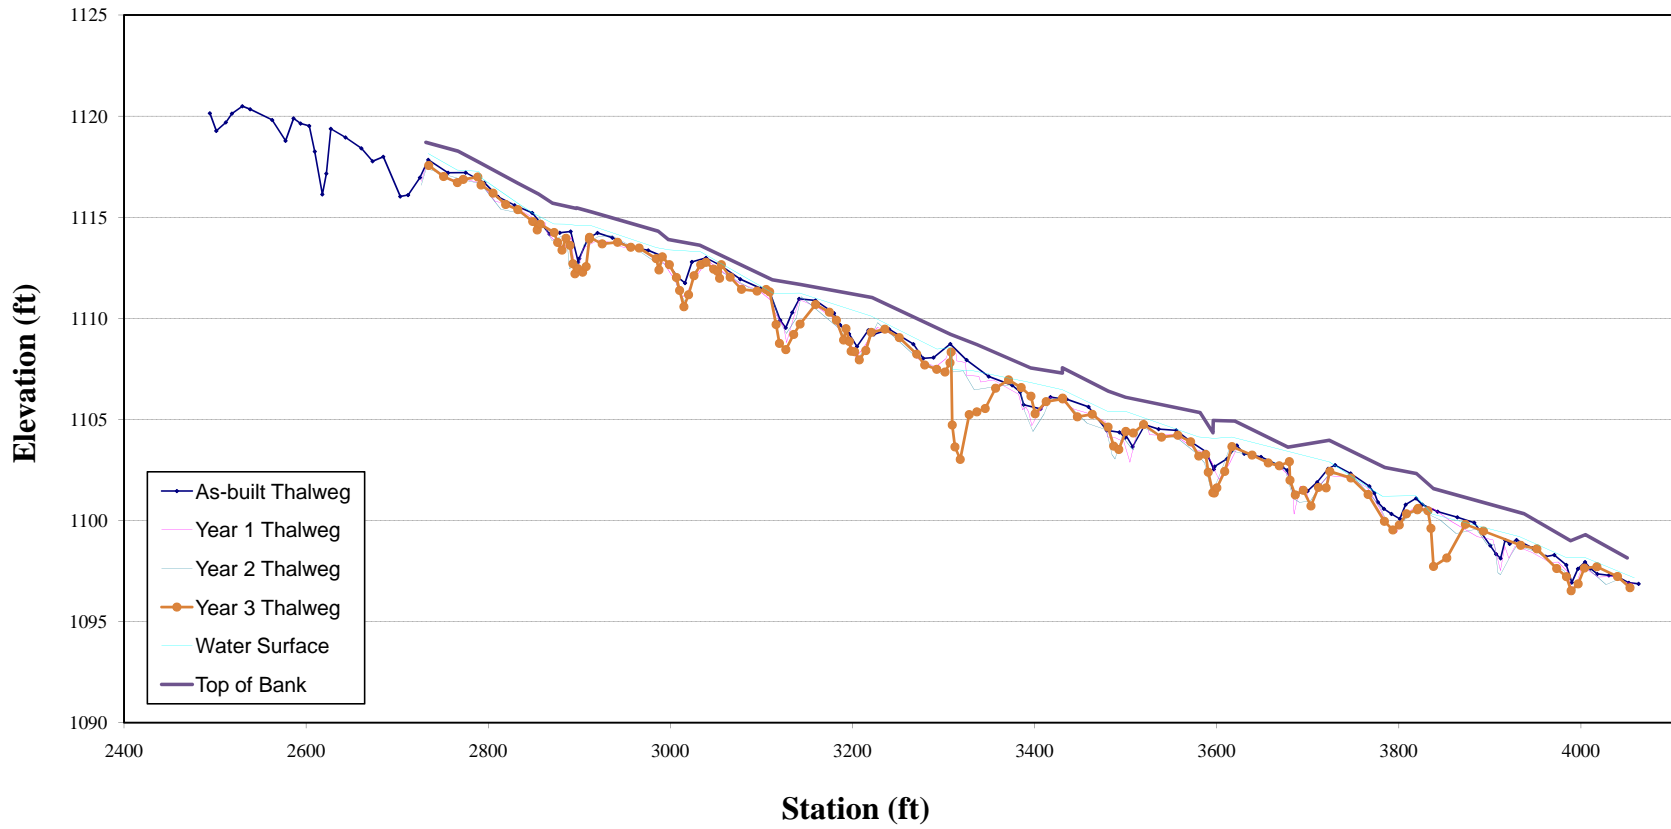
### UT1 Reach 2 - Year 3 Longitudinal Profile, Stations 24+94 to 40+63

Data for the UT1\_R2 Year 3 longitudinal profile indicates that the riffles in this reach have maintained relatively the same bed elevations since as-built conditions. Conversely, pools throughout UT1\_R2 have continued to increase in depth since as-built conditions. It was noted that increased pool depths were also measured in this reach following Year 1 monitoring. The deeper pools in UT1\_R2 are providing increased channel stability while promoting greater habitat diversity. However, two pools at stations 33+18 and 38+38 on UT1\_R2 have extended into the downstream riffle sections. These areas have demonstrated deeper thalweg measurements than that which was observed during as-built conditions and previous monitoring years. These two areas will be closely observed during Year 4 monitoring. Any future changes that may demonstrate a movement toward instability within

these areas will be noted and if repairs to these areas are needed, a thorough assessment will be completed before work is initiated. Overall, the longitudinal profile for UT1\_R2 demonstrates that the in-stream structures within the reach are stable and functioning as designed.

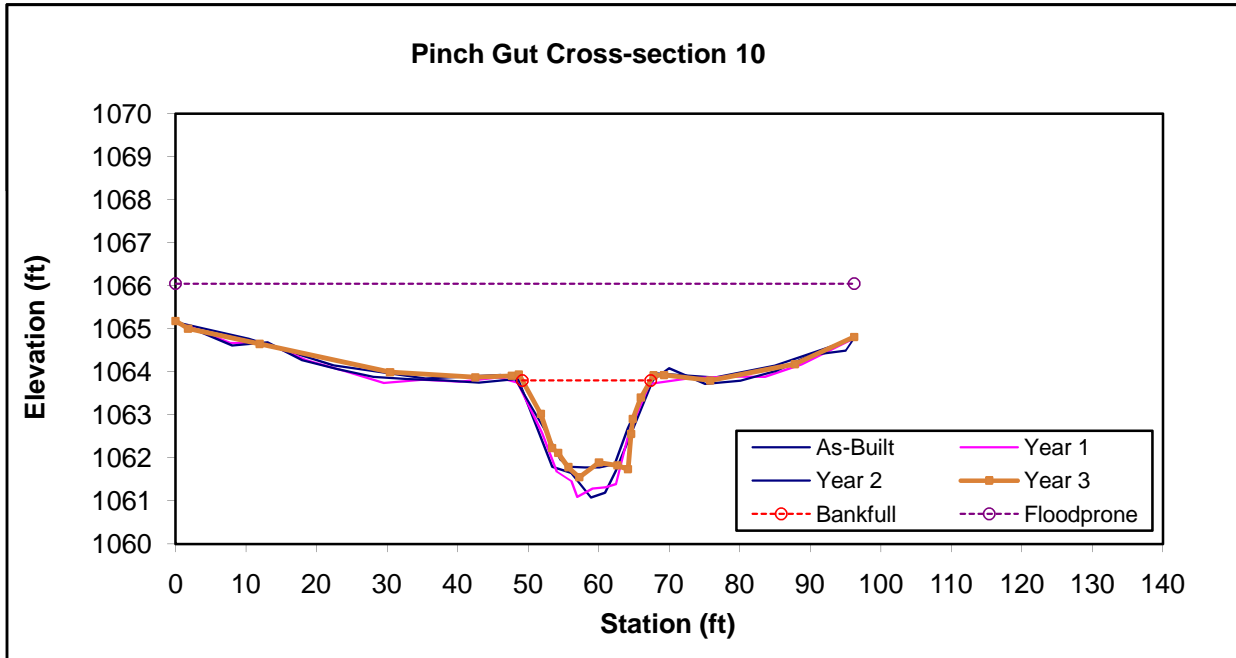
**Permanent Cross-section 10, Station 65+55**  
 (Year 3 Data - Collected November 2010)

Riffle cross-sections 10 and 12 underwent repairs during Year 3 by adding Class I/B stone and on-site alluvium to raise the bed elevations. The Year 3 data for cross-sections 10 and 12 provided in Appendix B show a higher bed elevation than was observed in as-built conditions and Year 1 monitoring. According to the Year 3 data, cross-sections 10 and 12 currently appear to be more stable than during Year 1 and as-built conditions due to better connection with the adjacent floodplain.

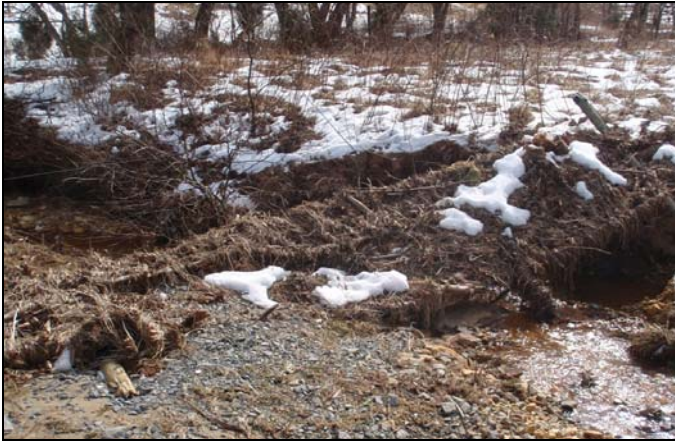
**BEFORE:** UT1\_R3 stream crossing after storm damage near station 57+00

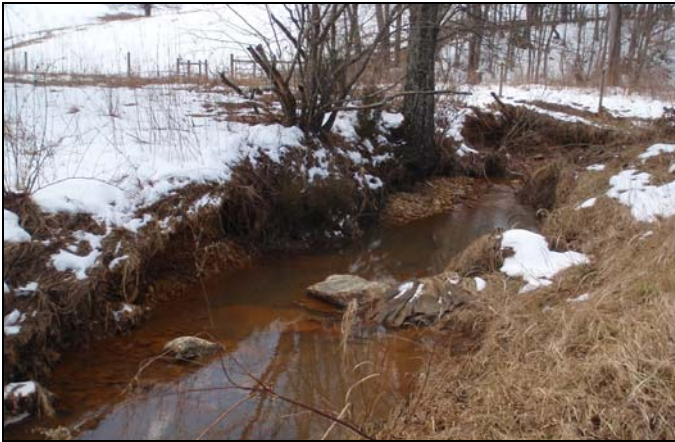
**BEFORE:** Observed right bank erosion and structure failure along UT1\_R3 near station 57+75

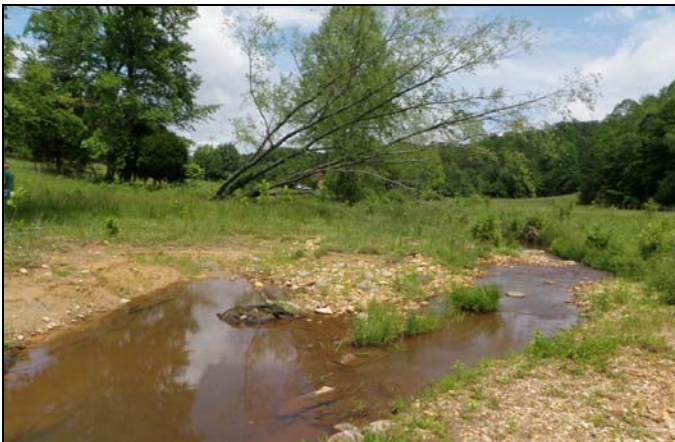
**BEFORE:** Looking downstream at left bank erosion from January 2010 storm damage

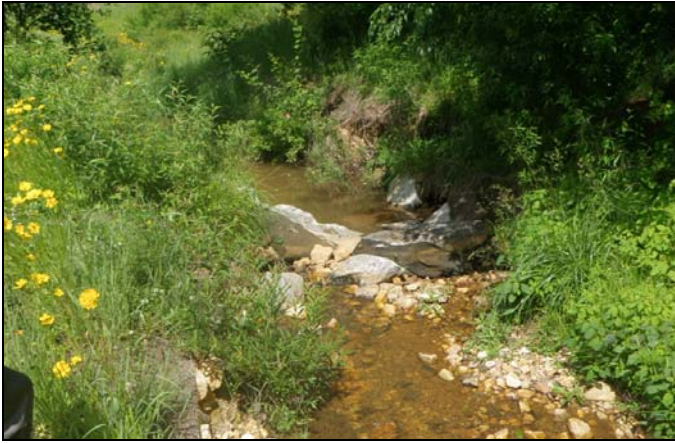
BEFORE: Repaired cross vane piping and right bank erosion along UT5\_R1 near station 18+25

During Year 3 in-stream repairs on UT5\_R1 and UT5\_R2 were also completed. On UT5\_R1, a brush mattress was installed along the right bank to increase bank stability near station 12+00. In-stream repairs on UT5\_R1 were also completed on a J-Hook structure that experienced minor piping at station 18+25.

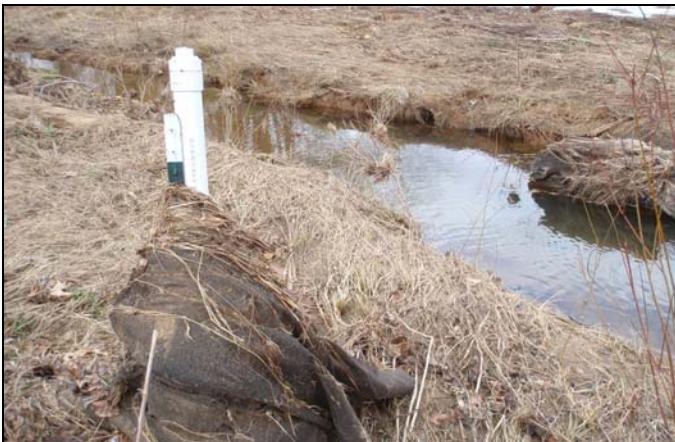
Following the January storm the crest gauge on UT5 was not read. However, the UT5 crest did document out of channel bankfull flows during Year 3 monitoring. The largest flow documented by the UT5 crest gauge during Year 2 of monitoring was 0.68 feet above bankfull stage. Inspection of conditions during site visits revealed visual evidence of out-of-bank flows.

Looking at debris line on crest gauge at UT5\_R2 after January 2010 storm event
