PINCH GUT CREEK STREAM RESTORATION PROJECT

ANNUAL MONITORING REPORT FOR 2011 (YEAR 4)

Contract Number D06043-A

Prepared by: Michael Baker Engineering, Inc.

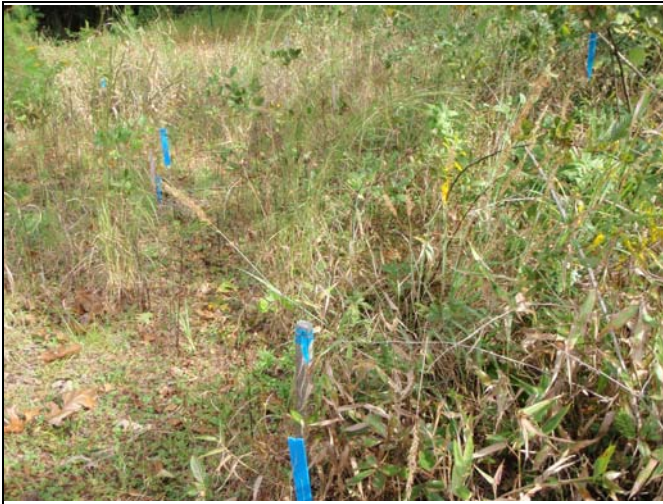
Approximately ten tulip poplars (*Liriodendron tulipifera*), 1 to 3 feet tall were observed in Vegetation Plot 1 following Year 4 monitoring. These volunteer species are native to the area and were also planted as part of the tree layer for this project. The stems of *Liriodendron tulipifera* did not seem to be posing a threat to the planted stems within the plot. Additionally, these stems have taken root in roughly the same areas within the plot where planted stems of spicebush (*Lindera benzoin*) failed to survive. Including the volunteer stems in the Year 4 count, the density of Plot 1 has a stem density greater than 320 stems per acre.

It was noted during Year 3 monitoring that Vegetation Plot 1 demonstrated a density of 440 stems per acre. However, following Year 4 vegetation monitoring, Plot 1 exhibited a density 200 stems per acre, mainly due to *Lindera benzoin* die off. The seven planted stems of *Lindera benzoin* in plot 1 failed to survive through Year 4.

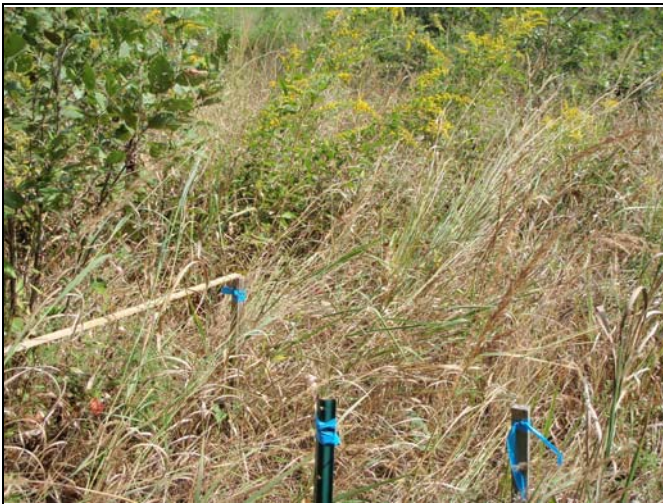
Six tag alders (*Alnus serrulata*), 1 foot to 3 foot in size were observed in Vegetation Plot 2 following Year 3 monitoring. These volunteer species are native to the area and were also planted as part of the shrub layer for this project. The stems of *Alnus serrulata* do not seem to be posing a threat to the planted stems within the plot and are not included in the density calculation for success.

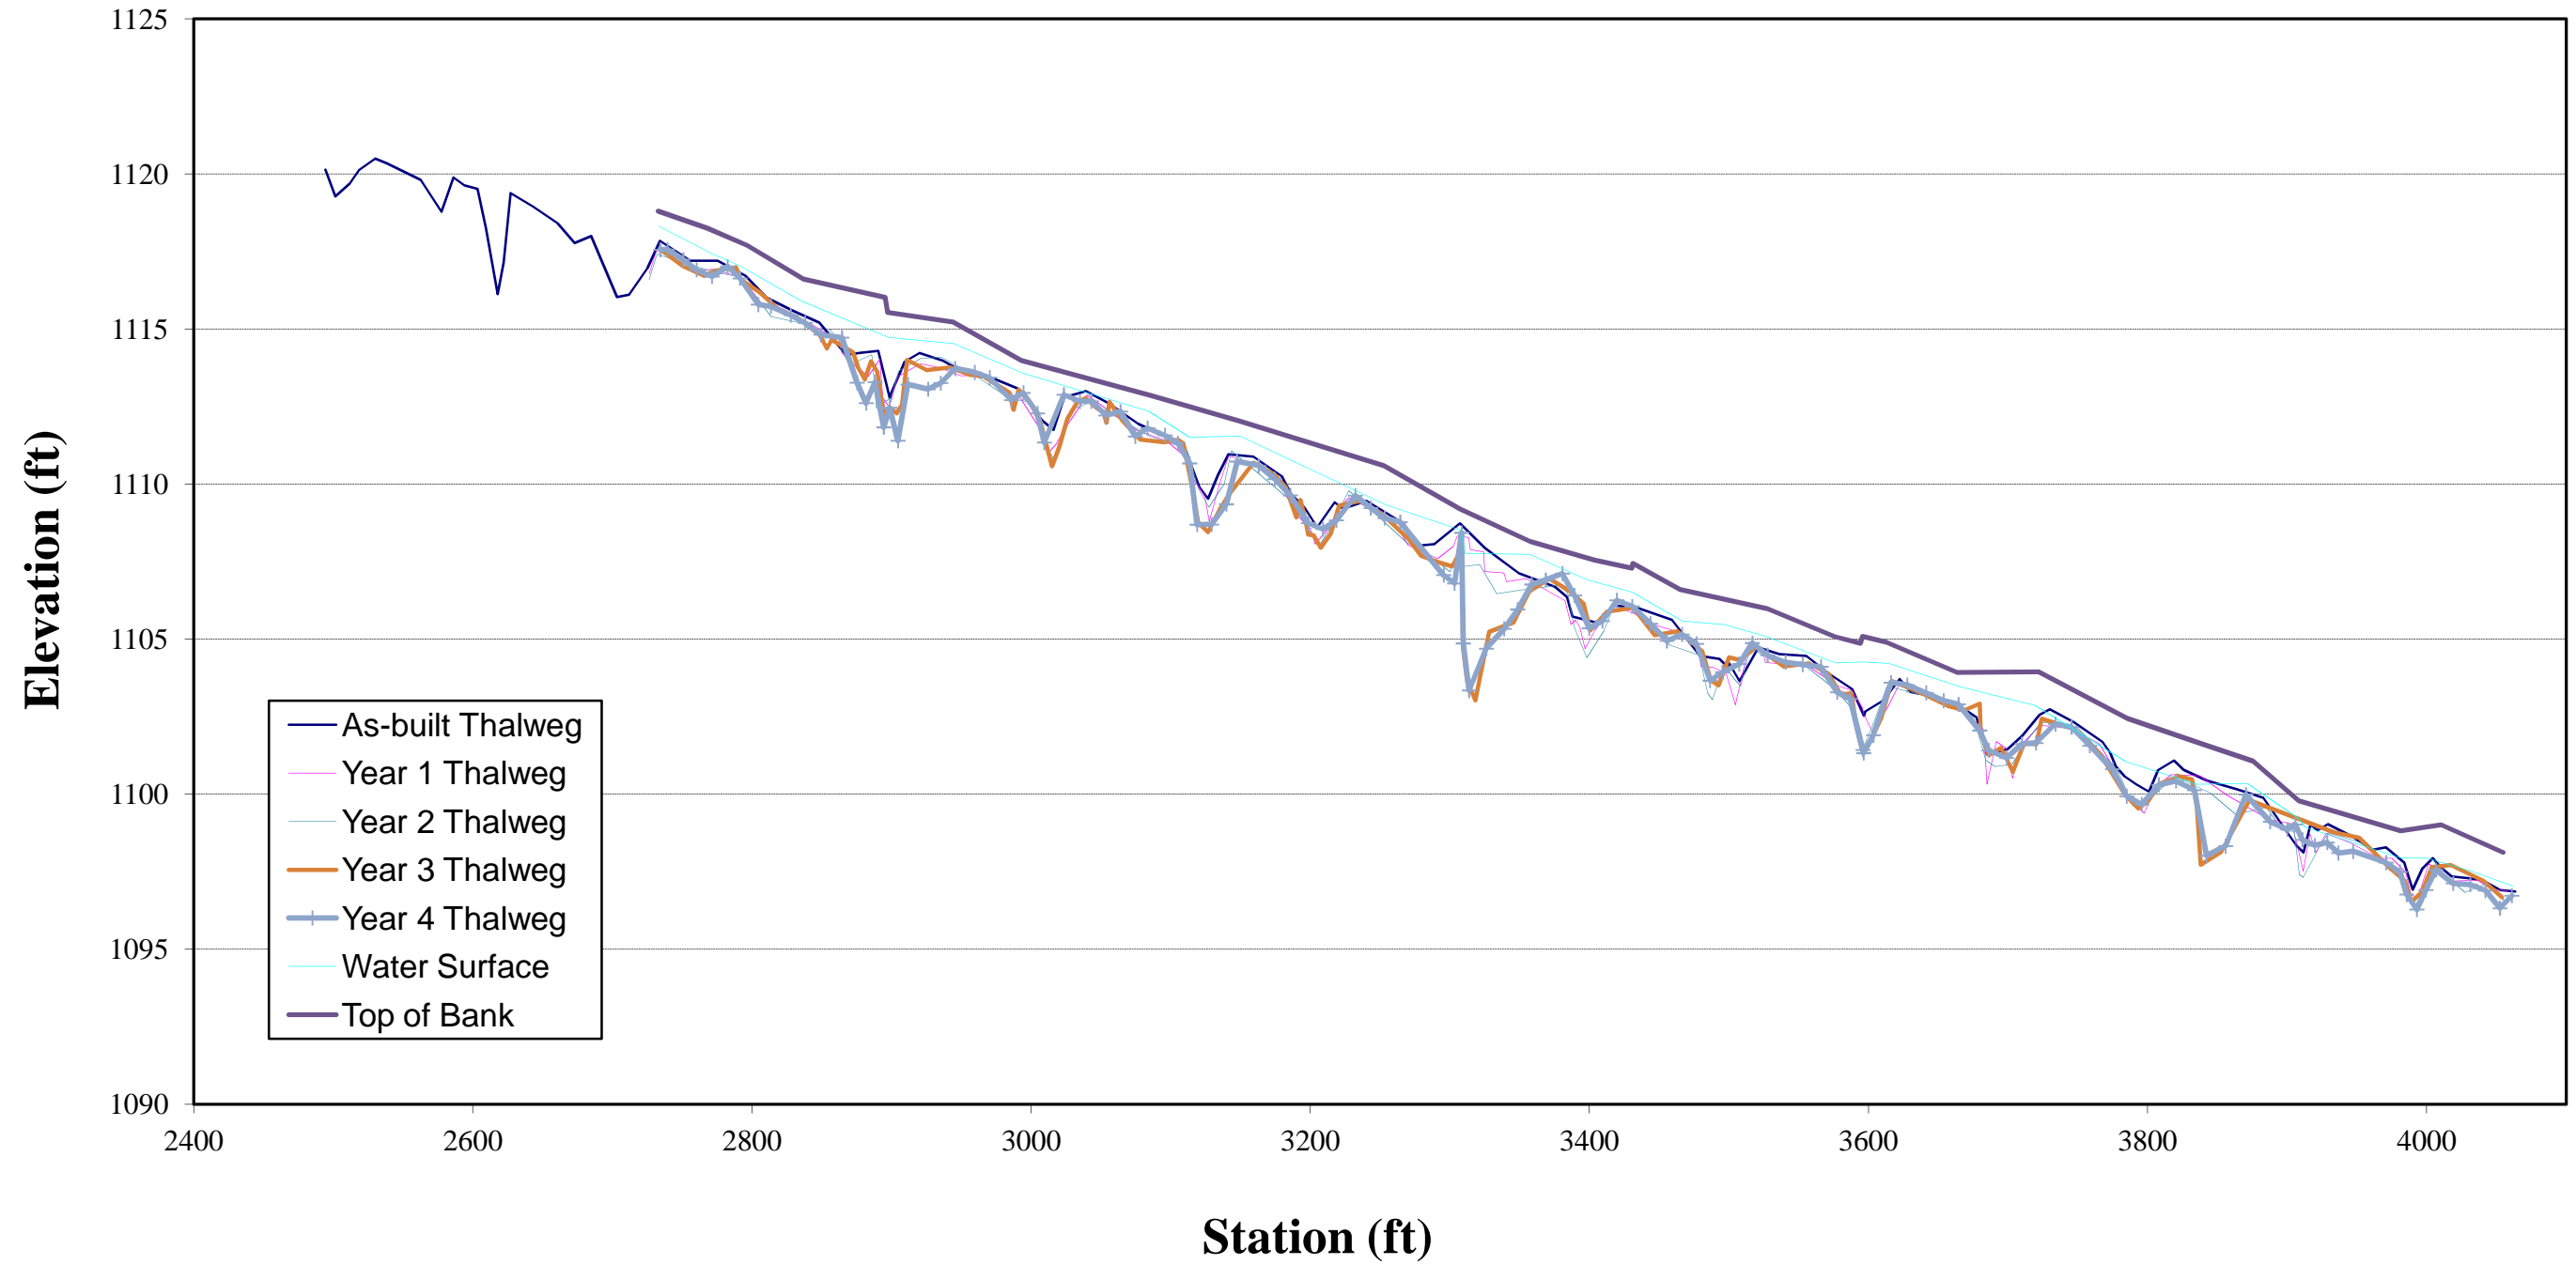
UT1 Reach 2 - Year 4 Longitudinal Profile, Stations 27+34 to 40+61

Data for the UT1_R2 Year 4 longitudinal profile indicates that the riffles in this reach have essentially maintained the same bed elevations since as-built conditions. Conversely, pools throughout UT1_R2 have continued to increase in depth since as-built conditions. It is noted that increased pool depths were also measured in this reach following Year 1 monitoring. The deeper pools in UT1_R2 are providing increased channel stability while promoting greater habitat diversity. However, two pools at stations 33+18 and 38+38 on UT1_R2 have extended into the downstream riffle sections. These areas have demonstrated deeper thalweg measurements than those which were observed during as-built conditions and previous monitoring years. These two areas will be closely observed during Year 5 monitoring. Any future changes that may demonstrate a movement toward instability within these areas will be noted and whether repairs to these areas are needed. Overall, the longitudinal profile for UT1_R2 demonstrates that the in-stream structures within the reach are stable and functioning as designed.
