Pinch Gut Creek Tributary Site
EEP ID (IMS) # 92518
FDP CONTRACT NUMBER # D06043-A
USACE ACTION ID # 2007-02849-285
DWQ 401 # 07-1420

CLOSEOUT REPORT

Stream

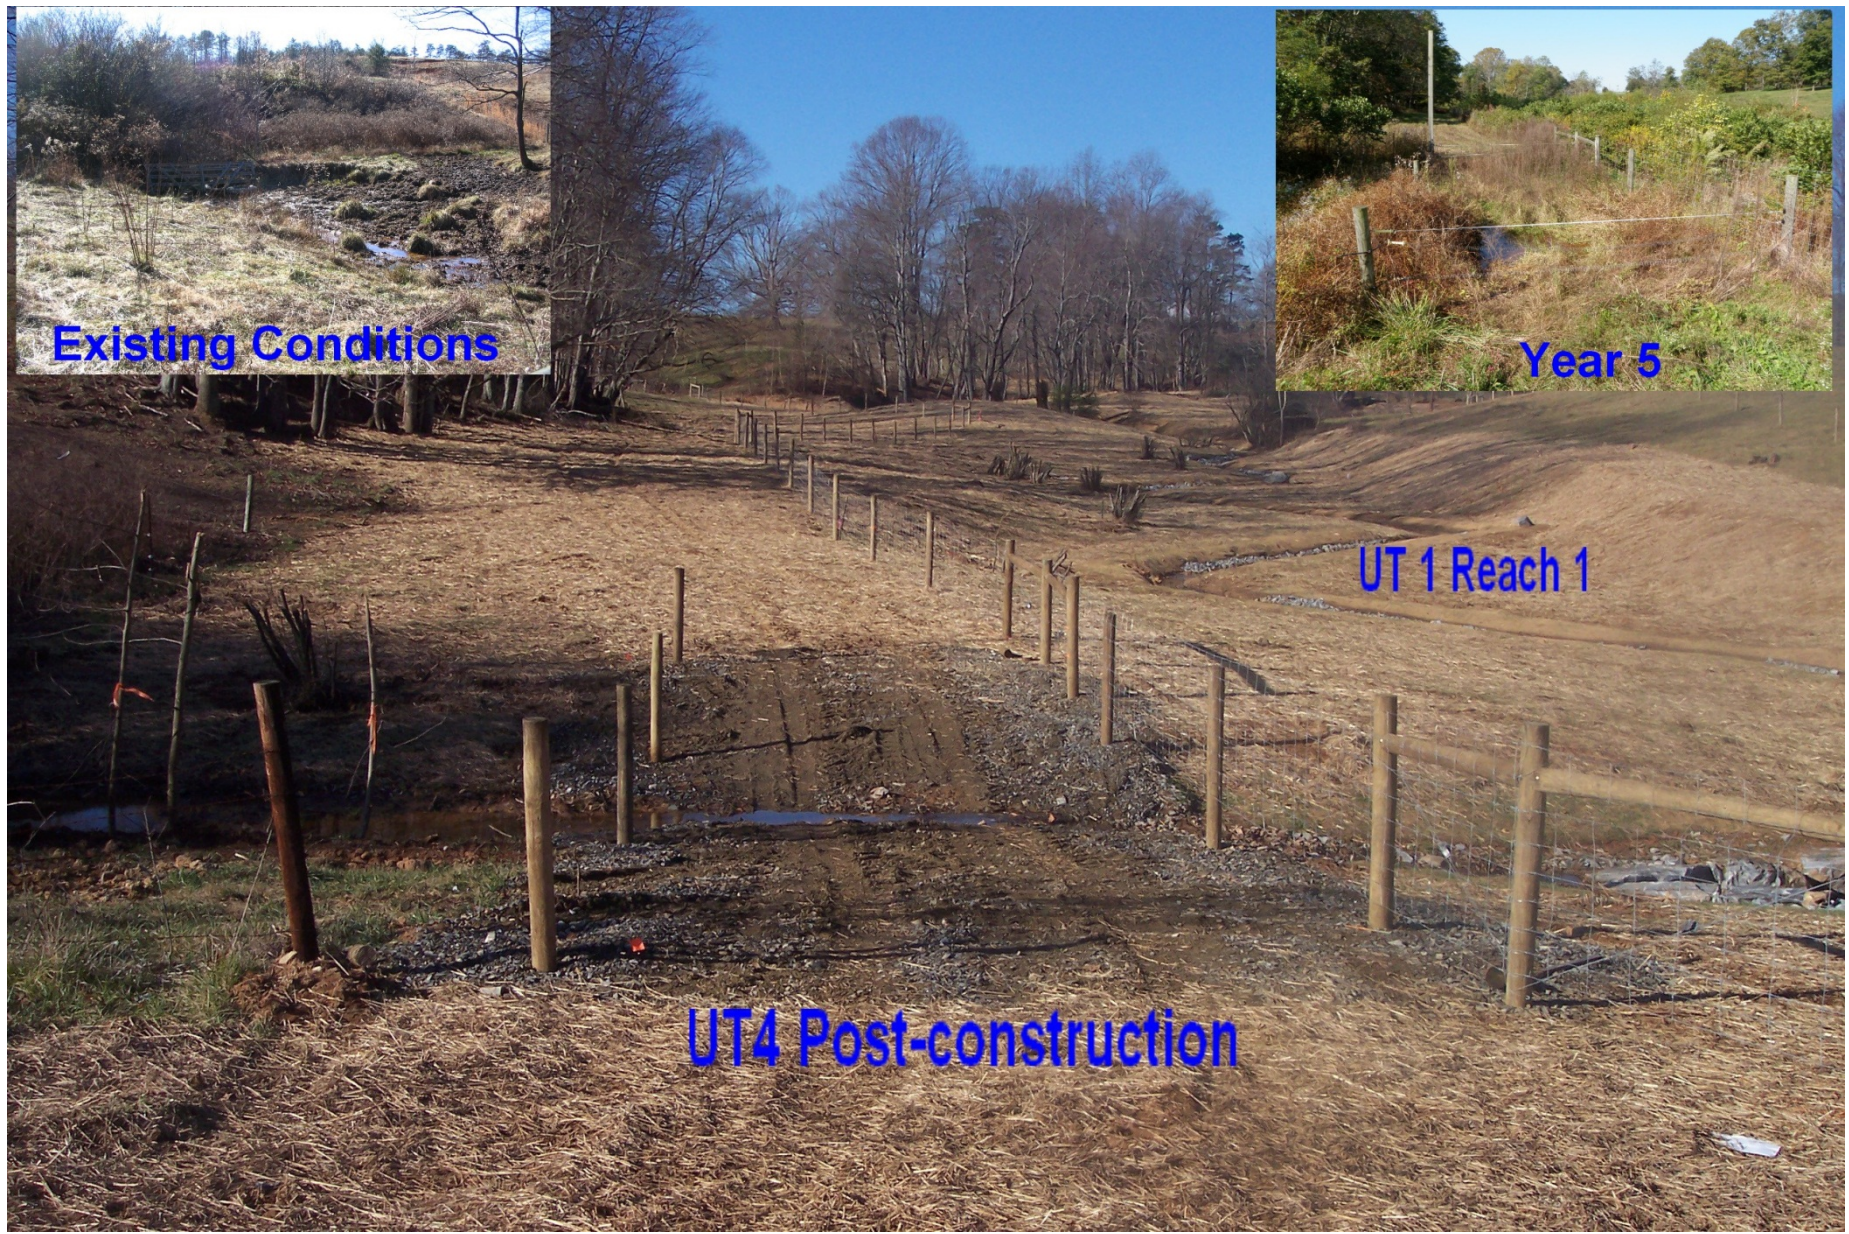
UT4 and UT1 Reach 1 as observed during the project phases

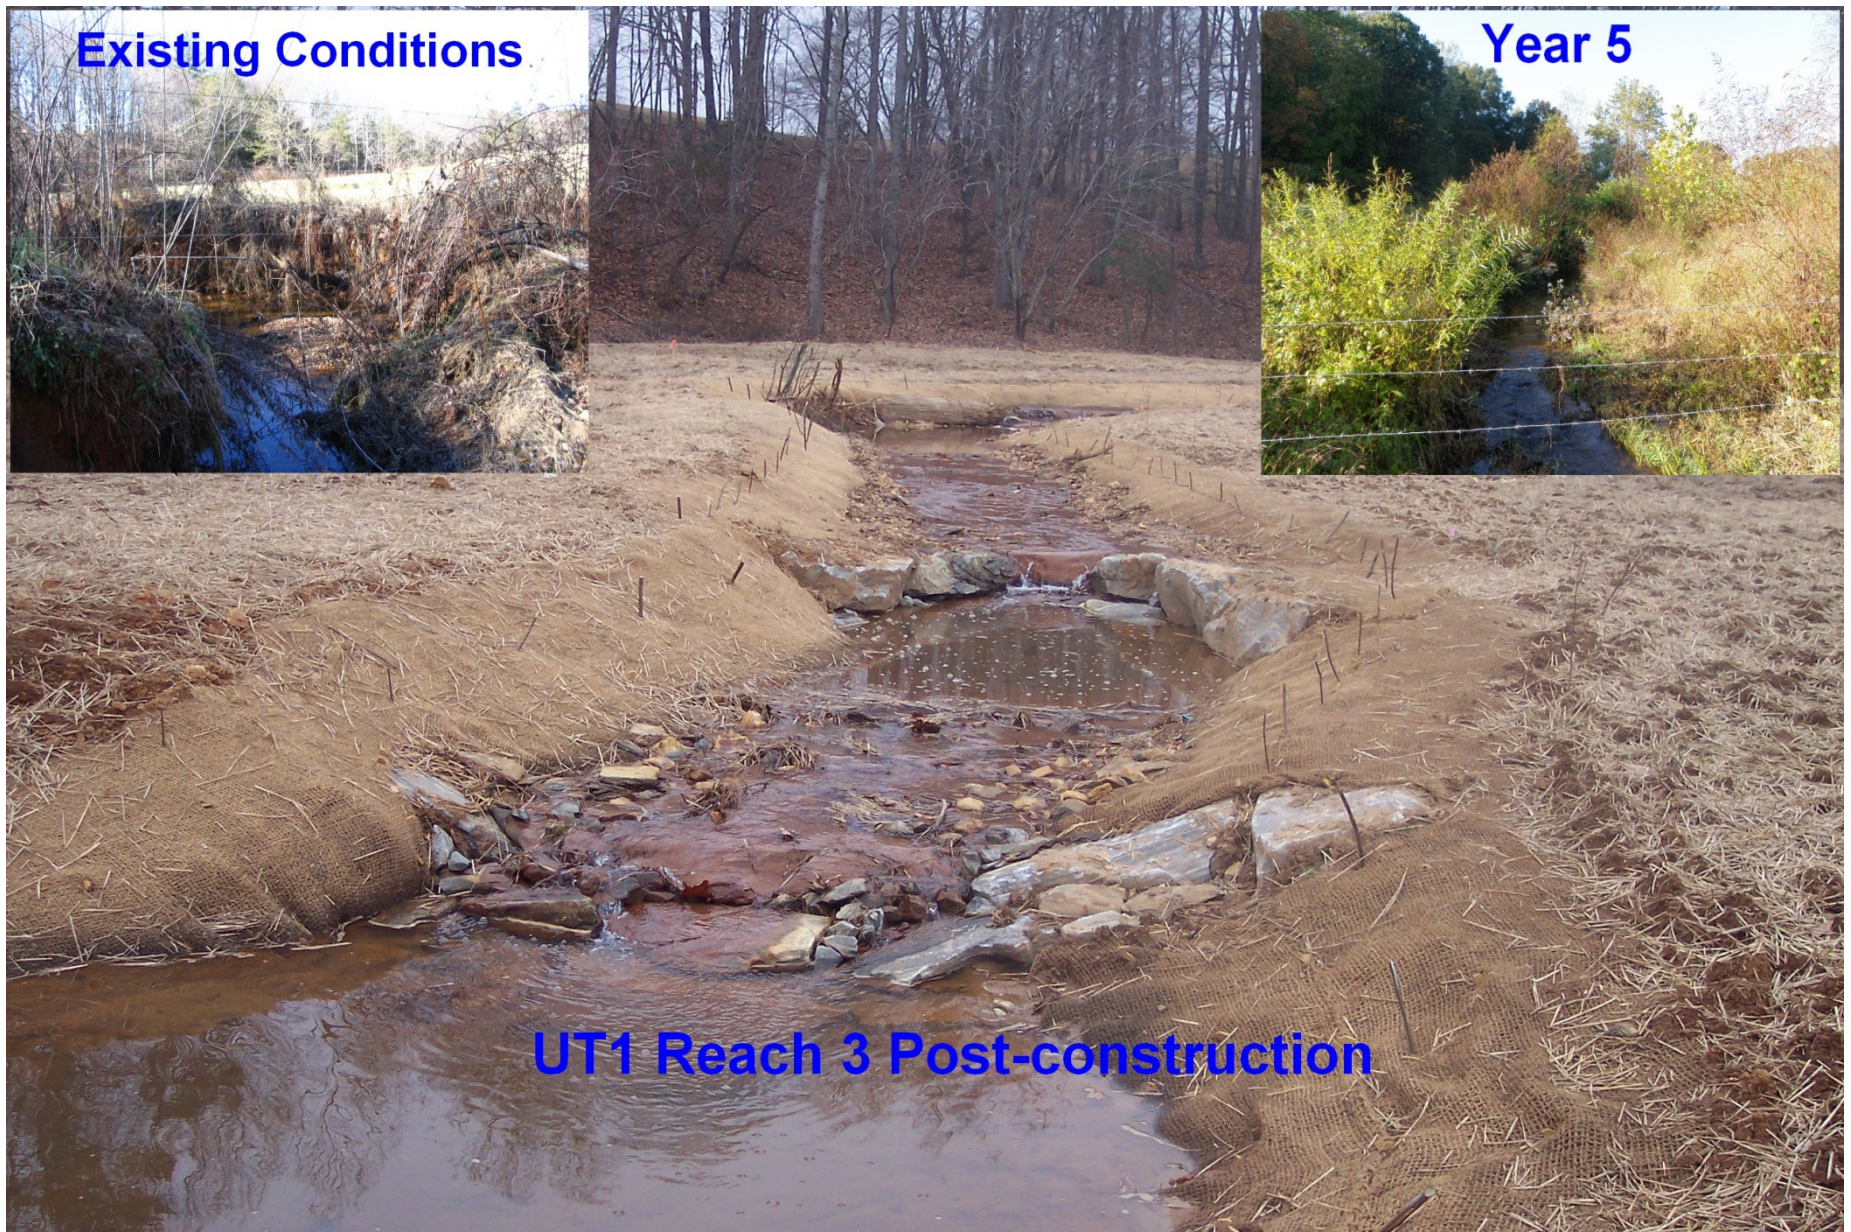
UT1 Reach 3 as observed during the project phases
