MITIGATION PLAN and AS-BUILT REPORT
PLEMMONS/KIRKPATRICK-SPRING CREEK
MITIGATION SITE

Madison County, North Carolina

FINAL

EEP Project Number: 92607
Contract Number: D06082; Task Order: 06FB05

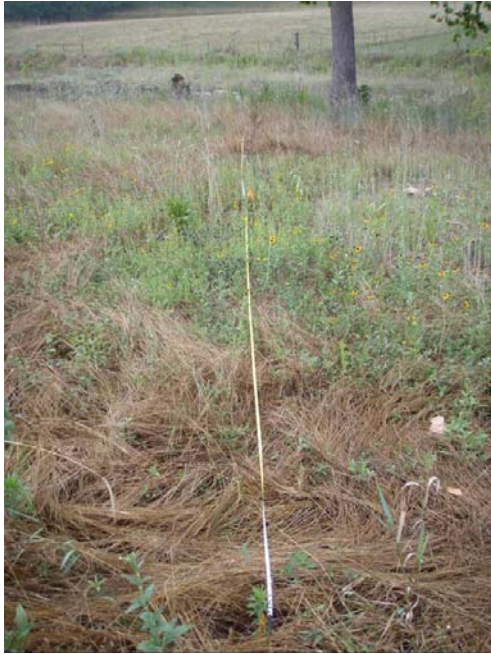
Vegetation plot 1, facing downstream (0,0), 19 Jun 2007.

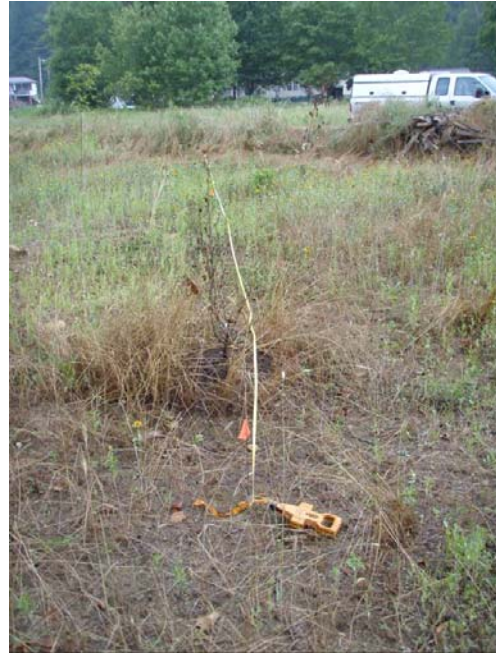
Vegetation plot 1, facing upstream (10,10), 19 Jun 2007.

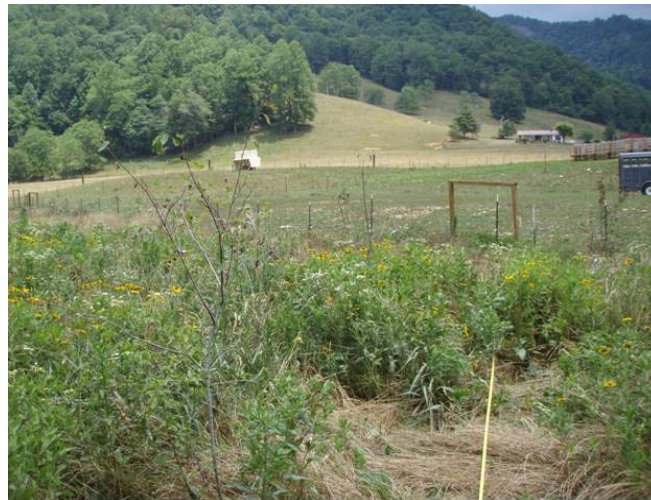
Vegetation plot 2, facing downstream (0,0), 19 Jun 2007.

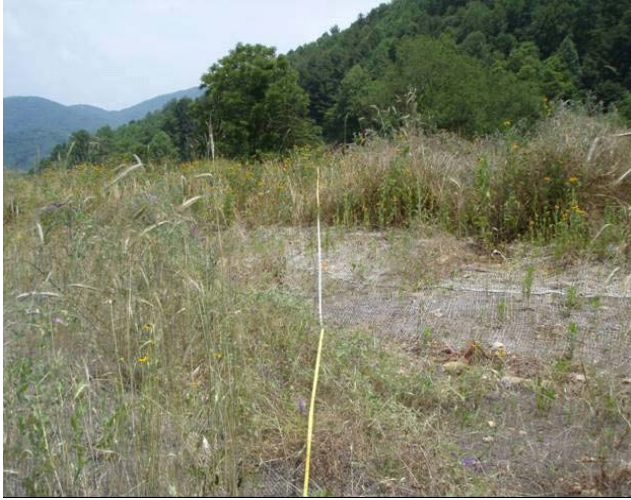
Vegetation plot 3, facing downstream (0,0), 19 Jun 2007.

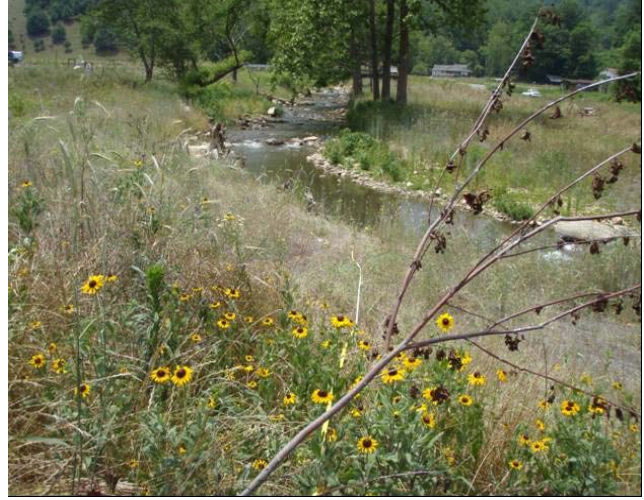
Vegetation plot 3, facing upstream (10,10), 19 Jun 2007.

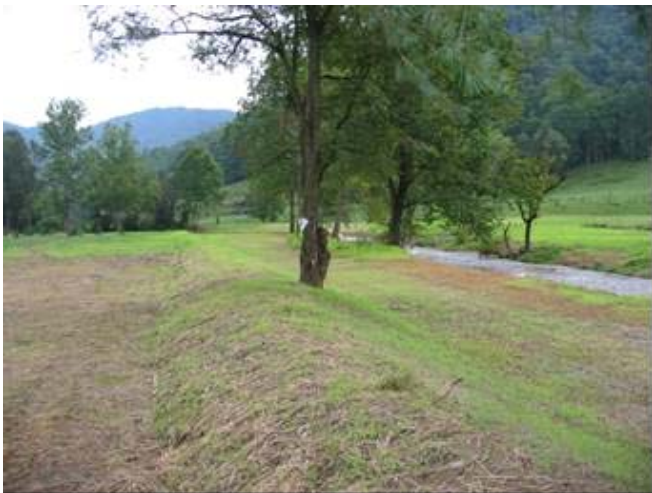
Photo station 1, left bank facing downstream, 5 Sep 2006.

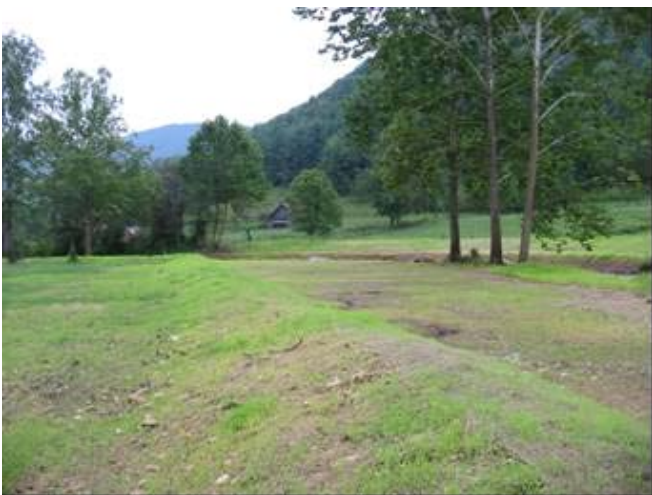
Photo station 2, left bank facing downstream, 5 Sep 2006.

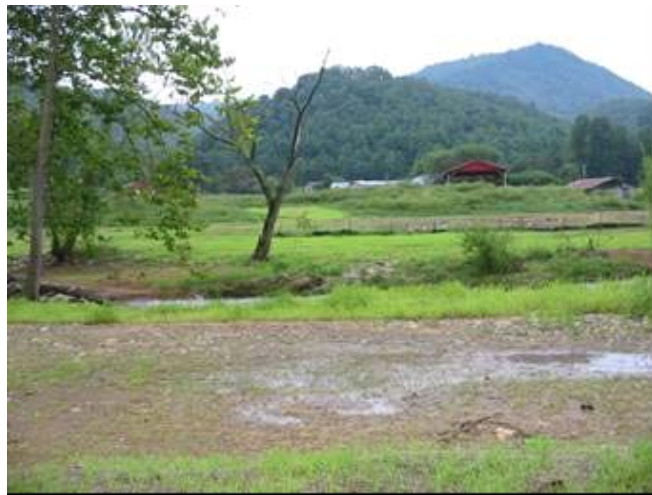
Photo Station 2, left to right bank, 5 Sep 2006.

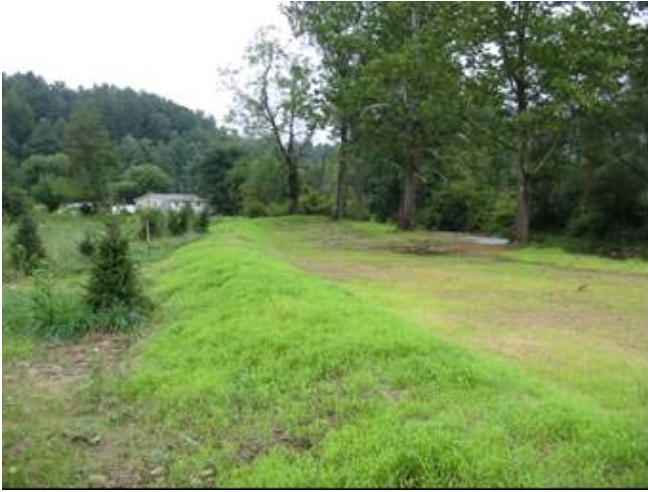
Photo station 3, left bank facing downstream, 5 Sep 2006.

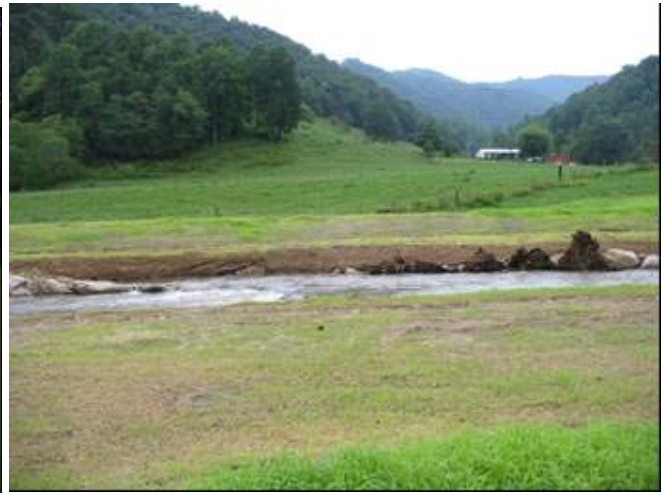
Photo station 3, left to right bank, 5 Sep 2006.

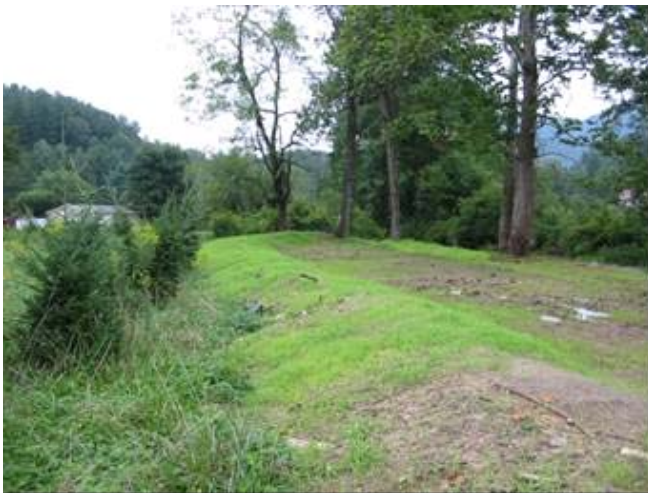
Photo station 4, left bank facing downstream, 5 Sep 2006.

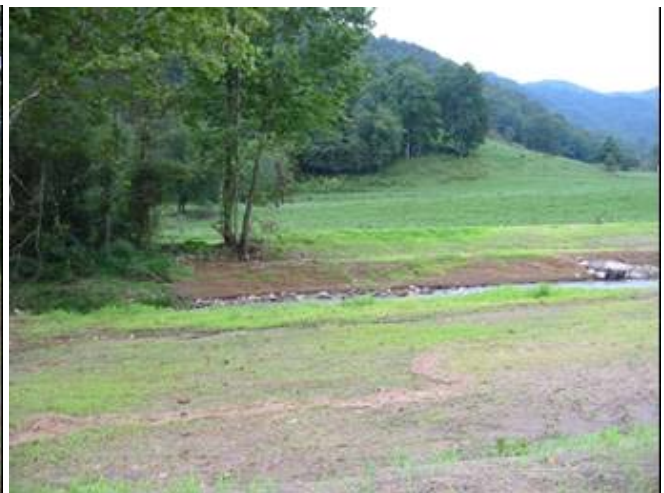
Photo station 4, left to right bank, 5 Sep 2006.

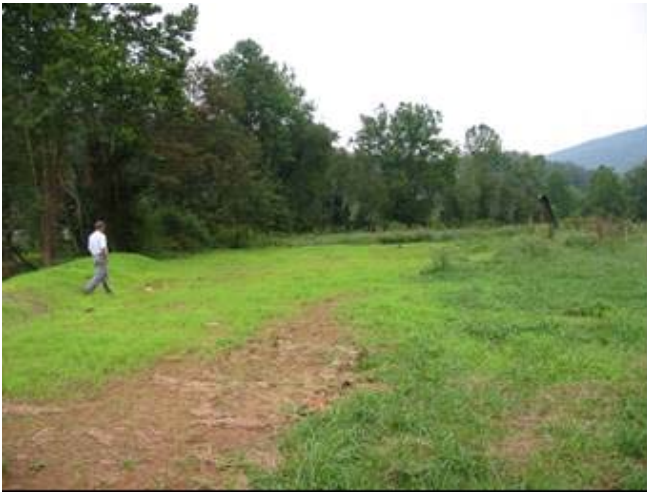
Photo station 5, right bank facing downstream, 5 Sep 2006.

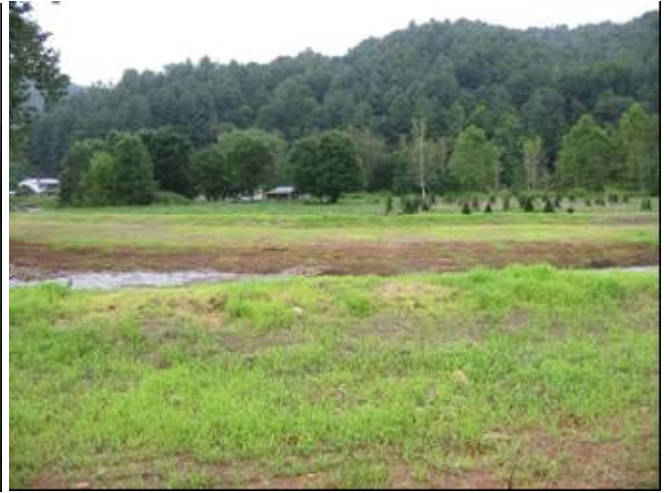
Photo station 5, right to left bank, 5 Sep 2006.

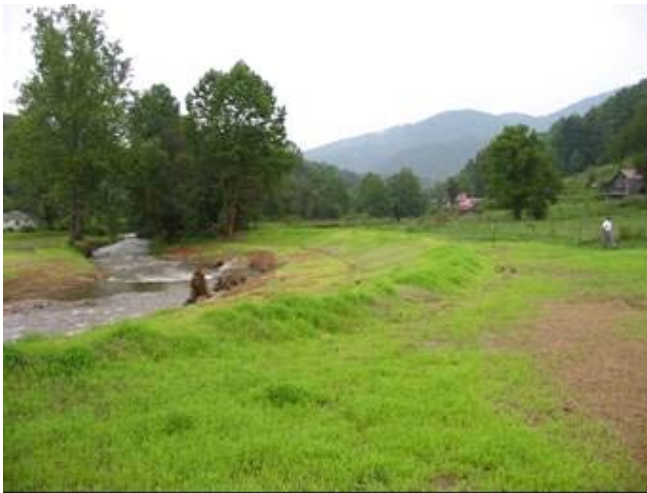
Photo station 6, right bank facing downstream, 5 Sep 2006.

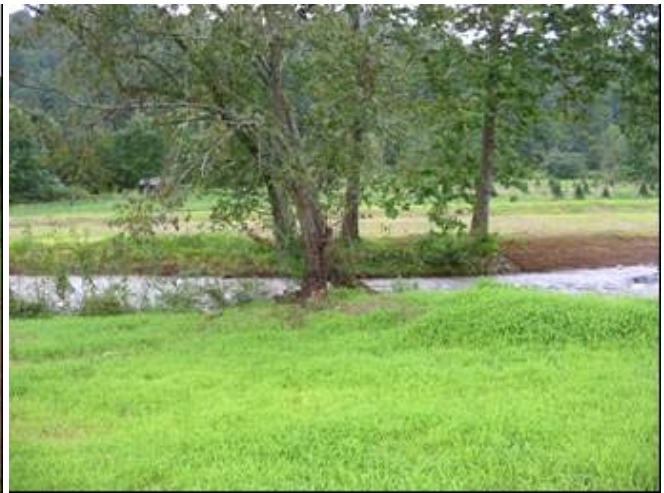
Photo station 6, right to left bank, 5 Sep 2006.

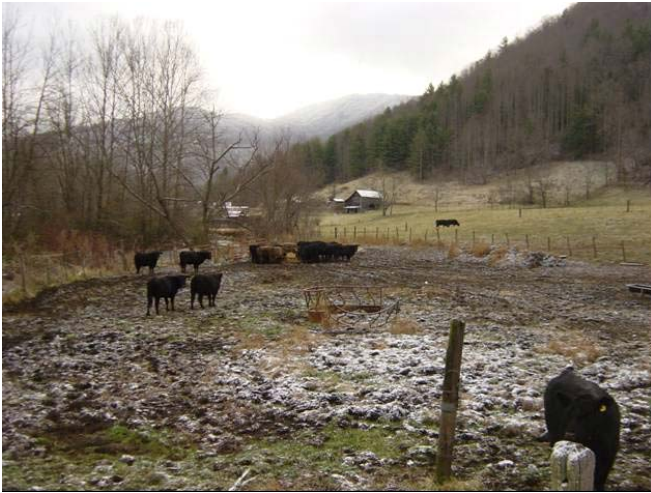
Photo station 7, right bank facing downstream, 6 Jan 2004.

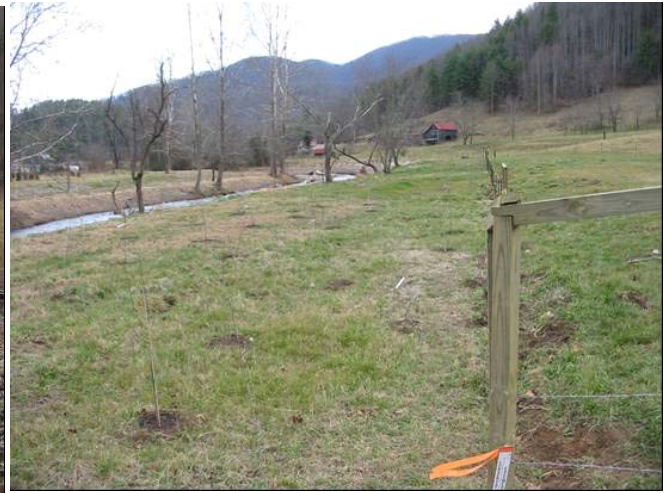
Photo station 7, right bank facing downstream, 5 Jan 2007.

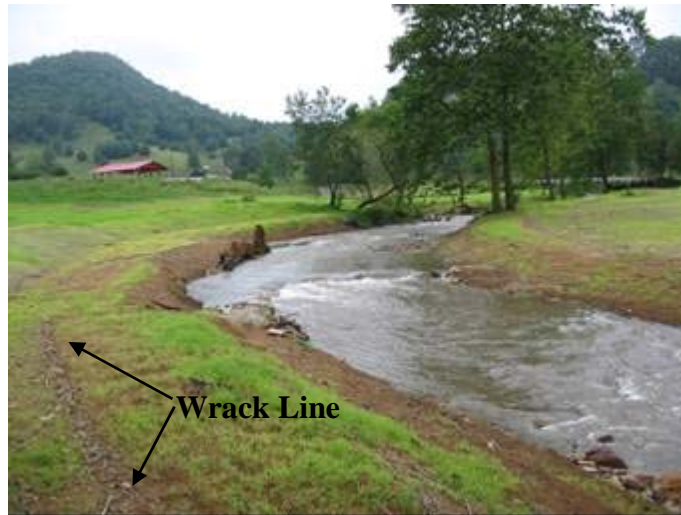
One bankfull event was documented between the end of construction and completion of the as-built survey (Exhibit Table V). A wrack line above the bankfull elevation was observed and photographed for verification on 5 Sep 2006 (Appendix B.9.). To monitor additional bankfull events, a simple crest gauge was installed on the left bank at sta. 2+30, downstream of cross-section 2 and adjacent to a large sycamore tree.

Wrack line following bankfull event on 1 Sep 2006.
