MONITORING YEAR 3 AND YEAR 4 REPORT
PLEMMONS/KIRKPATRICK MITIGATION SITE
SPRING CREEK

Madison County, North Carolina

EEP Project Number: 92607
Contract Number: D06082; Task Order: 06FB05-1

Period Covered: January 2009 – December 2010

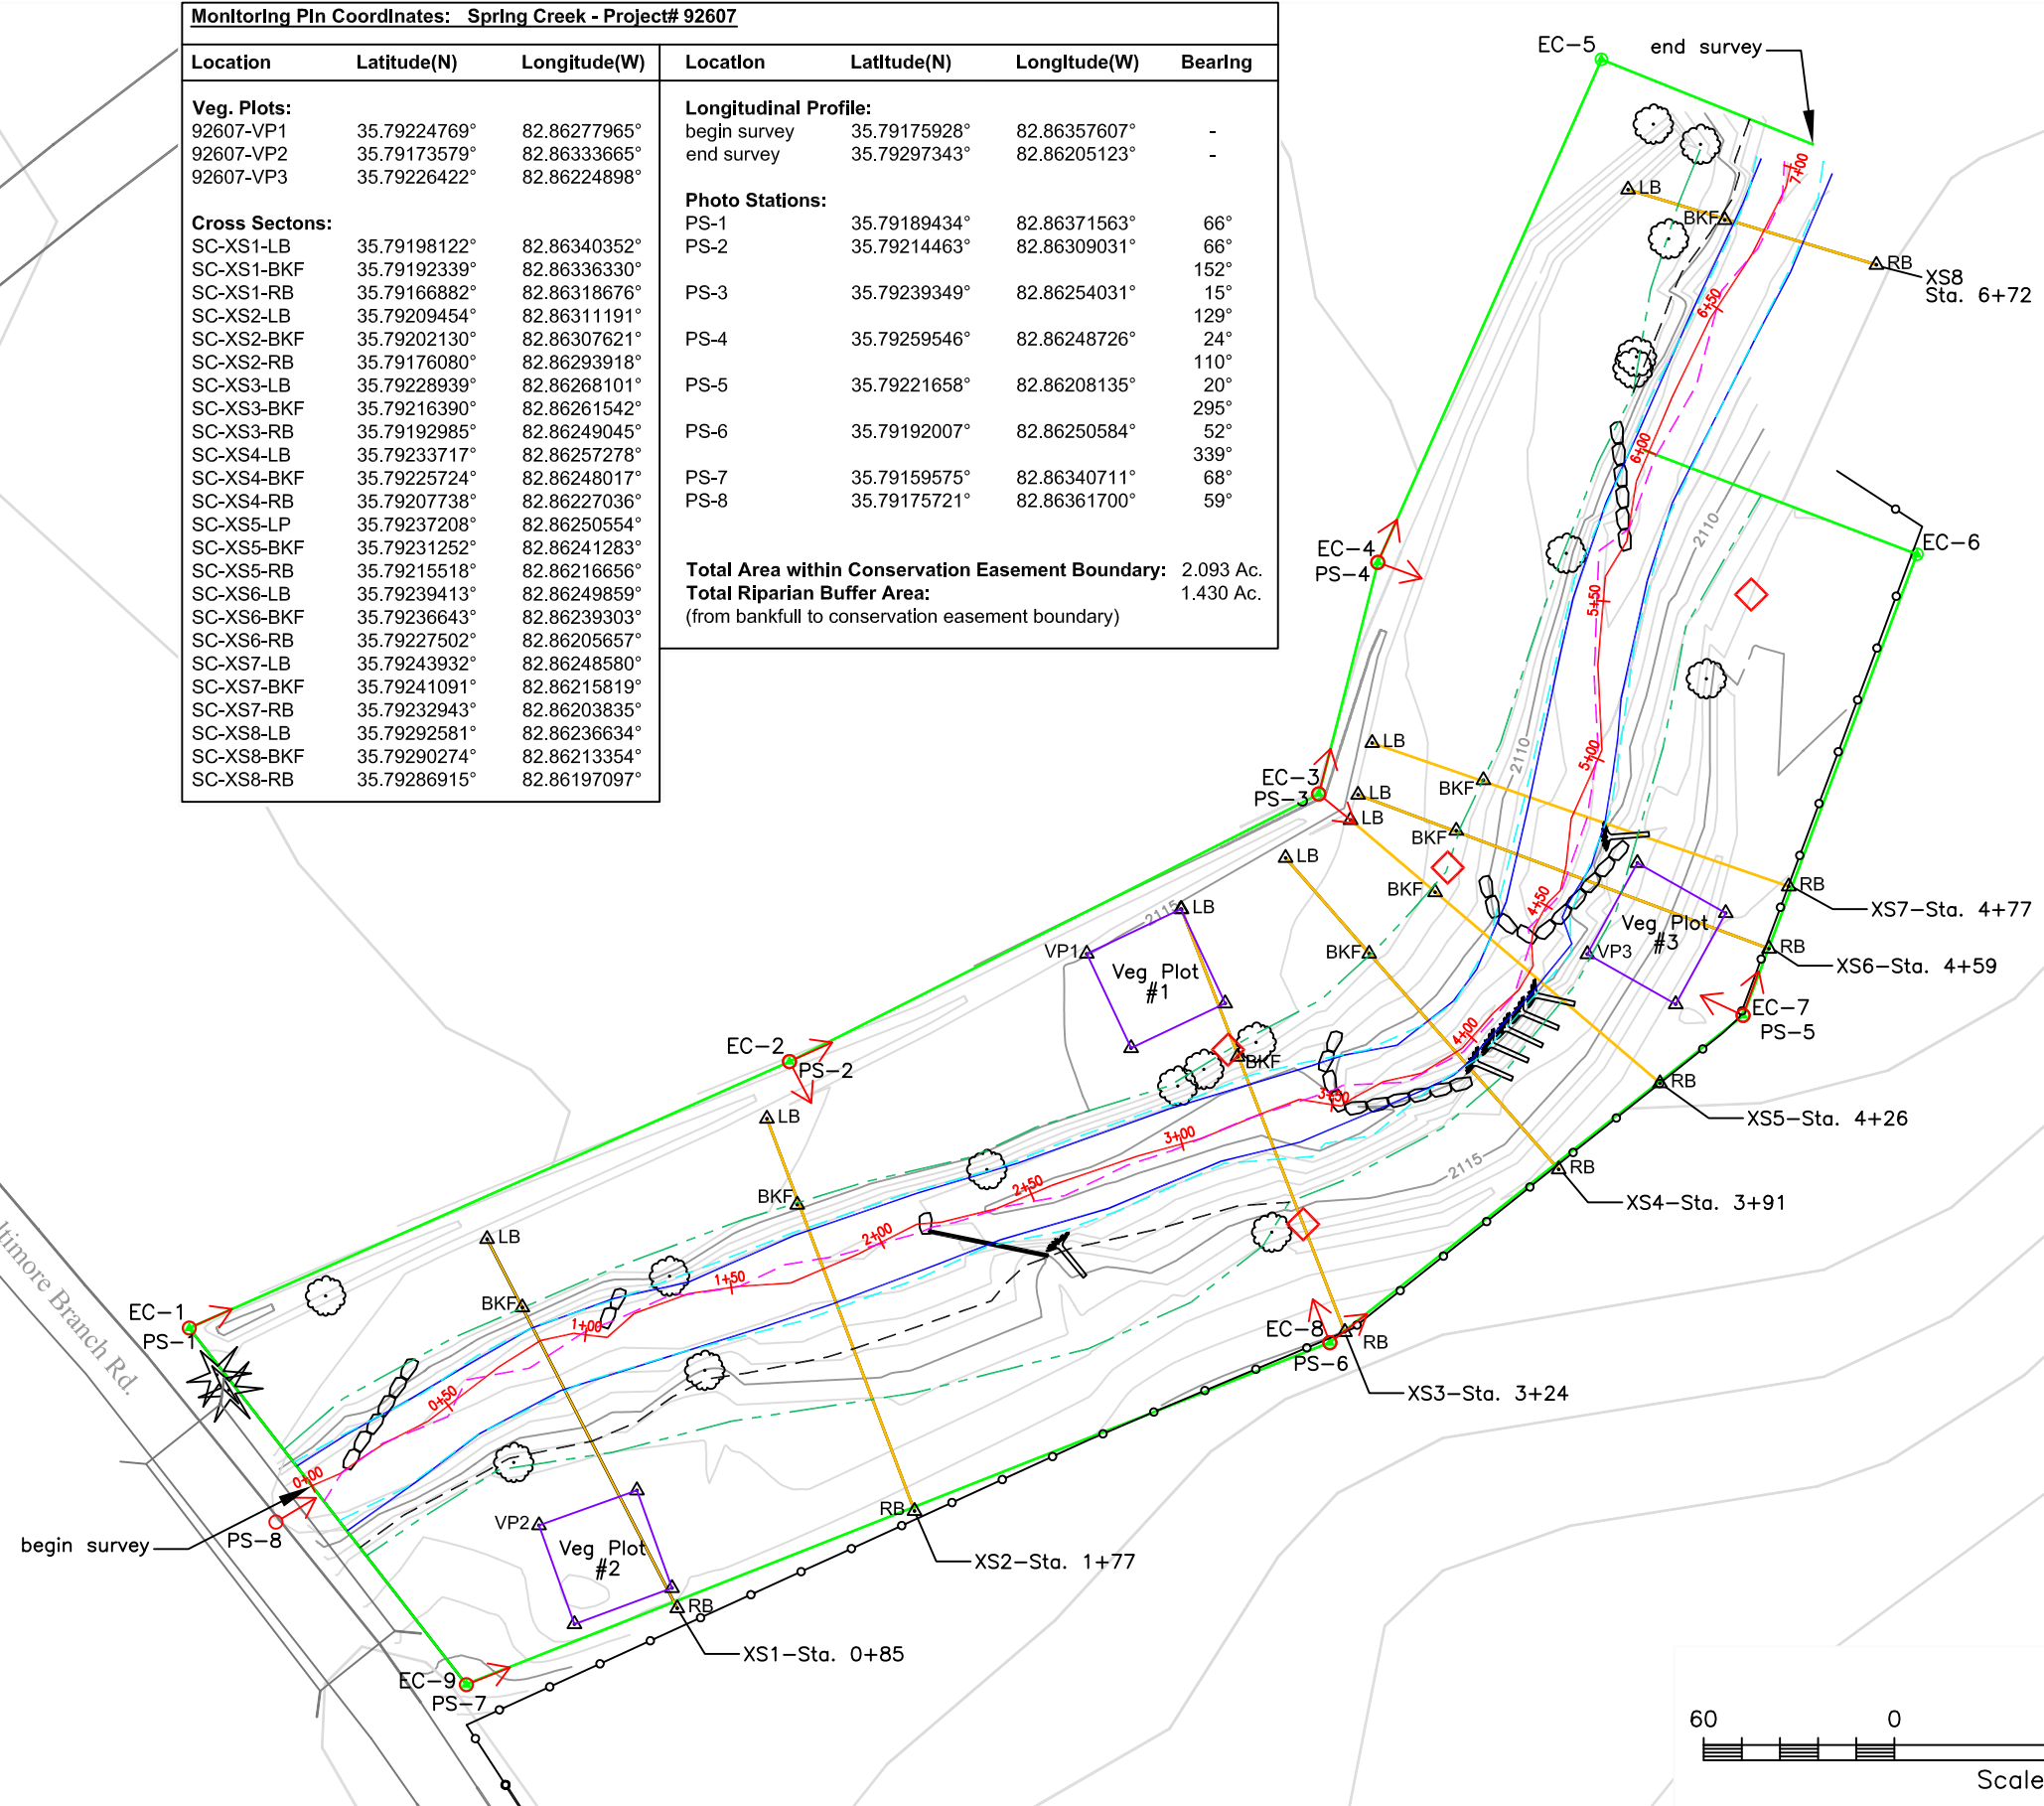
Spring Creek Project #92607
 Madison County Plemmons-Kirkpatrick Site
MY3 & MY4 Survey - Plan View

A vegetation problem areas plan view was not generated for MY3 or MY4 because ground cover vegetation and planted stems have performed satisfactorily since installation; there were no areas of the conservation easement that were devoid of vegetation. However, the location of non-native vegetation was noted on the plan view for MY3-MY4 (Figure 3).

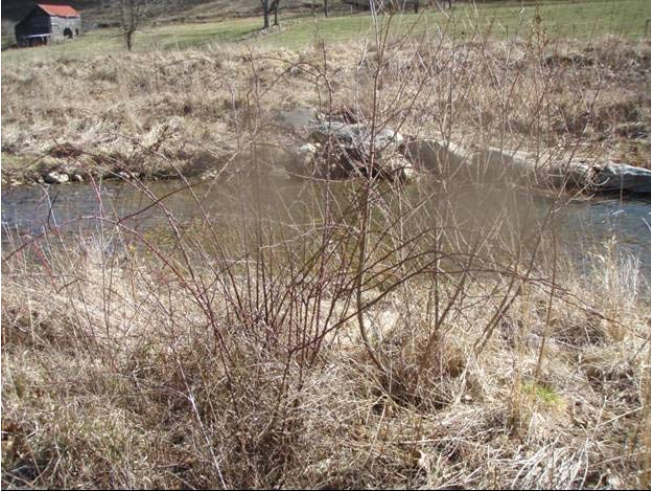
MY4 Vegetation Problem Areas Spring Creek (EEP project number 92607)			
Feature/Issue	Station Number/Range	Probable Cause	Photo Number
Chinese privet - sparse	3+00, left bank	Root stock	NA
Multi-flora rose - clump	4+75, left bank	Root stock	1
Multi-flora rose, Chinese privet, honeysuckle - clumps	5+75, right bank	Parent Stock	2
Chinese privet – single stem	3+25, right bank	Seed	3

Vegetation problem area photo 1, 13 Feb 2009.

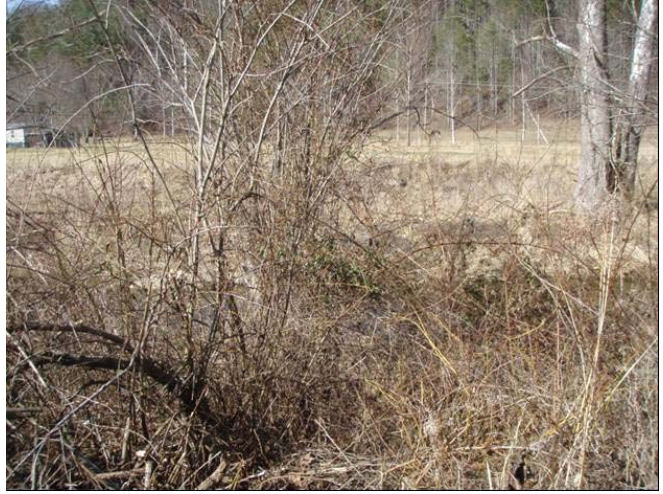
Vegetation problem area photo 2, 13 Feb 2009.

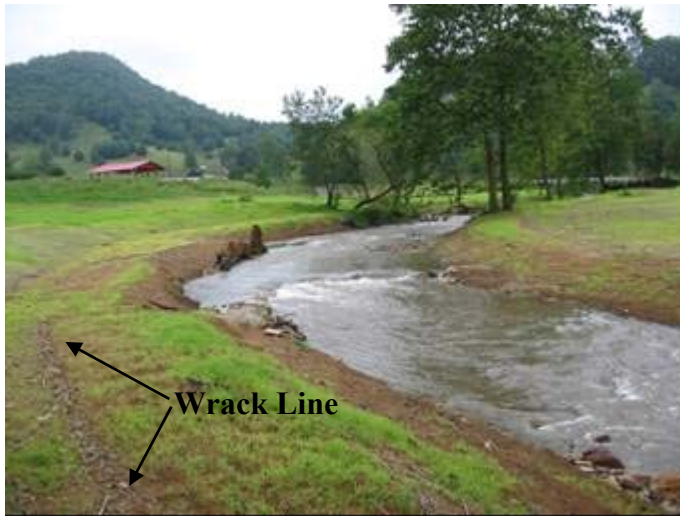
One bankfull event was documented between the end of construction and completion of the as-built survey (Table 5). A wrack line above the bankfull elevation was observed and photographed for verification on 5 Sep 2006 (Appendix B.9). To monitor additional bankfull events, a simple crest gauge was installed on the left bank (sta. 2+30) downstream of cross-section 2 and adjacent to a large sycamore tree. The crest gage was dislodged in July 2008 during a flow event that approached three-quarters of the bankfull elevation. The crest gage was relocated adjacent to the root wad structures in the large meander bend (Sta. 4+00). With the widespread drought conditions experienced during the 2007 and 2008 monitoring years, no bankfull events were documented. A second bankfull event was observed on 9 Dec 2009 and verified by the rivers crest elevation on the gage. Photograph documentation of the 9 Dec 2009 bankfull event is provided in Appendix B.9.

Wrack line following bankfull event on 1 Sep 2006.

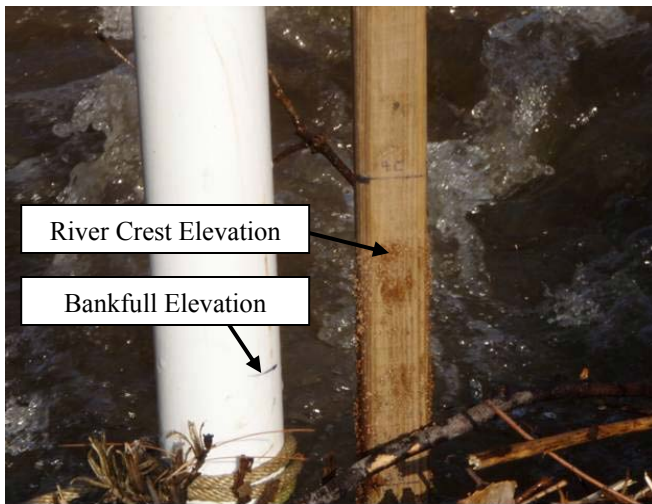
Bankfull verification on crest gage, 9 Dec 2009.

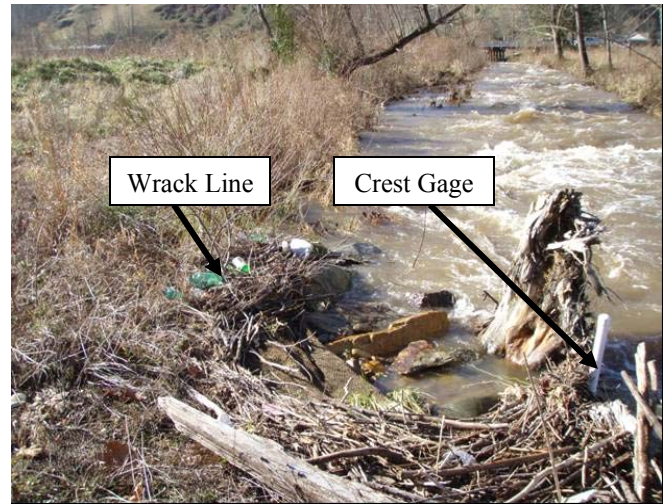
Wrack line following bankfull event, 9 Dec 2009.
