MONITORING YEAR 5 REPORT

PLEMMONS/KIRKPATRICK MITIGATION SITE SPRING CREEK

Madison County, North Carolina

EEP Project Number: 92607
Contract Number: D06082; Task Order: 06FB05-1

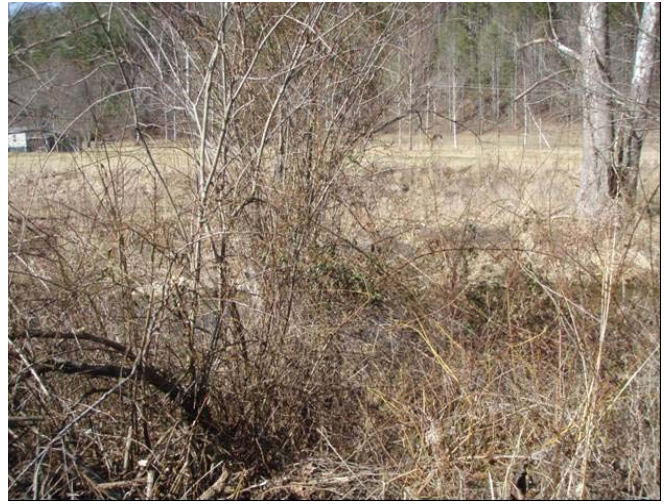
Vegetation problem area photo 2, 13 Feb 2009.

Small isolated areas of multiflora rose *Rosa multiflora* and Chinese privet *Ligustrum sinense* observed during the MY3 and MY4 site assessments were chemically treated in the spring of 2011 following the submission of the MY4 monitoring report. A follow up treatment of invasive exotic vegetation occurred in the spring of 2012 following the MY5 site assessment (Appendix Table A.3.1.). The presence of any invasive exotic vegetation should be minimal during the closeout visits scheduled for the fall of 2012.

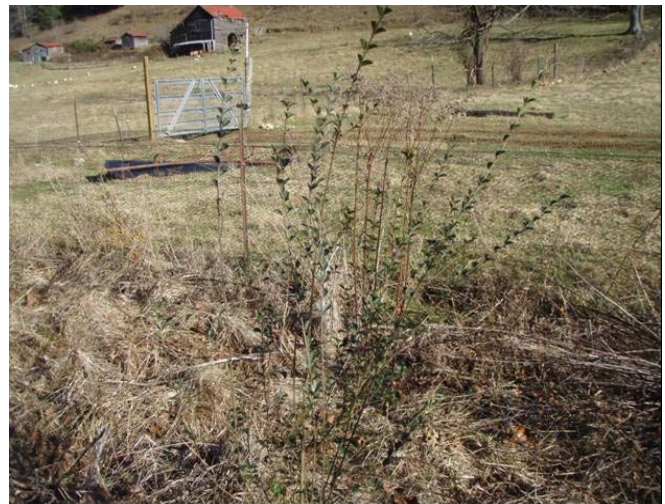
Vegetation problem area photo 4, 2 Nov 2011.

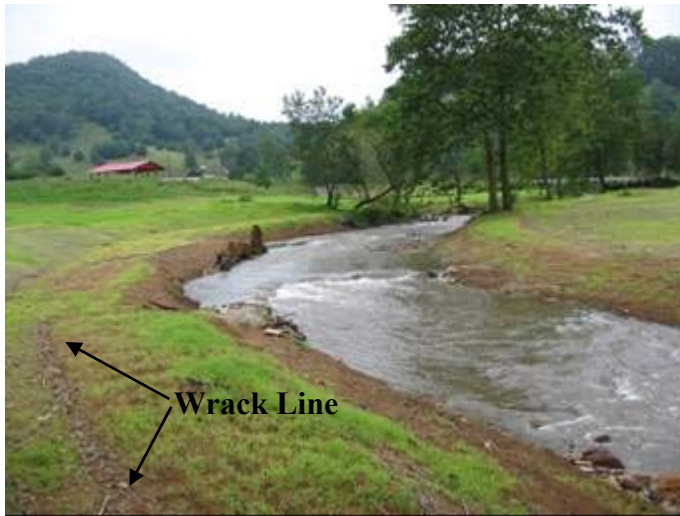
Wrack line following bankfull event on 1 Sep 2006.

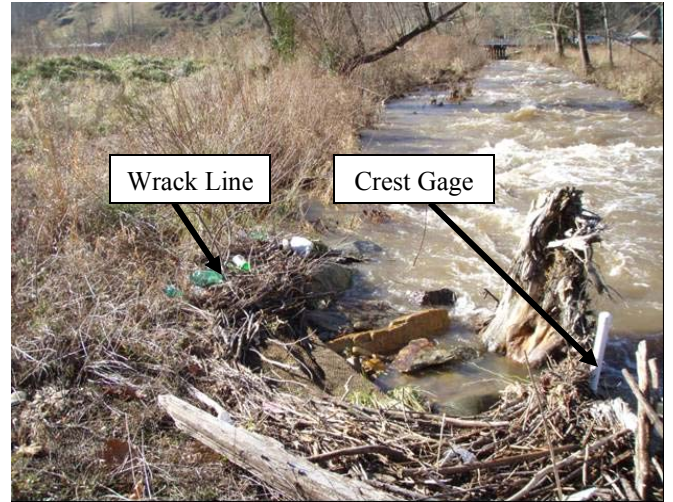
Wrack line following bankfull event, 9 Dec 2009.
