# **Pond Haven Buffer Restoration Site**

**Year 3 Monitoring Report  
Granville County, North Carolina  
Tar-Pamlico River Basin - 03020101**

**DMS Contract 7873  
DMS Project Number 100118  
DWR Project Number 20190646**

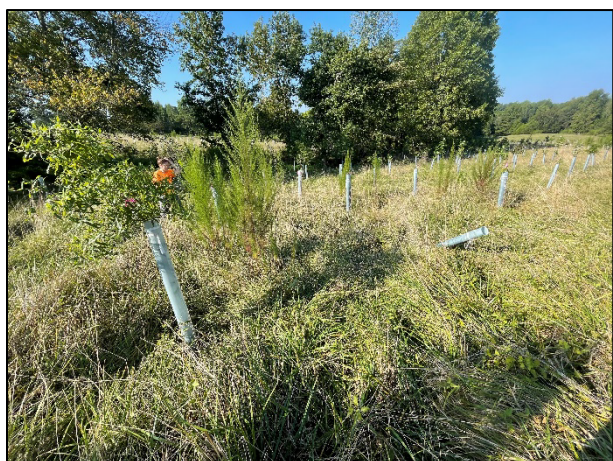
Plot 6 MY03 – 9/6/23

Monitoring Year 3 vegetation data was collected on August 24<sup>th</sup> and September 6<sup>th</sup> of 2023. 14 of the 15 vegetation monitoring plots had greater than 260 stems/acre, with only Plot 6F (243 stems/acre) below the density requirement. Plot 6F (3 species) was also the only plot with less than four native hardwood species. Overall, the site is well vegetated with extensive herbaceous coverage and many diverse volunteer woody species.
