Annual Monitoring Report

Monitoring Year 7 of 7

Poplin Ridge Stream Restoration Project

NCDMS Project No.: 95359

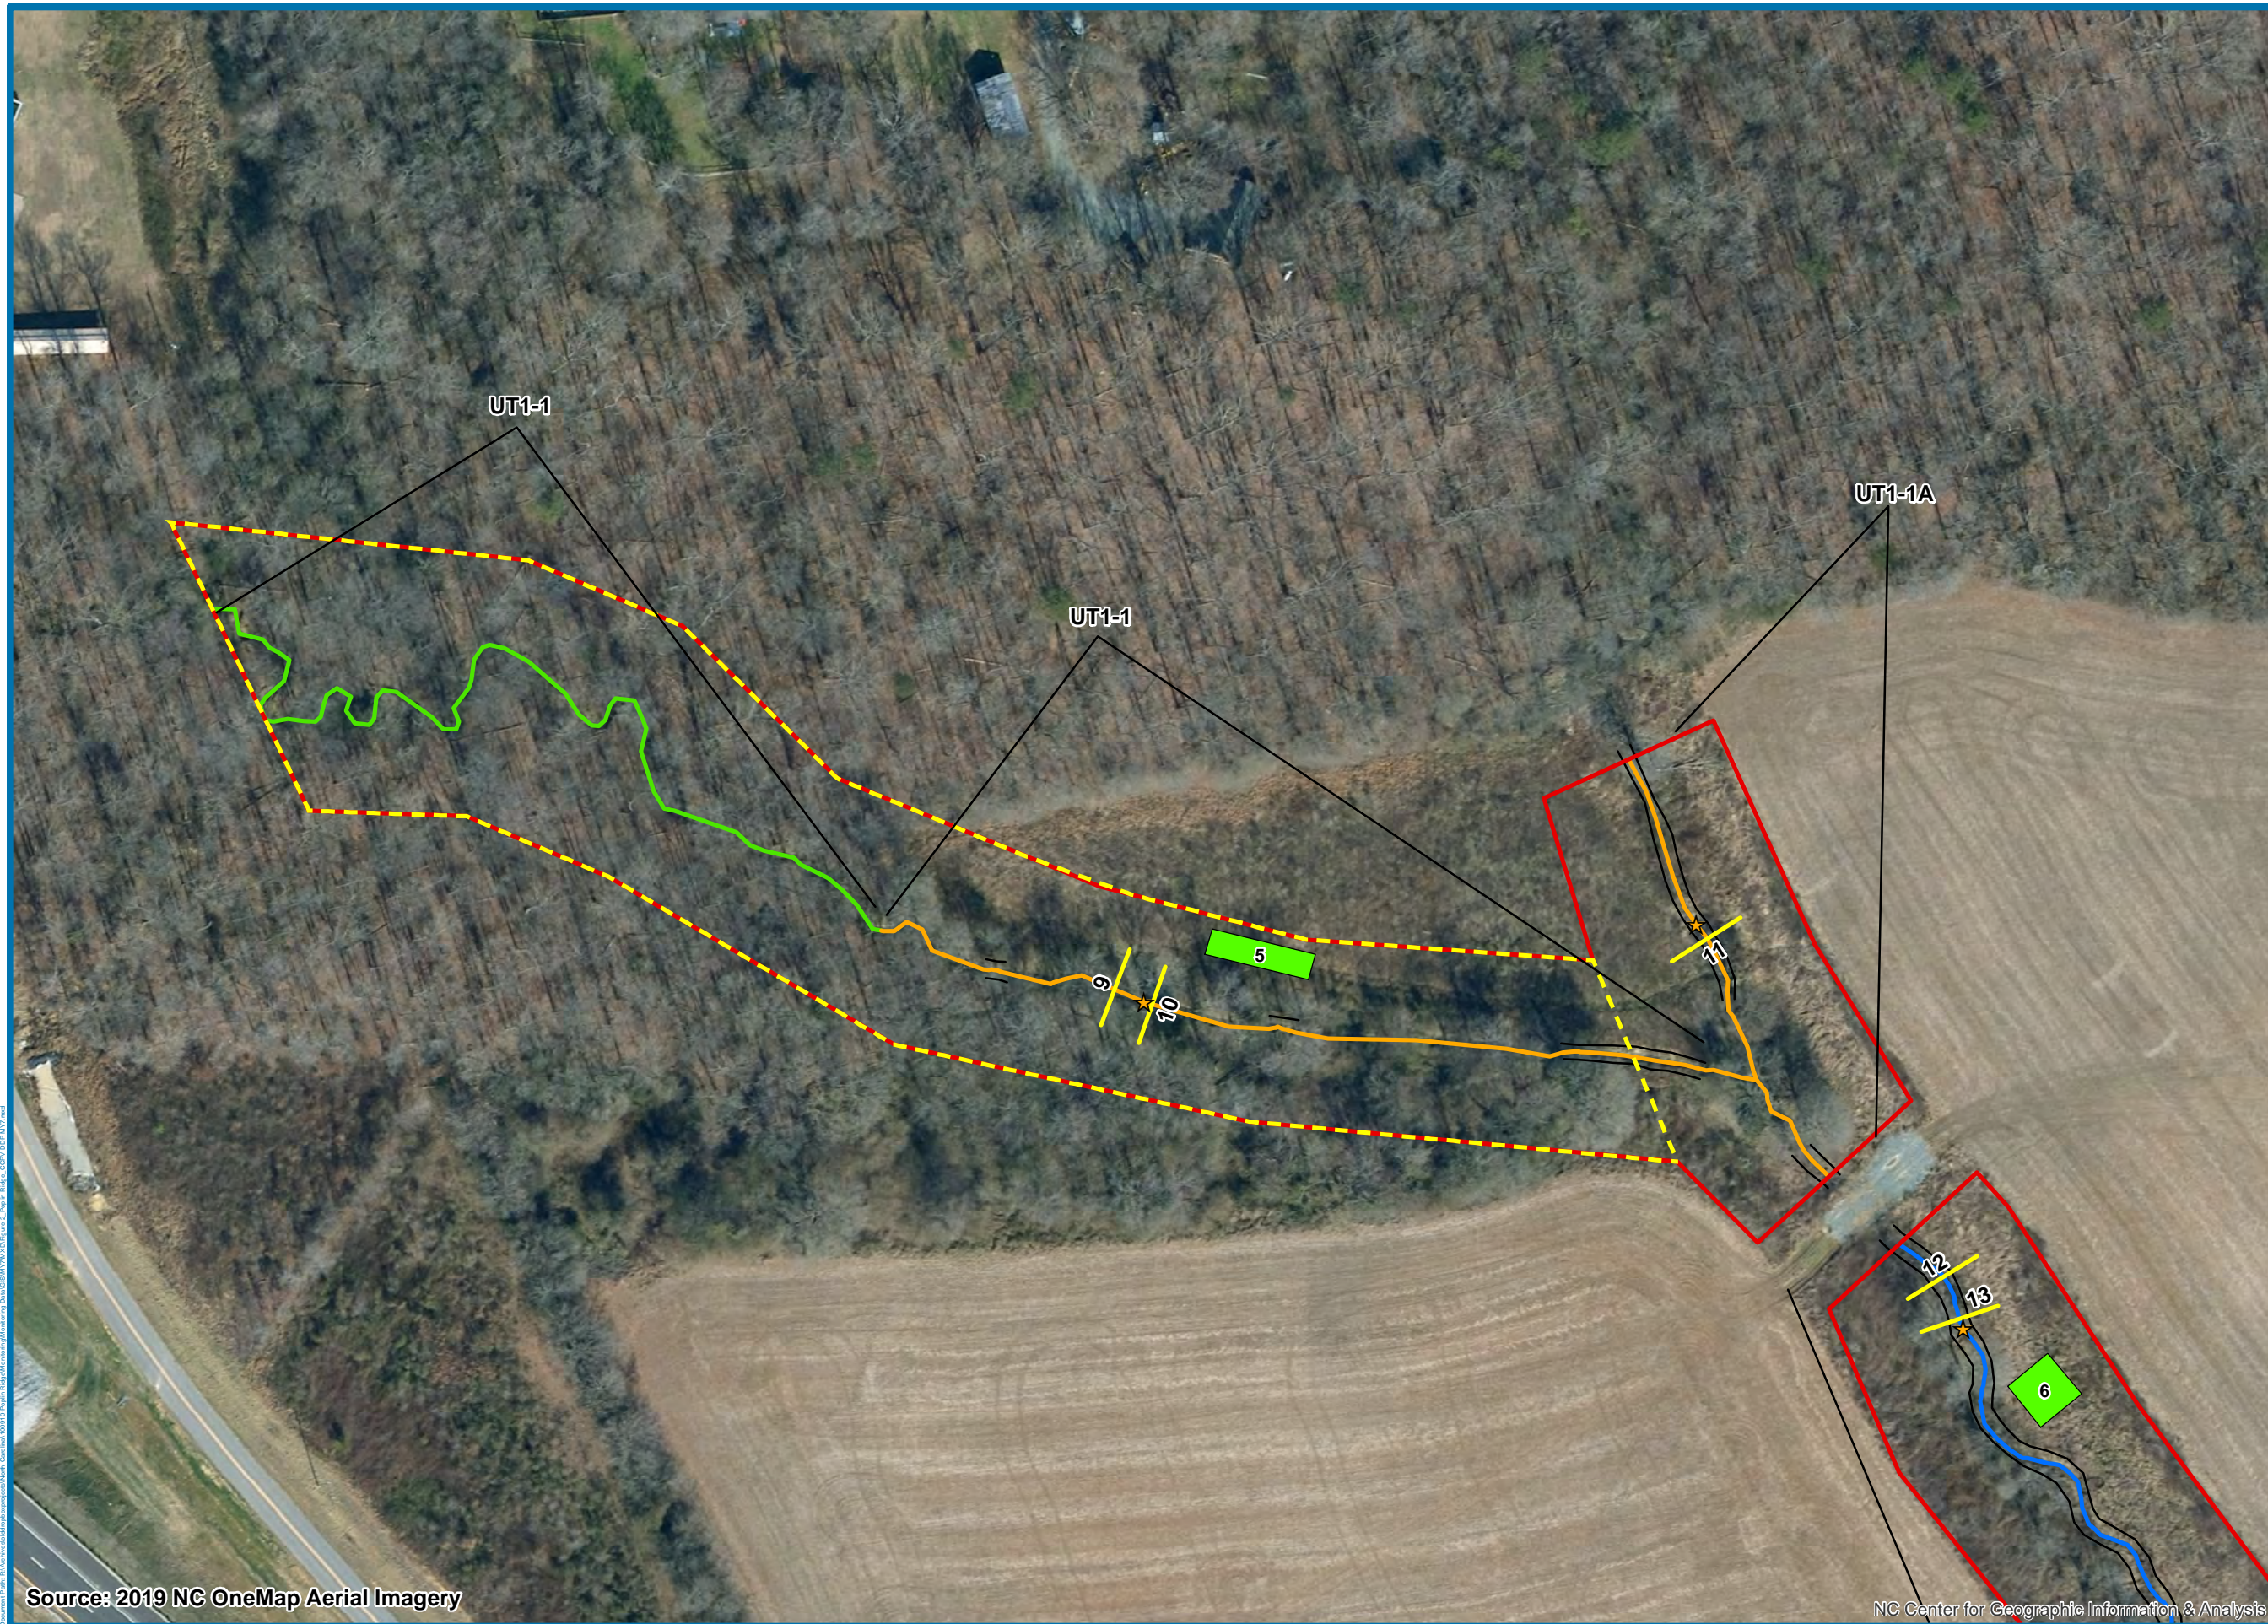
Figure 2
1
Poplin Ridge Stream Restoration Project
MY7 2021
Current Conditions
Plan View

Visual assessment of the site indicates that herbaceous vegetation has become well established on-site. The invasive species treatments were performed in October and November 2020 and then again in November 2021. Treatments focused in the resprouting areas along UT1-1, UT1-B, and UT2-1. Follow up treatments will be performed prior to closeout. In September 2021, DMS visited the site and observed multiple damaged easement markers and three areas of encroachment. The areas of encroachment are minor along UT1-2 and shown on **Figure 2**. The larger of the three areas was repaired in November 2021 with t-posts and horse tape and the other two areas will be repaired the same way before closeout. RES replanted the MY6 low stem density area in the pond bottom in January 2021. The replanting consisted of six-foot willow poles and silky dogwood livestakes. Encroachment and invasive treatment areas are included in **Table 6** and **Figure 2** for reference during the closeout site visit.

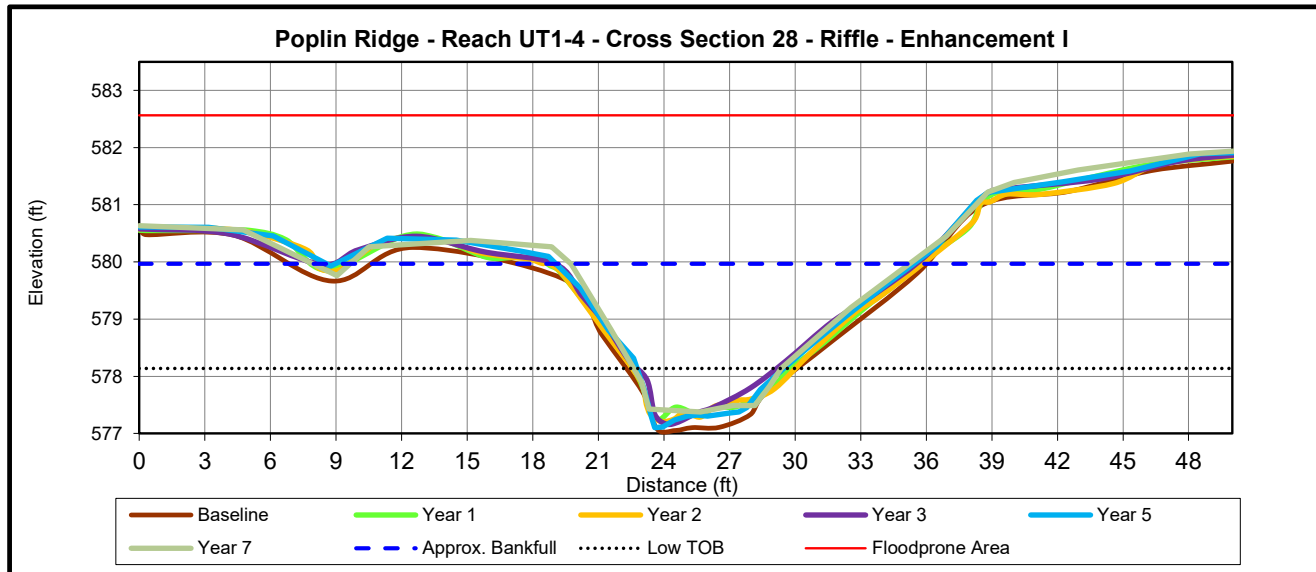
- Additionally, in the BHR workbook the bankfull elevation that achieves the MY0 cross sectional area for cross section 28 was calculated before excluding points outside of the main channel. The points outside of the main channel were also not excluded for cross section 4, and this may occur elsewhere. Note that failing to exclude these points will affect multiple parameters (e.g. BHR, cross sectional area, etc.), so please review and ensure these points are excluded for both the BHR and LTOB workbooks.

- Also note that when comparing the cross section 28 figure and table to Table 11a, it appears that the cross sectional areas are inconsistent. This may be caused by a mix up of data between cross sections 28 and 29. Please review and QA/QC all cross sections to confirm that they are reported accurately in the revised report.

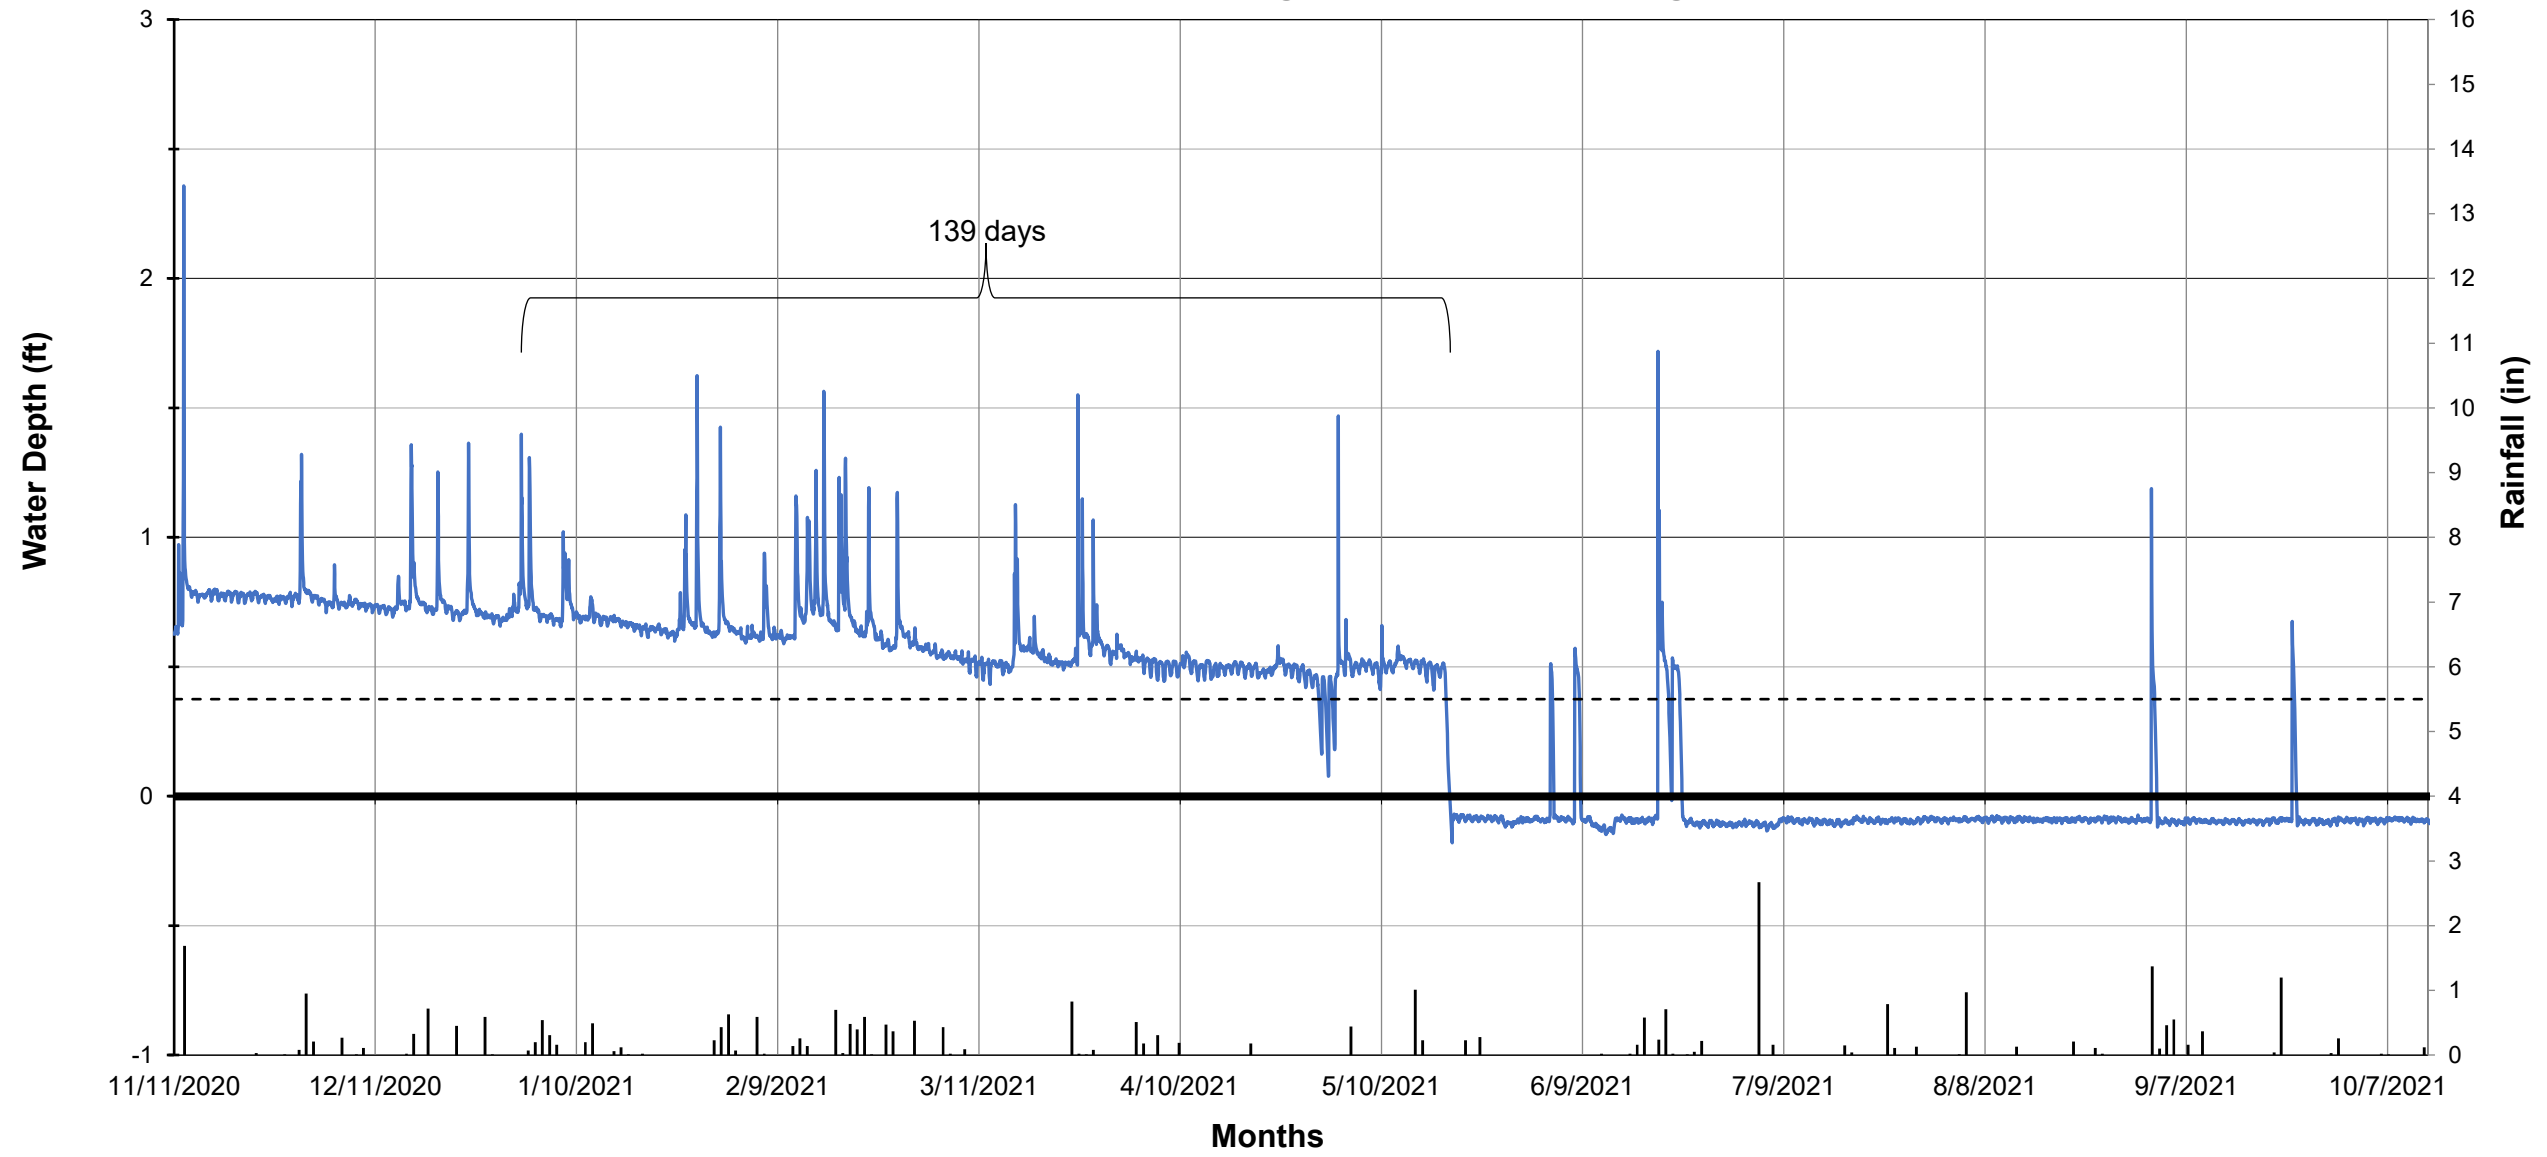
MY7 2021 Poplin Ridge UT2-A Flow Gauge

Appendix E – Flow Gauge Graph: DMS recommends showing the start and end points of the 139 days of consecutive flow reported.

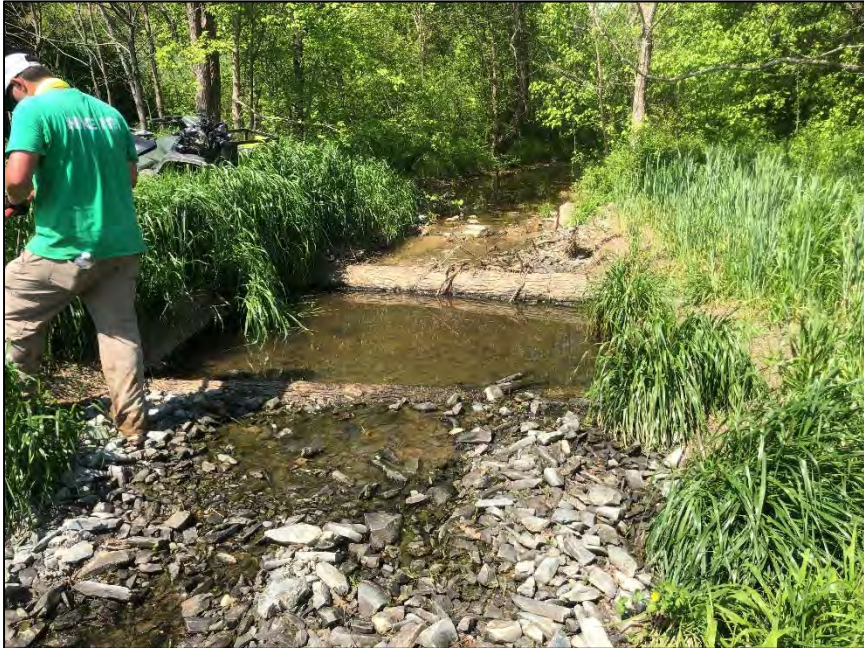
Newly replaced log sill at the top of the reach (Area 1 from AMP) looking upstream

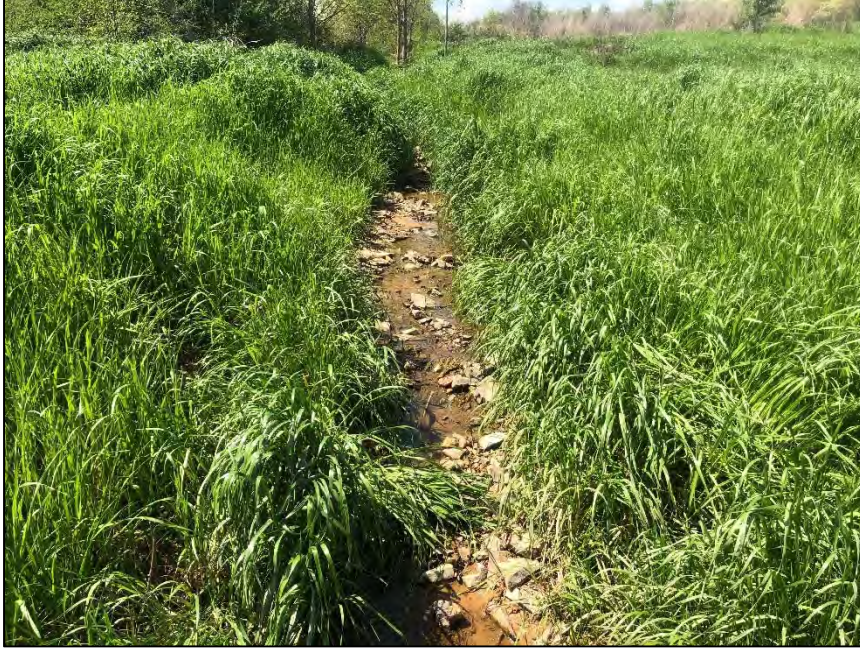
Lower UT2-A in the pond bottom looking upstream
