# **Annual Monitoring Report**

Monitoring Year 1 of 7

Poplin Ridge Stream Restoration Project

NCDMS Project No.: 95359

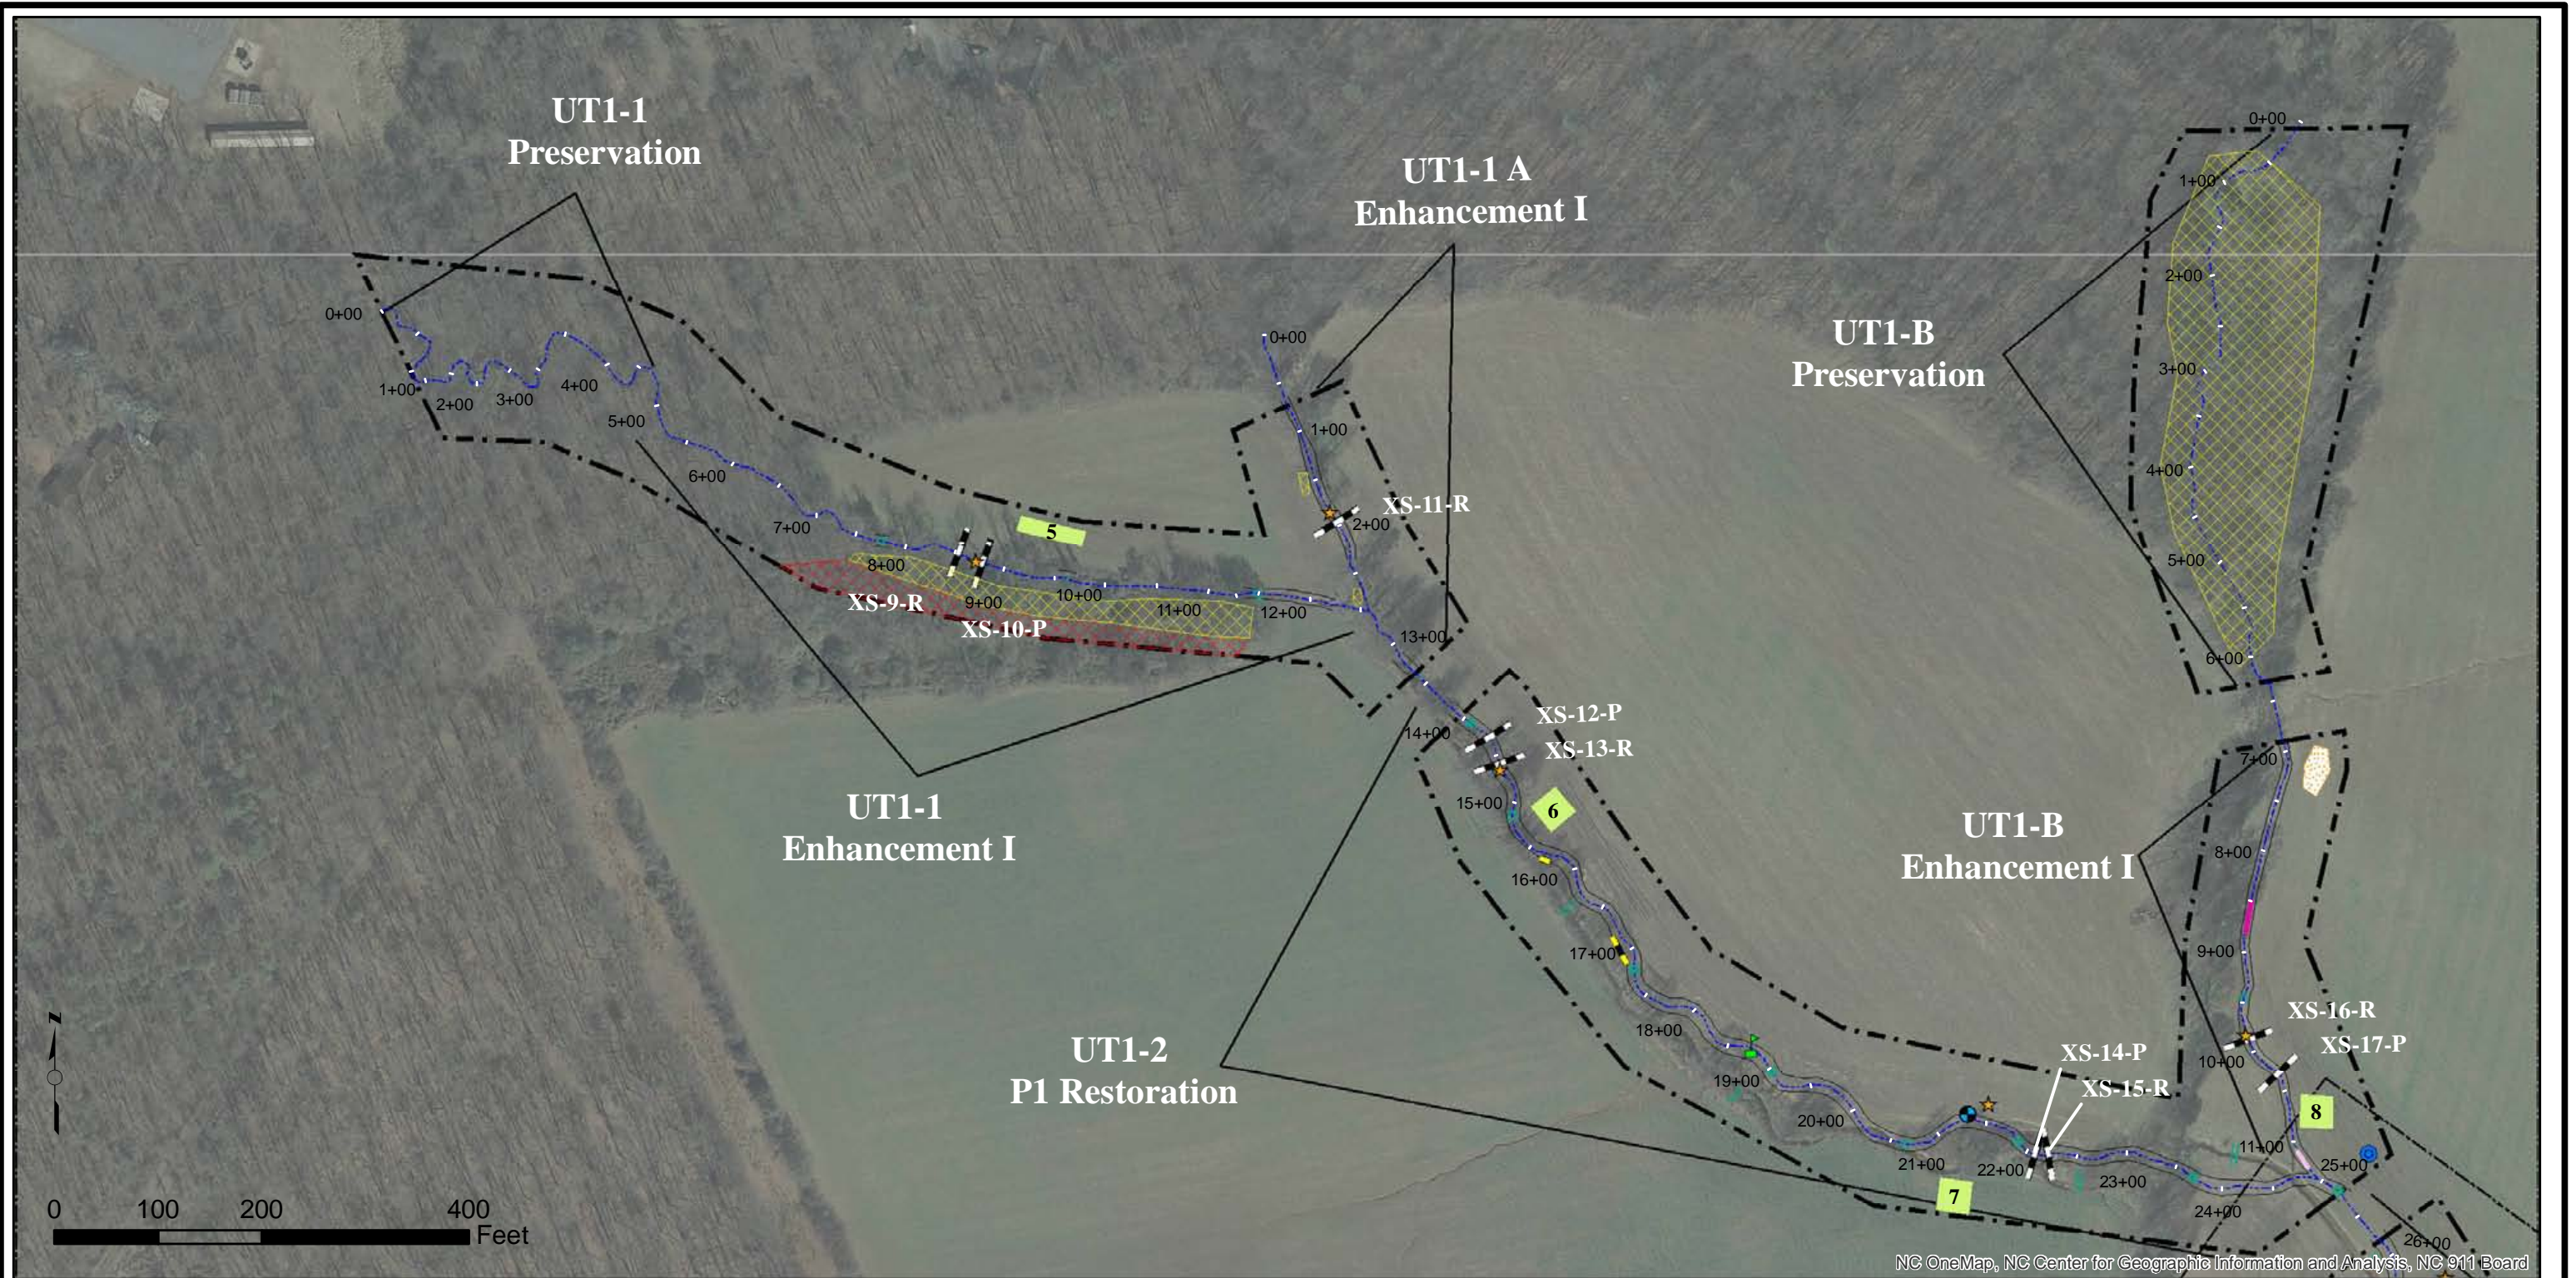
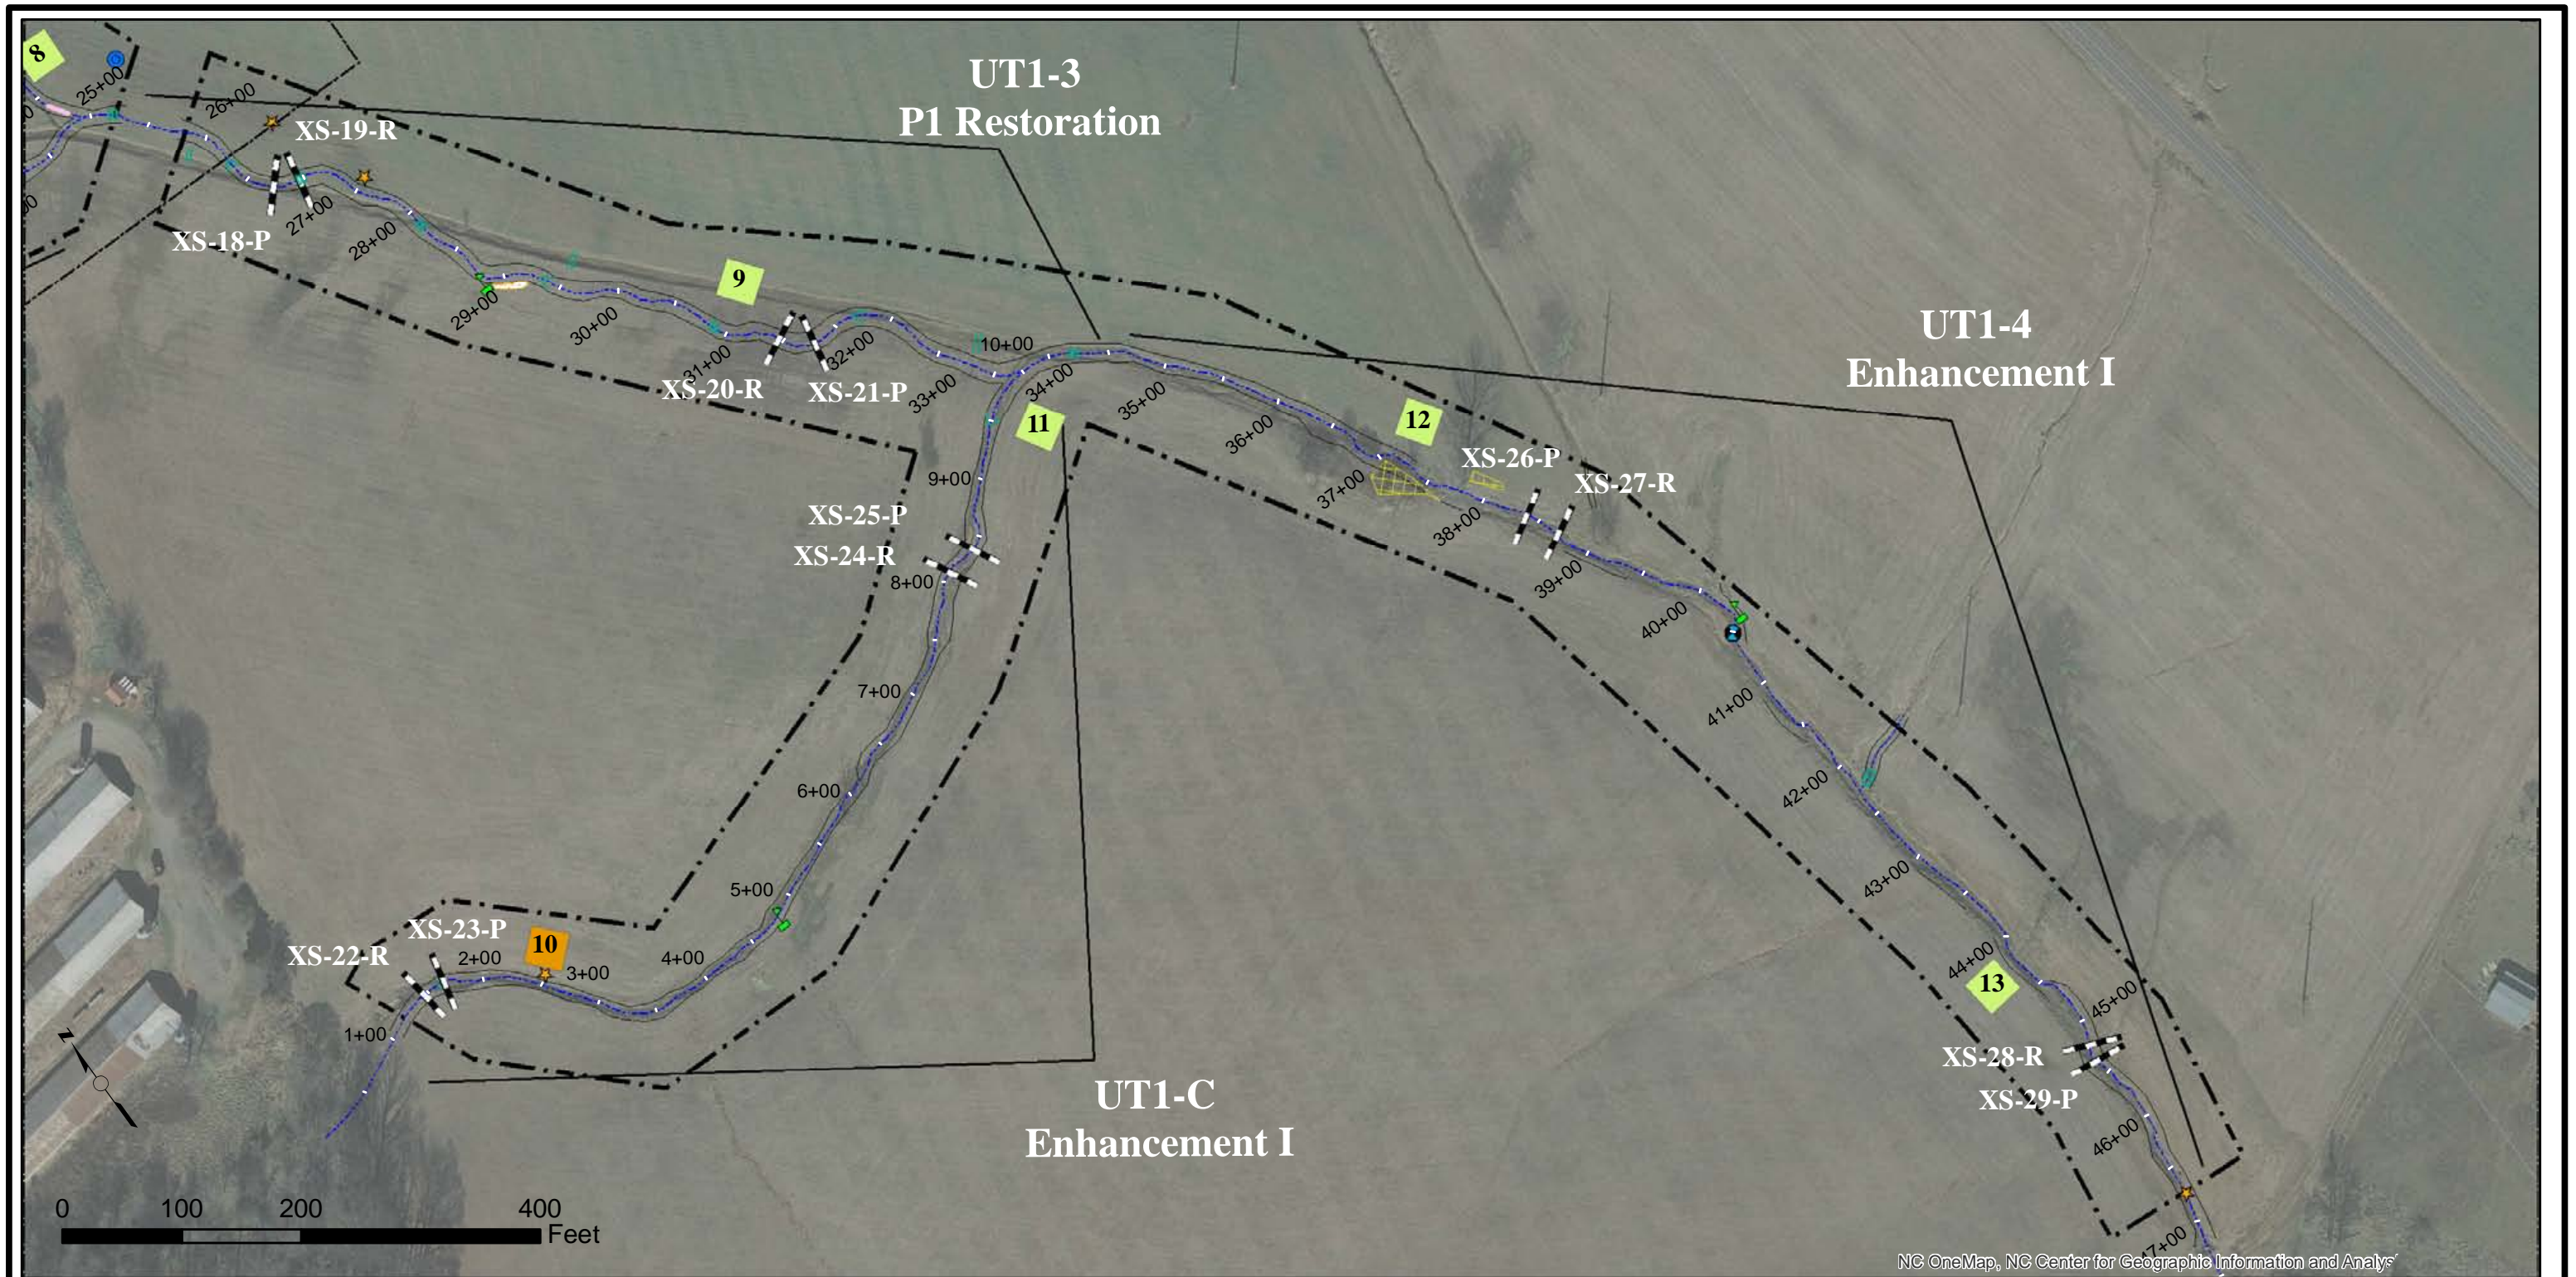
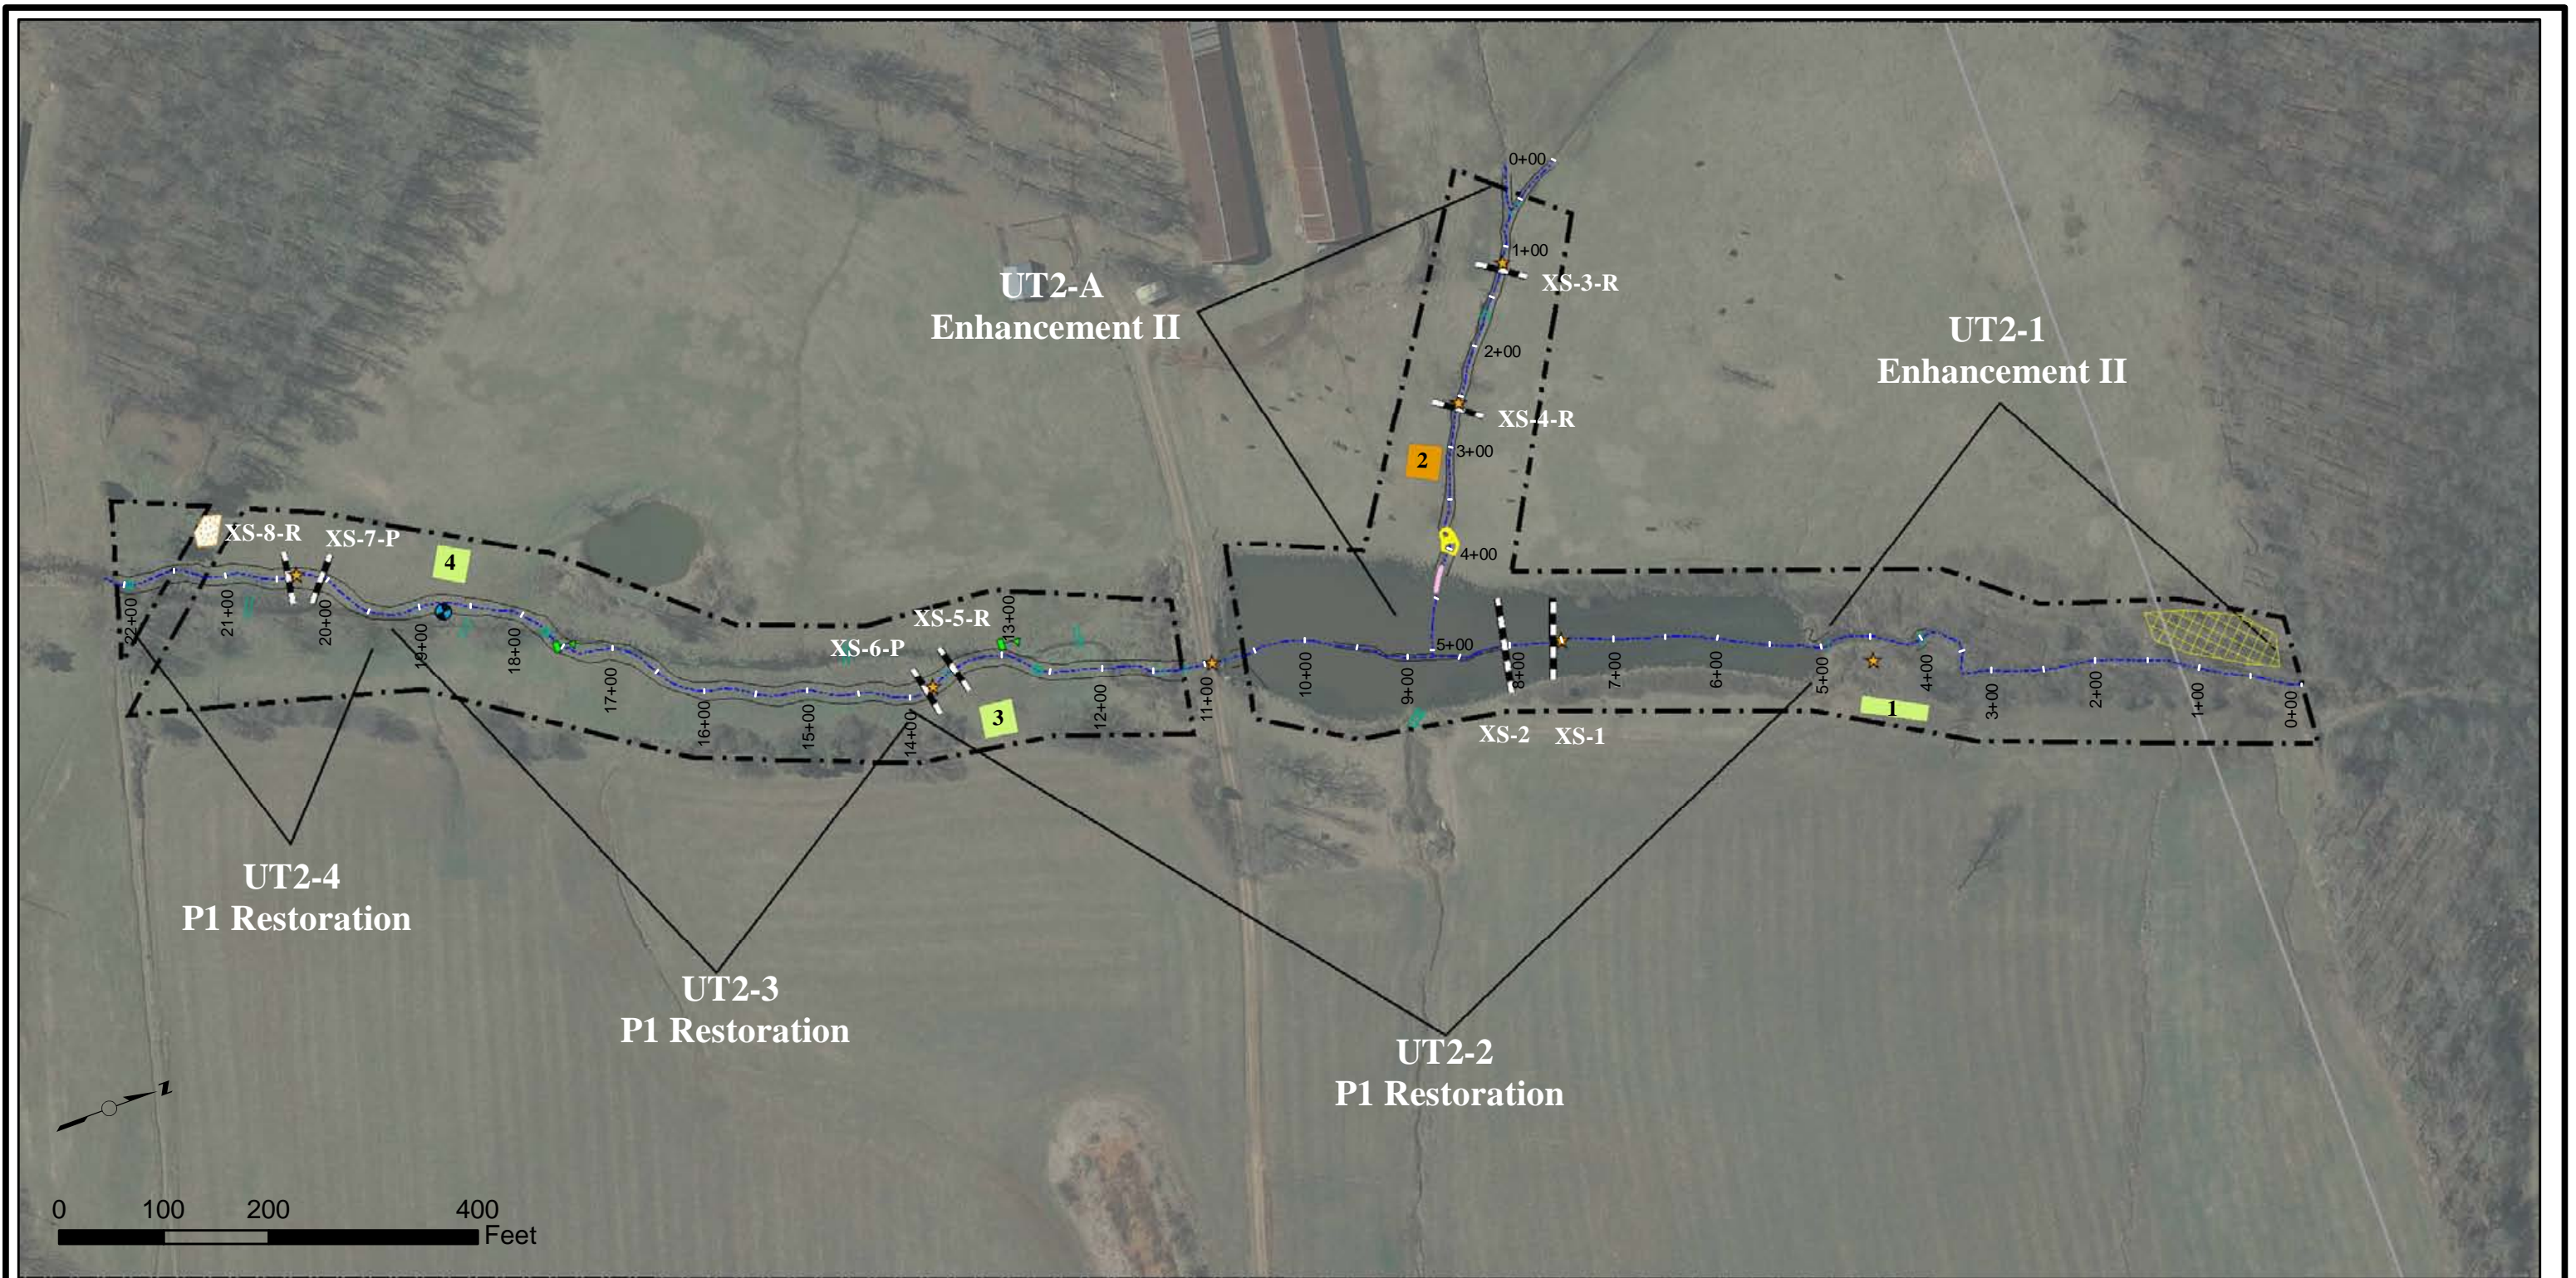
Visual assessment of the site indicates that herbaceous vegetation has become well established; however, three bare areas covering a total of 0.04 acres were associated with recent high-flow events that scoured parts of the floodplain (Table 6, Figure 2). Growth rate, vigor, and planted woody stem density outside of the permanent vegetation monitoring plots were difficult to assess during leaf-off conditions occurring during the monitoring period. These will be assessed during leaf-on conditions in MY2. Low density and bare areas will be replanted during the spring of 2016. Additionally, eight areas of invasive-exotic vegetation covering a total of 1.81 acres were noted within the easement (Table 6, Figure 2). A majority of the invasive-exotic vegetation was previously cut privet that is now re-sprouting. Treatment of these areas is scheduled for MY2 (2016).

Visual assessment of the stream channel was performed in order to document signs of instability, such as eroding banks, structural instability, or excessive sedimentation. Areas of bank scour, bed aggradation, and bed degradation were noted on reaches UT1-2, UT 1-B, and UT2-A (Table 5 and Figure 2). One stressed structure was noted on UT2-A at STA 4+00, near the confluence of UT2-A and UT2-2. This structure is considered stressed due to one dislodged boulder at the invert; however, the structure is still holding grade and providing habitat. It is likely that high flows post-construction affected the structure. Due to the position of the dislodged boulder, it is anticipated that the structure will stabilize with time. RES will monitor the structure during future visits to assess the integrity of the structure and the need for any repair. All other structures are intact and performing as designed.

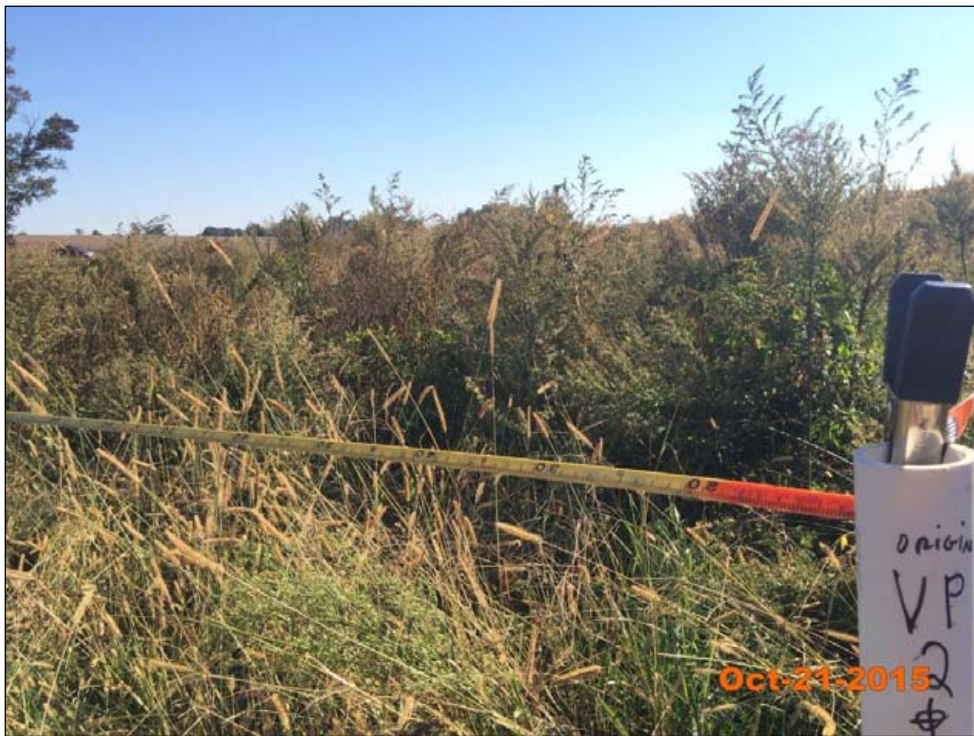
Poplin Ridge - Vegetation Monitoring Plot 2  
October 21, 2015

Monitoring of permanent vegetation plots (n = 13) was completed during October 2015. Summary tables and photographs associated with MY1 monitoring can be found in Appendix C. With the exception of Plots 2 and 10, MY1 monitoring data indicates that all vegetation monitoring plots are on track to meet the MY3 interim success criteria of 320 planted stems per acre. Planted stem densities among the plots were found to range from 0 to 1,093 planted stems per acre with a mean of 663 stems per acre across all plots. When volunteer stems are included, densities ranged between 121 and 1,821 total stems per acre with a mean of 753 stems per acre across all plots. A total of 18 plant species were documented within the monitoring plots. Low stem densities in plots 2 and 10 are likely attributed to a combination of landscape position and a dry summer following planting.
