Annual Monitoring Report

Monitoring Year 2 of 7

Poplin Ridge Stream Restoration Project

NCDMS Project No.: 95359

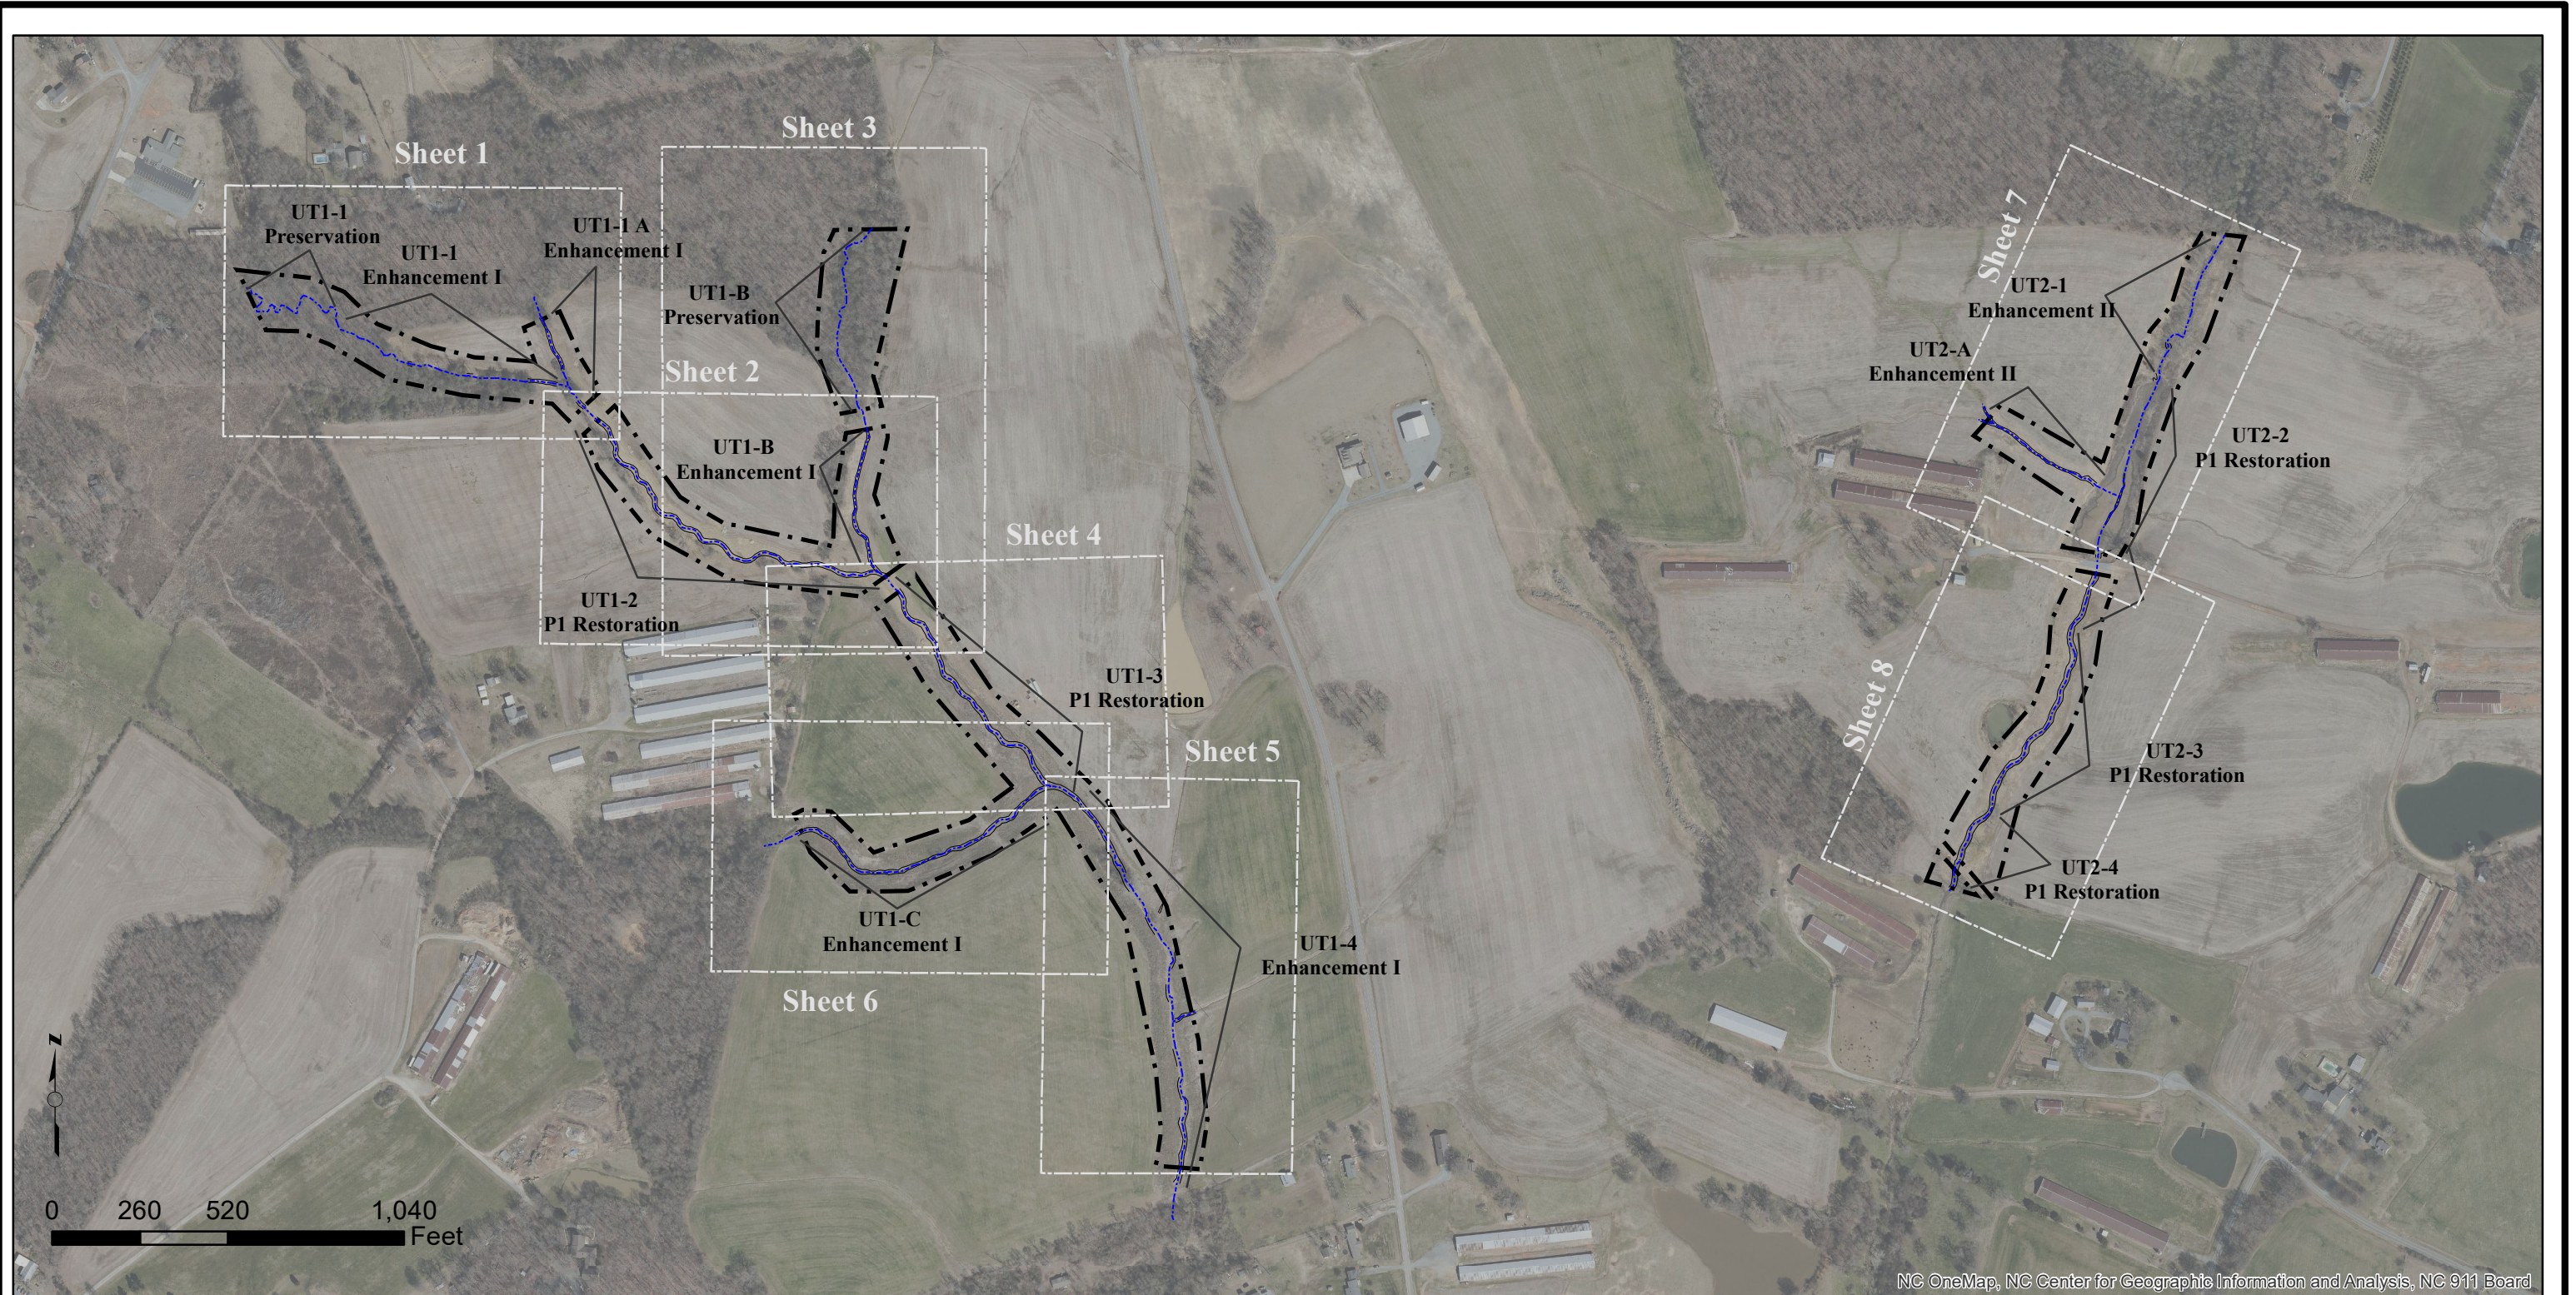
Figure 2. Current Condition Plan View
 Poplin Ridge Stream Restoration Project
 Union County, North Carolina
 NCDMS Contract No. 004672
 NCDMS Project No.: 95359
 September 2016
 Project Overview

Visual assessment of the site indicates that herbaceous vegetation has become well established; however, three bare areas covering a total of 0.03 acres were noted (Table 6, Figure 2). Five areas of low stem density were also noted during MY2 monitoring, totaling 2.26 acres. Areas of low stem density and poor growth rate/vigor will be replanted during 2017. Additionally, 15 areas of invasive-exotic vegetation, covering a total of 1.97 acres, were noted within the easement (Table 6, Figure 2). A majority of the invasive-exotic vegetation was previously cut privet (*Ligustrum sinense*) that is now re-sprouting, while the remainder consists of small patches of honeysuckle that are resprouting around mature trees left after construction. Treatment of these small areas of invasive exotic vegetation will be conducted in conjunction with the supplemental planting that will take place during 2017 (MY3).

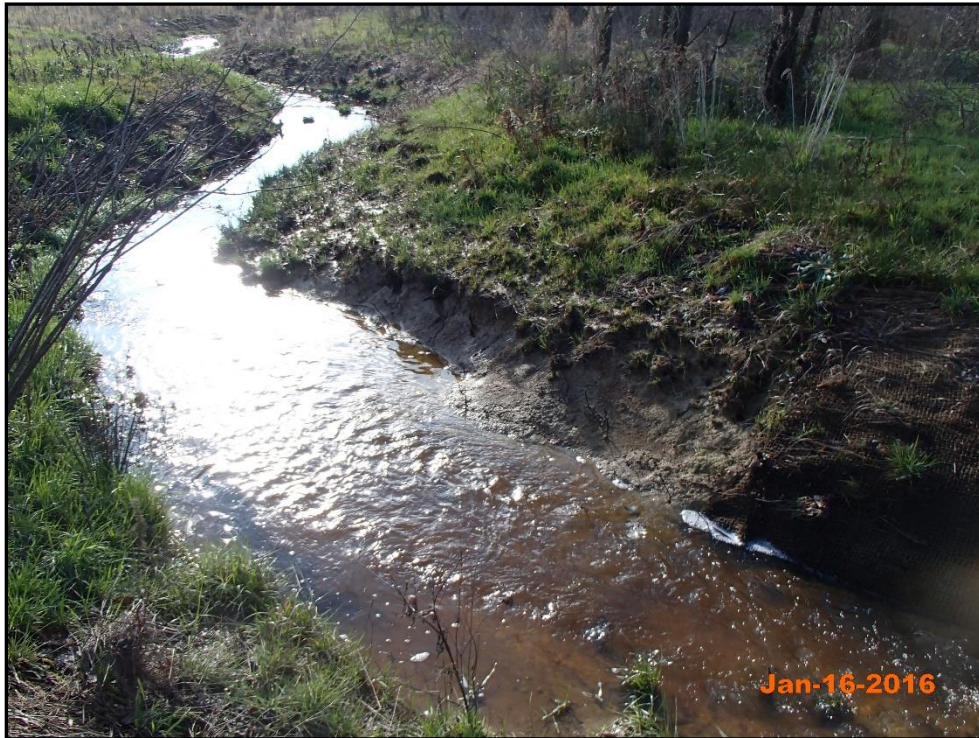
Project Reach UT1-2 – Bank Erosion 15+75 Right Descending Bank

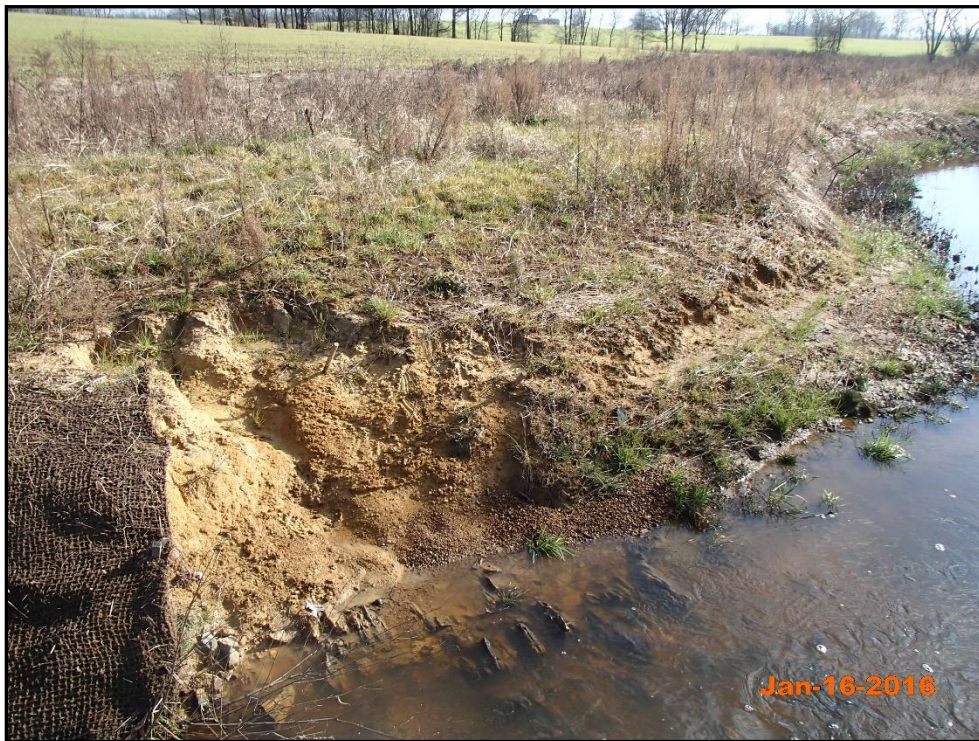
Project Reach UT1-2 – Bank Erosion 18+25 Left Descending Bank

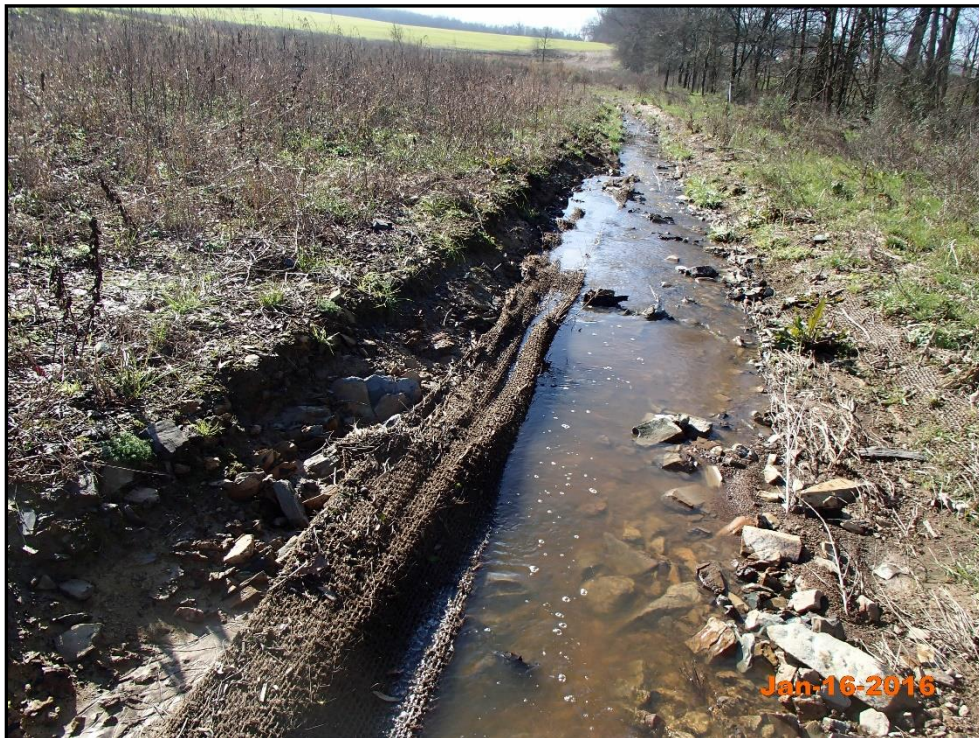
Project Reach UT1-B – Bank Erosion 7+25 Left Descending Bank

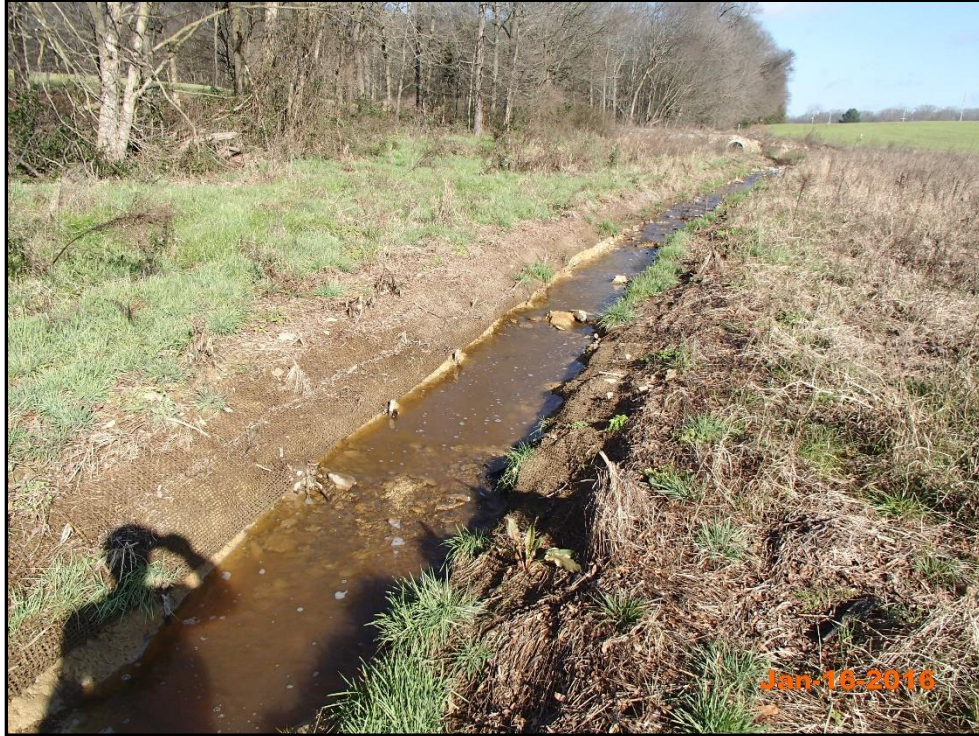
Project Reach UT1-B – Degradation 8+25 Left Descending Bank

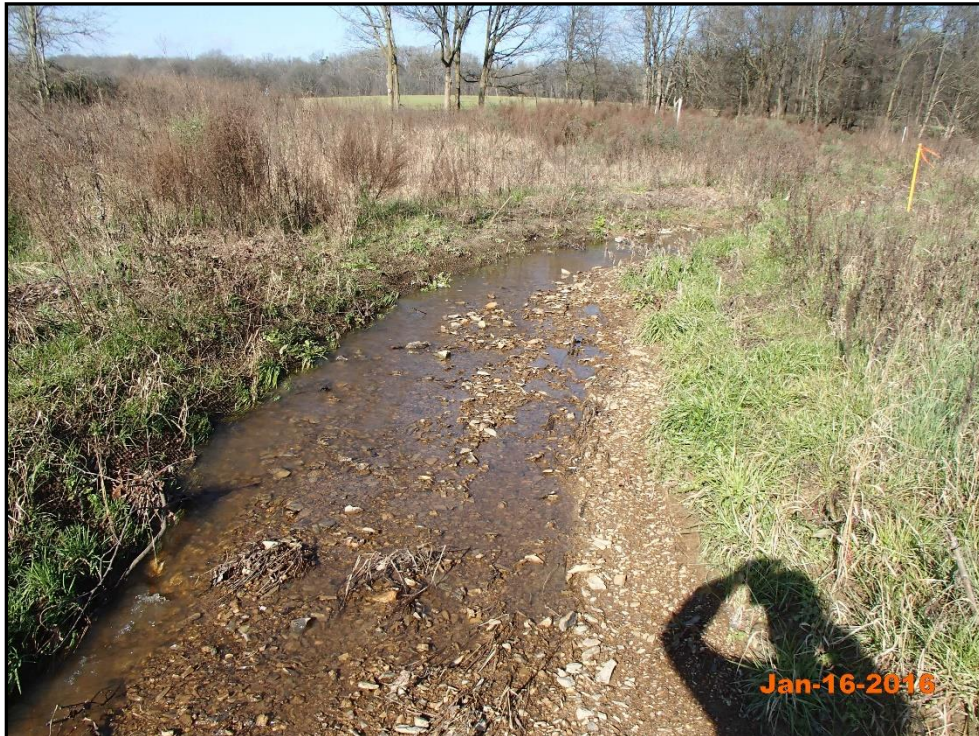
Project Reach UT1-B – Aggradation 11+25
