Annual Monitoring Report

Monitoring Year 3 of 7

Poplin Ridge Stream Restoration Project

NCDMS Contract No.: 004672

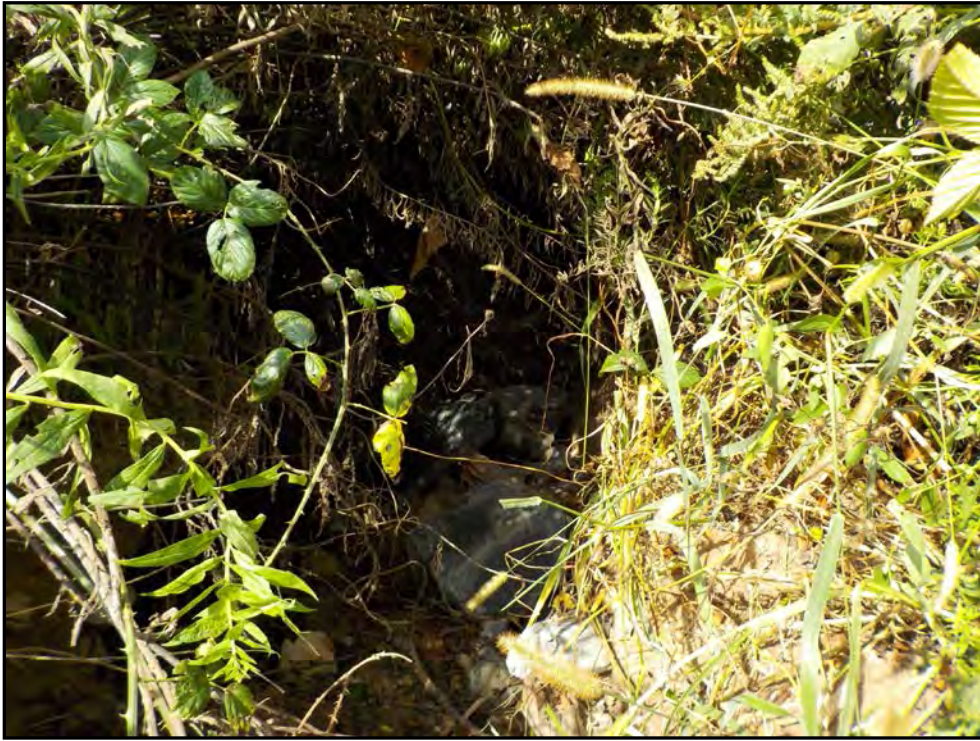
Farm field east of UT2-2 – Headcut

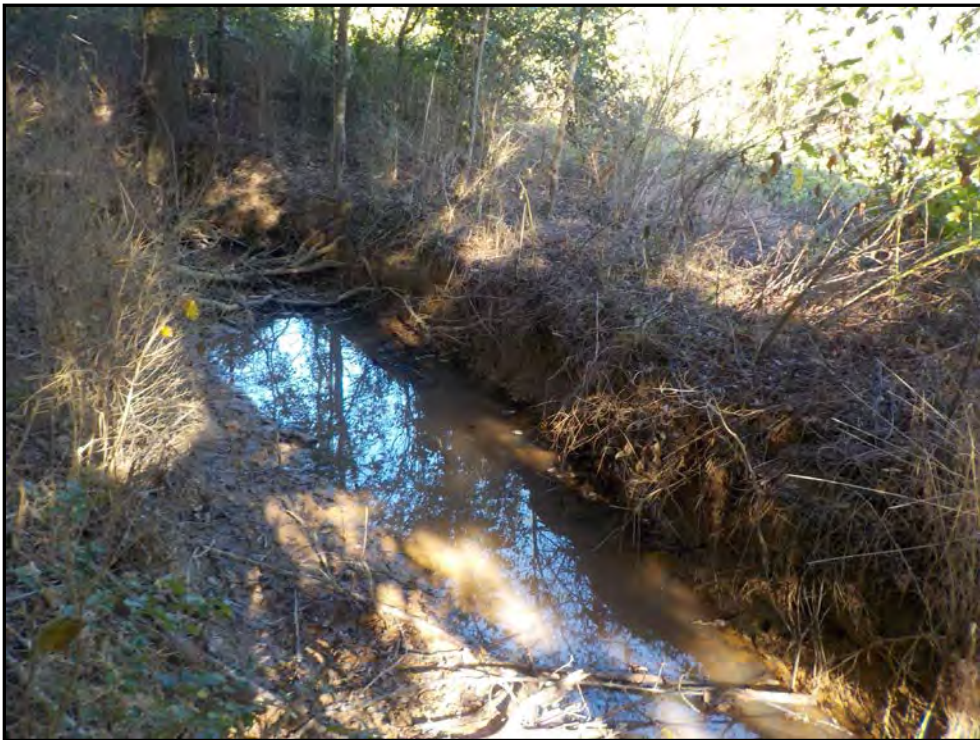
UT1-1 – Left and Right Bank Erosion

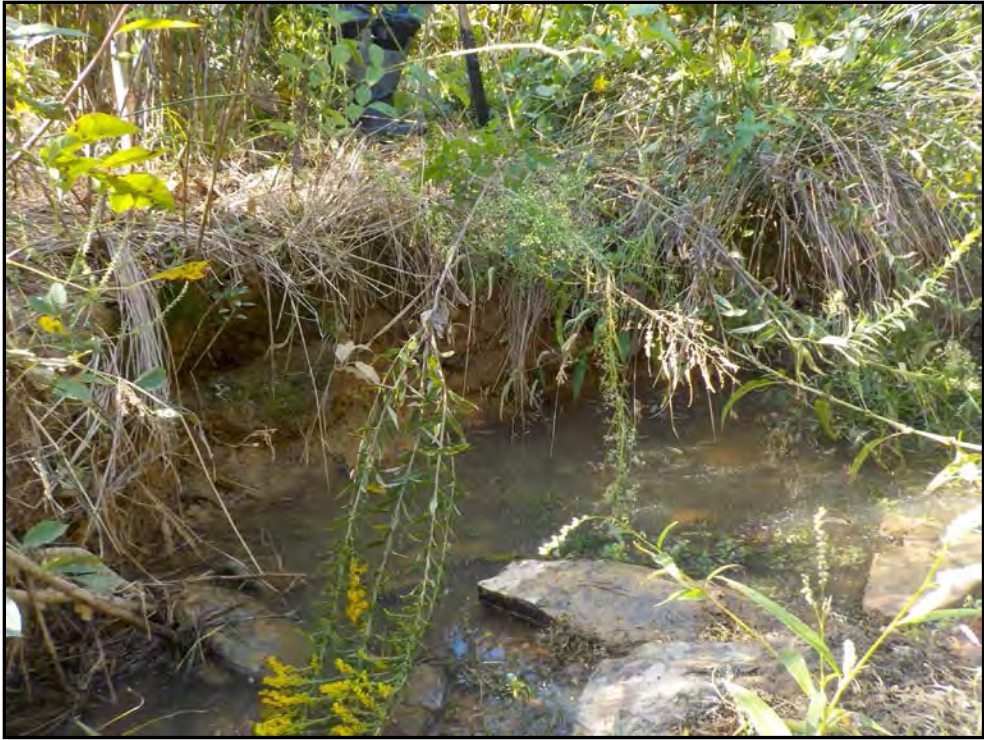
UT1-C – Right Bank Erosion

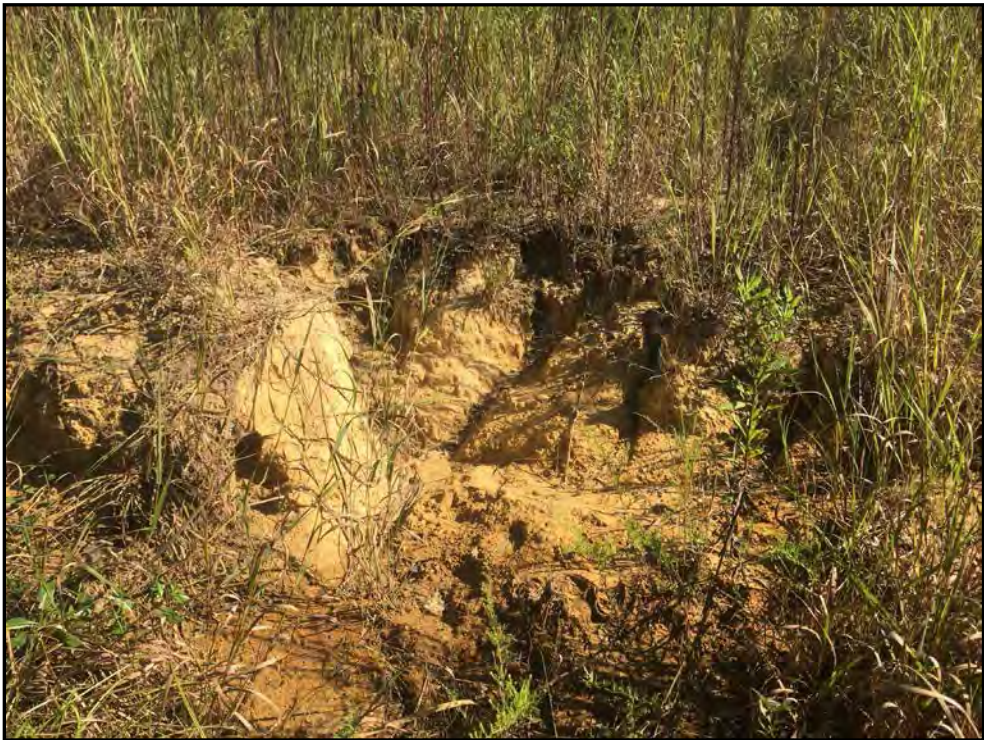
UT1-2 – Left Bank Erosion

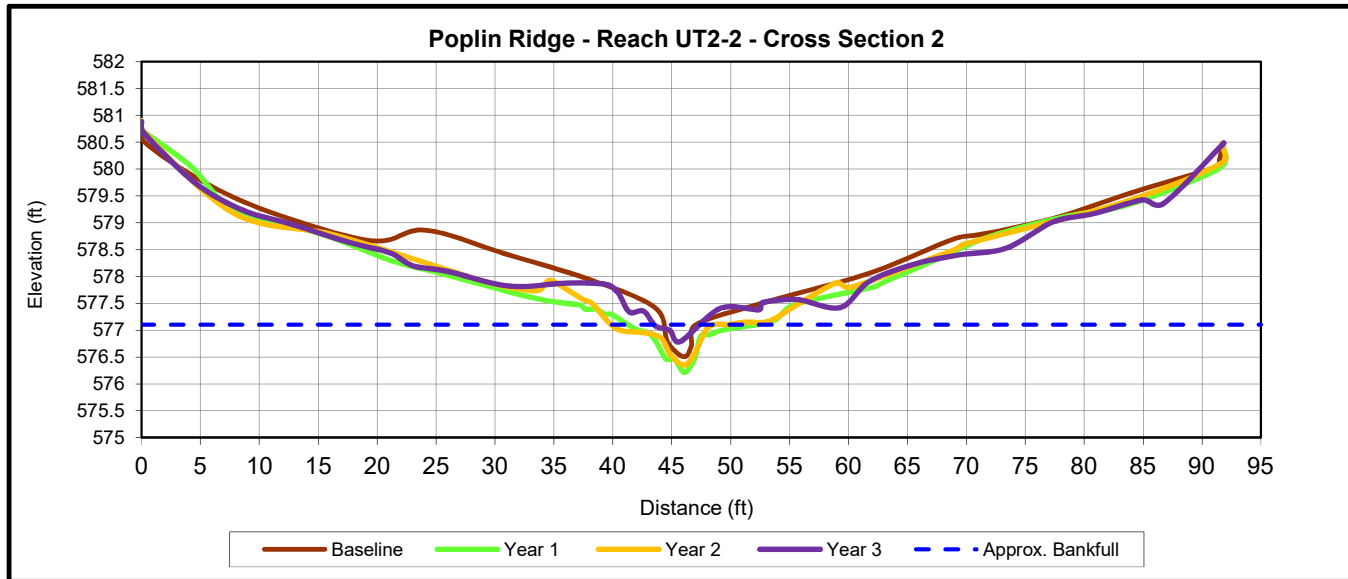
Cross Section 2						
Based on fixed baseline bankfull elevation	Base	MY1	MY2	MY3	MY5	MY7	MY+
Record elevation (datum) used	577.1	577.1	577.1	577.1			
Bankfull Width (ft)	3.0	5.6	5.3	3.9			
Floodprone Width (ft)	>15.2	>15.2	>15.2	11.2			
Bankfull Mean Depth (ft)	0.4	0.5	0.4	0.1			
Bankfull Max Depth (ft)	0.6	1.3	0.8	0.3			
Bankfull Cross Sectional Area (ft ²)	1.1	2.7	2.2	0.5			
Bankfull Width/Depth Ratio	7.9	11.5	12.5	28.8			
Bankfull Entrenchment Ratio	>2.2	>2.7	>2.9	2.9			
Bankfull Bank Height Ratio	1.0	1.0	1.0	2.0

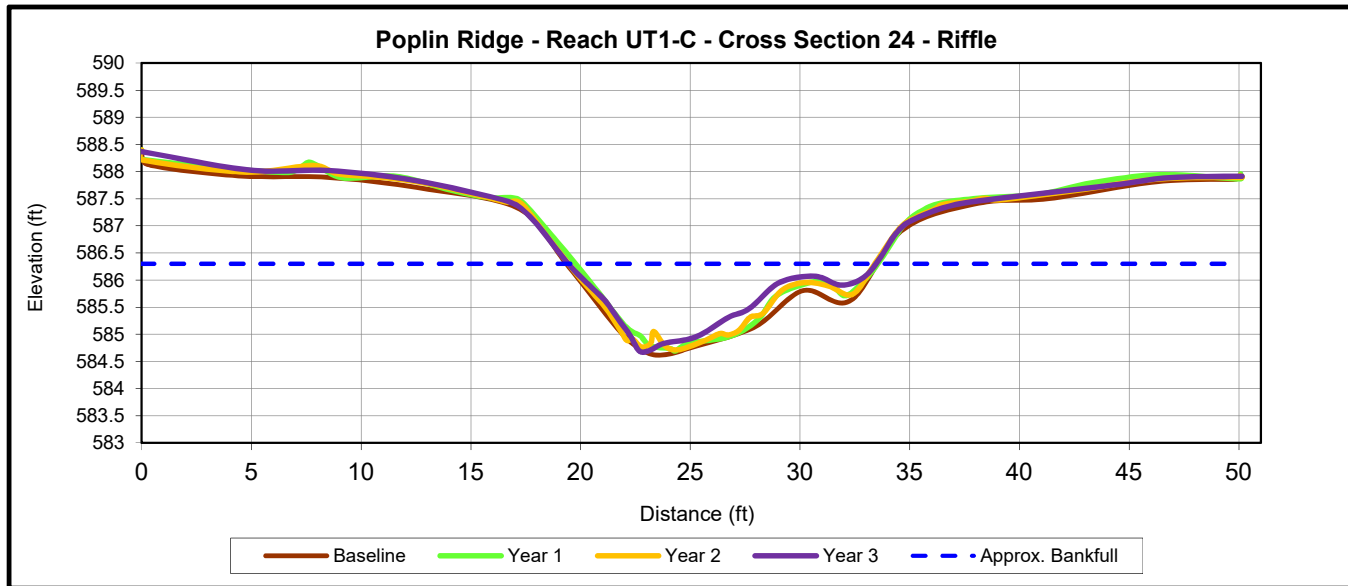
Cross Section 24 (Riffle)						
Based on fixed baseline bankfull elevation	Base	MY1	MY2	MY3	MY5	MY7	MY+
Record elevation (datum) used	586.3	586.3	586.3	586.3			
Bankfull Width (ft)	14.2	13.8	14.0	14.0			
Floodprone Width (ft)	>46.6	>46.6	>46.6	38.0			
Bankfull Mean Depth (ft)	1.0	0.9	0.9	0.8			
Bankfull Max Depth (ft)	1.7	1.6	1.6	1.6			
Bankfull Cross Sectional Area (ft ²)	14.0	12.2	12.4	10.8			
Bankfull Width/Depth Ratio	14.3	15.6	15.7	18.1			
Bankfull Entrenchment Ratio	>2.2	>3.4	>3.3	2.7			
Bankfull Bank Height Ratio	1.0	1.0	1.0	1.5
