# **Annual Monitoring Report**

Monitoring Year 4 of 7

Poplin Ridge Stream Restoration Project

NCDMS Project No.: 95359

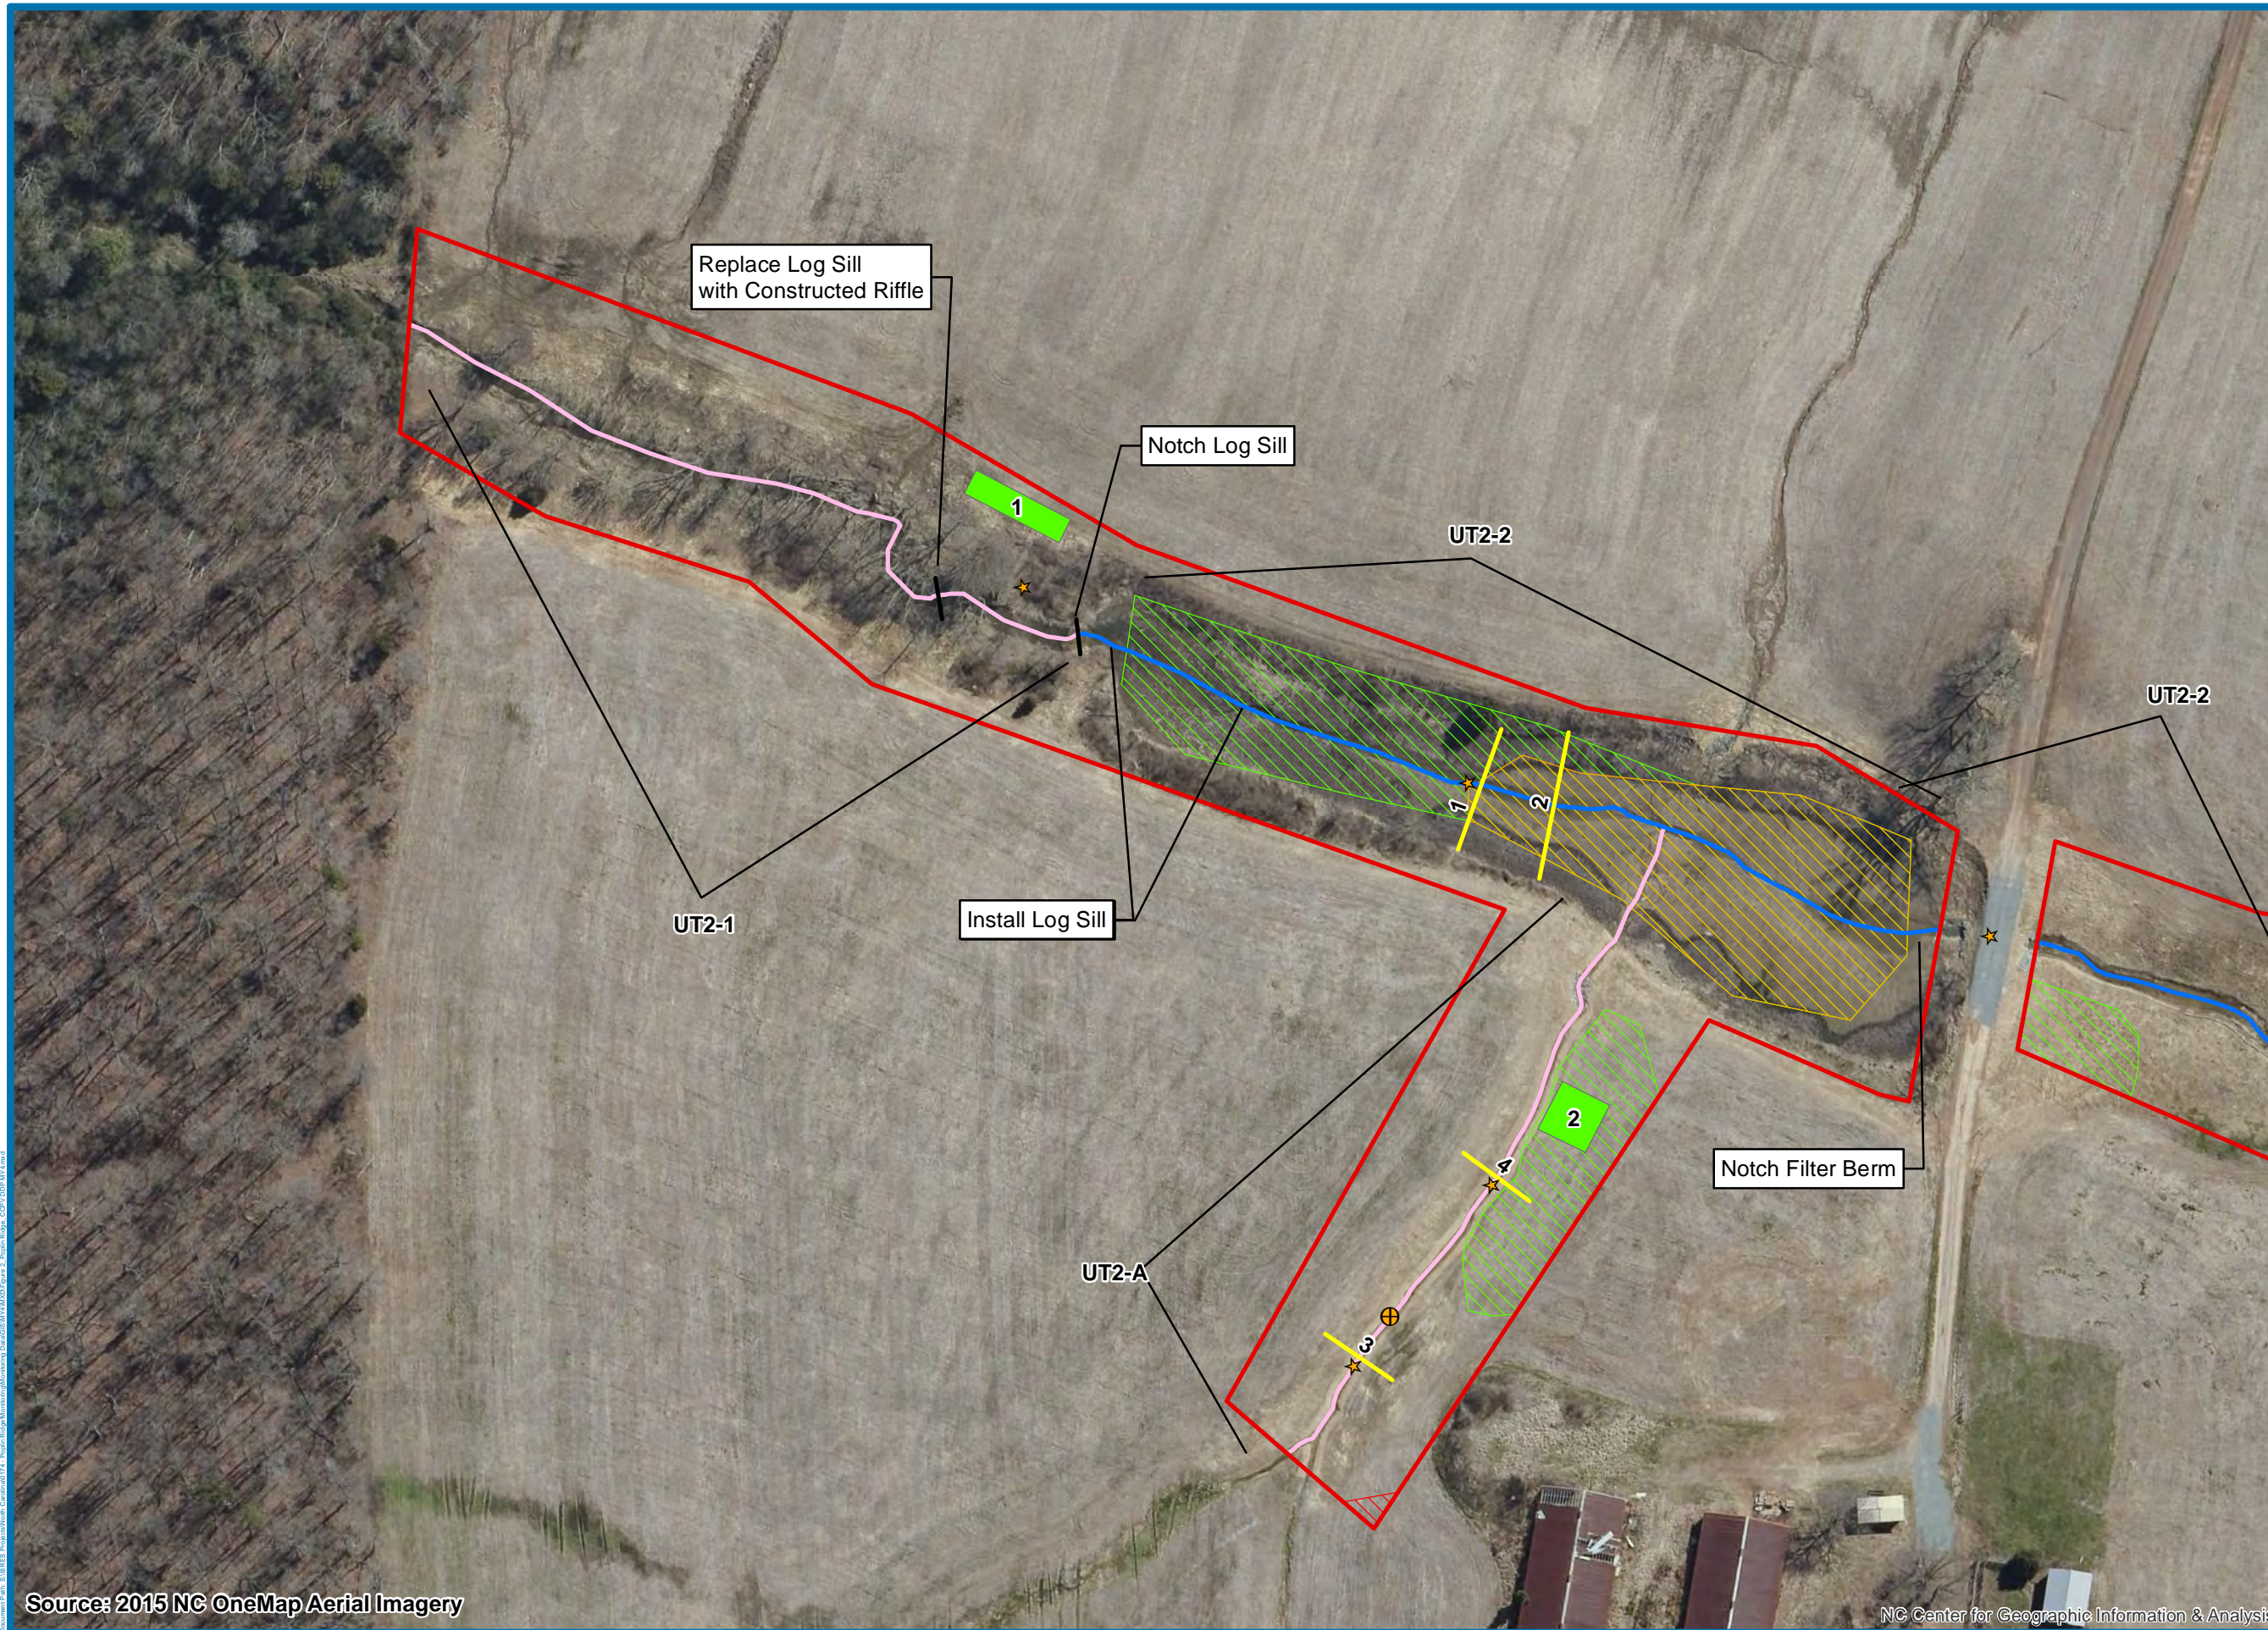
**Figure 2**  
6  
**Poplin Ridge Stream Restoration Project**  
MY4 2018  
**Current Conditions**  
Plan View

**Section 1.4.1 -Vegetation & CCPV Maps:** This section reports that areas were replanted in February 2018 and one (1) area of conservation easement encroachment was observed. Please clearly identify and label the replanted areas on the MY4 CCPV maps. Please add a legend label to the CCPV map for the small encroachment area (Figure 2 (6)).

The replant areas have been labeled on the CCPV and the legend label for the encroachment area is in the “Vegetation Condition Assessment” in the bottom right corner of the map.

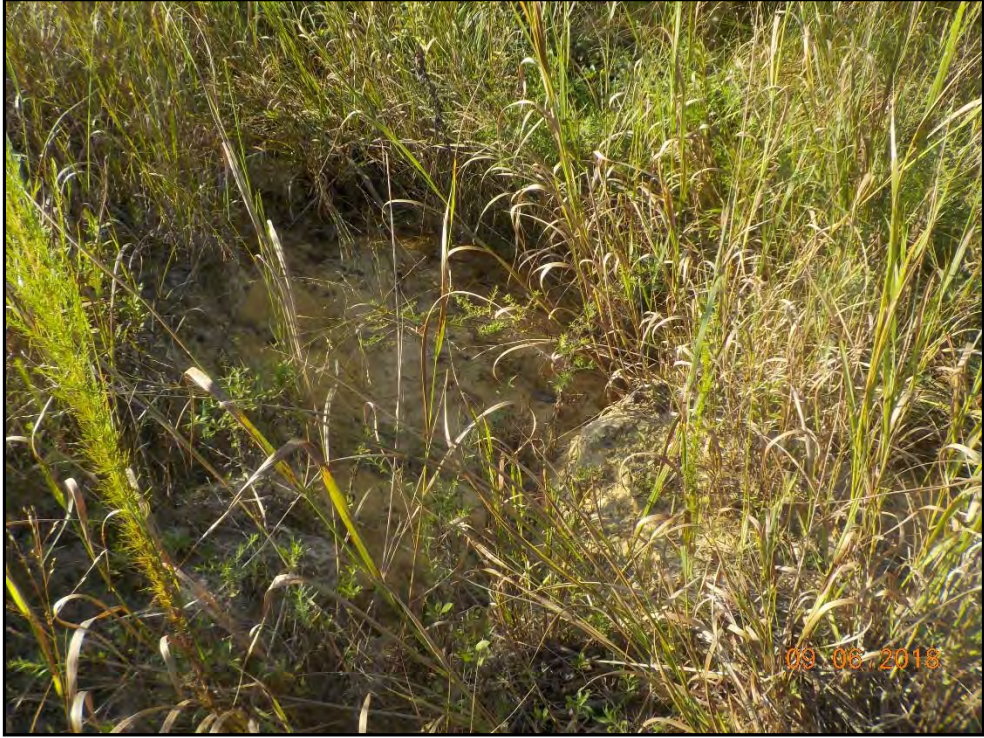
UT1-2 – Left Bank Headcut

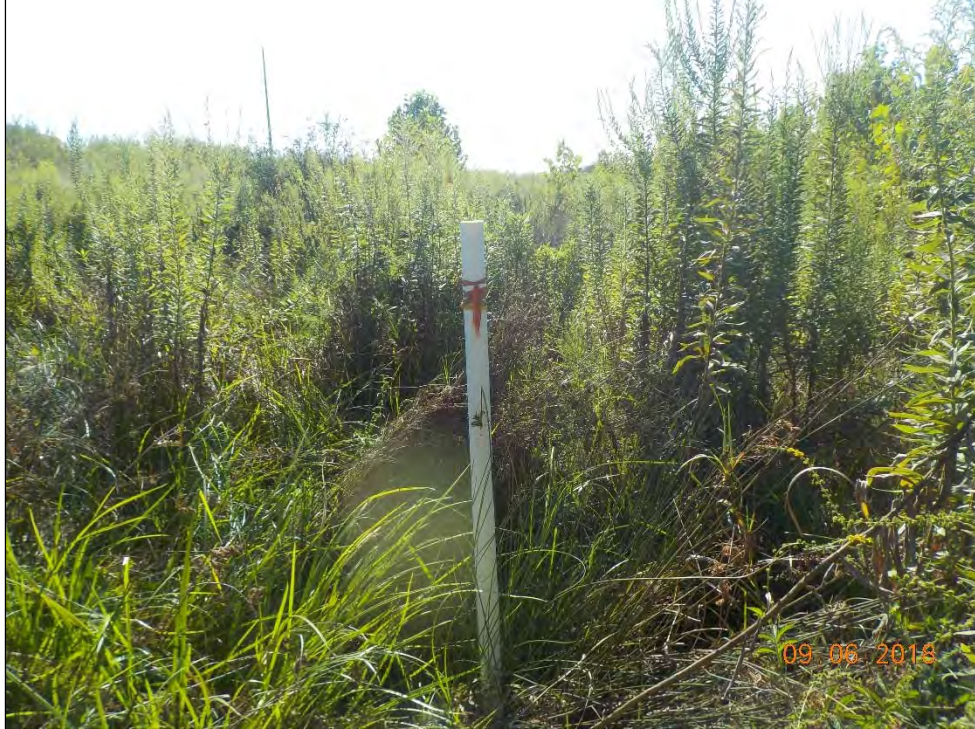
Poplin Ridge - Vegetation Monitoring Plot 9

Monitoring of 13 permanent vegetation plots was completed in September 2018. Summary tables and photographs associated with MY4 monitoring can be found in **Appendix C**. With the exception of Plots 9 and 10, MY4 monitoring data indicates that all vegetation monitoring plots met the MY5 interim success criteria of 260 planted stems per acre. Planted stem densities among the plots ranged from 40 to 1,052 planted stems per acre with a mean of 595 stems per acre across all plots. When volunteer stems are included, densities ranged between 121 and 1,578 total stems per acre with a mean of 672 stems per acre across all plots. A total of 19 plant species were documented within the monitoring plots. The estimated average planted stem height was 6.8 feet. Low stem densities in plots 9 and 10 are likely attributed to a combination of dry conditions and shallow, rocky soil. The areas in and around these plots were replanted in early 2018 but the replanted stems did not survive.

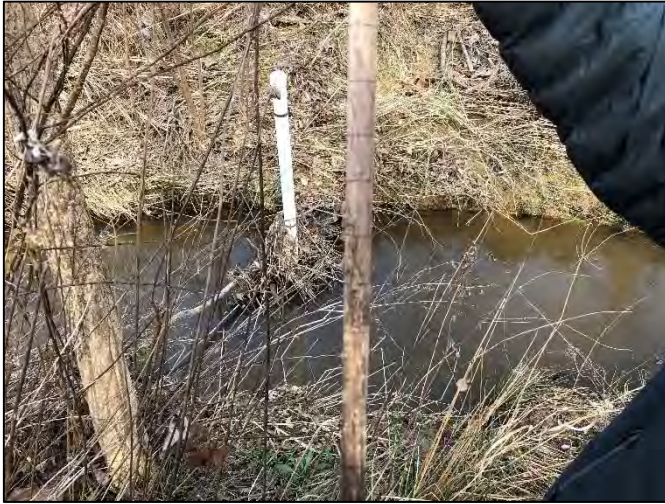
Crest Gauge @ UT1-2 – 0.95 ft. (Est. Date of Occurrence: 9/16/2018)

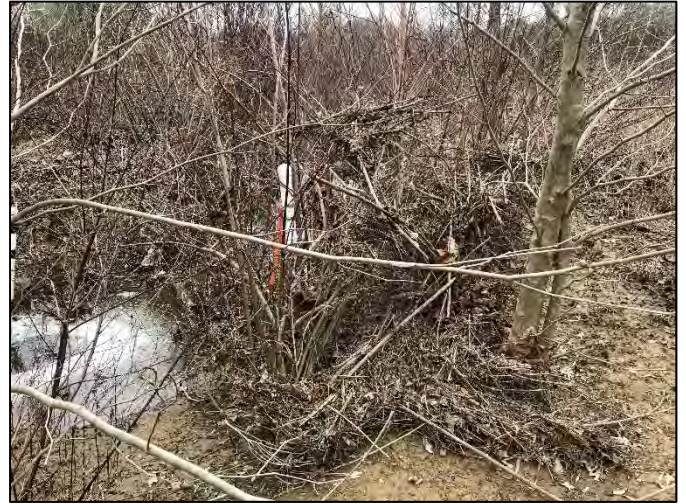
Crest Gauge @ UT1-4 – 4.86 ft. (Est. Date of Occurrence: 9/16/2018)

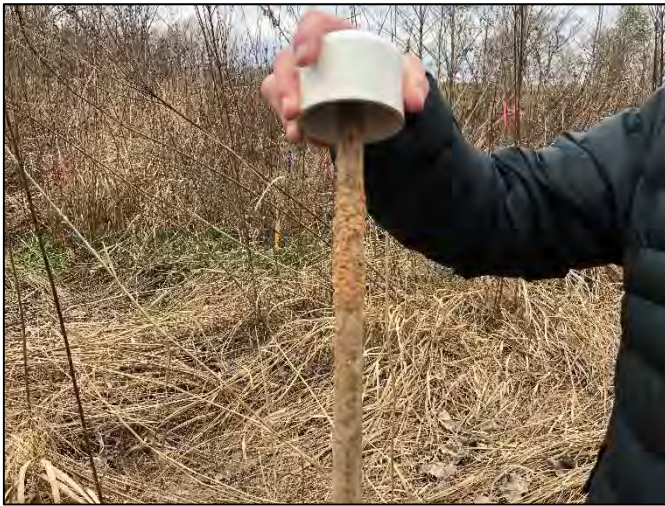
Crest Gauge @ UT2-3 – 3.70 ft. (Est. Date of Occurrence: 9/16/2018)
