Annual Monitoring Report

Monitoring Year 5 of 7

Poplin Ridge Stream Restoration Project

NCDMS Project No.: 95359

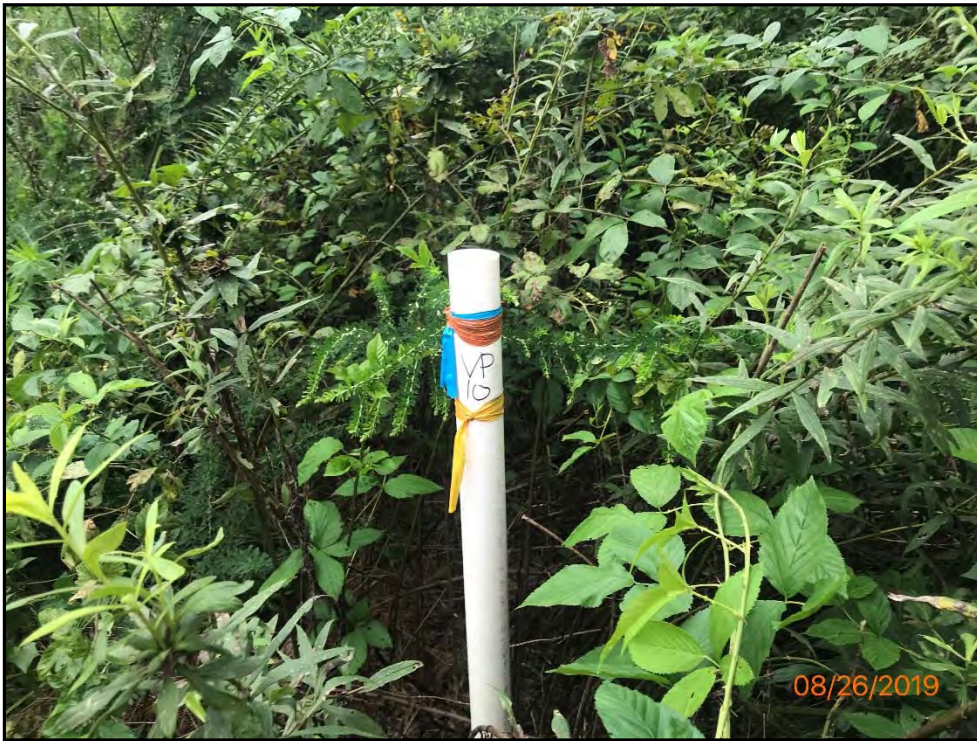
Monitoring of 13 permanent vegetation plots was completed in late August 2019. Summary tables and photographs associated with MY5 monitoring can be found in **Appendix C**. With the exception of Plots 9 and 10, MY5 monitoring data indicates that all vegetation monitoring plots met the MY5 interim success criteria of 260 planted stems per acre. Planted stem densities among the plots ranged from 40 to 931 planted stems per acre with a mean of 576 stems per acre across all plots. When volunteer stems are included, densities ranged between 40 and 1,578 total stems per acre with a mean of 669 stems per acre across all plots. A total of 19 plant species were documented within the monitoring plots. The average planted stem height in plots was 9.3 feet. Low stem densities in plots 9 and 10 are likely attributed to a combination of dry conditions and shallow, rocky soil. The areas in and around these plots were replanted in early 2018 but the replanted stems did not survive.

Low Stem Density Area (VP10)

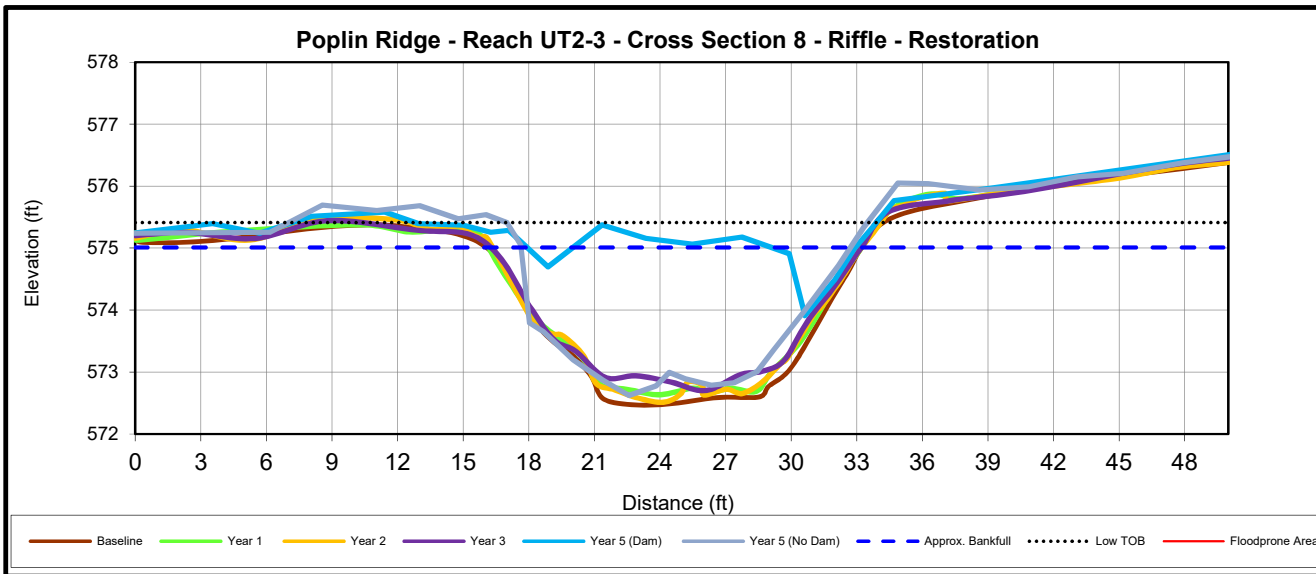
After Dam Removal

This section also notes a beaver pond/ beaver dam on UT2-4. Cross section 8 indicates that the beaver dam has been removed. Please confirm in the revised report and indicate the date removed. If not removed, the beaver dam location should also be shown on the CCPV sheets. DMS recommends removing beaver dams as soon as possible to avoid potential project damage and additional maintenance.

Dimension	Cross Section 8 (Riffle)						
	Base	MY1	MY2	MY3	MY5	MY7	MY+
Bankfull Elevation (ft) - Based on AB-XSA ¹	575.01	575.01	575.01	575.01	575.34		
Bankfull Width (ft) ¹	17.4	17.1	16.9	17.2	16.2		
Floodprone Width (ft) ¹	>50.0	>50.0	>50.0	>50.0	>50.2		
Bankfull Mean Depth (ft)	1.8	1.7	1.7	1.6	---		
Bankfull Max Depth (ft) ²	2.5	2.4	2.5	2.3	2.8		
Low Bank Elevation (ft)	-	-	-	-	575.41		
Bankfull Cross Sectional Area (ft ²) ²	30.8	28.4	28.5	26.7	32.0		
Bankfull Width/Depth Ratio	9.8	10.3	10.0	11.0	---		
Bankfull Entrenchment Ratio ¹	>2.2	>2.9	>3.0	>2.9	>3.1		
Bankfull Bank Height Ratio ¹	1.0	1.0	1.0	1.1	1.0
