Annual Monitoring Report

Monitoring Year 6 of 7

Poplin Ridge Stream Restoration Project

NCDMS Contract No.: 004672

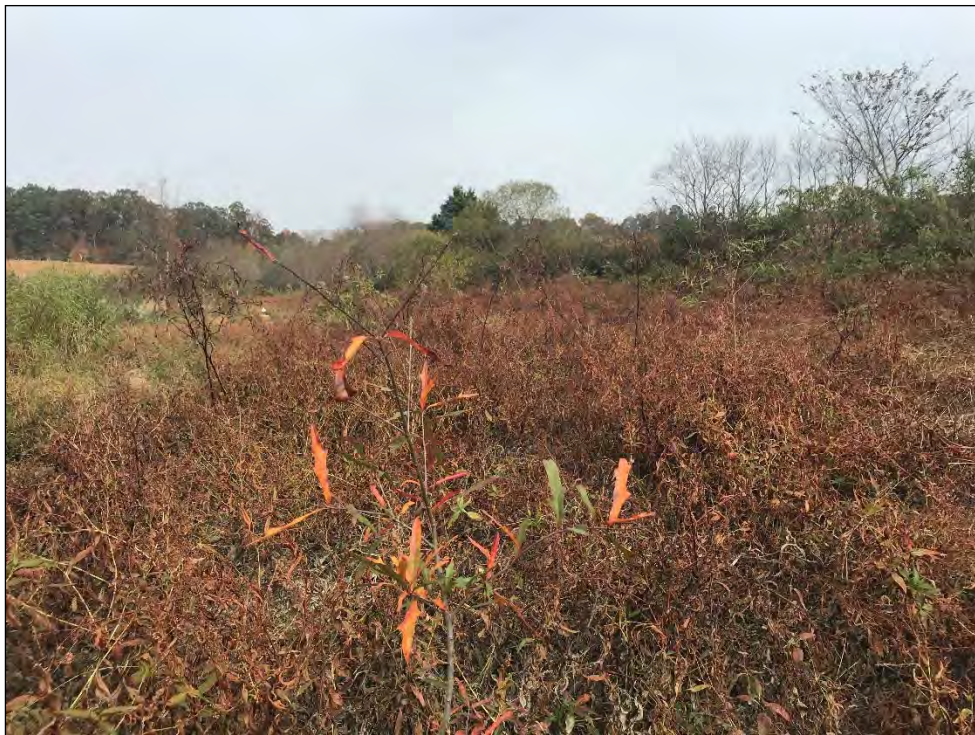
Poplin Ridge – Random Vegetation Monitoring Plot 2

Monitoring of 13 permanent vegetation plots was completed in November 2020. Summary tables and photographs associated with MY6 monitoring can be found in **Appendix C**. MY6 monitoring data indicates that all vegetation monitoring plots met the MY6 interim success criteria of 210 planted stems per acre. Planted stem densities among the plots ranged from 243 to 890 planted stems per acre with a mean of 607 stems per acre across all plots. When volunteer stems are included, densities ranged between 243 and 1,497 total stems per acre with a mean of 750 stems per acre across all plots. A total of 15 plant species were documented within the monitoring plots. The average planted stem height in plots was 11.5 feet. The data from the two random vegetation plots in the pond bottom repair area showed 283 stems per acre in Random Plot 1 and 202 stems per acre in Random Plot 2. The average stem heights were 6.3 and 5.9 feet, respectively.

Random Plot 2		
#	Common Name	Height (cm)
1	Willow Oak	170
2	Black Willow	175
3	Willow Oak	160
4	Black Willow	180
5	Black Willow	220
Stems/Acre	202	
Average Height (cm)	181	
Average Height (ft)	5.9	
Plot Size (m)	25 x 4

Visual assessment of the site indicates that herbaceous vegetation has become well established on-site. RES replanted the MY5 low stem density areas as well as the pond bottom in April 2020. The invasive species treatments were performed in October and November 2020 and will continue as needed throughout the monitoring period. In December 2020, RES inspected the entire easement boundary and replaced all missing easement signage. There was no easement encroachment observed. RES plans to supplemental plant the area in and around Random Plot 2 (0.20 acres) this dormant season.

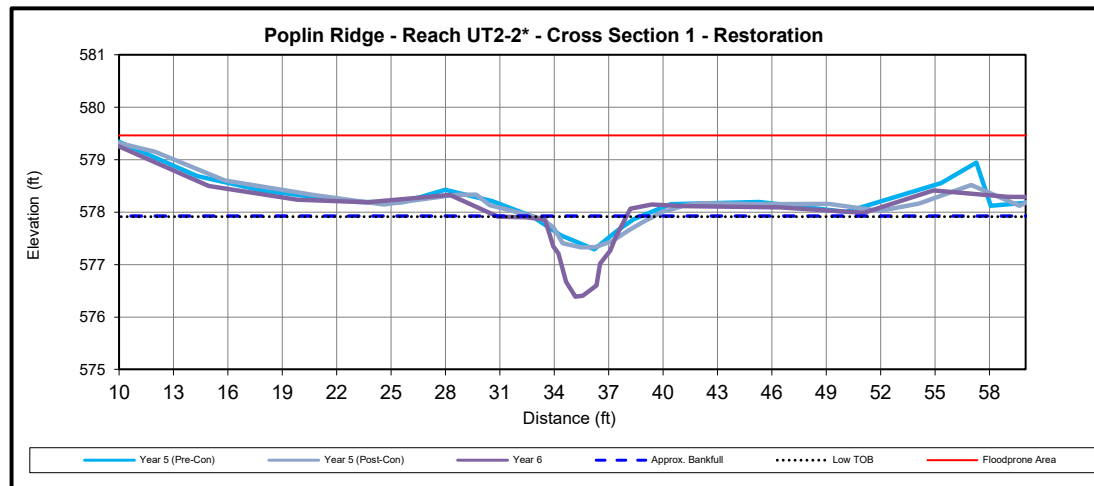
Dimension	Cross Section 1							
	Base	MY1	MY2	MY3	MY5	MY6	MY7	MY+
Bankfull Elevation (ft) - Based on AB-XSA ¹	577.24	577.24	577.24	577.24	578.14	577.93		
Bankfull Width (ft) ¹	3.2	5.5	5.2	4.3	10.8	5.5		
Floodprone Width (ft) ¹	>17.2	>17.2	>17.2	26.2	52.4	65.6		
Bankfull Mean Depth (ft)	0.5	0.7	0.6	0.3	---	---		
Bankfull Max Depth (ft) ²	0.9	1.4	1.1	0.5	0.8	1.5		
Low Bank Elevation (ft)	-	-	-	-	578.14	577.91		
Bankfull Cross Sectional Area (ft ²) ²	0.6	3.7	3.3	1.1	4.2	4.1		
Bankfull Width/Depth Ratio	6.4	8.2	8.1	16.7	---	---		
Bankfull Entrenchment Ratio ³	>2.2	>3.1	>3.3	6.0	4.8	14.2		
Bankfull Bank Height Ratio ¹	1.0	1.0	1.0	1.3	1.0	1.0

*Reach UT2-2 was reconstructed in September 2019

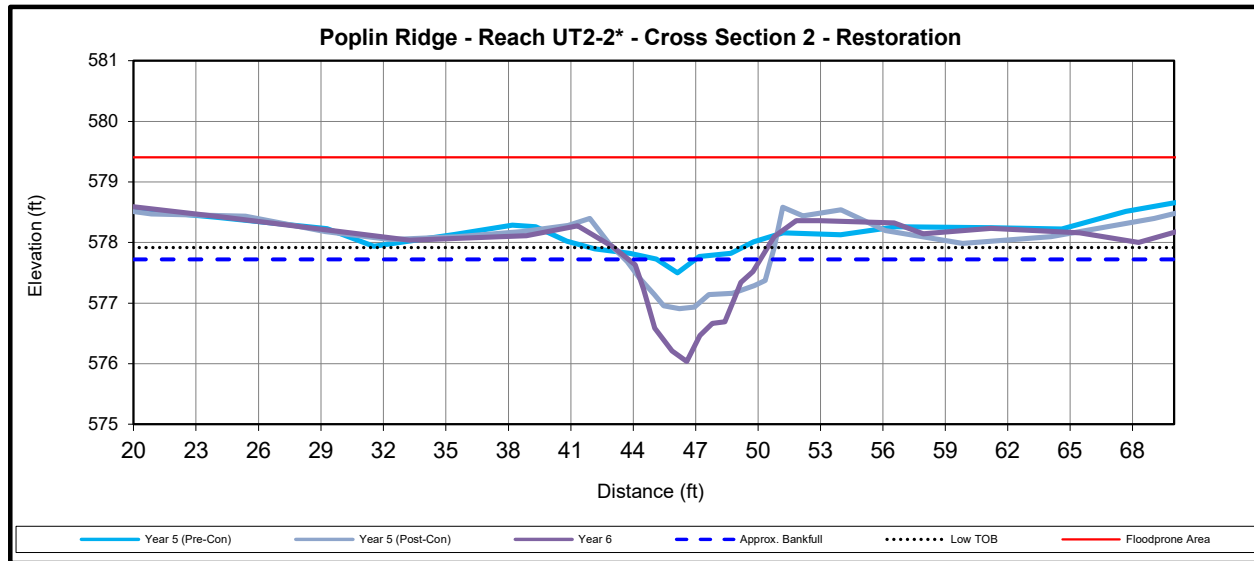
Dimension	Cross Section 2							
	Base	MY1	MY2	MY3	MY5	MY6	MY7	MY+
Bankfull Elevation (ft) - Based on AB-XSA ¹	577.10	577.10	577.10	577.10	577.99	577.72		
Bankfull Width (ft) ¹	3.0	5.6	5.3	3.9	8.0	6.3		
Floodprone Width (ft) ¹	>15.2	>15.2	>15.2	11.2	66.2	78.8		
Bankfull Mean Depth (ft)	0.4	0.5	0.4	0.1	---	---		
Bankfull Max Depth (ft) ²	0.6	1.3	0.8	0.3	1.1	2.2		
Low Bank Elevation (ft)	-	-	-	-	577.99	578.28		
Bankfull Cross Sectional Area (ft ²) ²	1.1	2.7	2.2	0.5	5.8	10.3		
Bankfull Width/Depth Ratio	7.9	11.5	12.5	28.8	---	---		
Bankfull Entrenchment Ratio ¹	>2.2	>2.7	>2.9	2.9	8.3	14.5		
Bankfull Bank Height Ratio ¹	1.0	1.0	1.0	2.0	1.0	1.3

*Reach UT2-2 was reconstructed in September 2019

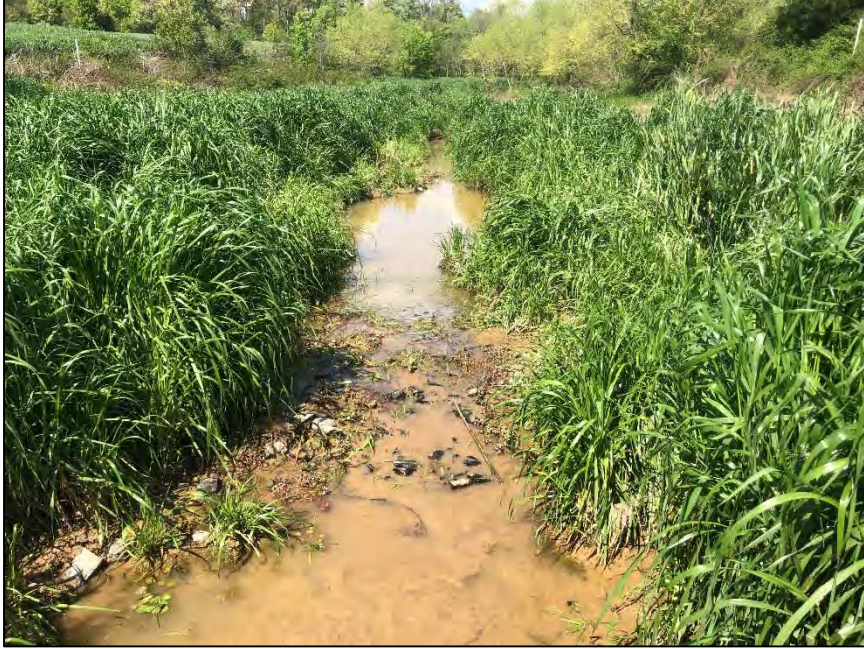
Constructed riffle looking upstream

Method: Dimension/Profile Grading and Structure Installation as proposed in the 2019 Adaptive Management Plan. Installed structures are shown on the attached map.

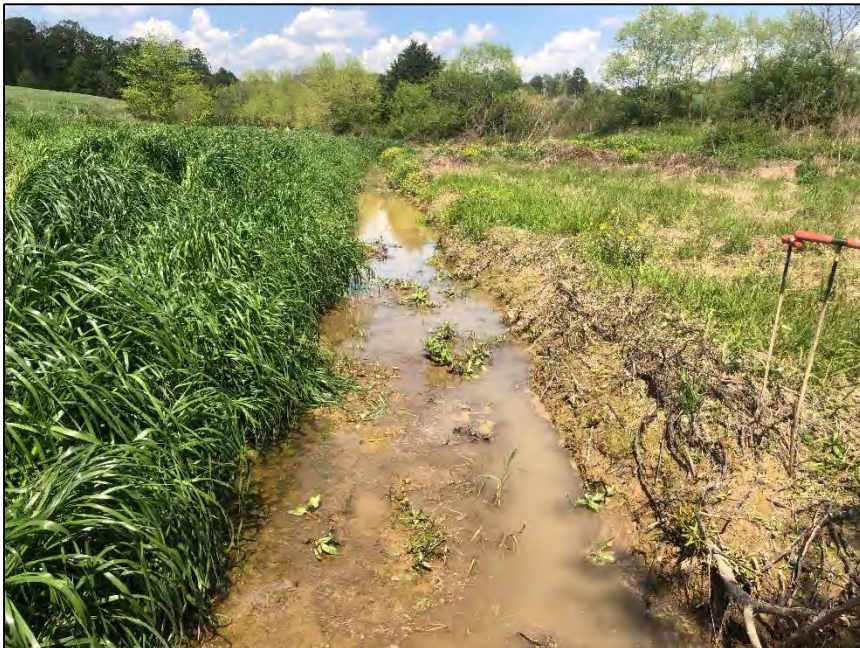
Livestakes on UT2-2 looking upstream

of Livestakes: 800

Species: Black willow, Buttonbush, and Cottonwood

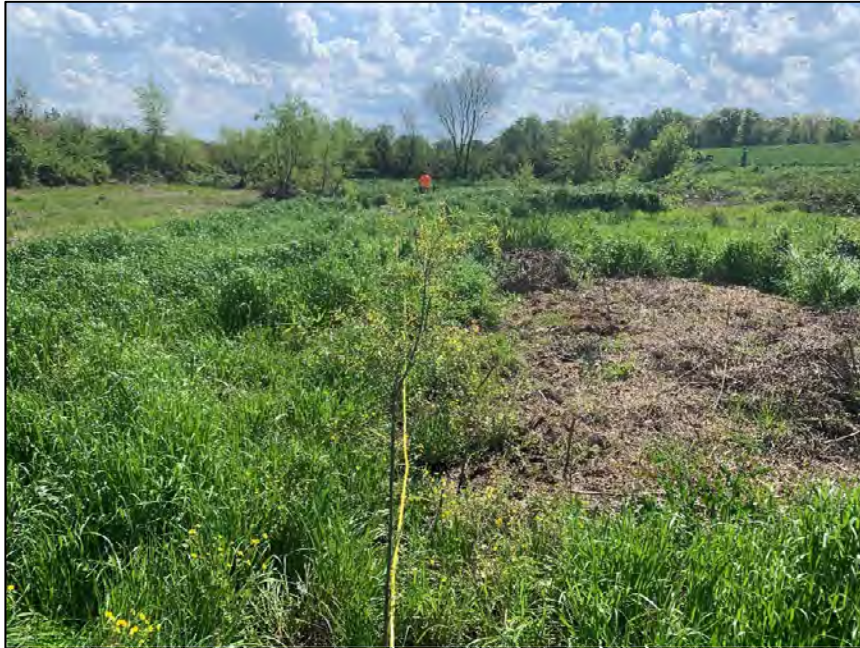
Random Vegetation Plot looking downstream

of Livestakes: 500

Species: Black willow, Buttonbush, and Cottonwood
