Pott Creek II Stream Restoration Project Year 1 Monitoring Report - 2005

November 23, 2005

**Mid - Atlantic
Mitigation, LLC
(AN EARTHMARK COMPANY)**

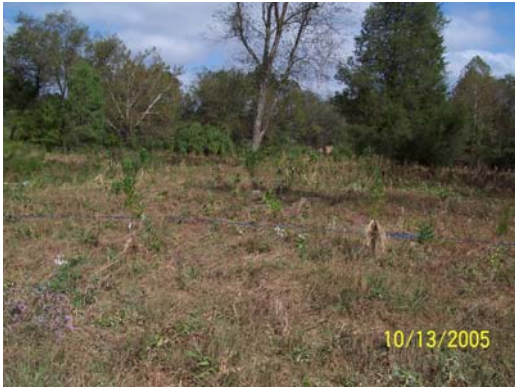
1 (Northeast)

Comments: Erosion at stream bank in plot, small piece of plot missing, may have lost some live stakes, area will be live staked again this winter

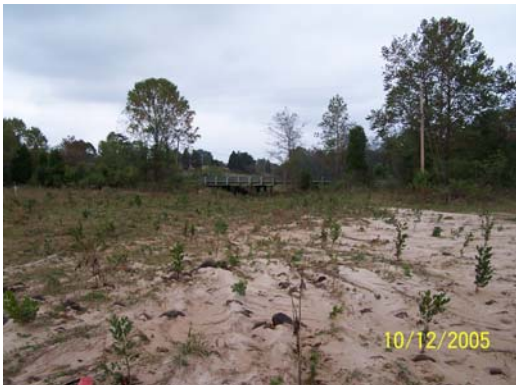
9 (North) Sand deposition, trees seem fine, herbaceous community will need time to recover.

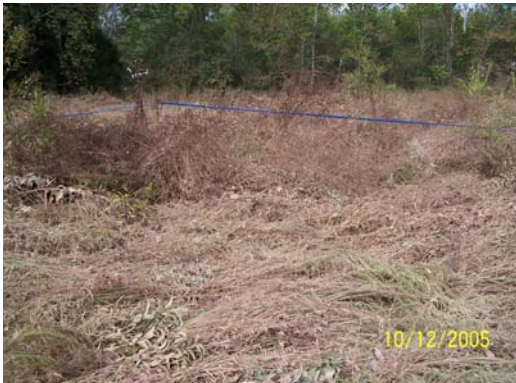
11 (Along Rhodes Mill North) This plot had the highest amount of herbaceous competition.

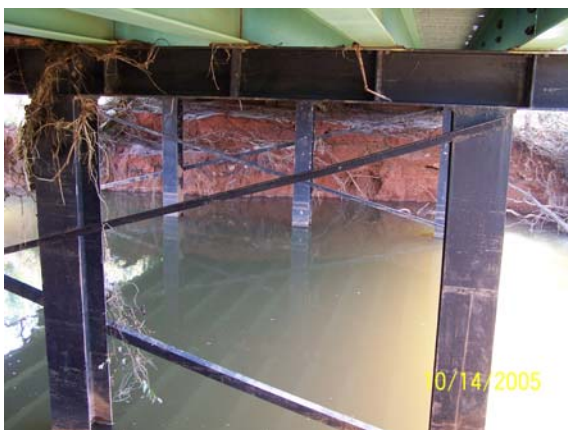
Debris hanging under bride.

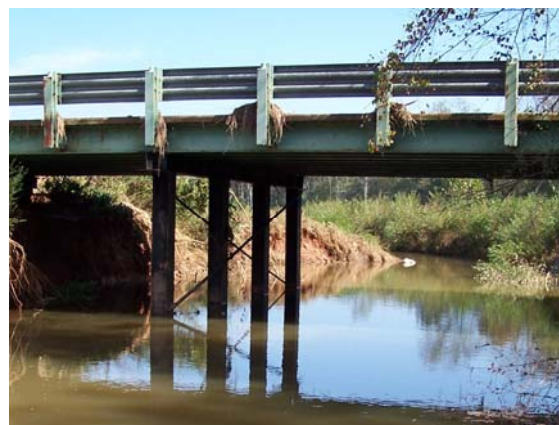
Debris hung on railings of the bridge.
