Pott Creek II Stream Restoration Project Year 2 Monitoring Report - 2006

October 31, 2006

**Mid - Atlantic
Mitigation, LLC
(AN EARTHMARK COMPANY)**

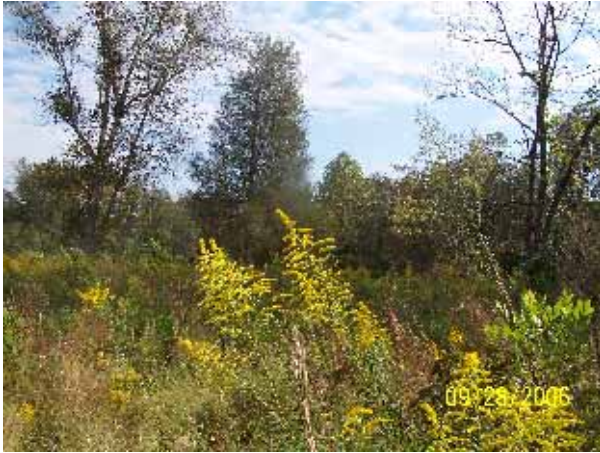
1 (Northeast)

Comments: Found some Rubus in this plot not very bad

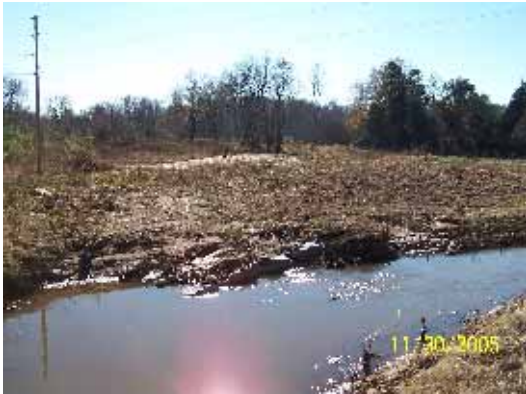
Silt deposition and minor scour at rock vane downstream of bridge.

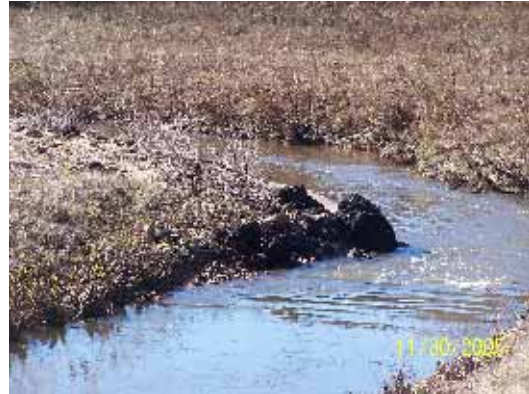
Clay chunks deposited on point inside meander bend.

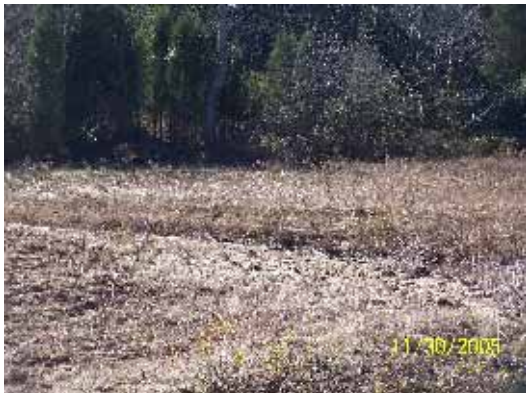
Rack line on meander bend.

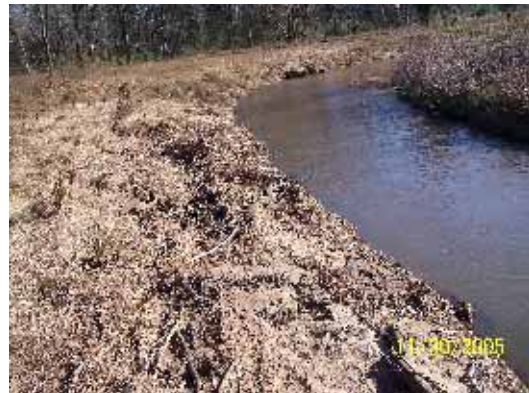
Sand deposition and rack line.

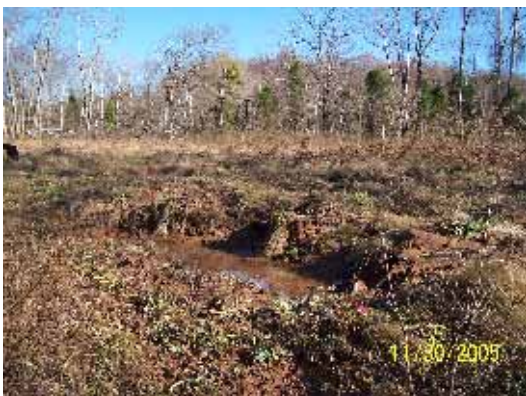
Small scour hole in flood plain with puddle.
