Pott Creek II Stream Restoration Project Year 3 Monitoring Report - 2007

**October 2007
Prepared By:**

**M i d - A t l a n t i c
M i t i g a t i o n , L L C**

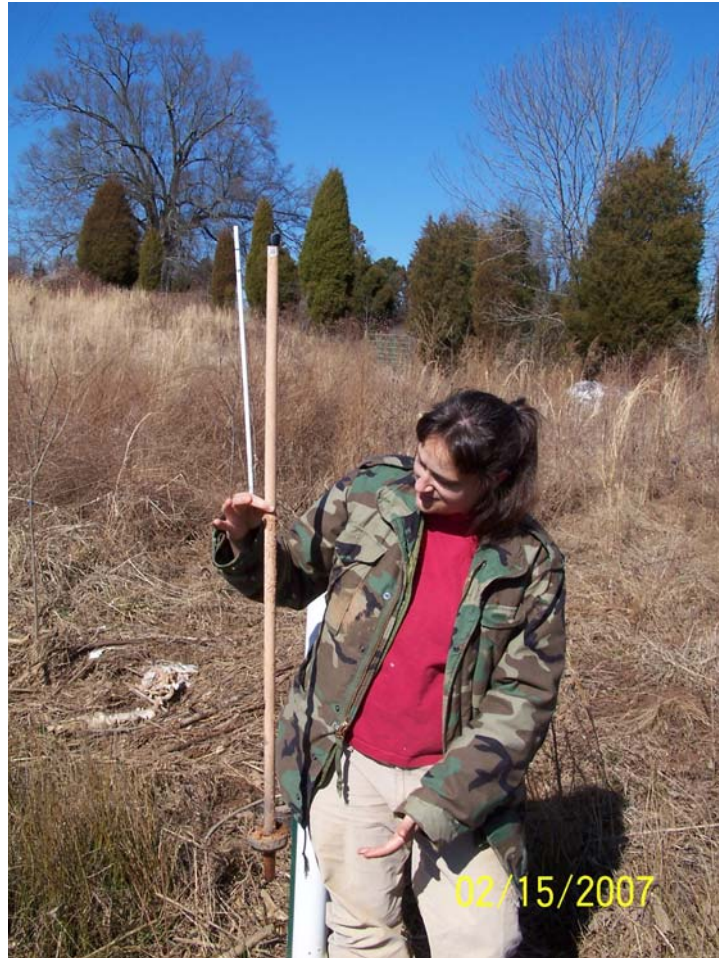
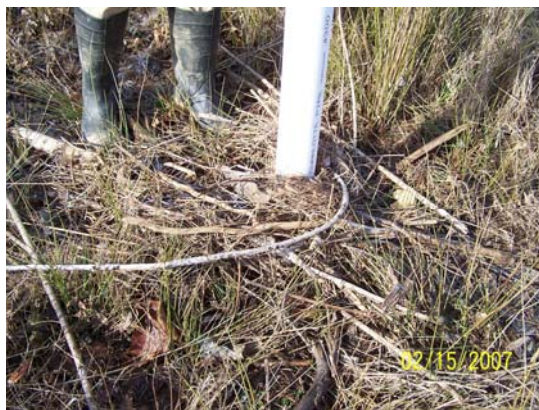
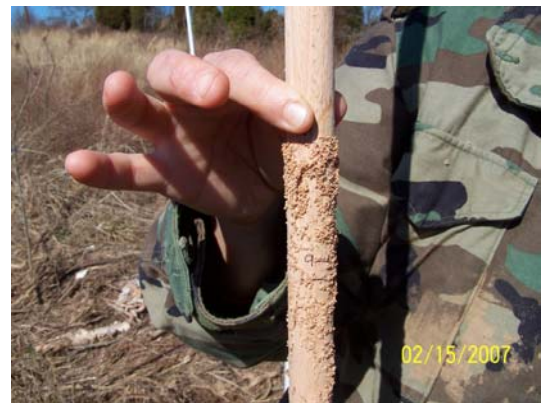
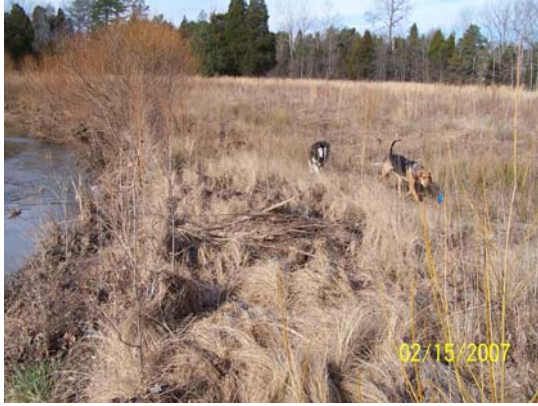
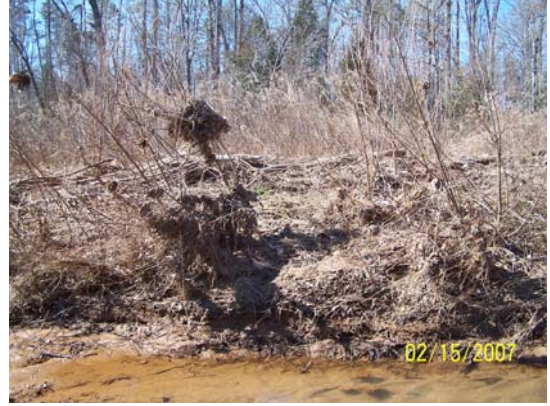
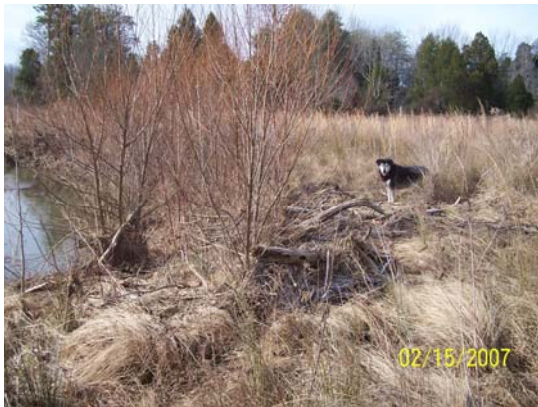
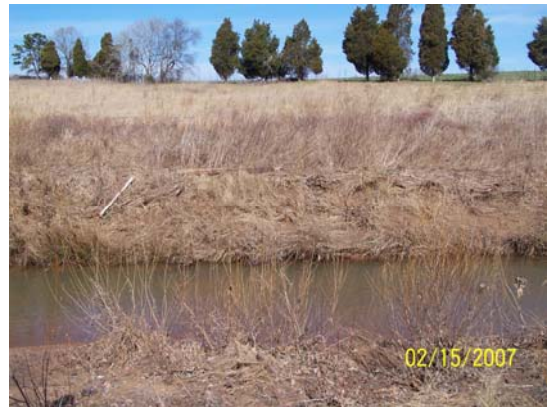
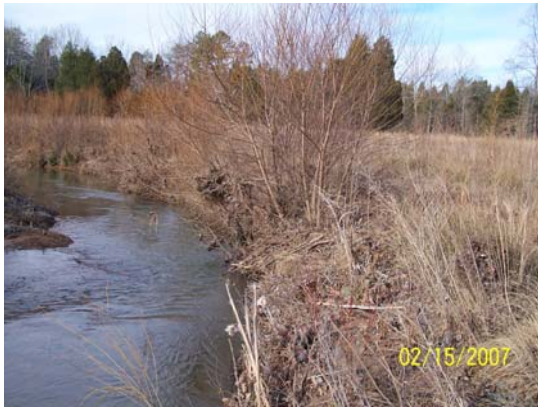
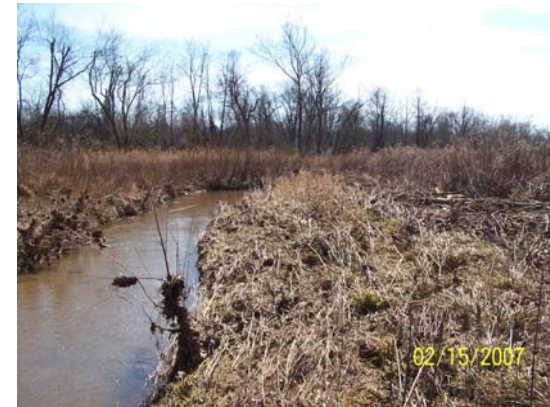
Bank Full Event February 15th, 2007

The site was visited and showed signs of over-bank flow, rack lines and drift debris, but no signs of severe damage or erosion caused by the event. The Crest Stage gage was checked on February 15, 2007 and documented a bank full event. According to rainfall data from both Lincoln and Hickory significant rainfall came through the area within 5 days of the site visit. A rainfall event immediately preceding the site visit on February 13th and 14th, 2007 generated approximately 1.5 inches of rain fall and a similar event was recorded by the SCO (State Climate Office) on January 1st, 2007 with an average of 1.25 inches of rainfall between the Lincoln and Hickory areas.
