Pott Creek II Stream Restoration Project Year 4 Monitoring Report - 2008

**November 2008
Prepared By:**

**Mid - Atlantic
Mitigation, LLC**

1.0 EXECUTIVE SUMMARY/PROJECT ABSTRACT

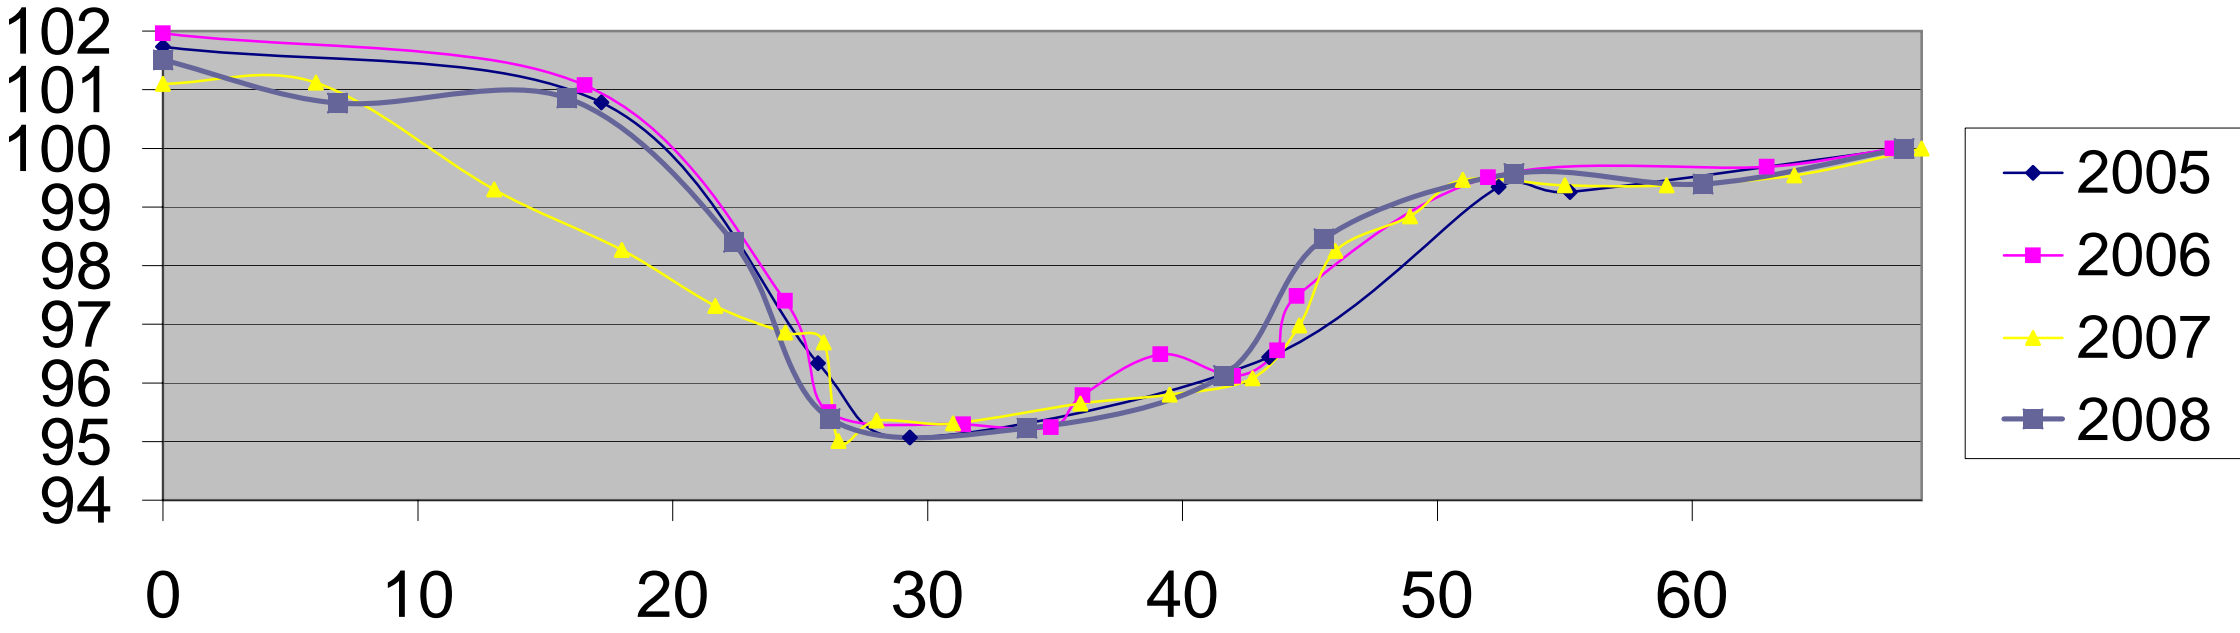
Pott Creek CS5 (Riffle)

Photos show this area as being well vegetated and stable. A sand bar has formed and stabilized with vegetation on the right side of the channel.

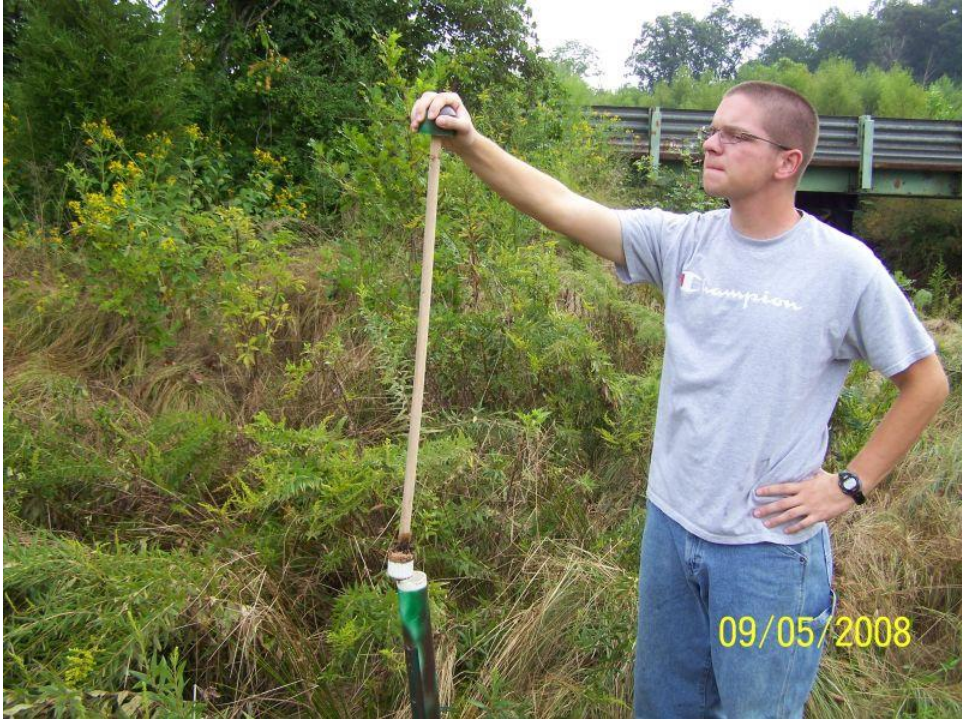
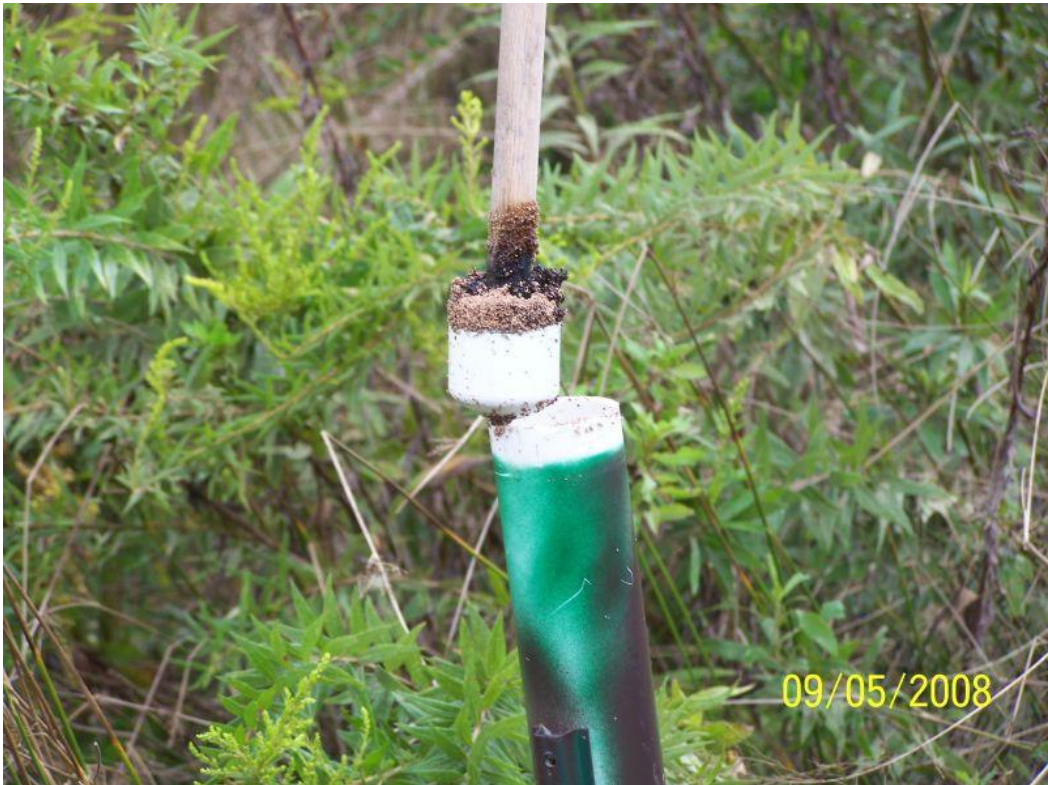
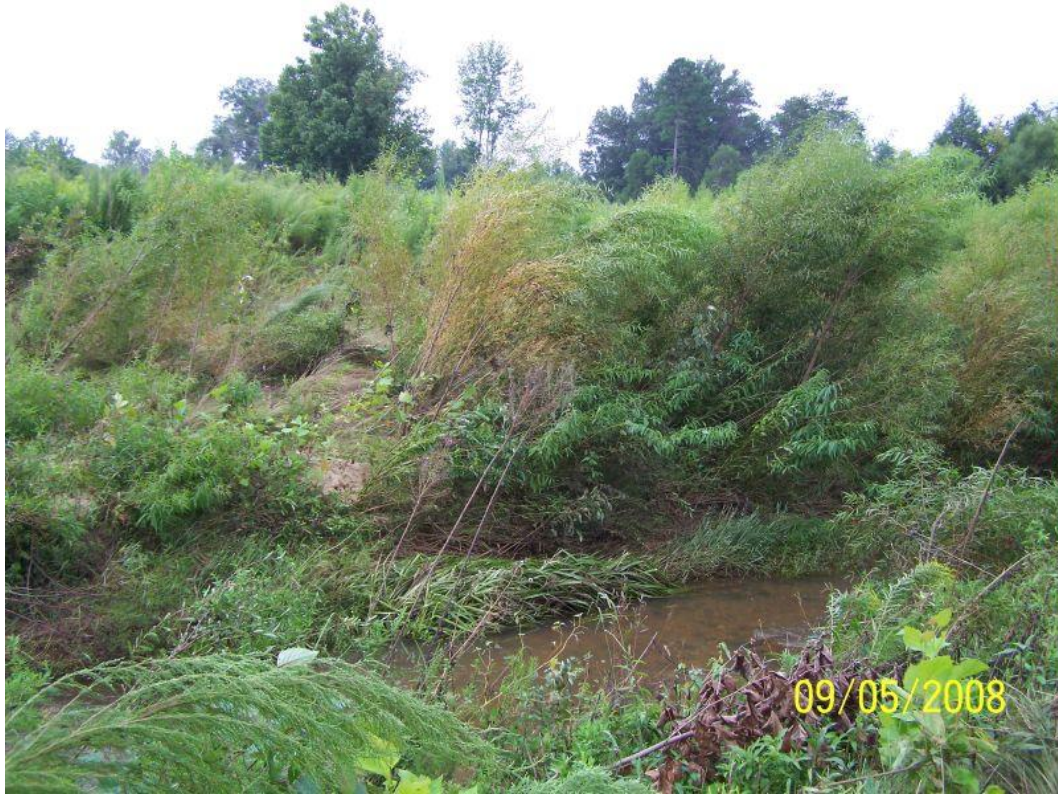
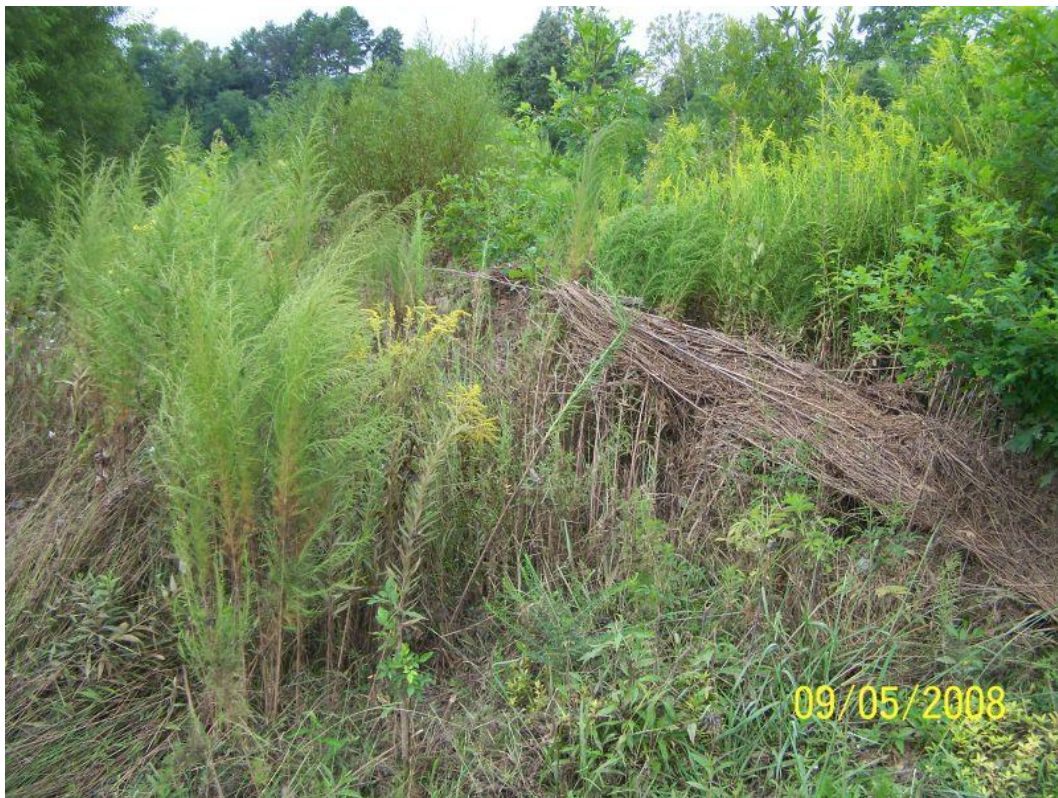
Bankfull Event documented September 5th, 2008, actual event was hurricane associated rainfall from August 25th through 28th when an excess of 14 inches fell in the Lincolnton area over a 4 day period.

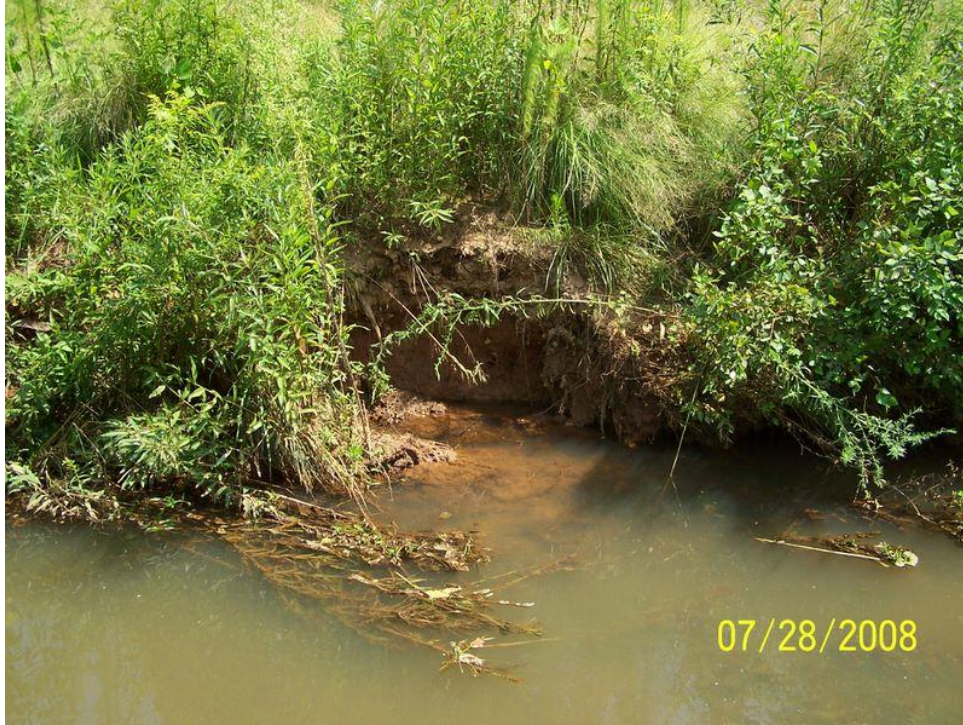
Small problem area near confluence of Pott Creek and Rhodes Mill

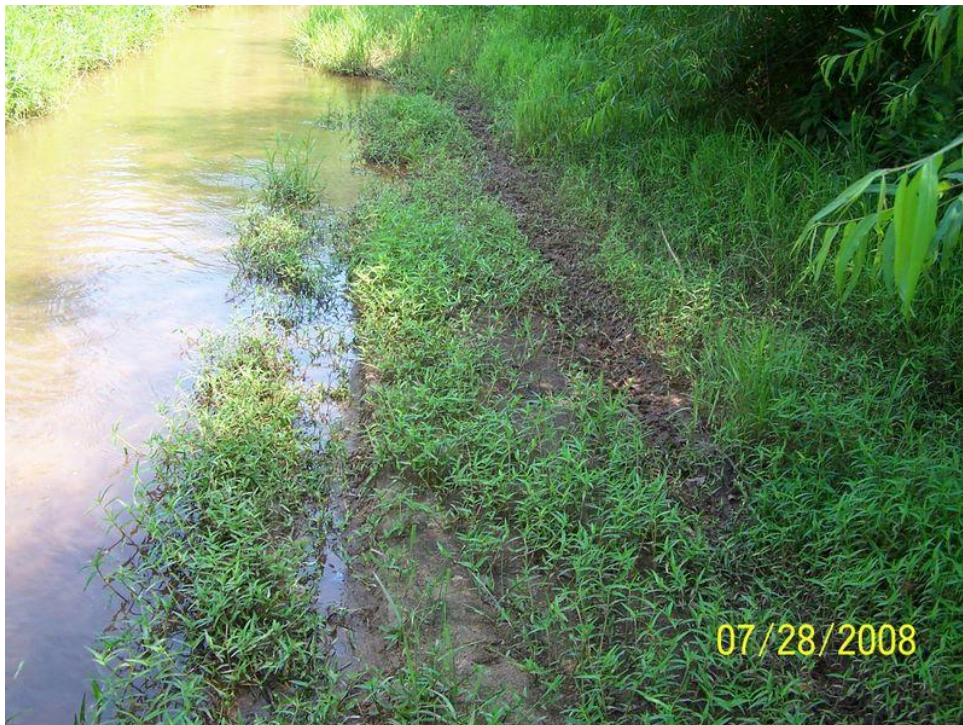
Evidence of 4-Wheeler trespassing, damage to project is minor.

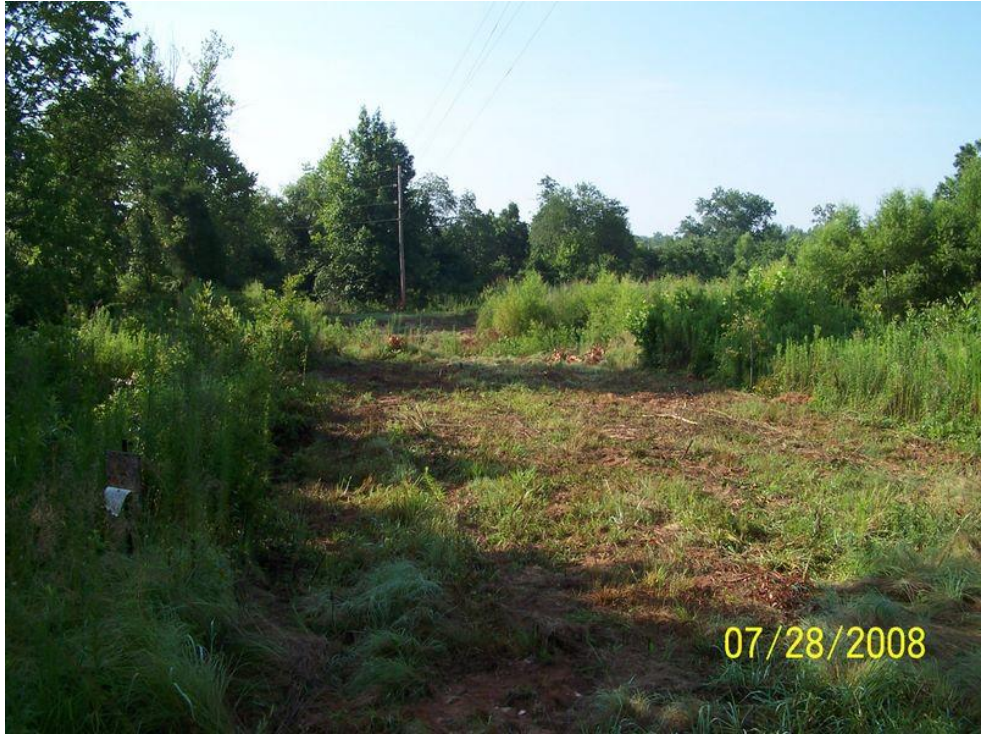
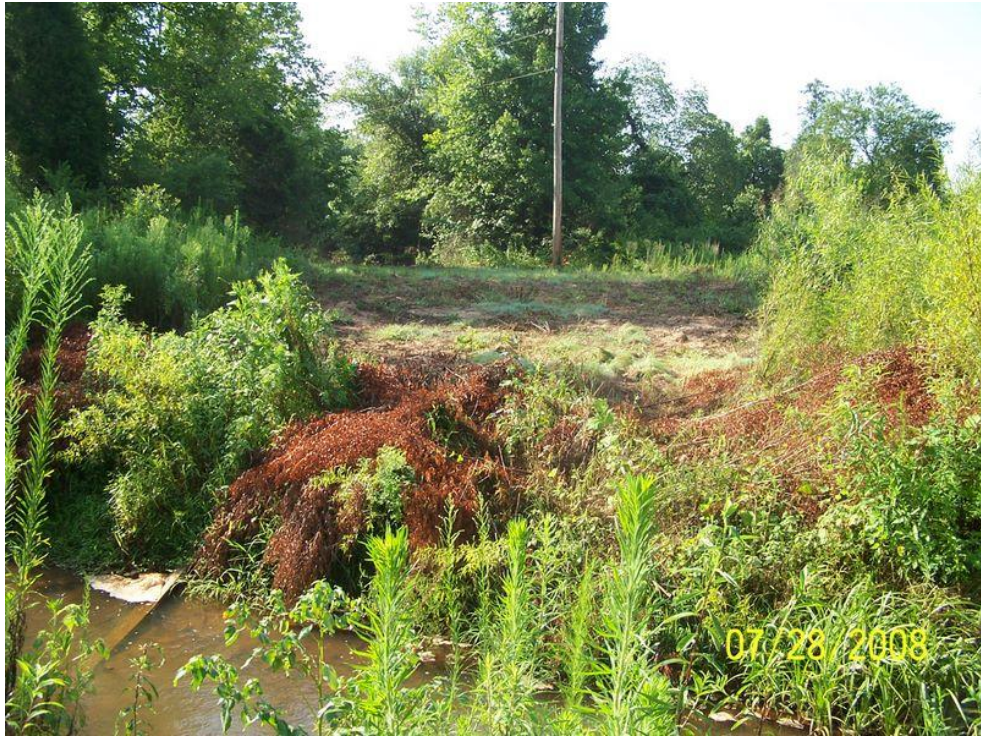
Due to poor placement, half of Veg Plot 8 is located in a small powerline easement and was moved in Summer of 2008.
