Pott Creek II Stream Restoration Project Year 5 Monitoring Report - 2009

**November 2009
Prepared By:**

**M i d - A t l a n t i c
M i t i g a t i o n , L L C**

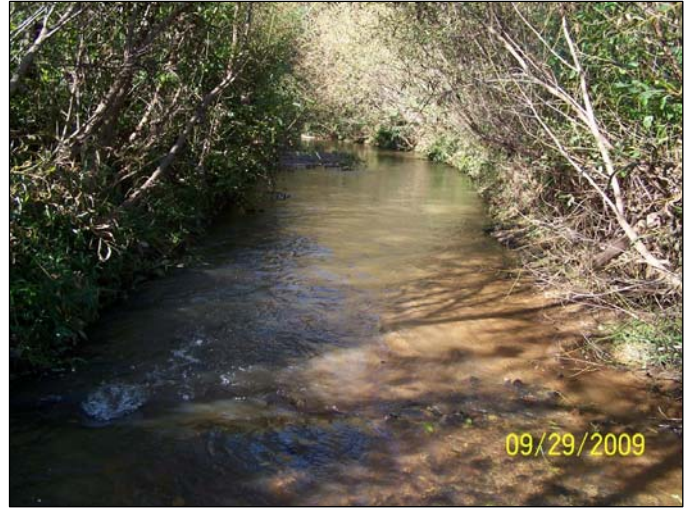
CS 1 facing upstream

Sand deposition causes slight fluctuations in bed and bank elevations, but does not appear significant. Photos show this area as being well vegetated and stable. The thalweg has stayed left of center in all years except 2006 when the stream bed appeared flat and the max depth of 5.4 was shallower than other survey years.

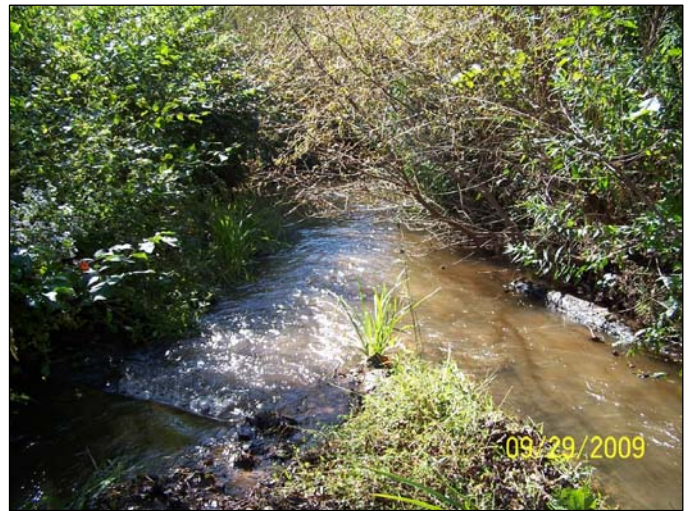
CS 2 facing upstream

There appear to be no significant differences between the year 1 (2005) and year 5 (2009) surveys, however it is evident that deposition has allowed vegetation to take root on the island/ point bar right of center, and that this island continues to evolve. The thalweg has remained right of center for five years. Photos show this area as being well vegetated and stable. Point bars are a natural feature of sandy piedmont streams. For conditions of the riffle see pebble count information in section 3.2.3 and Appendix D.

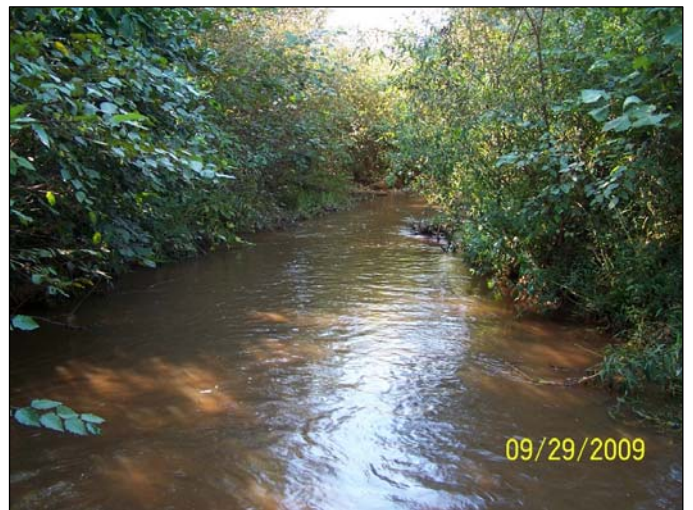
CS 3 facing upstream

The depth of the pool fluctuates year to year, but has not decreased significantly since 2006. While still not as deep as the original pool, it is within the range of designed pool depths for the reach. The thalweg also tends to fluctuate and is currently left center. Photos show this area as being well vegetated and stable. This is a dynamic system with much sand being passed through during larger storm events.

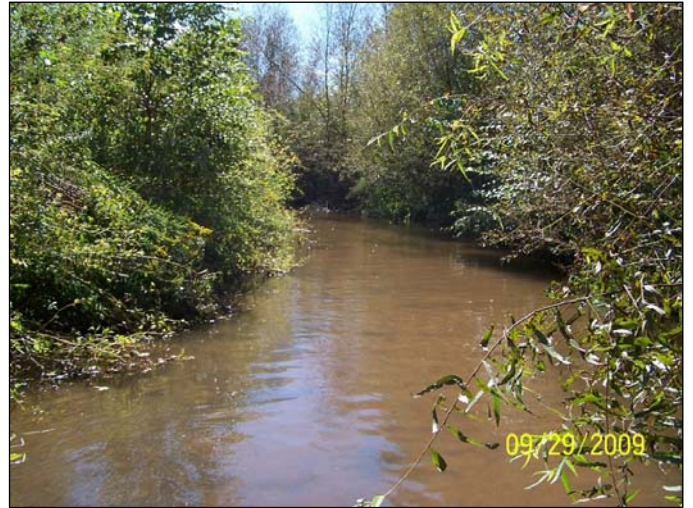
CS 4 facing upstream

Sand fluctuates in and out of this pool area, but the pool depth has remained relatively stable since 2006 and is within the range of designed pool depths for the reach. The thalweg tends to fluctuate from year to year and is currently close to center. Photos show this area as being well vegetated and stable.

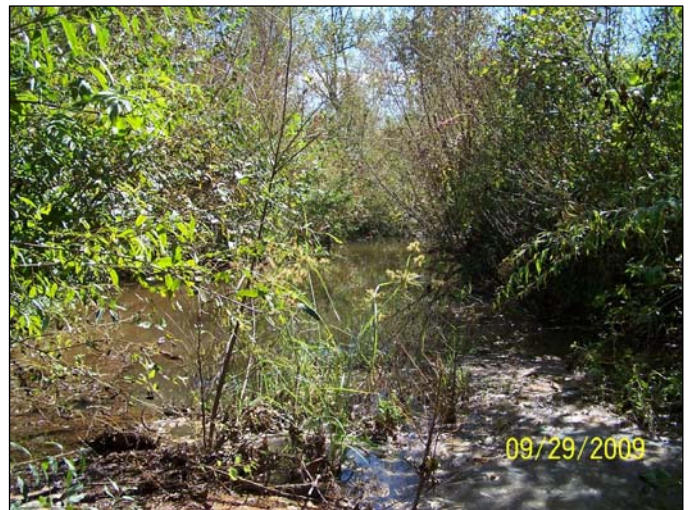
CS 5 facing upstream

This cross section shows only minor changes since 2005, except for the irregularity of the left bank in 2007. Several low points surveyed in 2007 would appear to be the result of an error in survey equipment or technique, given that the graphs from the two previous and two succeeding years were all virtually identical. The thalweg tends to fluctuate throughout the channel and currently right of center. Photos show this area as being well vegetated and stable.

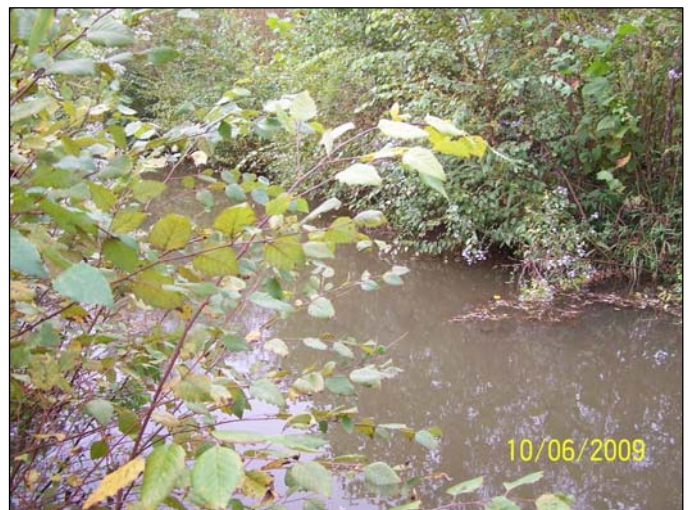
CS 6 facing upstream

Pool depth has remained relatively stable since 2005 and is within the range of designed pool depths for the reach. The 2007 survey appeared to show some scour on the left side, but this appears to have stabilized or may be a function of a survey error as noted on CS5. Photos show this area as being well vegetated and stable.

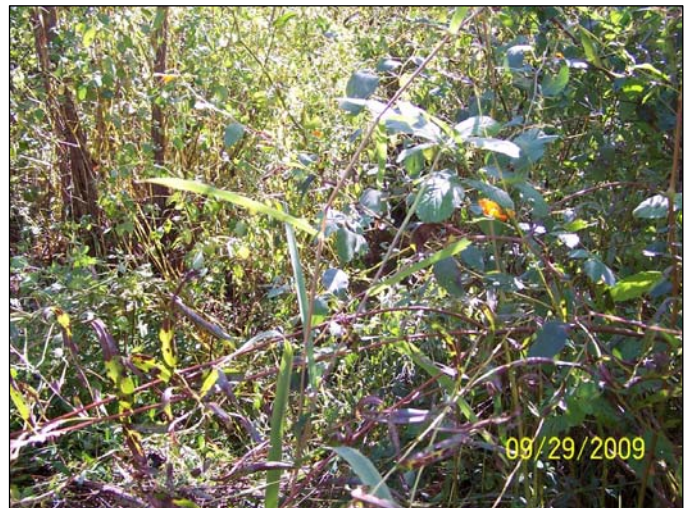
CS UT1 facing upstream

UT 1 is the largest of the UTs and shows a trend of shallowing and deepening from year to year. It appeared that some silt deposition and/or deposition of organic material from vegetation growth caused the cross section to become shallower in years 2006 and 2008. Years 2005, 2007 and 2009 all indicate a deeper cross section. The thalweg of UT1 has been left of center every year except 2006, and photos show this area as being well vegetated and stable.

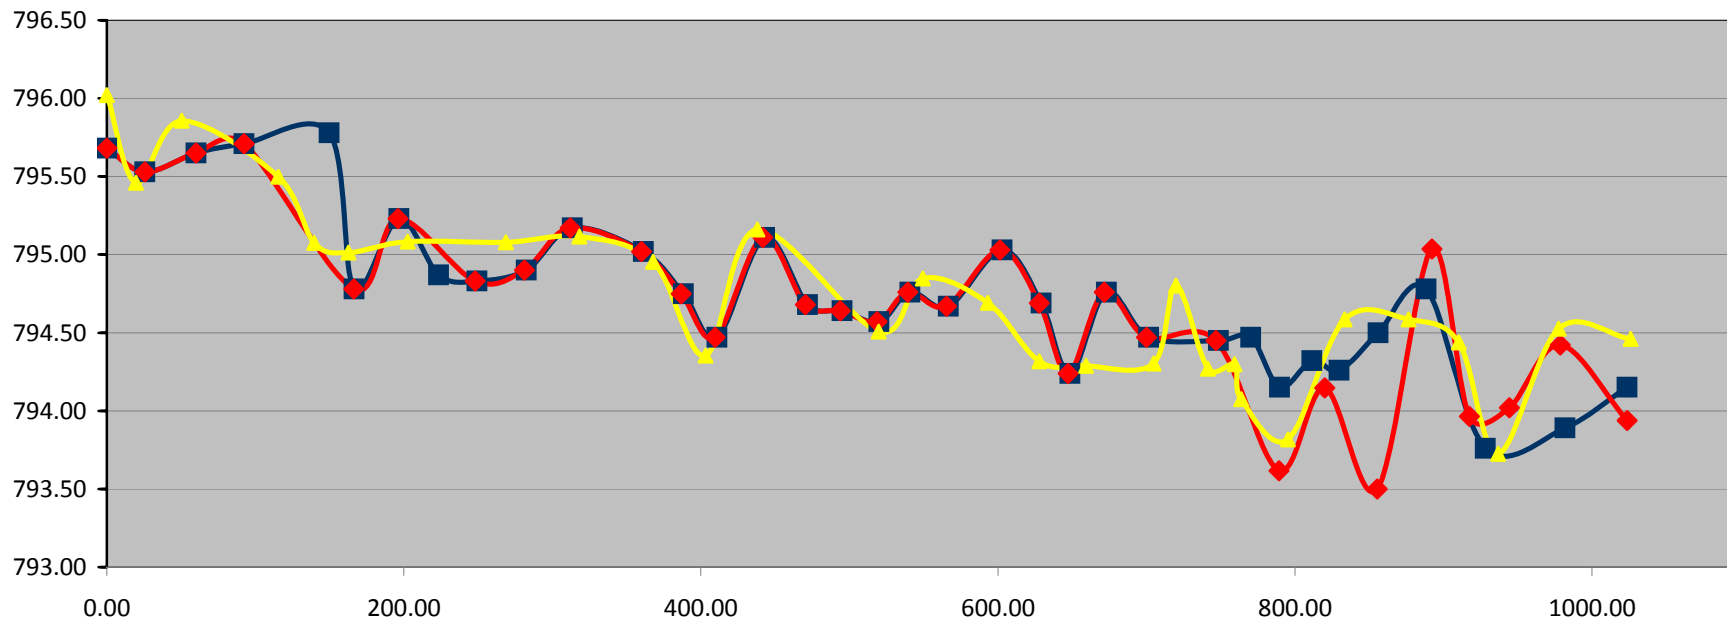
Pott Creek Main Channel 1000 foot Profile

Pott Creek – 1023 foot profile: No significant erosion problems were noted inside the profile reach. There are two constructed riffles inside profile limits and a pebble count was done on each. There are also several naturally forming riffles, but no significant bed material has accumulated and no pebble counts were done on these riffles. This reach carries a significant bed load of sand and the naturally forming sand riffles appear to be relatively stable. Riffle 1 is located near the beginning of the project where the effects of the sandy bed load are most evident. Riffle 1 showed an increase in sand, particularly very course sand in 2008, but shows no additional increase for 2009. The 2009 sample of Riffle 2 is a well mixed sample resembling all previous years samples including the increase in sand noted in 2008, there has been no additional increase in sand or finer substrates since 2008. Stable sand bars are present in several of the riffles above UT 1, not just within the Profile limits. The significant bed load of sand carried in Pott Creek has the greatest effect on the pool areas. Pools may be shorter in overall length, but deep areas remain stable with excess sand accumulating in the run and glide sections of the stream channel. This is the upper most segment of the project where most sand and silt washes in from upstream of the project during high flow events settles out. With that in mind, this section of the project is in excellent condition.

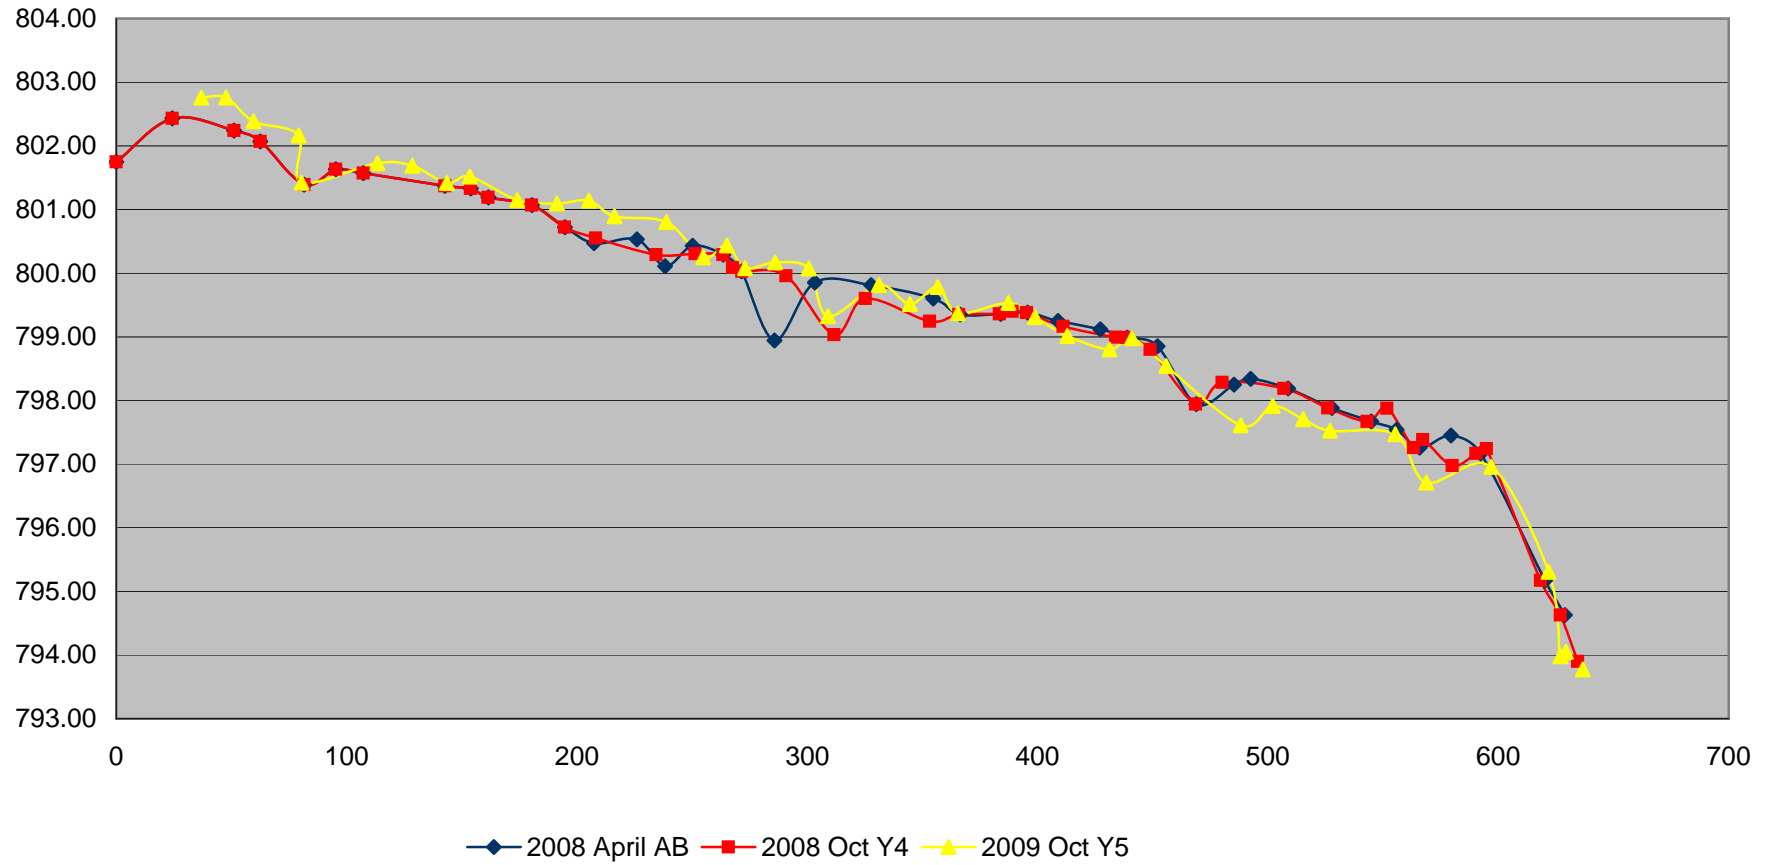
UT 1 Profile

UT1 – 630 foot Profile: This stream is the largest and most active of all the UT's, but contains no defined substrate other than sand and silt. 2009 observations show the bed to be mostly sand and to have no evidence of any permanent vegetative growth in the stream bed. The profile survey shows little change from 2008 except for a pool around the 475 foot mark appears to have migrated downstream slightly. The pool below the structure at the confluence of Pott Creek appears to have lengthened and deepened, but was observed to be stable during the survey work.
