**Powell Property Wetland and Stream Mitigation Project
Bertie County, NC**

**2009 Annual Monitoring Report
Year 1**

**NCEEP Project Number D06065-B
Chowan River Basin
USGS Catalog Unit 03010203**

Date: March, 2010

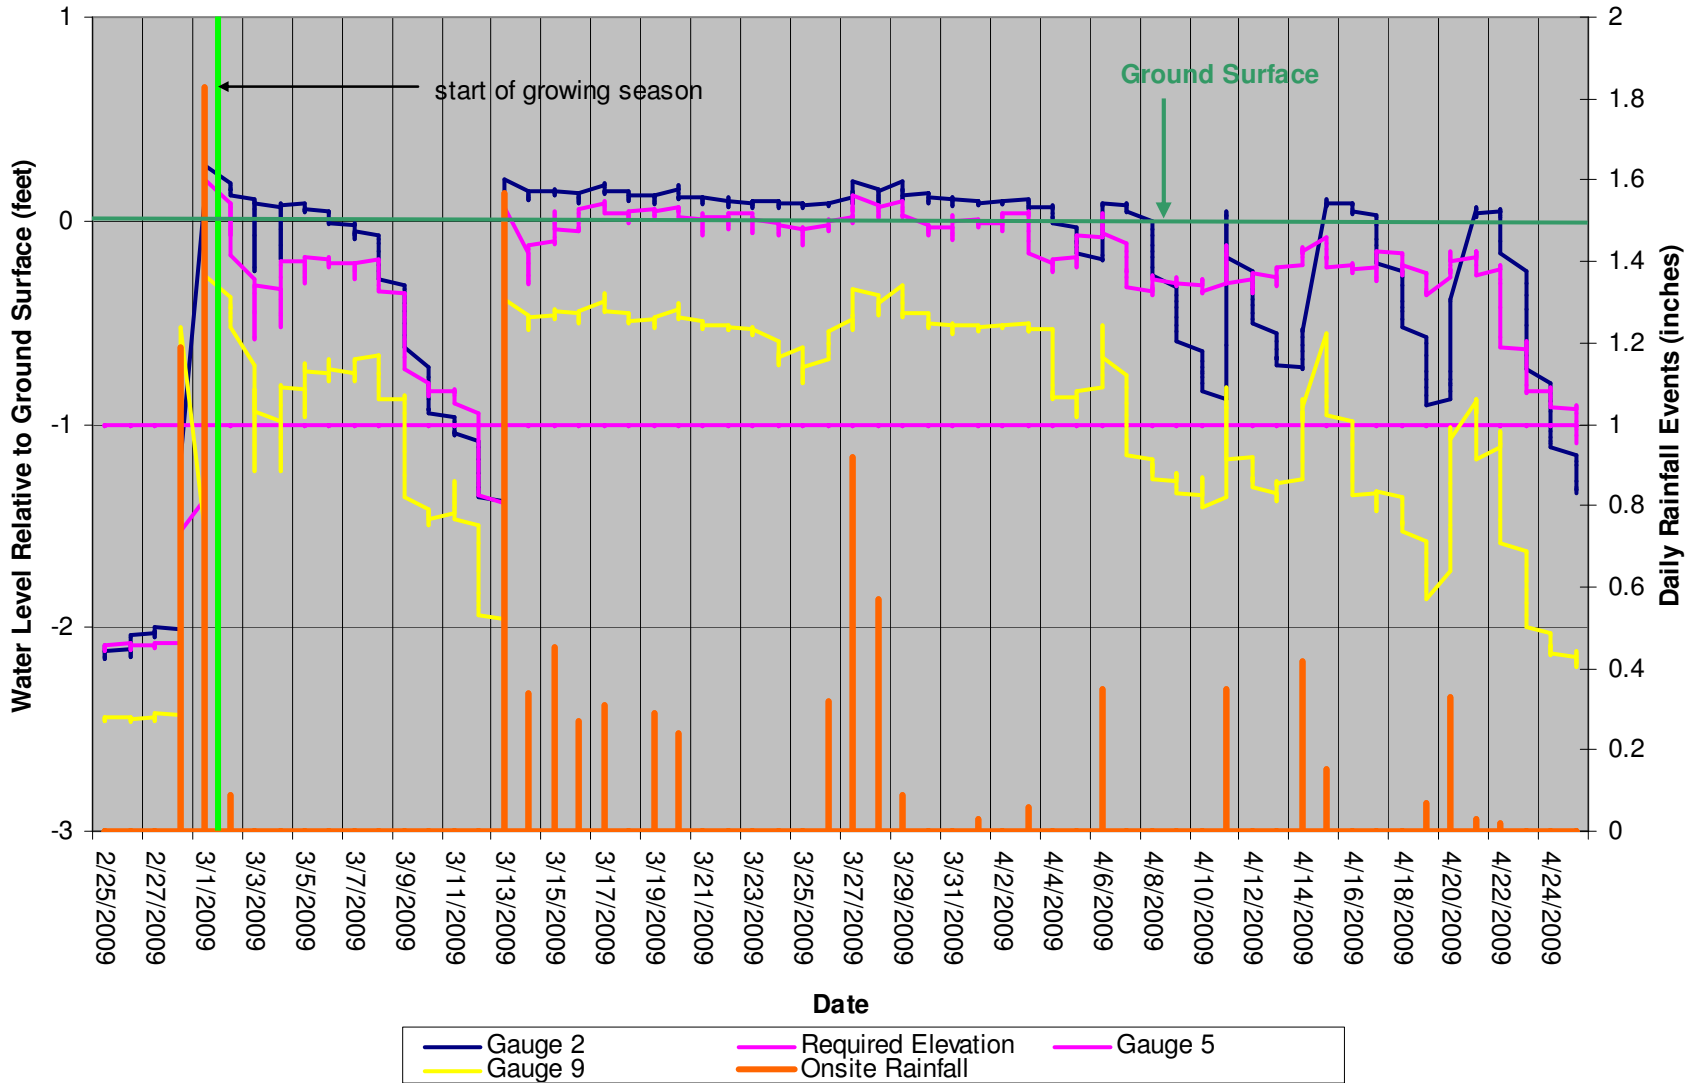
**Figure F1.
Monitoring Gauges 2, 5 & 9 Correlated
to Video Evidence of Flow in April 2009**

Refer to Figures F1, F2 and F3 which are composite charts for gauges 2, 5 & 9, for the following discussion of evidence of flow within the swamp runs. Figure F1 is a composite chart showing the water level during a period in April when flow in the swamp runs was visually confirmed and recorded on video. This flow event was very early in the life of the project, occurring in April,

only two and a half months after the project was completed. Gauge 9, at the lower end of the project wasn't inundated above the ground line so flow at that gauge is not identified as it is at the two upstream gauges. It is important to note that the channelization that can be seen in the early stage photos in Appendix A were developed by this flow event.

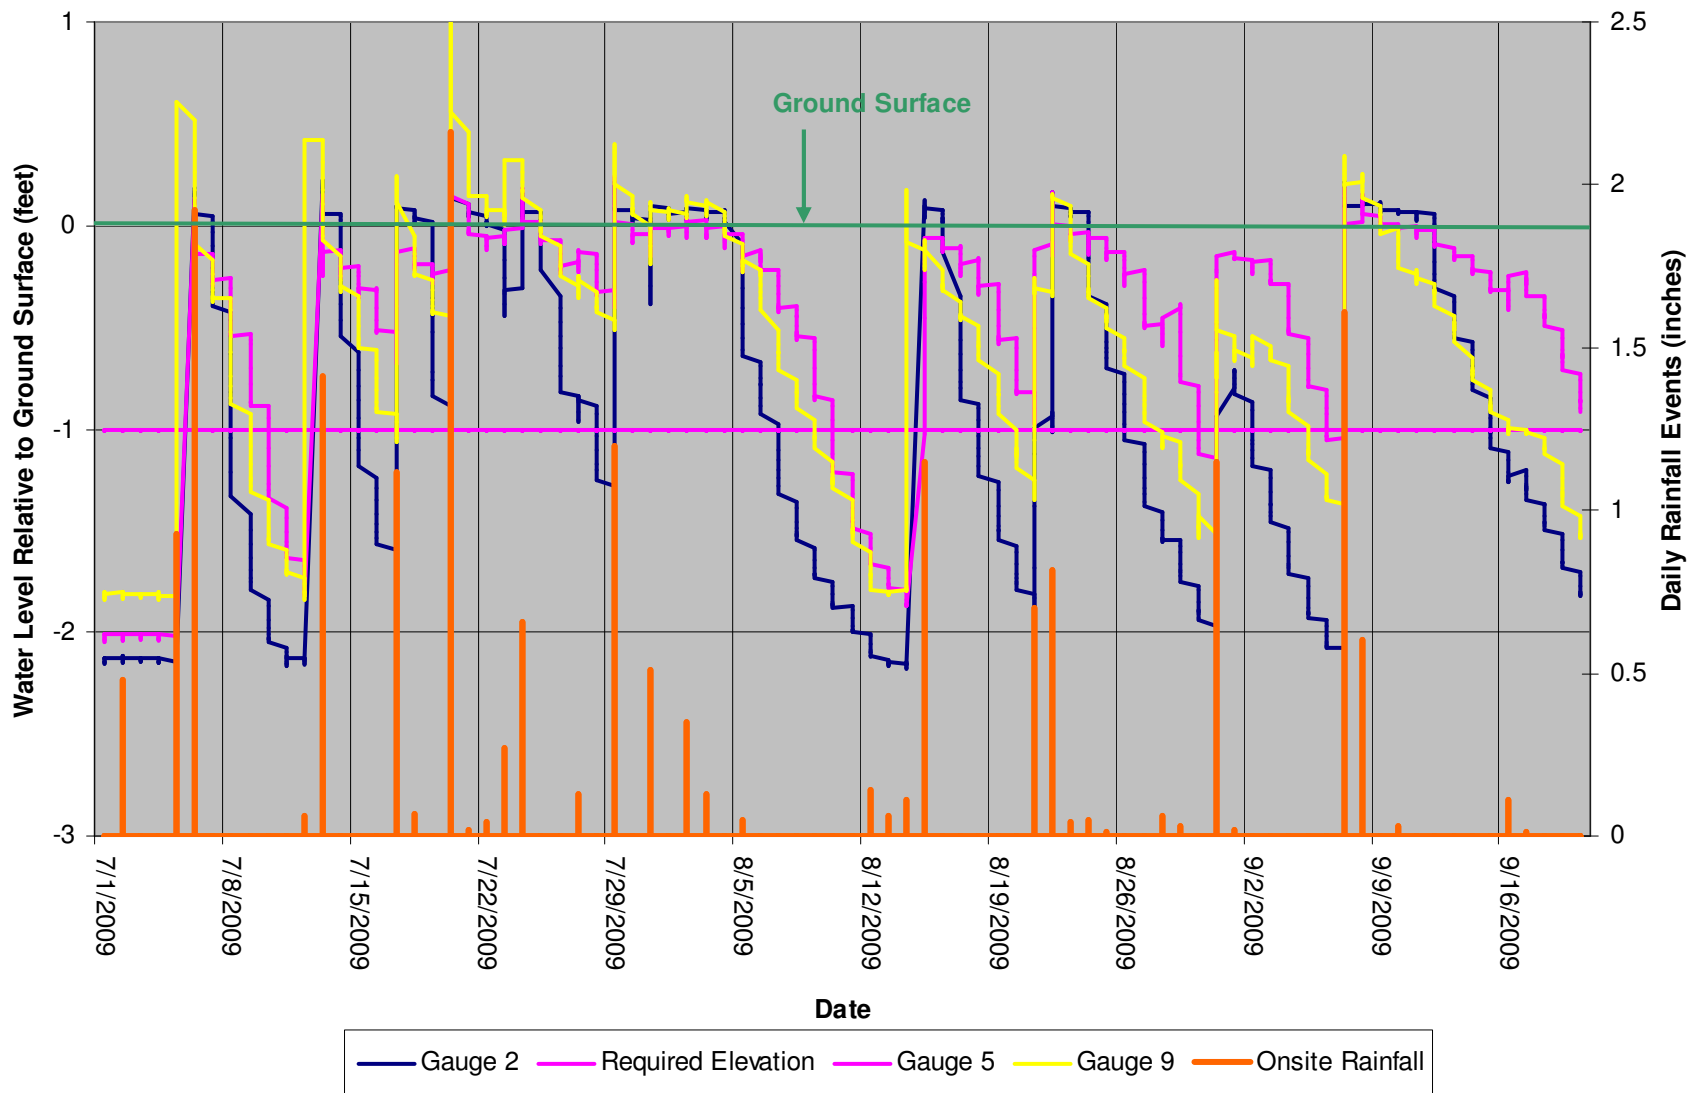
**Figure F2.
Minor Flow Events During Summer 2009**

Figure F2 illustrates several small flow events that occurred during the growing season during periods of heavier rainfall. By this time, all three gauges were successfully registering the rise and fall of above ground water indicating water flow.

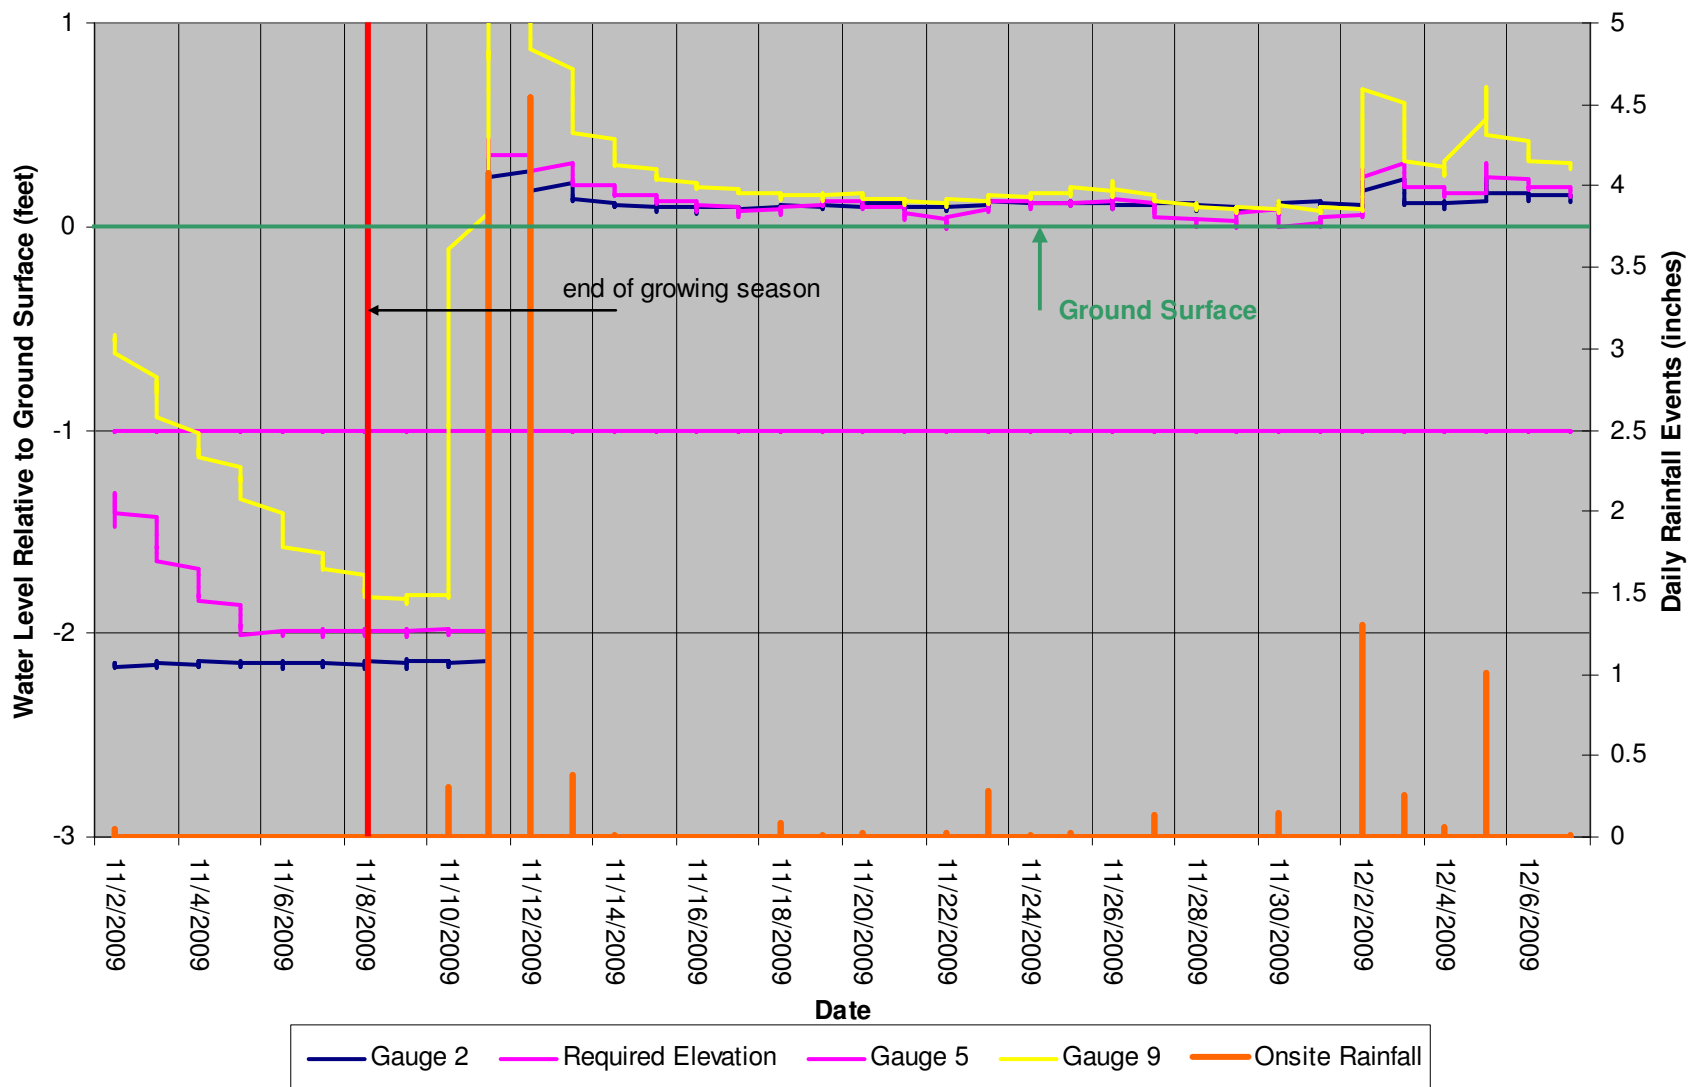
**Figure F3.
Monitoring Gauges 2, 5 & 9 Correlated
to Video Evidence of Flow in November 2009**

Figure F3 illustrates a major flow event that took place just at the end of the 2009 growing season. The accompanying video shows the water coming onto the site quickly fanning out and flooding the entire upper portion of the project area. There was substantial overbank flooding from the midpoint down to the outlet where water that was forced back toward the outlet increased in velocity and matted the existing herbaceous vegetation.

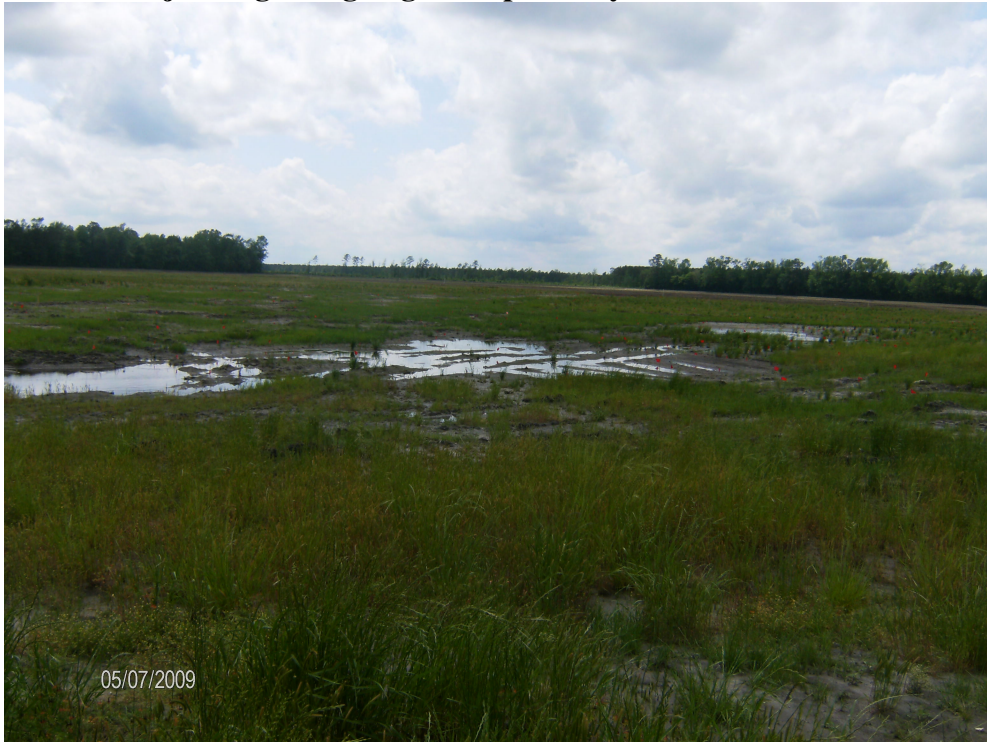
Project beginning to green up in May after construction

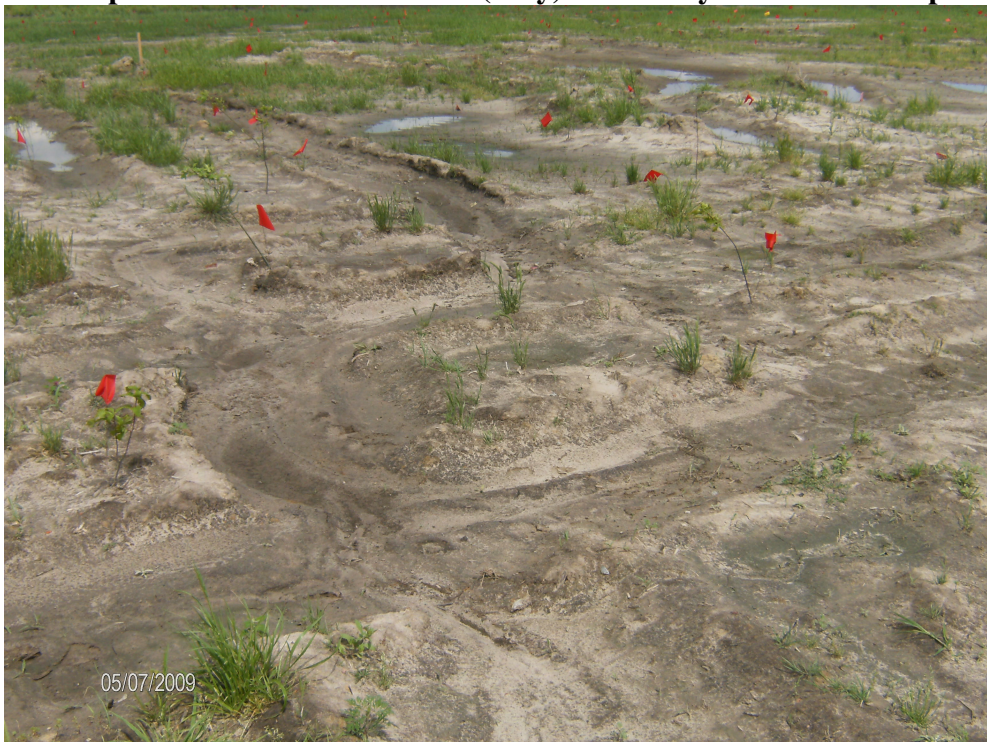
Development of braided channels (May) created by flow event in April

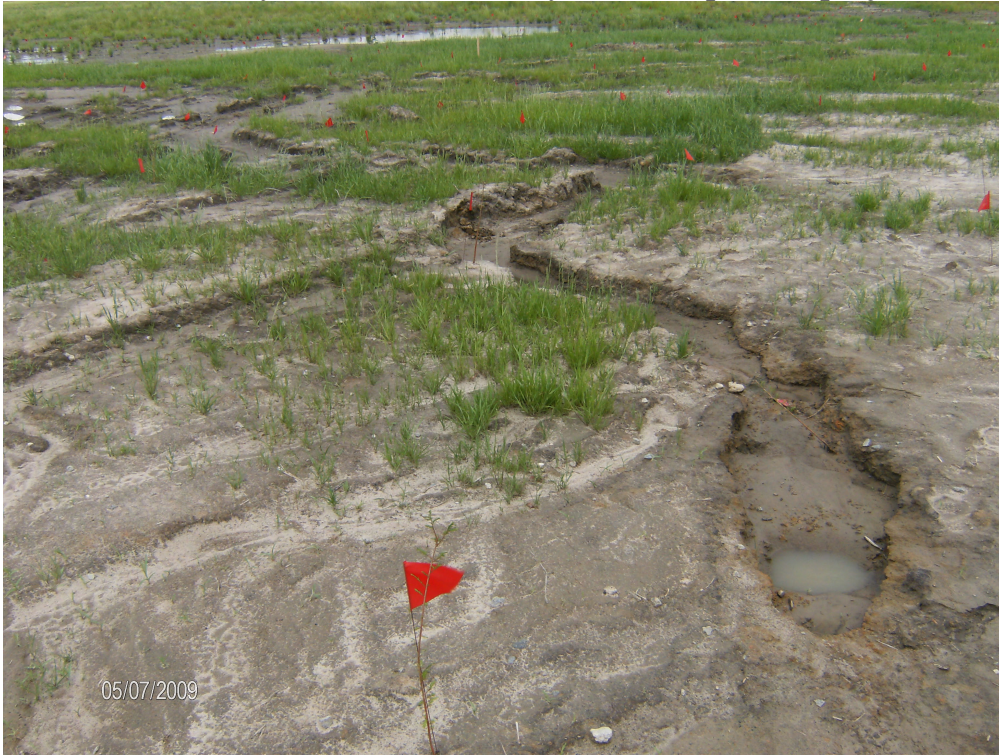
Further early channelization (May) near midpoint of project

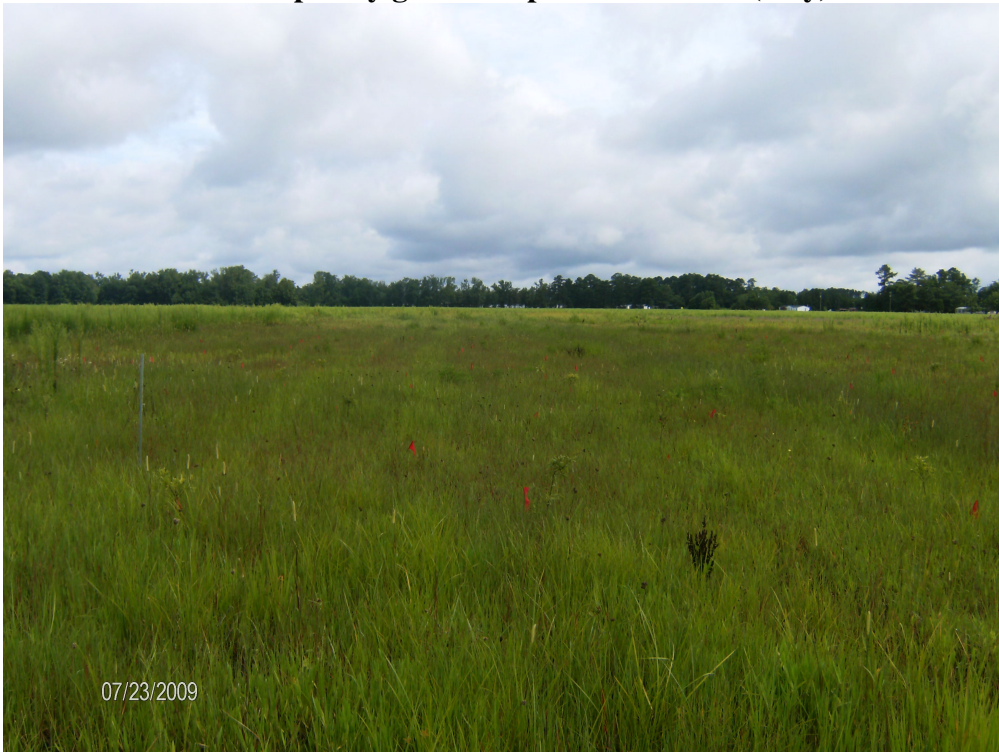
Site completely greened up and stabilized (July)

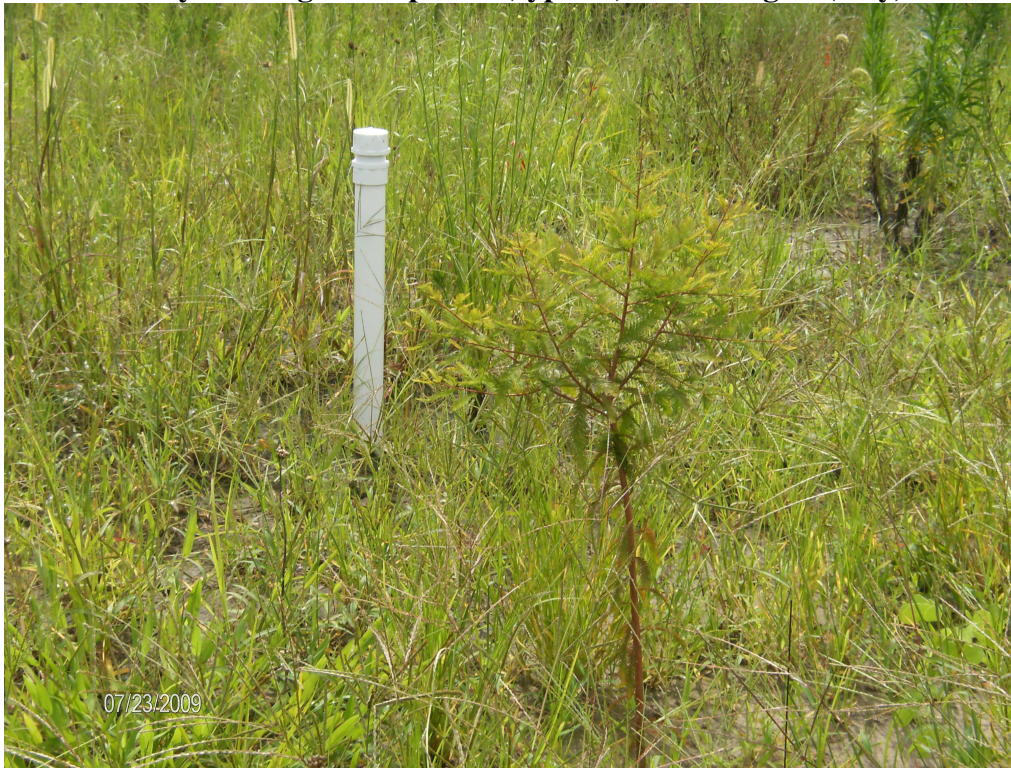
Early seedling development (cypress) near Gauge 7 (July)

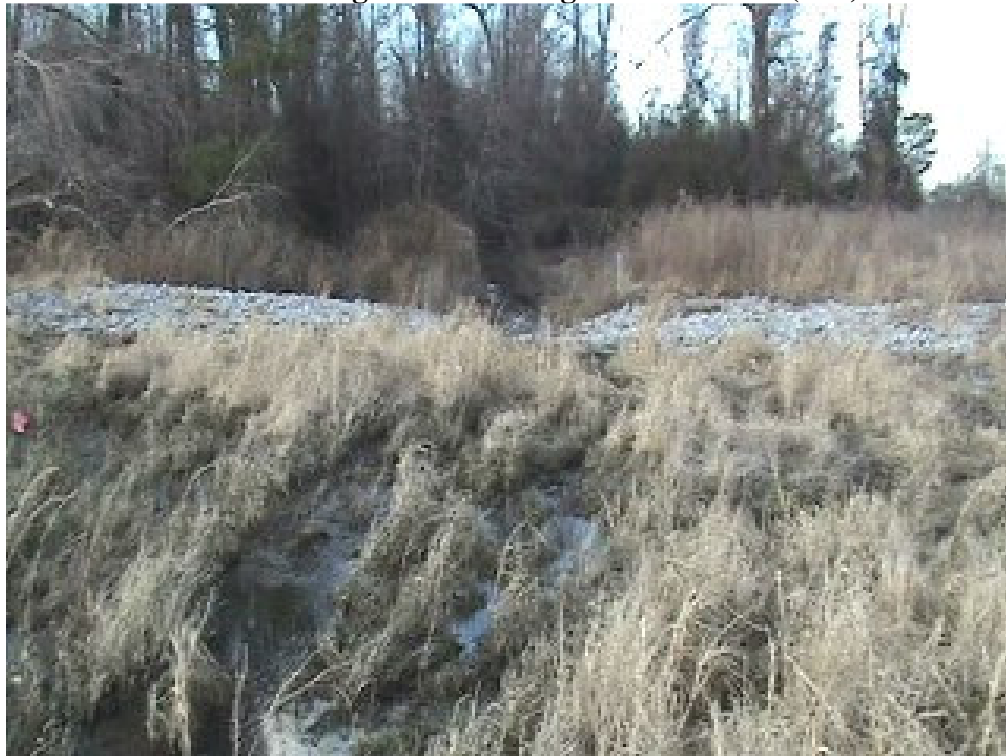
Substantial vegetation matting at outflow end (Dec)

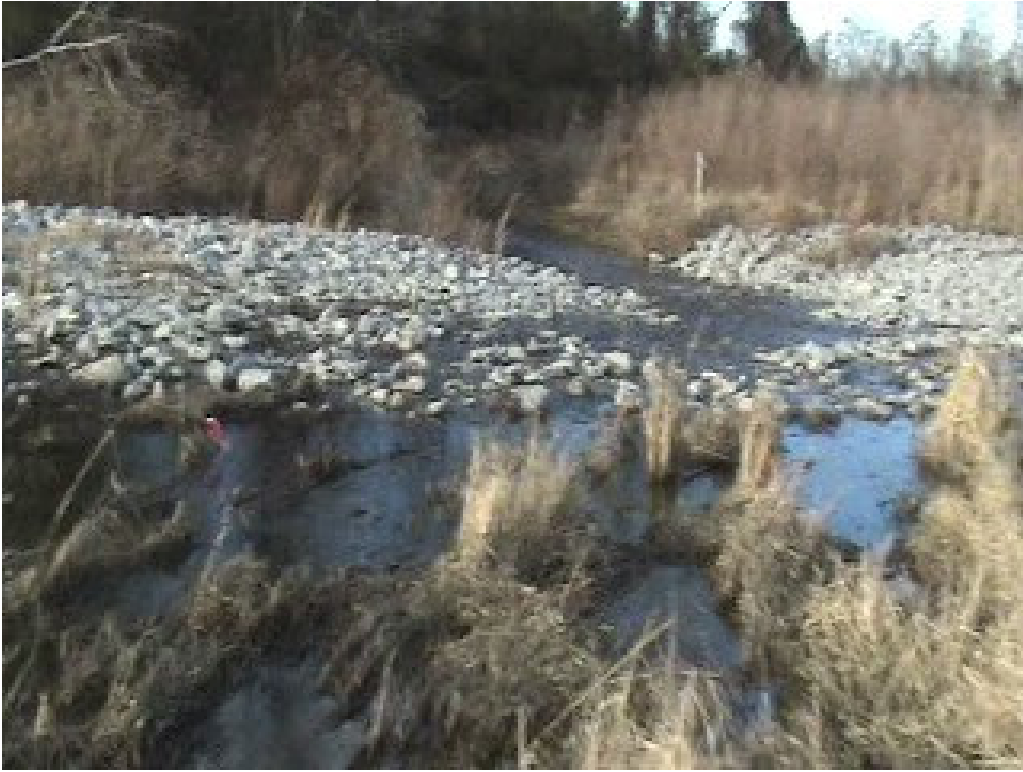
Heavy flow at outfall end (Dec)

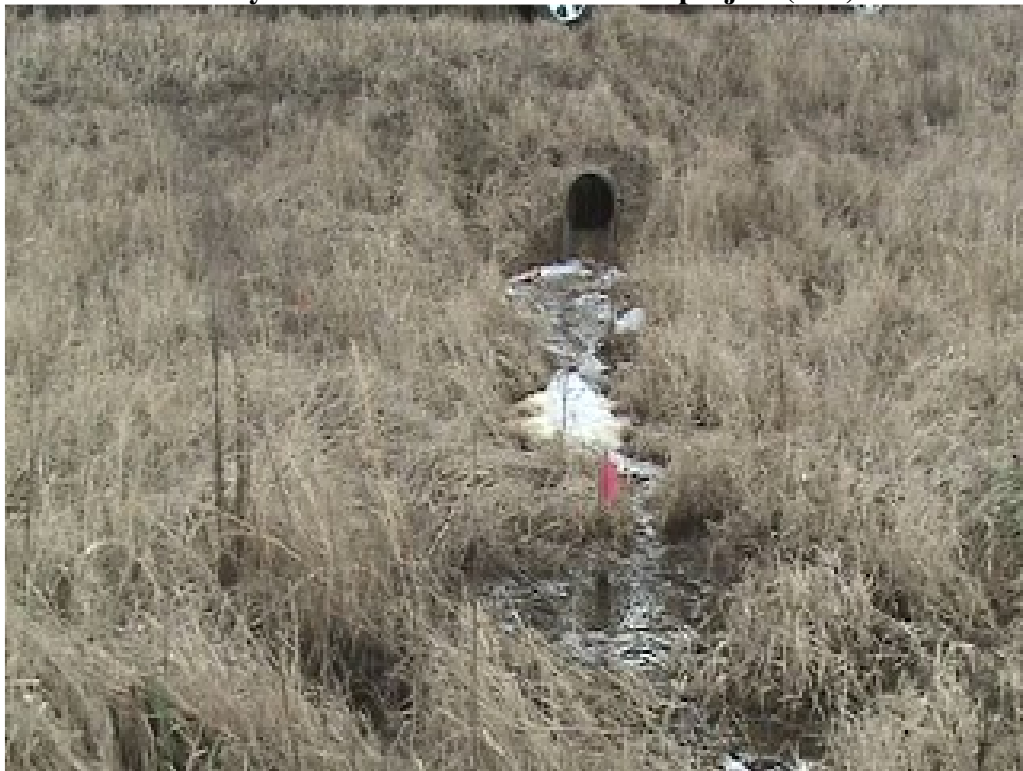
Steady inflow from watershed above project (Dec)

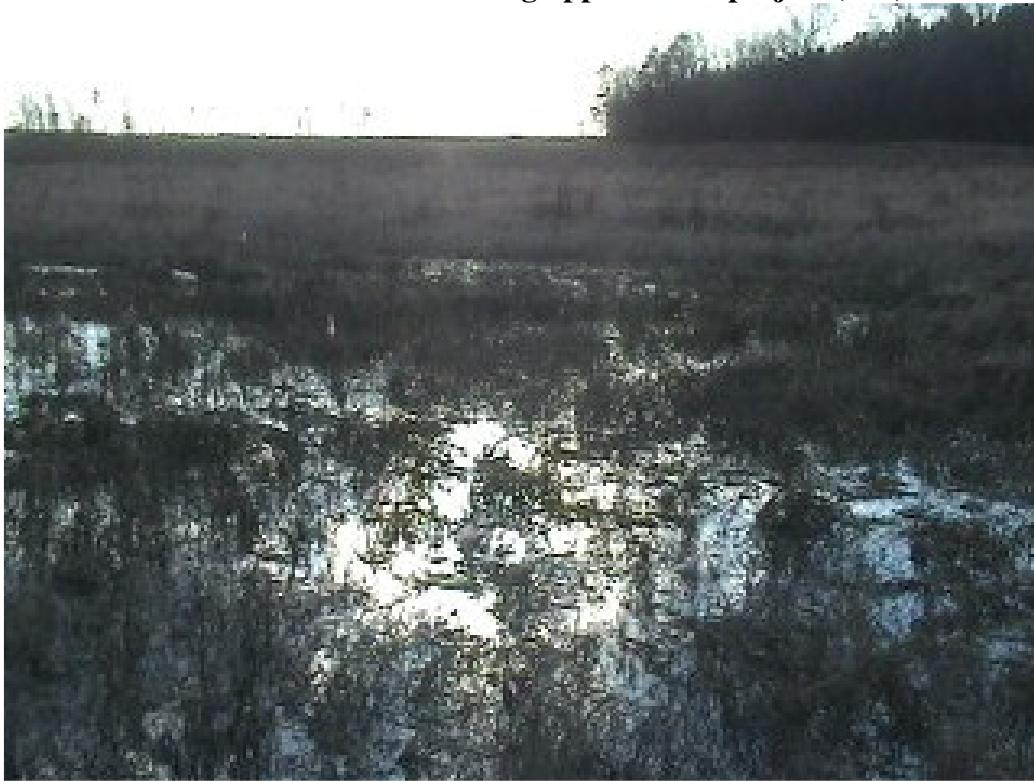
Water fans out after entering upper end of project (Dec)

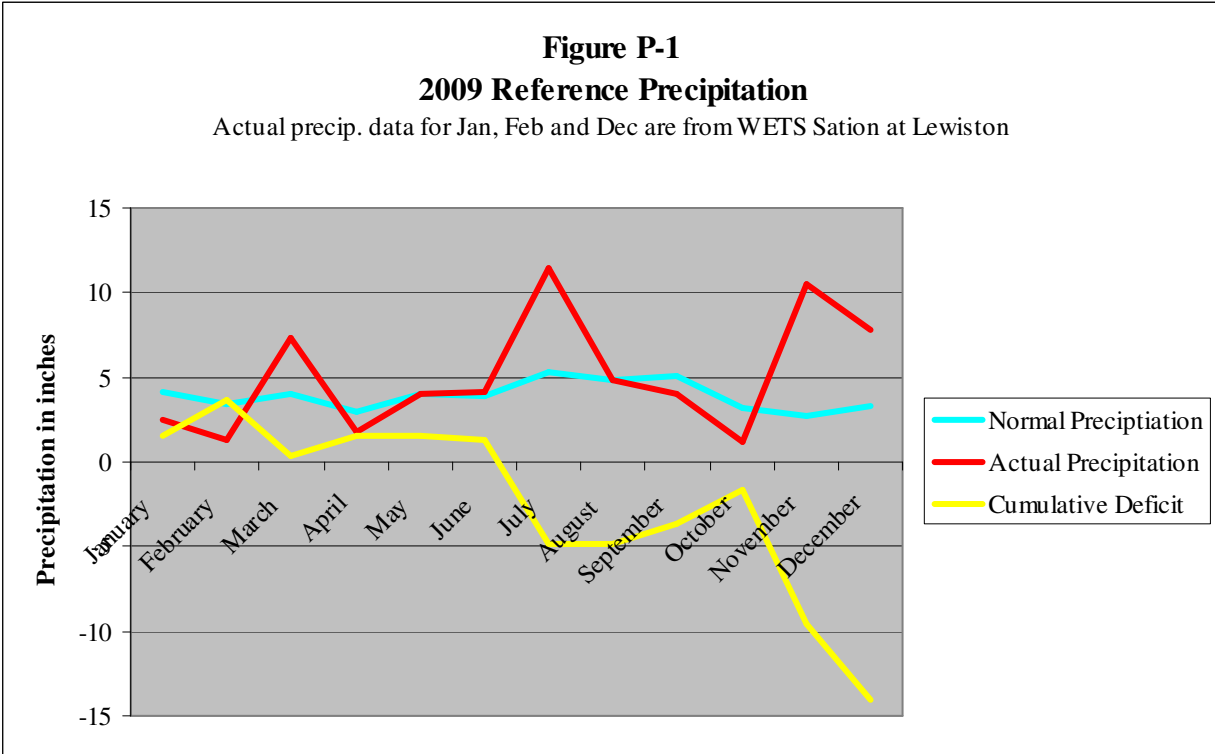
Because of heavy rainfall in November and December, total annual precipitation on the Powell project was 14" above normal.
