# Hatchet's Grove Stream and Neuse Riparian Buffer Mitigation Plan and As-built Report

September 2004

# **Hatchet's Grove Tributary Stream and Riparian Buffer Mitigation Plan**

# RECORD DRAWINGS FOR:

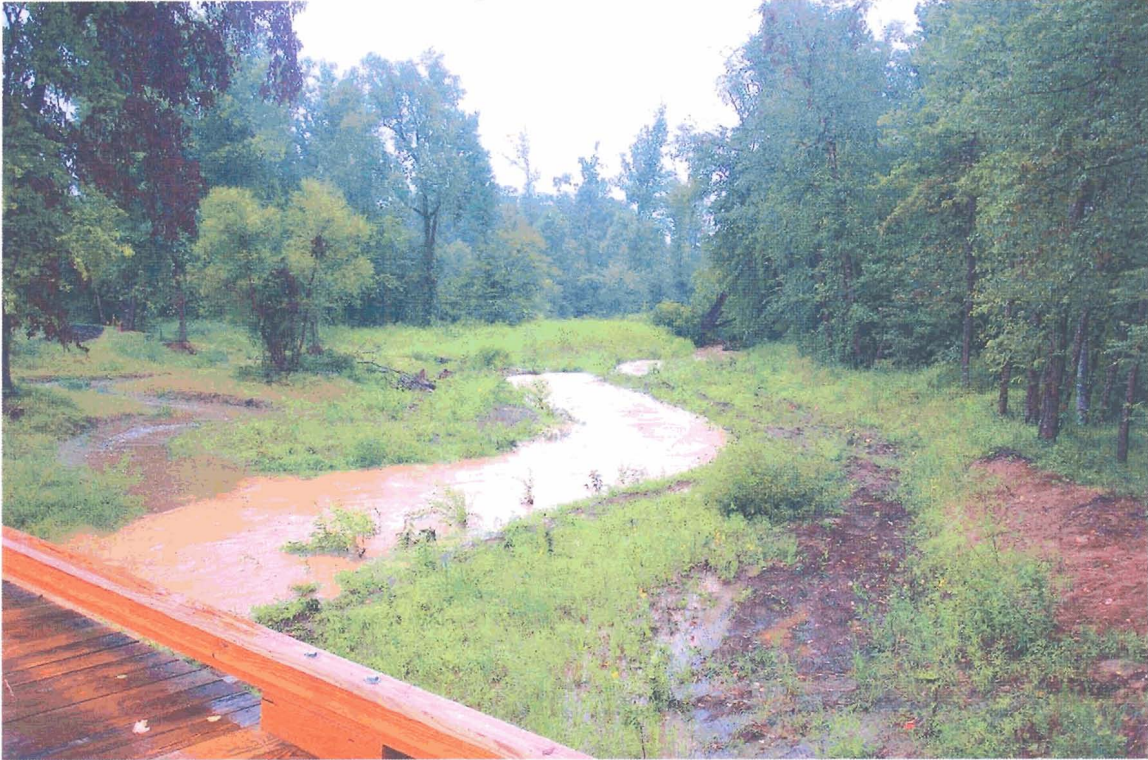
Tropical Storm Gaston

Since the completion of the construction activities in May 2004, the restored stream channel has experience approximately 6 individual bankfull events and 3 out of bank events. Four of these events were caused by precipitation produced by tropical storms Frances, Gaston, Ivan, and Jeanne. Flood flows were estimated to be approximately 2 feet above bankfull on two occasions and 3 foot above bankfull on one occasion. Although the project has only been in the ground for 4 months and located in a

Confluence of Hatchet's Grove and Meadow Creek after Flooding Receded

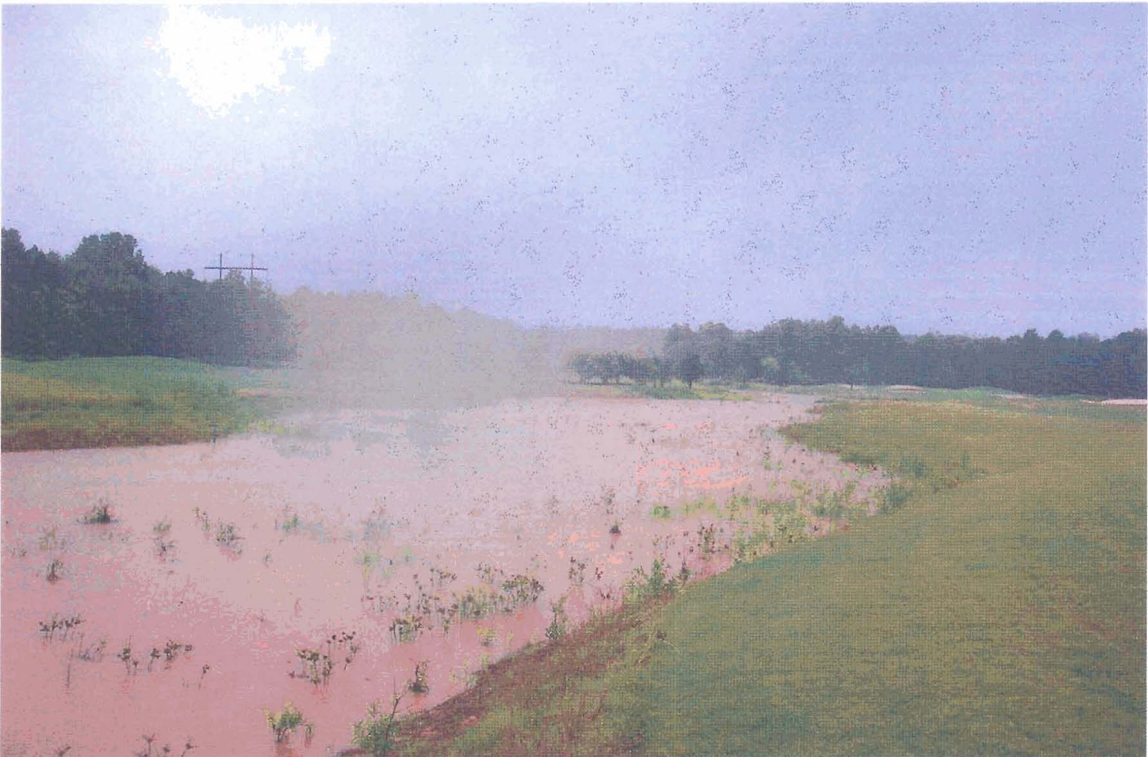
Nested Flood Plain Inundated with Approximately 1-foot of Water Below Station 20+00

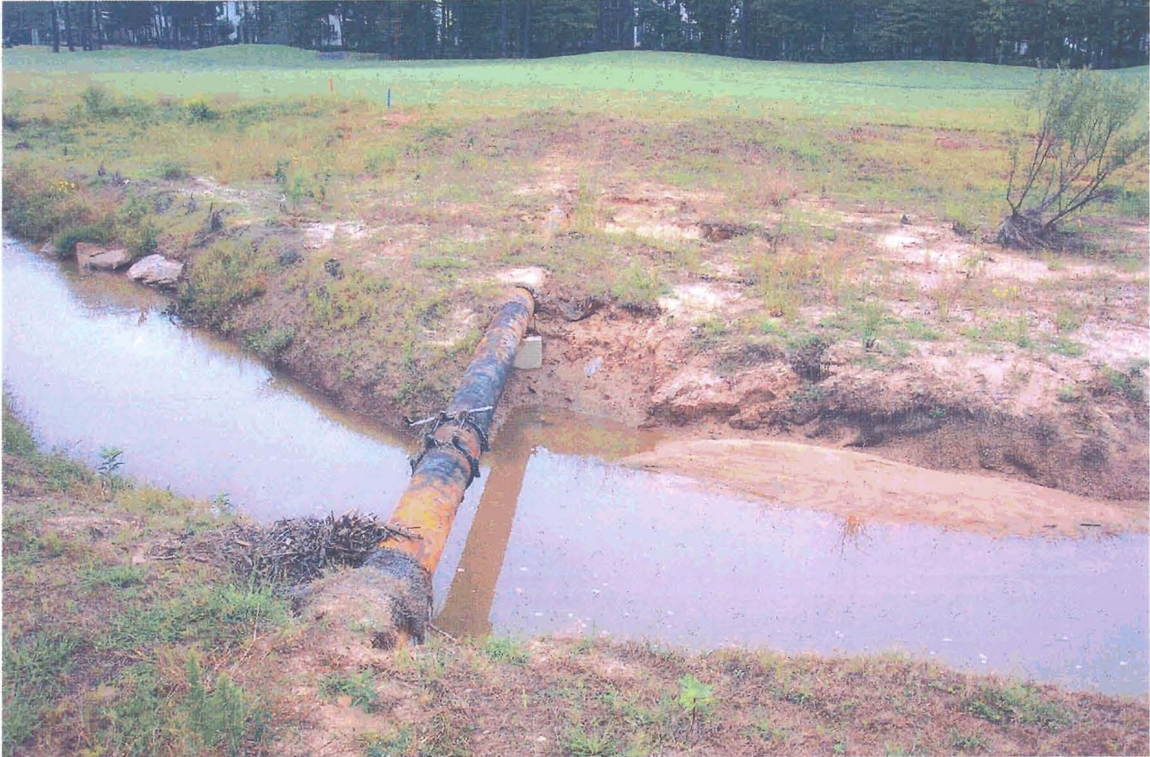
Recommended Repair Area

highly urbanized environment, the channel has performed better than would be expected. Although the site has been planted and stabilized with the application of temporary and permanent seed, the vegetation has not completely anchored the surrounding soil profile. Immature vegetation has to a point led to some minor scour in the near bank regions and within the flood plain. The majority of these scoured areas are beginning to naturally stabilize and fill in with transported substrate deposited by the stream during high flows. It is estimated that less than 1% of the total bankfull channel area has been affected by scour or slumping. At this time, the only segment that S&EC recommends should be repaired is the banks that have failed immediately below pre-existing sewer line outfall. Unfortunately the sewer pipe elevation matches the bankfull elevation resulting in the maximum expected force on the downstream bank due to constriction of maximum cross-section discharge and the subsequent generation of secondary flow vectors due to the pipe orientation and trapped debris. Although the inside of the meander is becoming stable, the outer bend will need some additional stabilization to prevent further bank erosion from occurring. It is our recommendation to slope the banks back to a 2:1 ratio and install a brush mat consisting of willow cuttings, permanent seed mix, straw and coir matting. Root wads are not recommended and were not installed because of existing irrigation lines located in this area.

Bank Scour Located Immediately Below Sewer Pipe

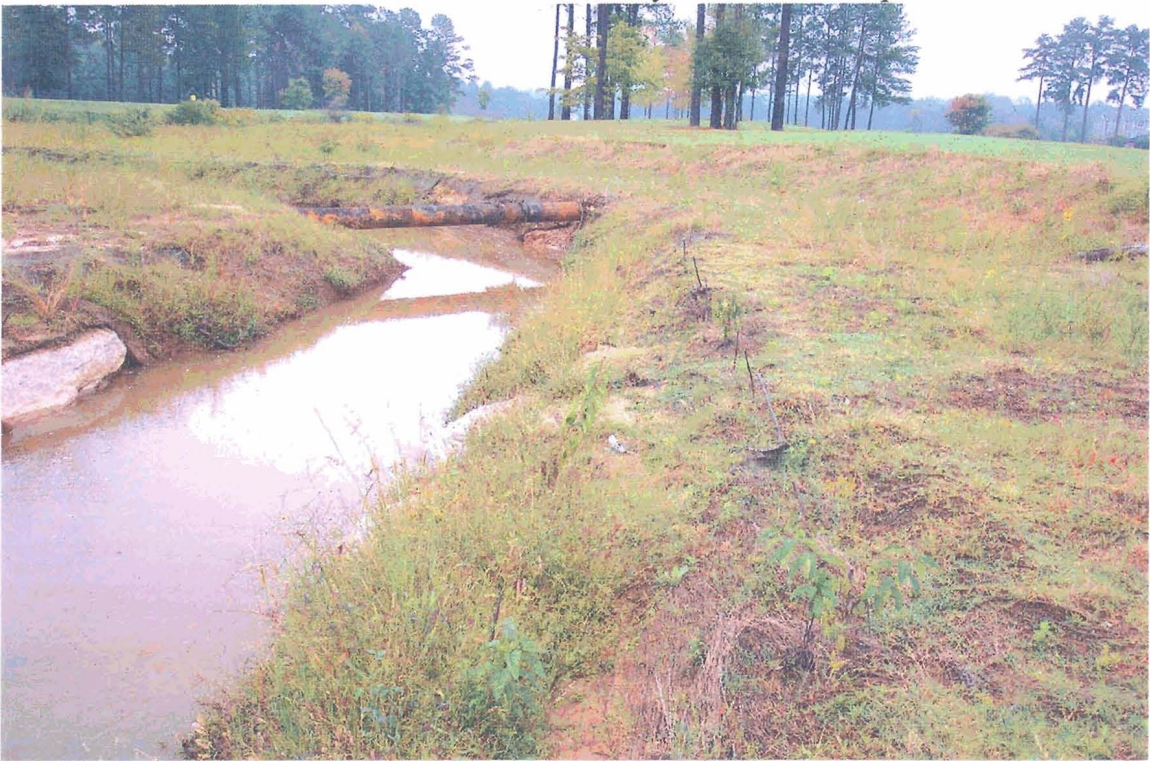
Channel Condition Upstream of Sewer Pipe Appears Stable
