**Prestonwood Golf Course
(Hatchet's Grove)
Stream Restoration Monitoring Report
EEP Project # 289
Monitoring Year – 02
2006**

January 2007

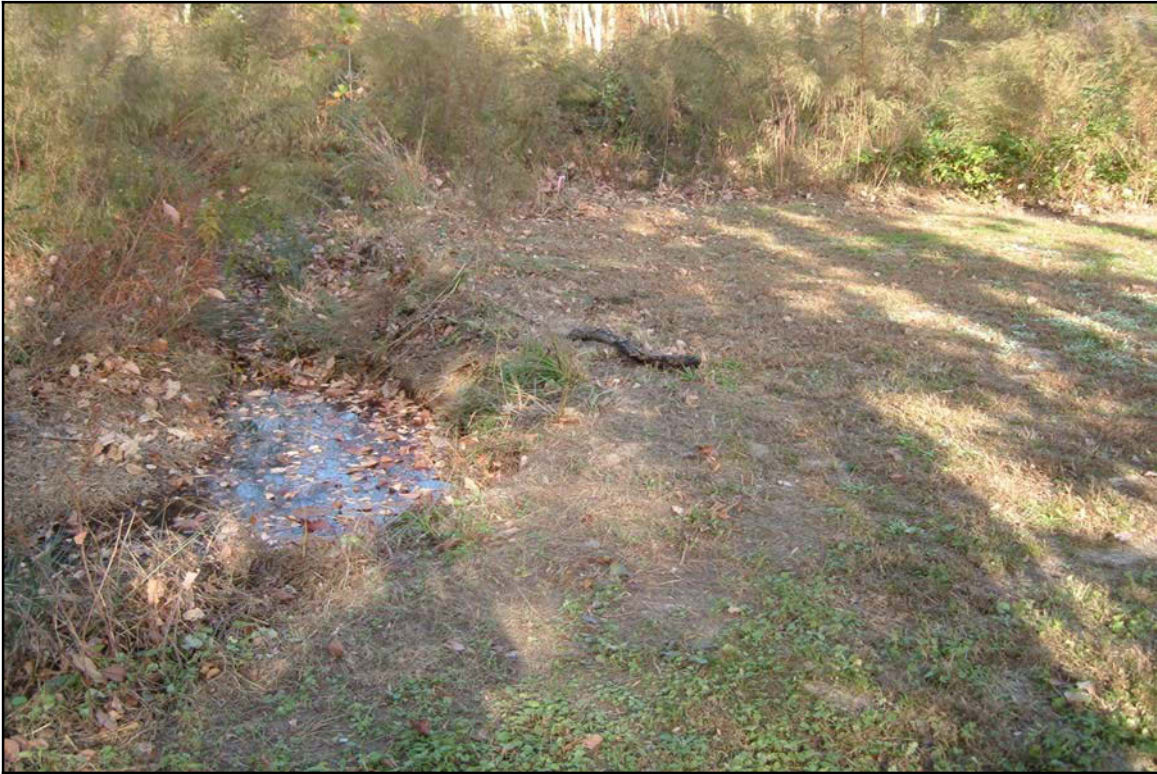
Table A6b. Vegetative Problem Areas			
Project Number and Name: 289 – Prestonwood Golf Course (Hatchet’s Grove)			
Segment/Reach: Meadow Creek (295 ft.)			
Feature/Issue	Station # / Range	Probable Cause	Photo #
Mowed Riparian Buffer	00+00 – 01+50	Golf course maintenance	VP3

VP1 – Mechanically mowed buffer area 00+75. 11/5/06 - MY 02

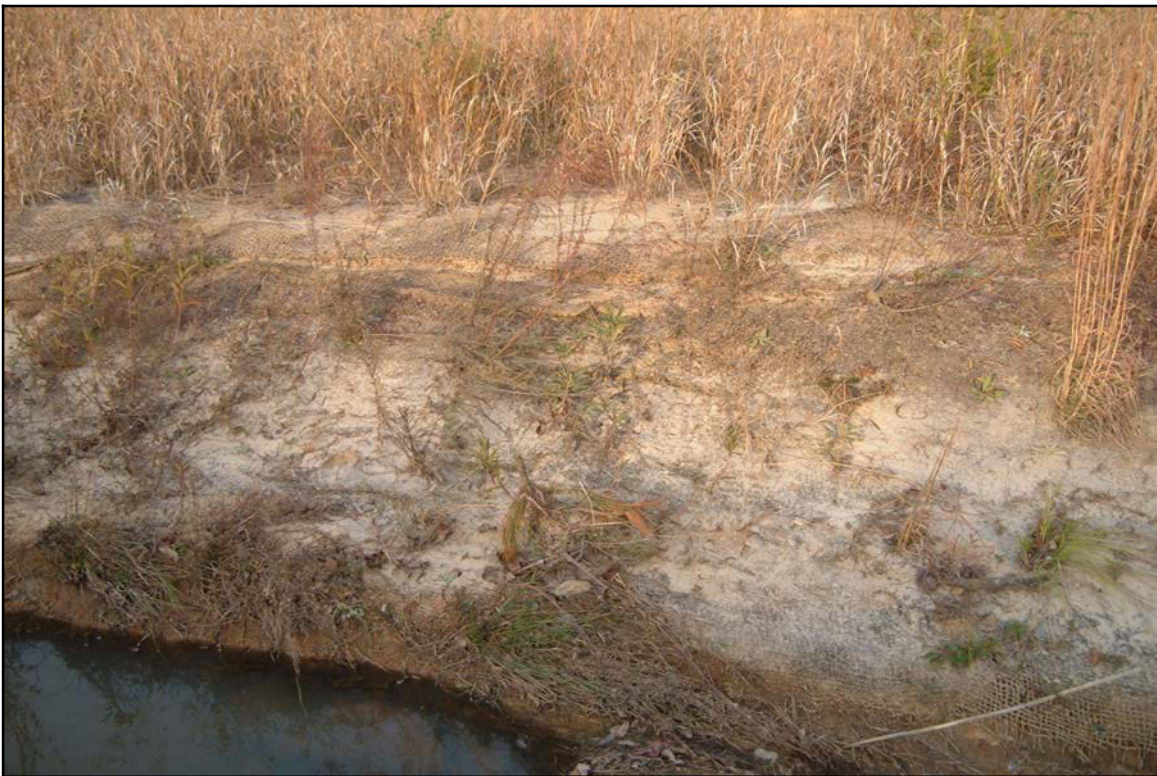
Table A6a. Vegetative Problem Areas			
Project Number and Name: 289 – Prestonwood Golf Course (Hatchet’s Grove)			
Segment/Reach: Hatchet’s Grove (3,828 ft.)			
Feature/Issue	Station # / Range	Probable Cause	Photo #
Bare Floodplain	29+25 – 29+50	Floodplain erosion	VP1
	29+70 – 30+20	Floodplain erosion	
	30+30 – 30+80	Floodplain erosion	
	31+60 – 32+15	Floodplain erosion	
	32+85 – 33+25	Floodplain erosion	
	35+75 – 36+05	Floodplain erosion	
	37+60 – 38+10	Floodplain erosion	
Mowed Riparian Buffer	12+95 – 13+70	Golf course maintenance	VP2

VP2 – Bare bank / floodplain 35+75. 11/5/06 - MY 02

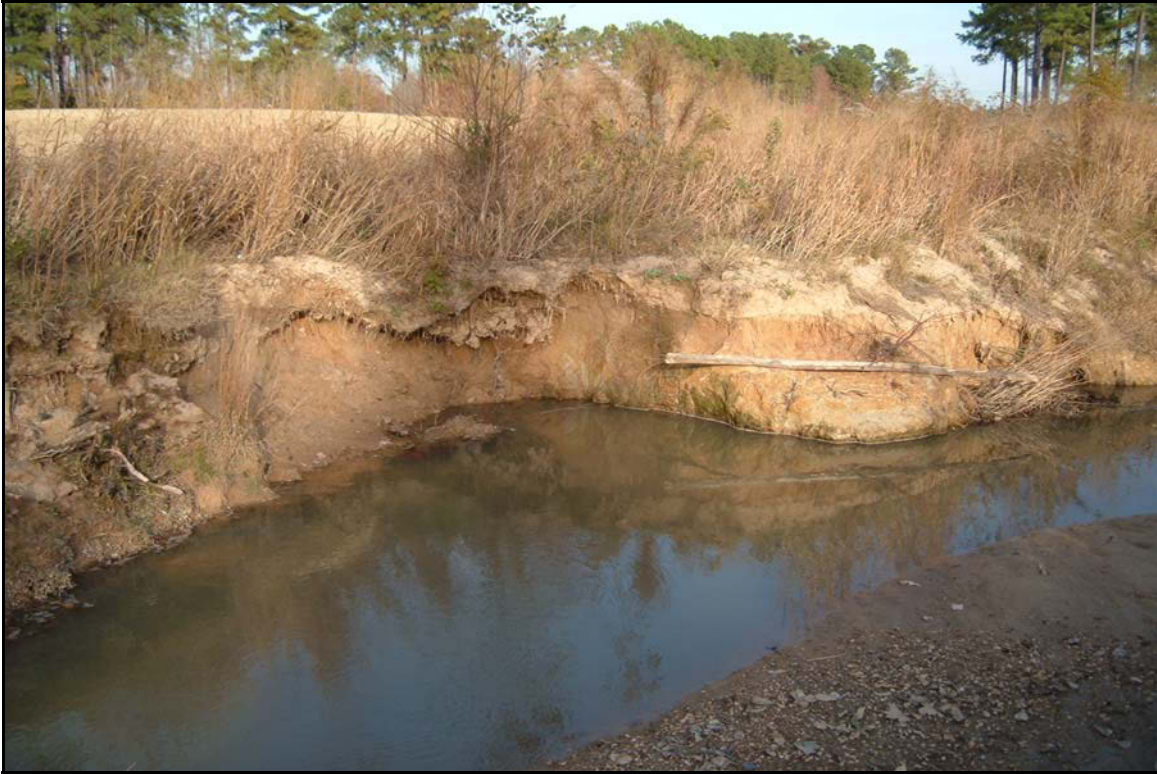
The primary problem facing the Hatchet's Grove stream are extended areas of severe bank erosion. While the specific cause of the bank erosion is unknown, the radius of curvature applied to many of the meanders appears to be too small for this suburban watershed, causing instability throughout the meanders. These eroded banks should be closely monitored to determine if corrective actions are warranted. Floodplain conditions along the stream varied in terms of erosion and deposition. Between stations 10+00 and 28+00 the floodplain shows signs of aggradation as sand has been deposited on the floodplain during high flow events, see SP5. From station 28+00 to 39+00, the floodplain has eroded creating the bare areas shown in Appendix A2 and areas of floodplain scour as listed above. Most of the floodplain scour appears to have occurred immediately following construction, before vegetation stabilized the floodplain surface. These areas were reevaluated during the second year monitoring and they appear to be stabilizing as vegetation cover becomes more prominent. The lower third of the stream appears to have a stable floodplain. No significant aggradation or degradation was noted during the second monitoring year.

SP1 – Bank erosion. Photo taken near station 18+75. 11/5/06 - MY 02

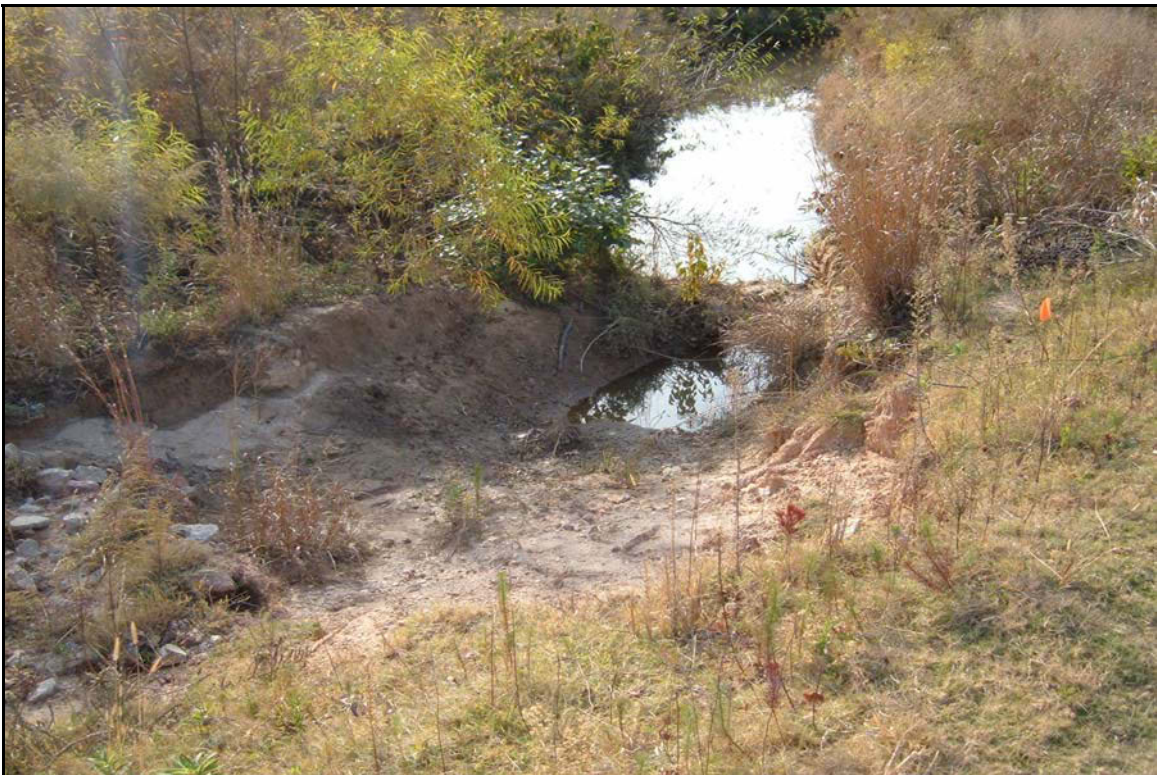
SP2 – Severe bank erosion and floodplain scour. Photo taken near station 14+75, looking down on an eroded bank and a scour hole in the floodplain. 11/5/06 - MY 02

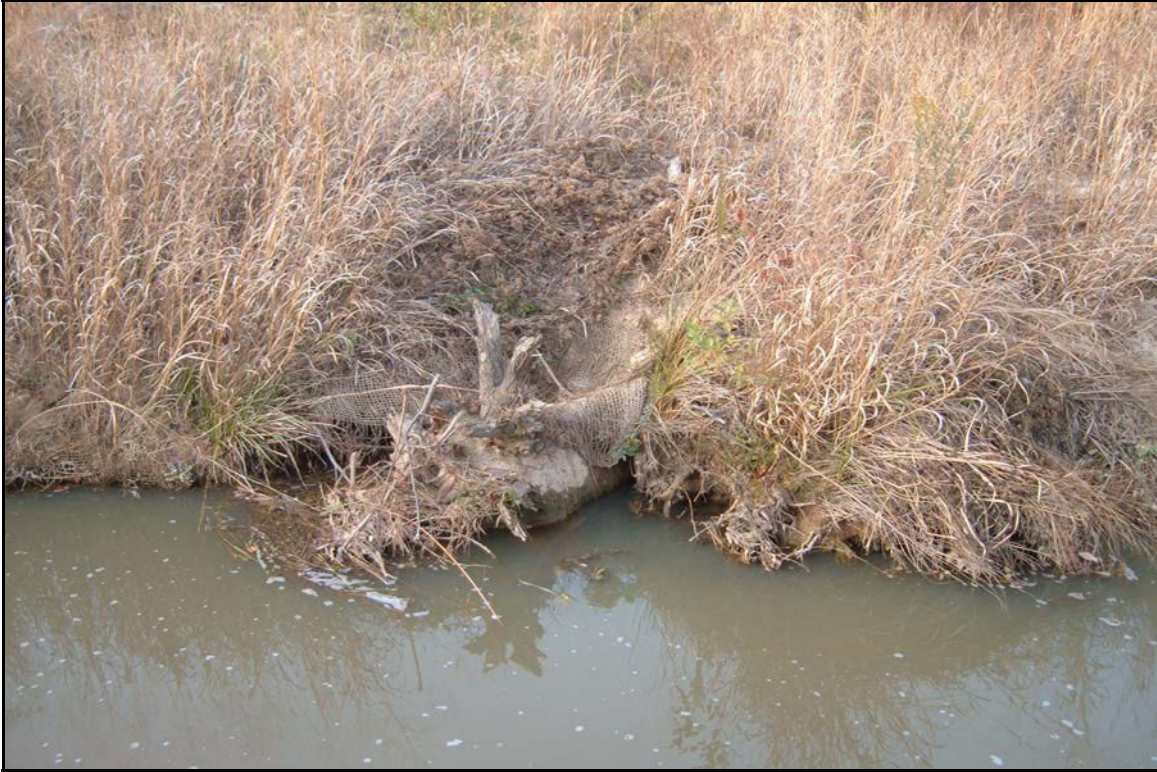
SP3 – Scour around rootwad. Vegetation and coir matting partially obscure the erosion behind the rootwad. Photo taken near station 29+10. 11/5/06 - MY 02

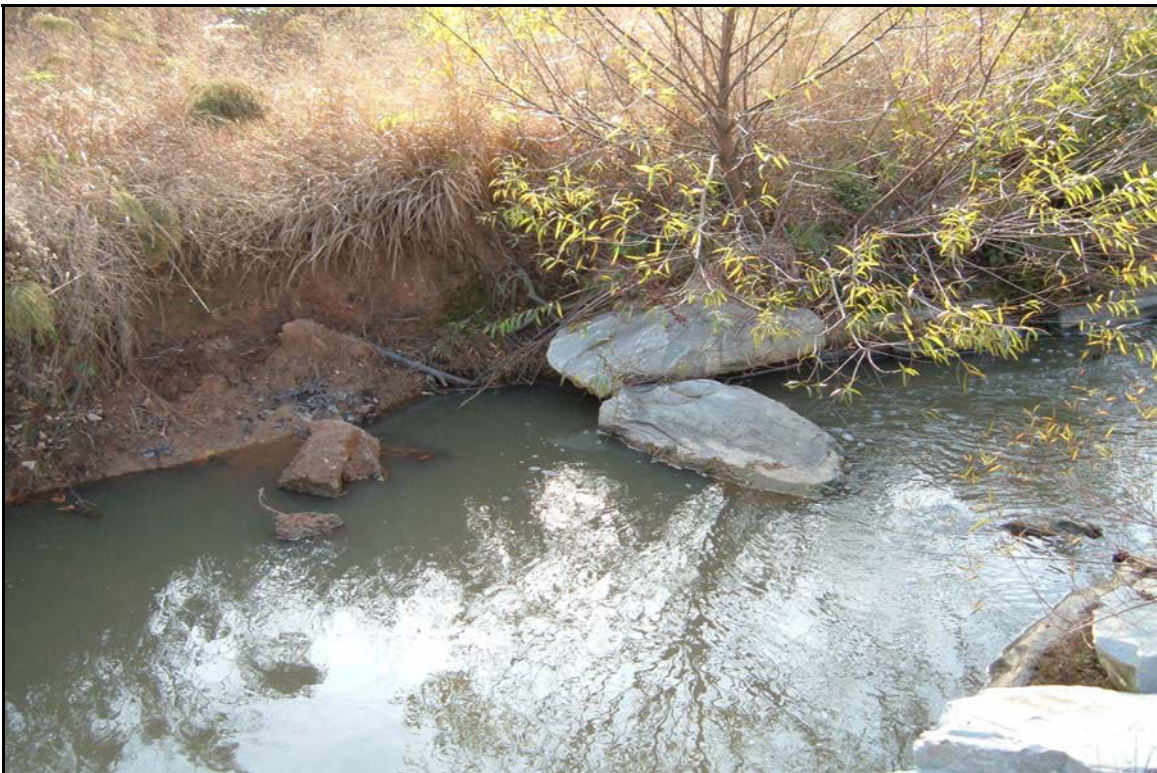
SP4 – Rock from cross vane has moved and bank has eroded behind cross vane arm. Photo taken near station 16+50. 11/5/06 - MY 02

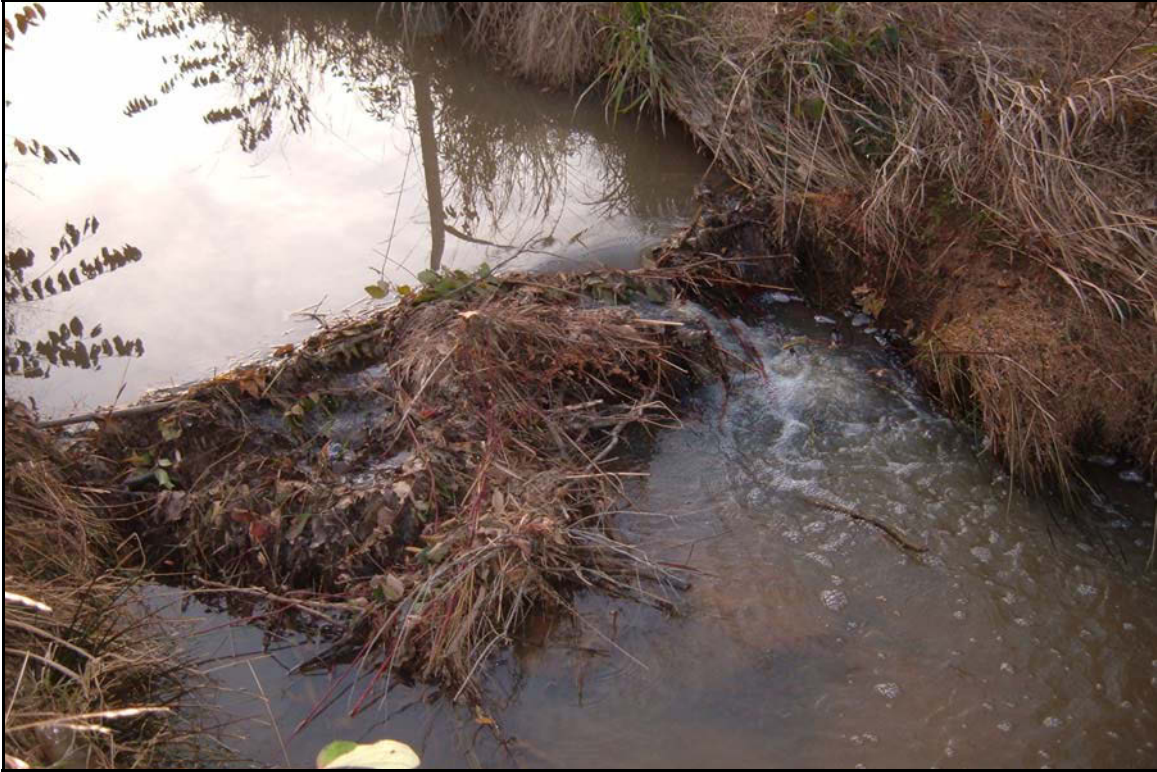
SP5 – Beaver dam. Photo taken near station 39+45. 11/5/06 - MY 02

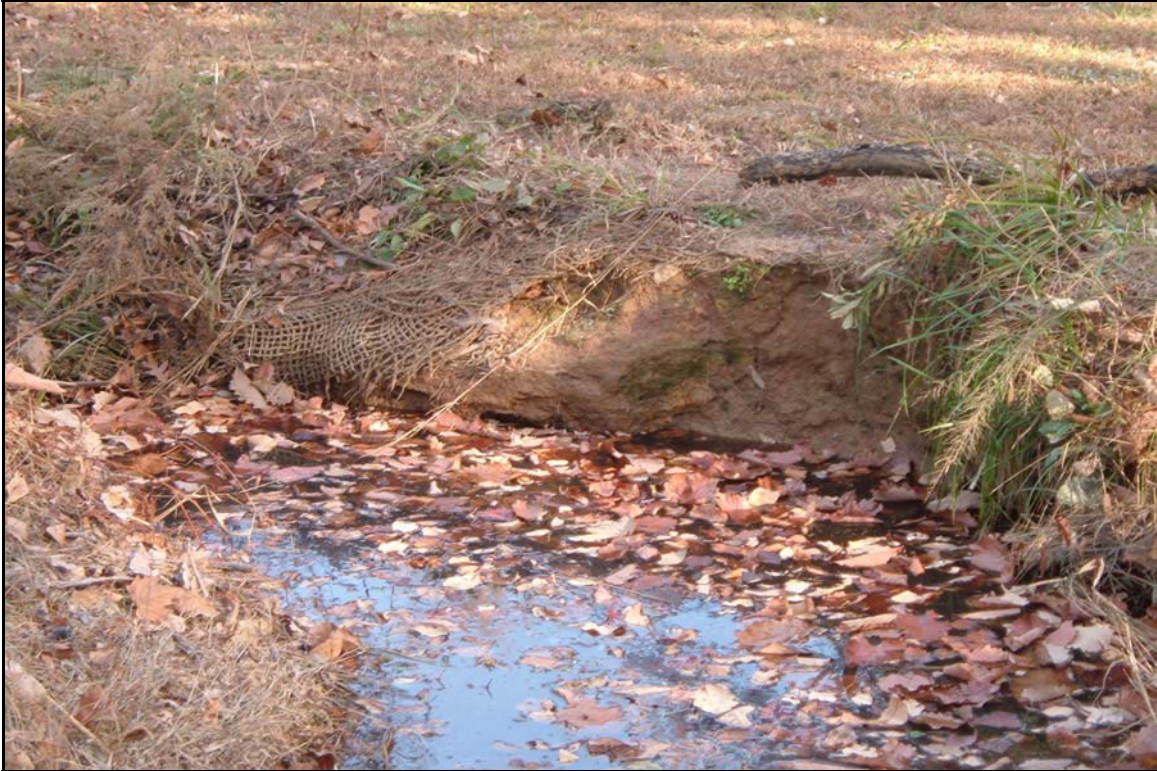
Table B1b. Stream Problem Areas			
Project Number and Name: 289 – Prestonwood Golf Course (Hatchet's Grove)			
Segment/Reach: Meadow Creek (295 ft.)			
Feature Issue	Station numbers	Suspected Cause	Photo #
Bank Erosion	00+70 – 00+80	unknown	SP6
	01+05 – 01+15	unknown	
	02+00 – 02+20	unknown	
Engineered Structure Problems	00+80	wood sill undermined	SP7
	01+10	rootwad scour	
	02+10	rootwad scour	
	02+60	scour on downstream side of sill	
	02+80	bed degradation on step pool structure	
Beaver Dam	upstream of STA 00+00	beavers	SP8
	upstream of STA 00+00	beavers

SP6 – Bank erosion. Photo taken near station 00+75. 11/5/06 - MY 02

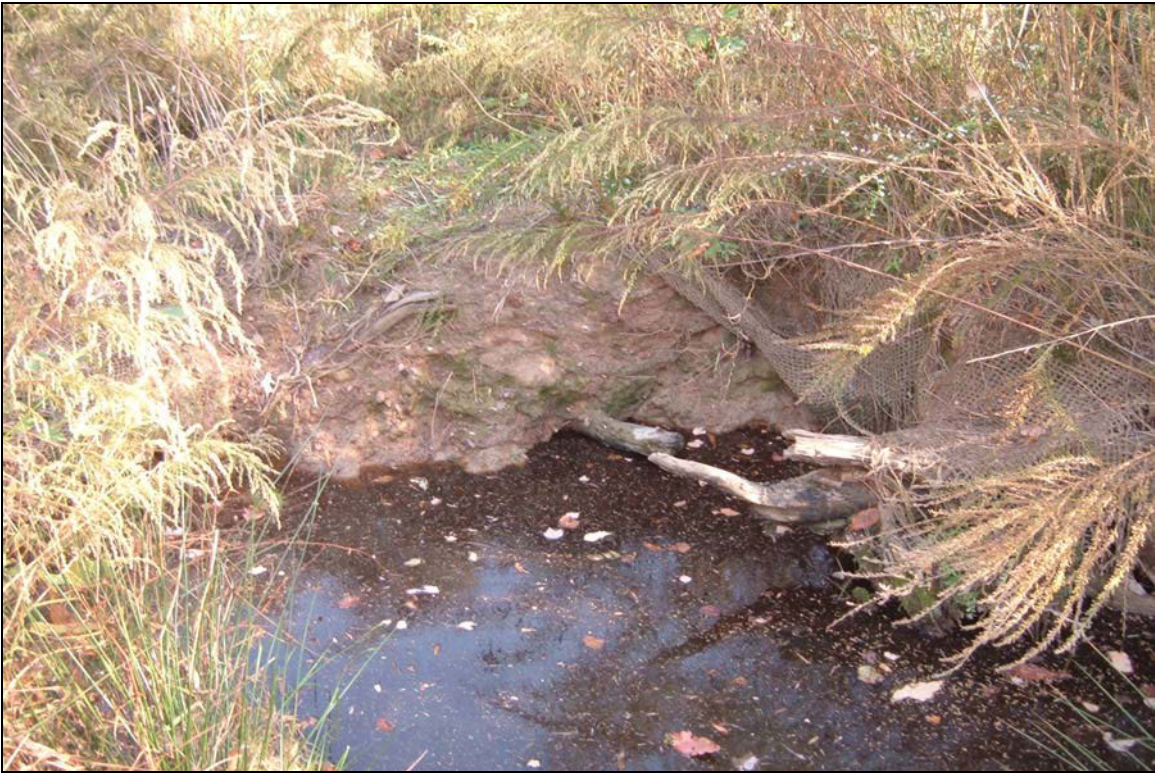
SP7 – Back scour around rootwad and bank erosion. Rootwad partially obscured by coir matting. Photo taken near station 02+10. 11/5/06 - MY 02

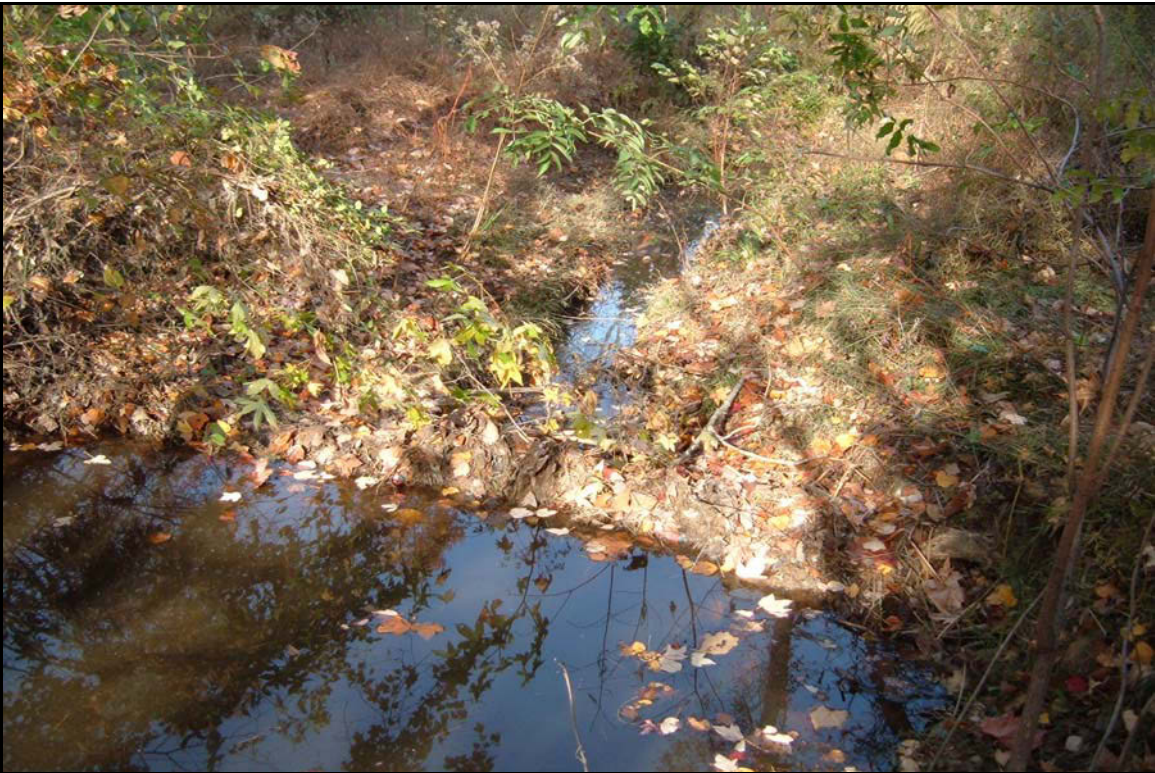
SP8 – Beaver dam. Photo taken upstream of station 00+00, looking downstream. 11/5/06 - MY 02
