**Prestonwood Golf Course  
(Hatchet's Grove)  
Stream Restoration Monitoring Report  
EEP Project # 289  
Monitoring Year – 03  
2007**

**February 2008**

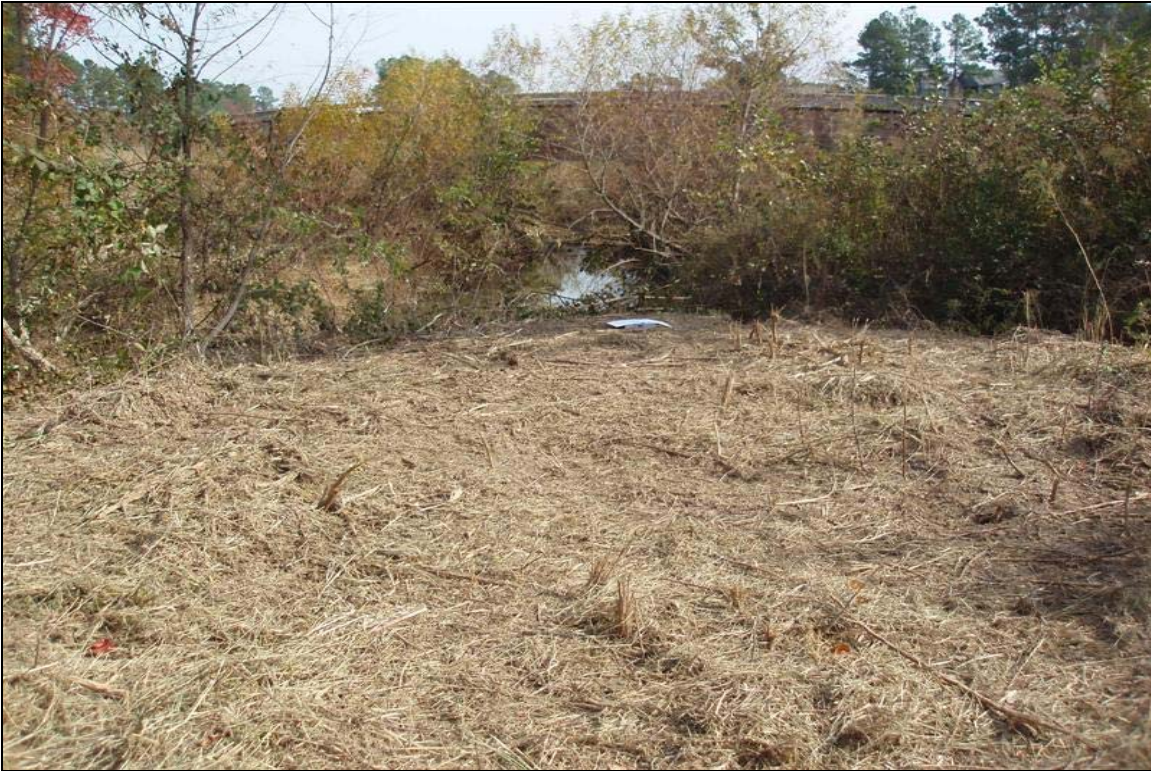
VP1 – Photo taken at cleared sewer easement near the confluence looking downstream. 11/13/07 - MY 03

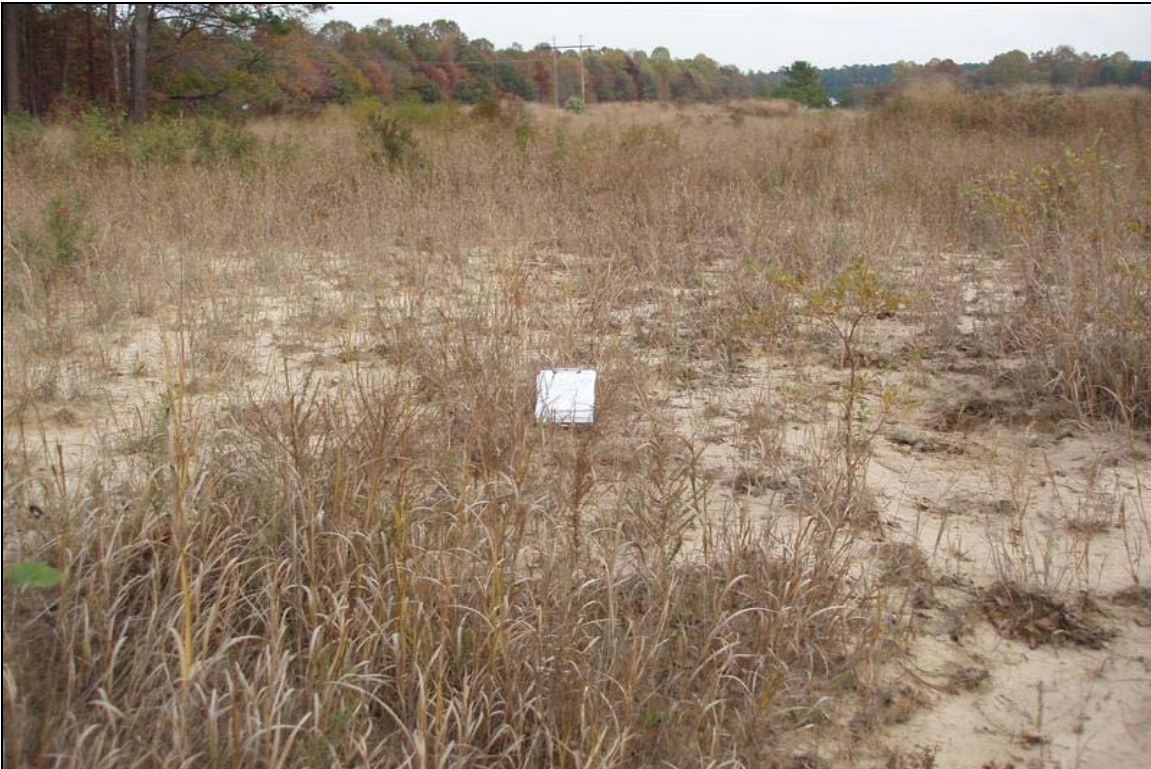
VP2 - Sparsely vegetated floodplain near Station 30+00. 11/13/07 - MY 03

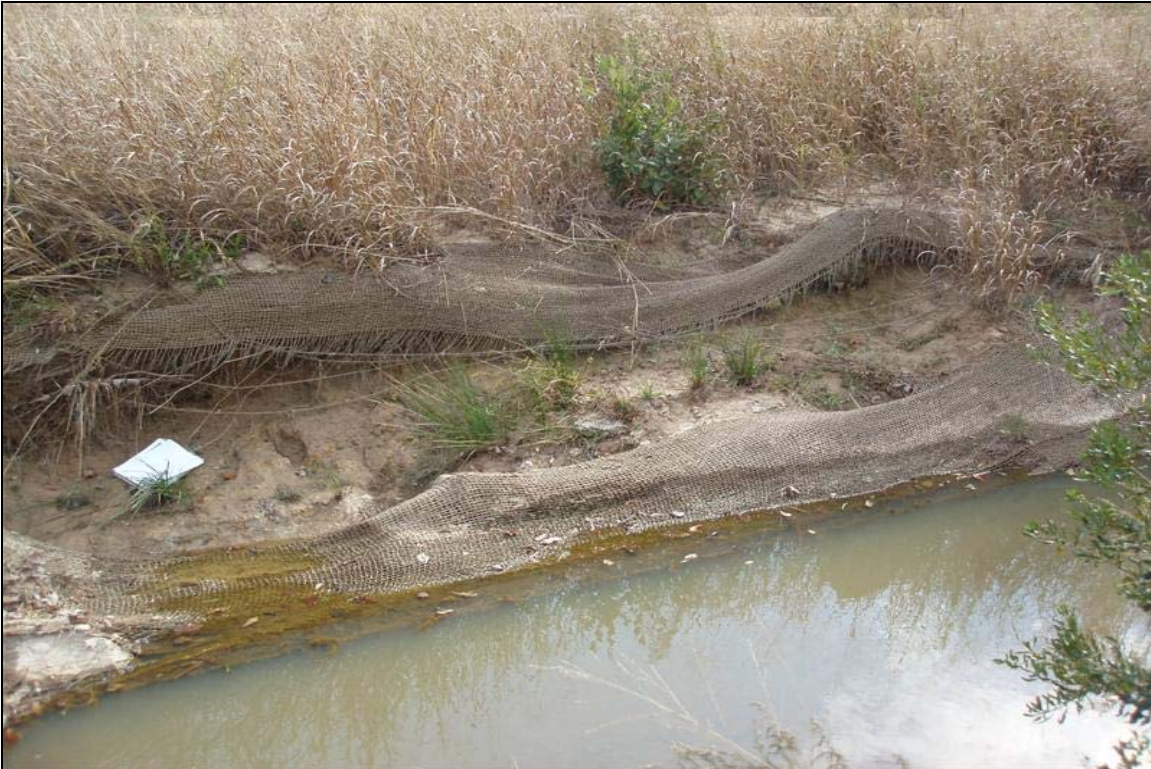
SP1 - Bank erosion. Photo taken near Station 18+60. 11/13/07 - MY 03

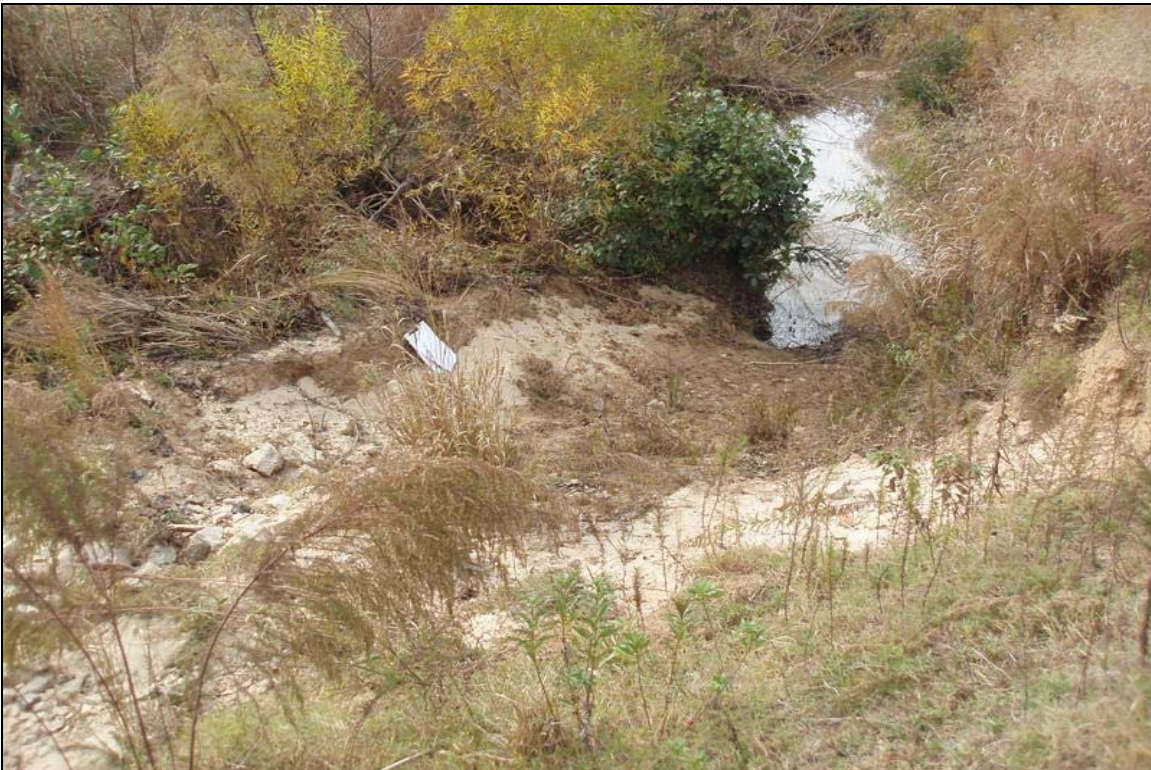
The Hatchet's Grove stream has extended areas of severe bank erosion. While the specific cause of the bank erosion is unknown, the radius of curvature applied to many of the meanders appears to be too small for this suburban watershed, causing instability throughout the meanders. These eroded banks should be closely monitored to determine if corrective actions are warranted. Floodplain conditions along the stream varied in terms of erosion and deposition. Most of the floodplain scour likely occurred immediately following construction before vegetation stabilized the floodplain surface. Monitoring Year 03 found that some of these areas continue to stabilize as vegetative cover becomes more established. The lower third of the stream has a stable floodplain with no significant aggradation or degradation noted during the third monitoring year.

SP2 - Severe bank erosion and floodplain scour. Photo taken near Station 14+75, looking down on an eroded bank and a scour hole in the floodplain. 11/13/07 - MY 03

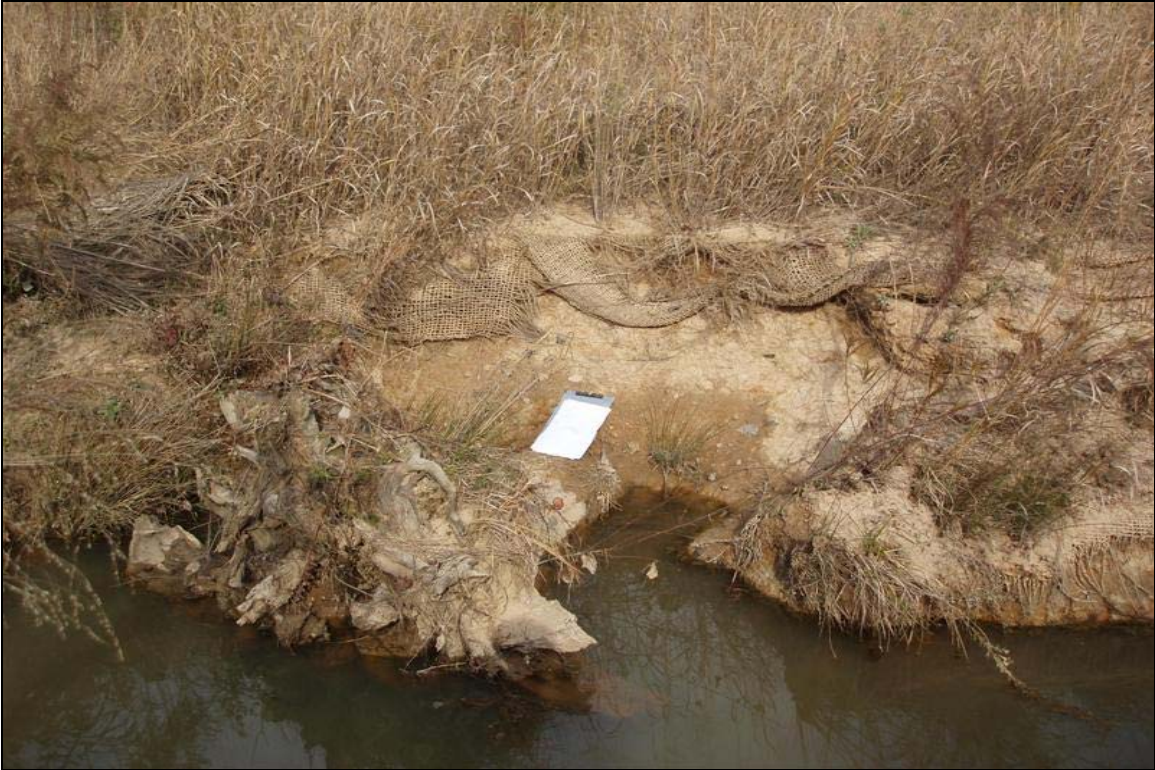
SP3 - Scour around rootwad. Vegetation and coir matting partially obscure the erosion behind the rootwad. Photo taken near Station 37+50. 11/13/07 - MY 03

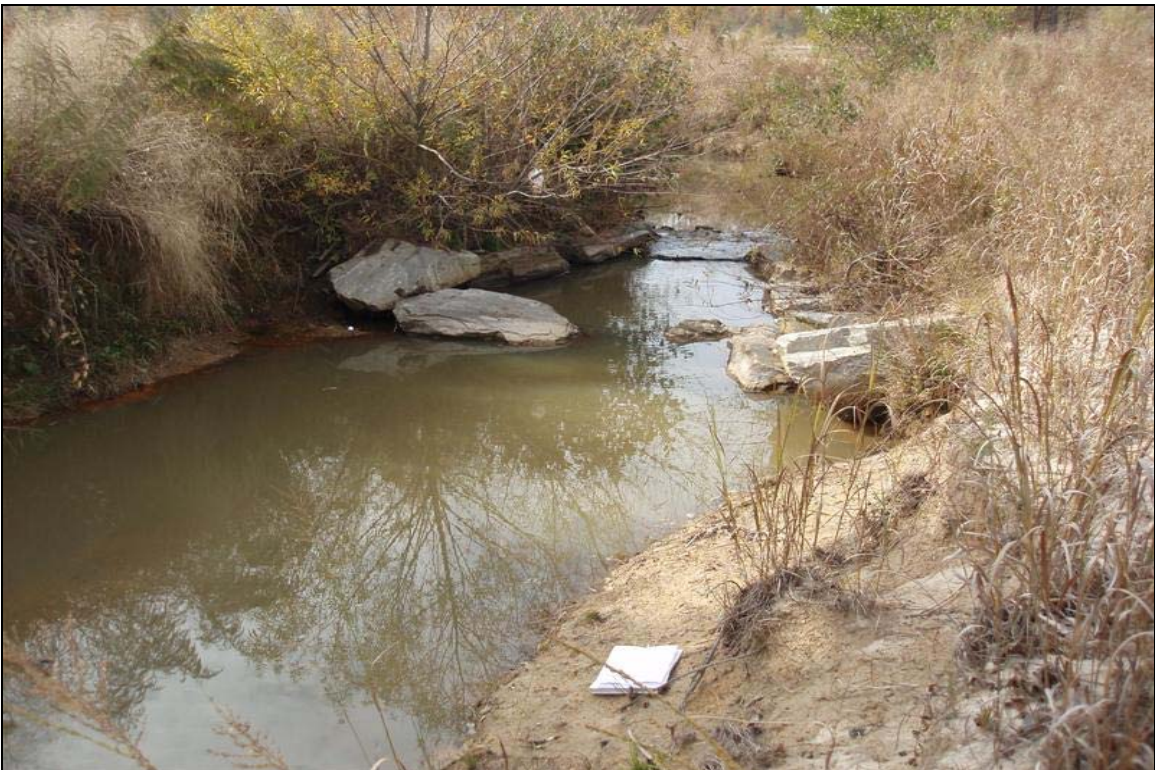
SP4 - Rock from cross vane has moved and bank has eroded behind cross vane arm. Photo taken near Station 16+75. 11/13/07 - MY 03

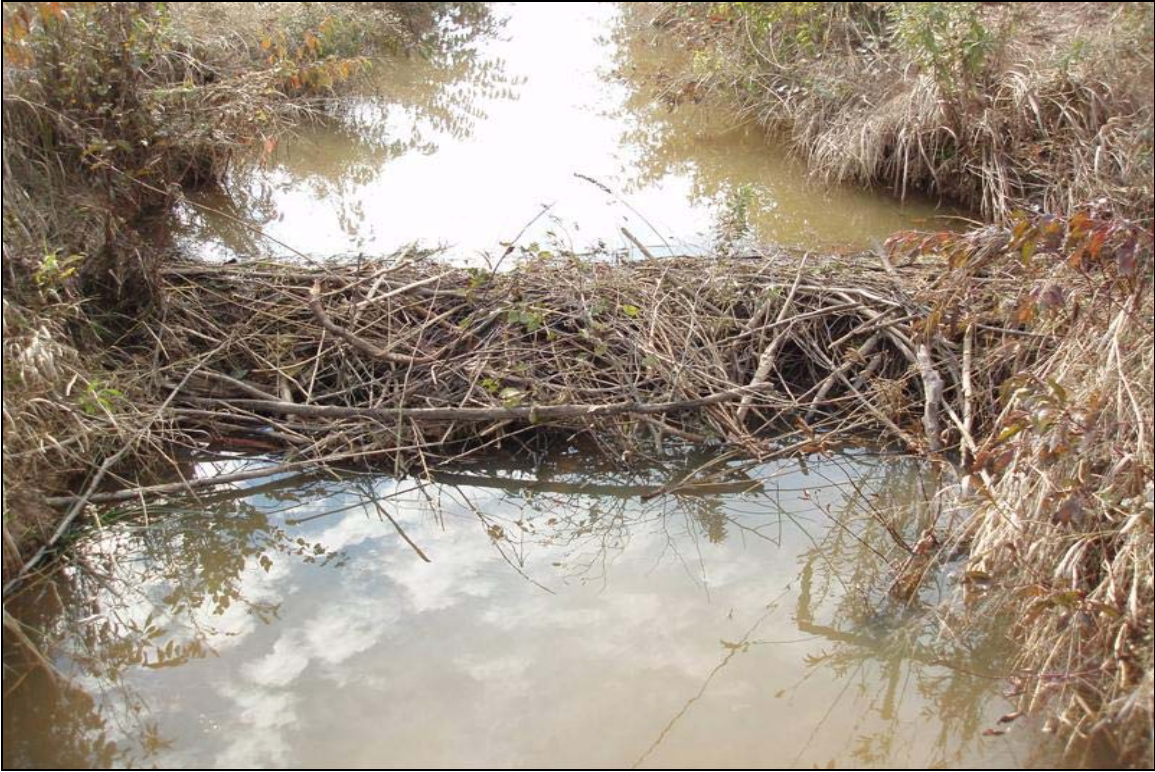
Two new beaver dams have been built just downstream of the project boundary, 15 feet apart, but still on the main channel. The previous beaver dam along the downstream portion of the project is no longer present. The new beaver dam is ponding the lower portion of the stream, as described in the Current Conditions Plan View. This beaver dam should be removed to allow normal stream flow.

SP5 – Upstream Beaver dam. Photo taken near Station 49+75. 11/13/06 - MY 03

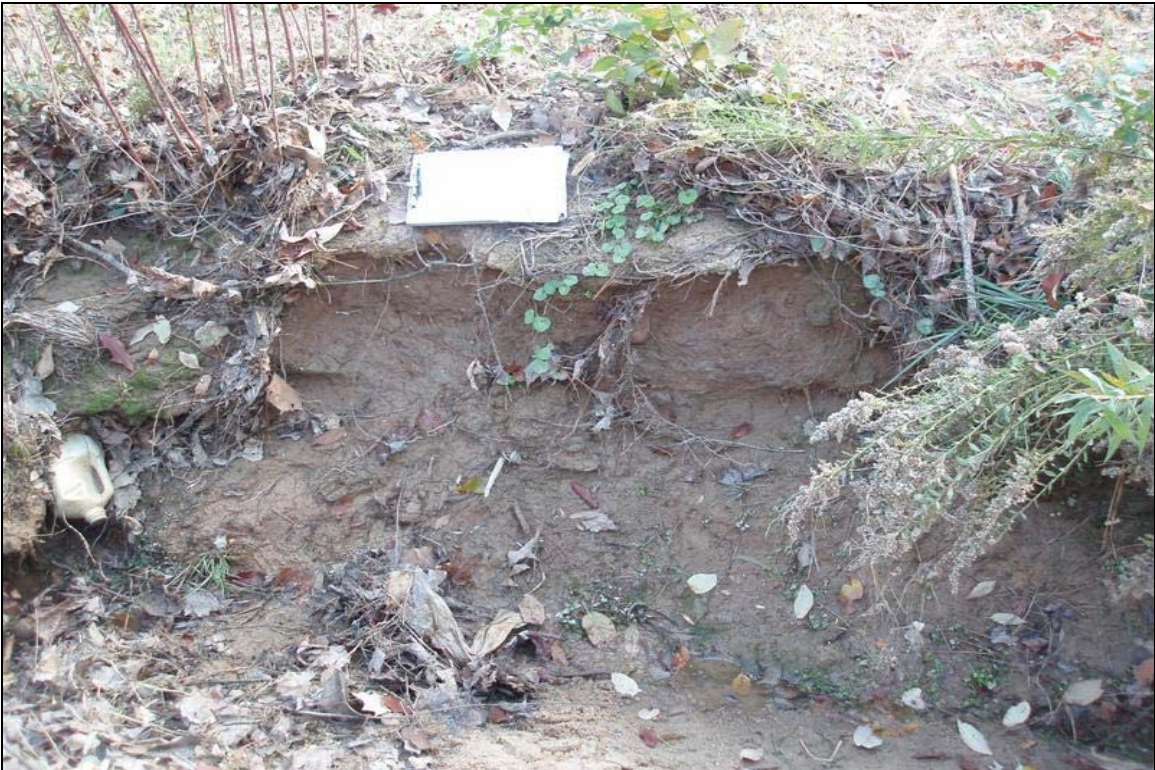
SP6 - Bank erosion. Photo taken near Station 00+75. 11/13/07 - MY 03

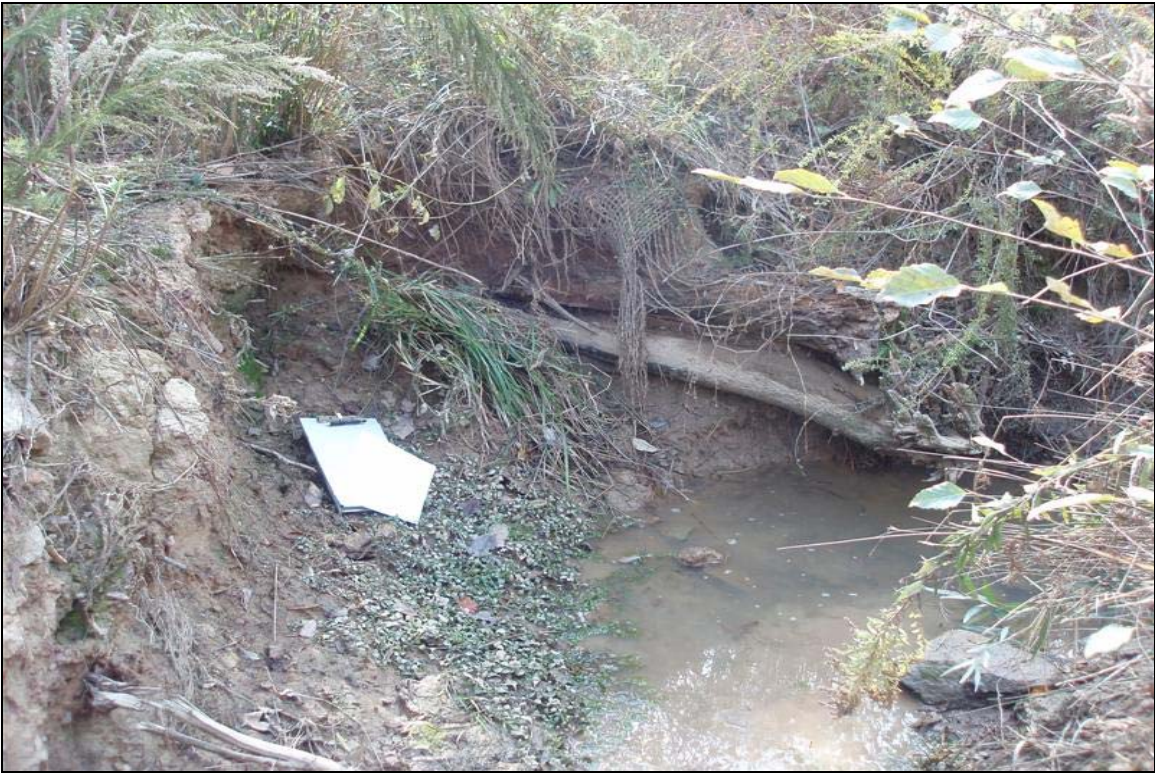
SP7 - Back scour around rootwad and bank erosion. Rootwad partially obscured by coir matting. Photo taken near Station 02+10. 11/13/07 - MY 03
