**Prestonwood Golf Course
(Hatchet's Grove)
Stream Restoration Monitoring Report
EEP Project # 289
Monitoring Year – 04
2008**

March 2009

In 2004, the North Carolina Ecosystem Enhancement Program (EEP) conducted restoration of Hatchet's Grove Tributary and a tributary to Hatchet's Grove (Meadow Creek). Soil and Environmental Consultants, PA (S&EC) designed the restoration. The watershed of approximately 3.7 square miles is located within the USGS 14-digit HUC 03020201080010 and the NCDWQ Sub-basin 03-04-02 of the Neuse River Basin. The project restored approximately 4,123 linear feet of channel, 3,828 feet on Hatchet's Grove and 295 feet on Meadow Creek through the Prestonwood Golf Course in Cary, North Carolina. The restoration was designed to correct problems within the existing stream corridor from channelization and poor vegetation maintenance practices. Construction was completed in 2004, and the first through third years of monitoring took place from 2005 through 2007. This report describes the findings of the fourth year of monitoring that took place in 2008.

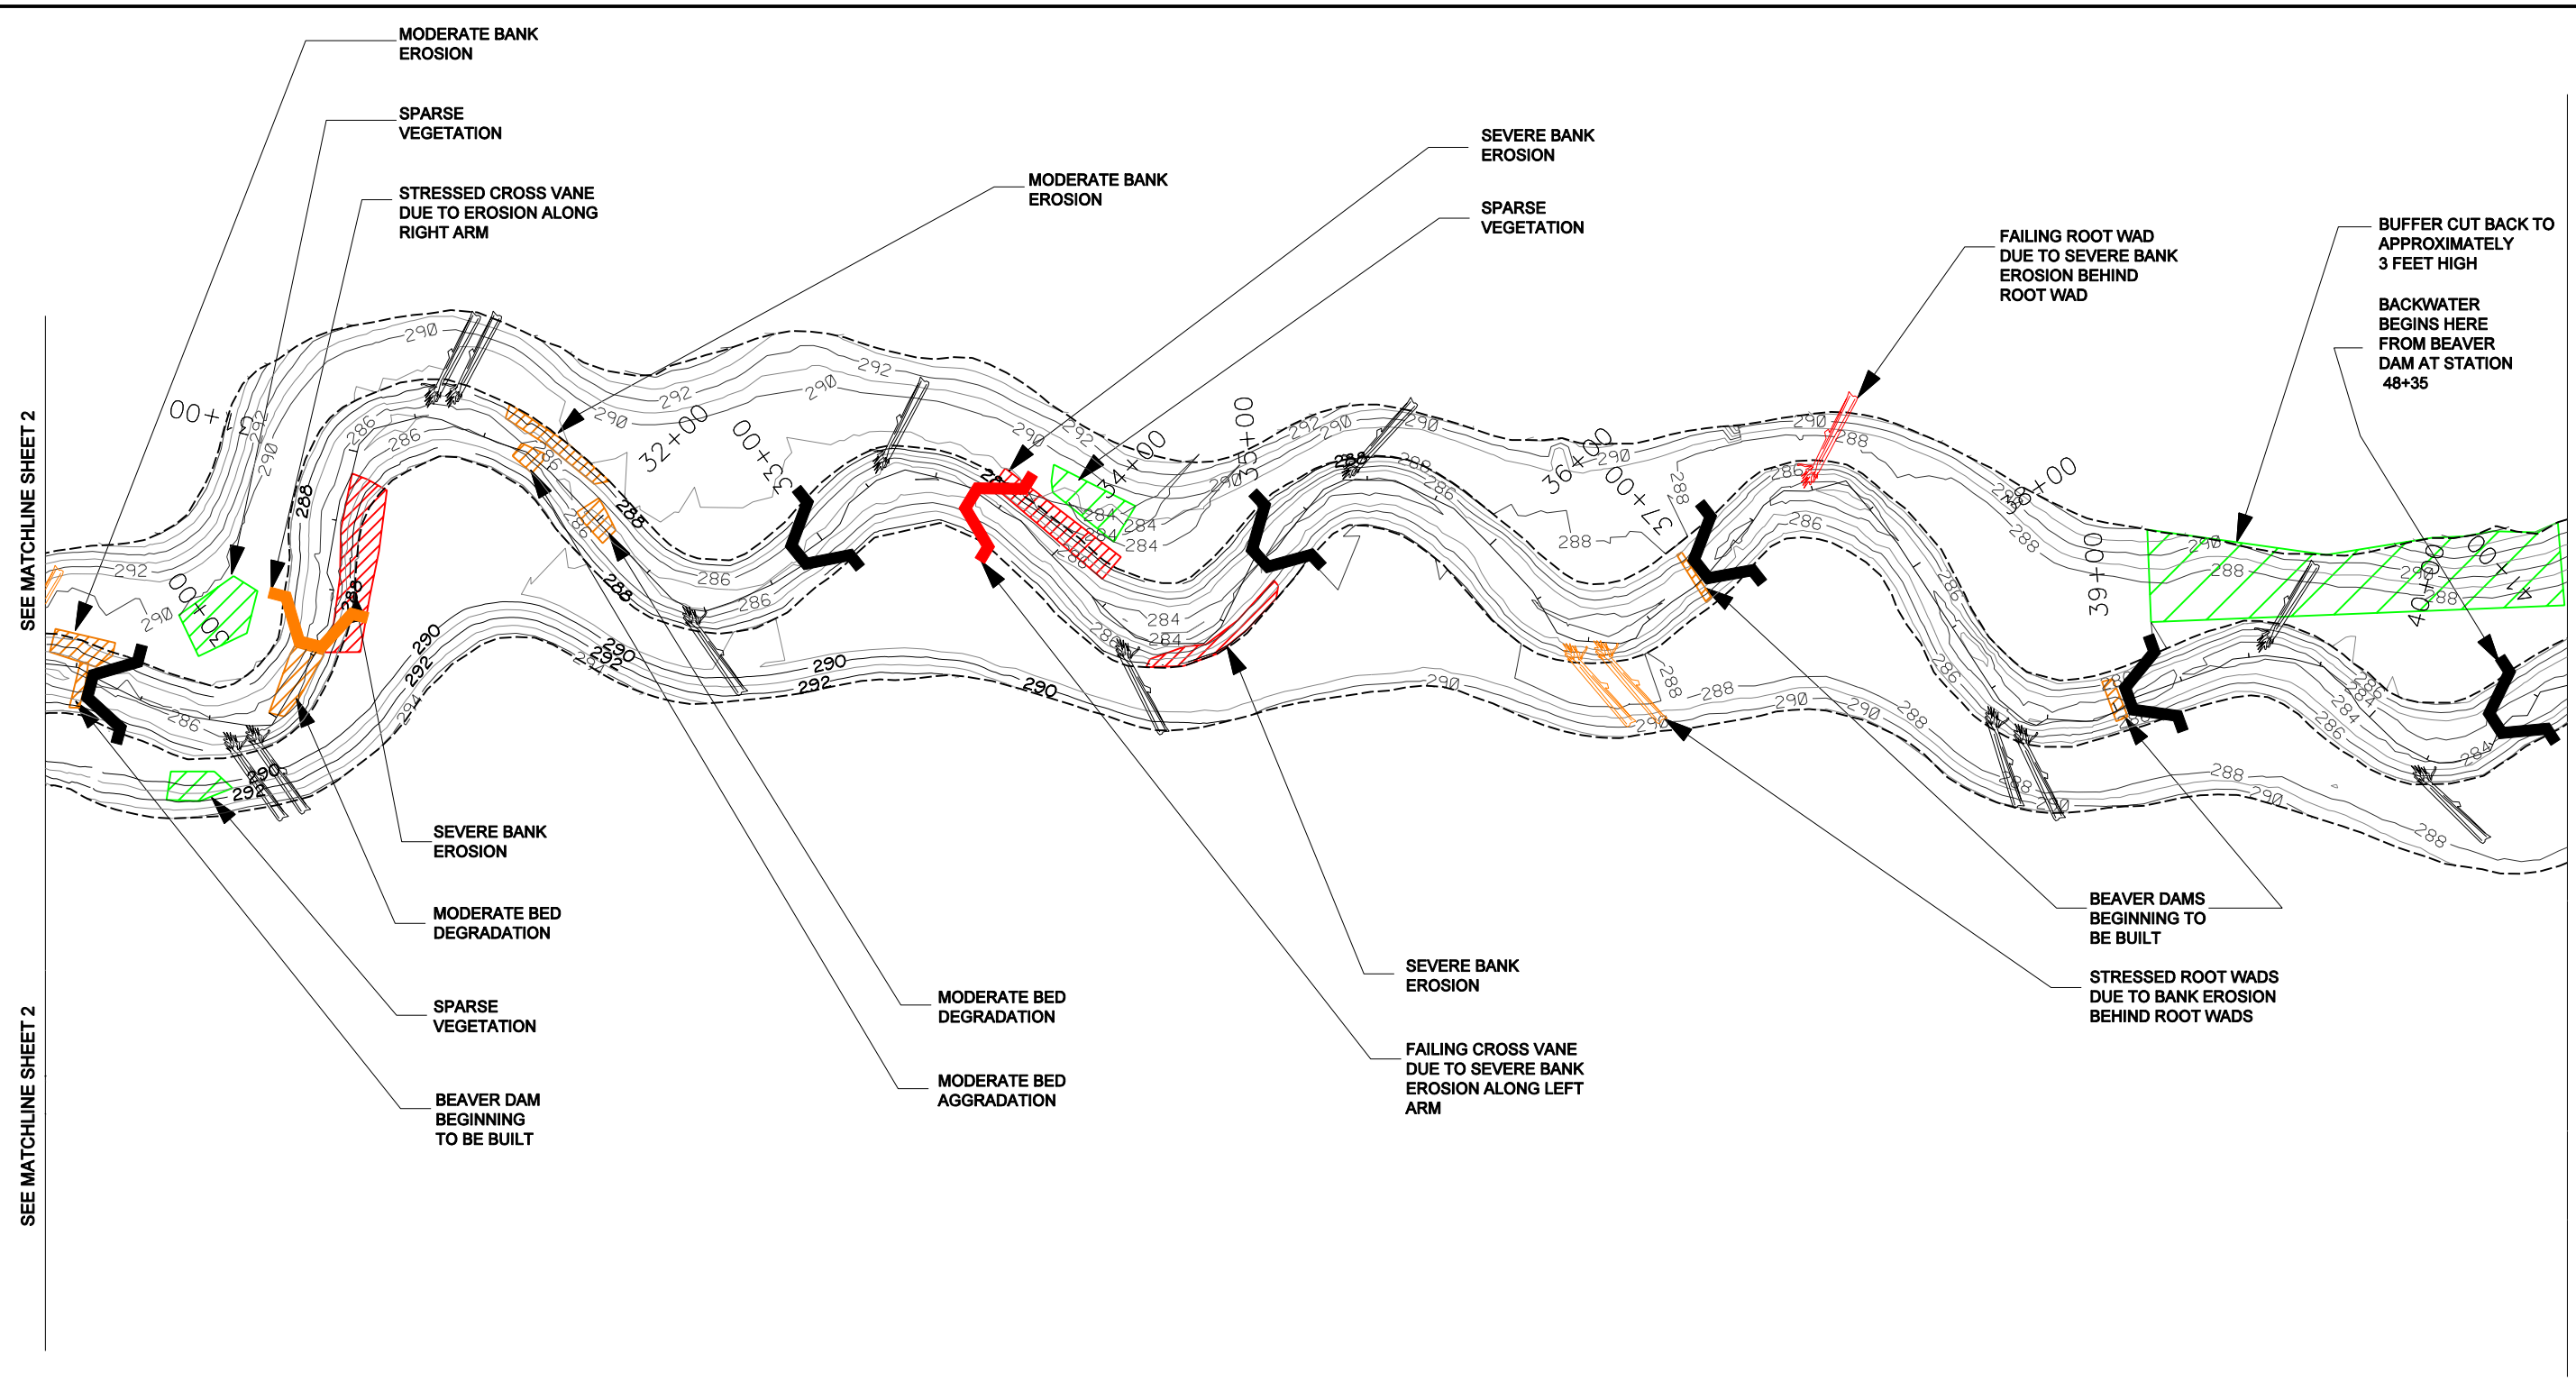
DATE: NOVEMBER 2008
SCALE: SEE SHEET
CURRENT CONDITIONS PLAN VIEW
SHEET 3 OF 4

FAILING ROOT WAD DUE TO SEVERE BANK EROSION BEHIND ROOT WAD

MODERATE BED DEGRADATION

FAILING CROSS VANE DUE TO SEVERE BANK EROSION ALONG LEFT ARM

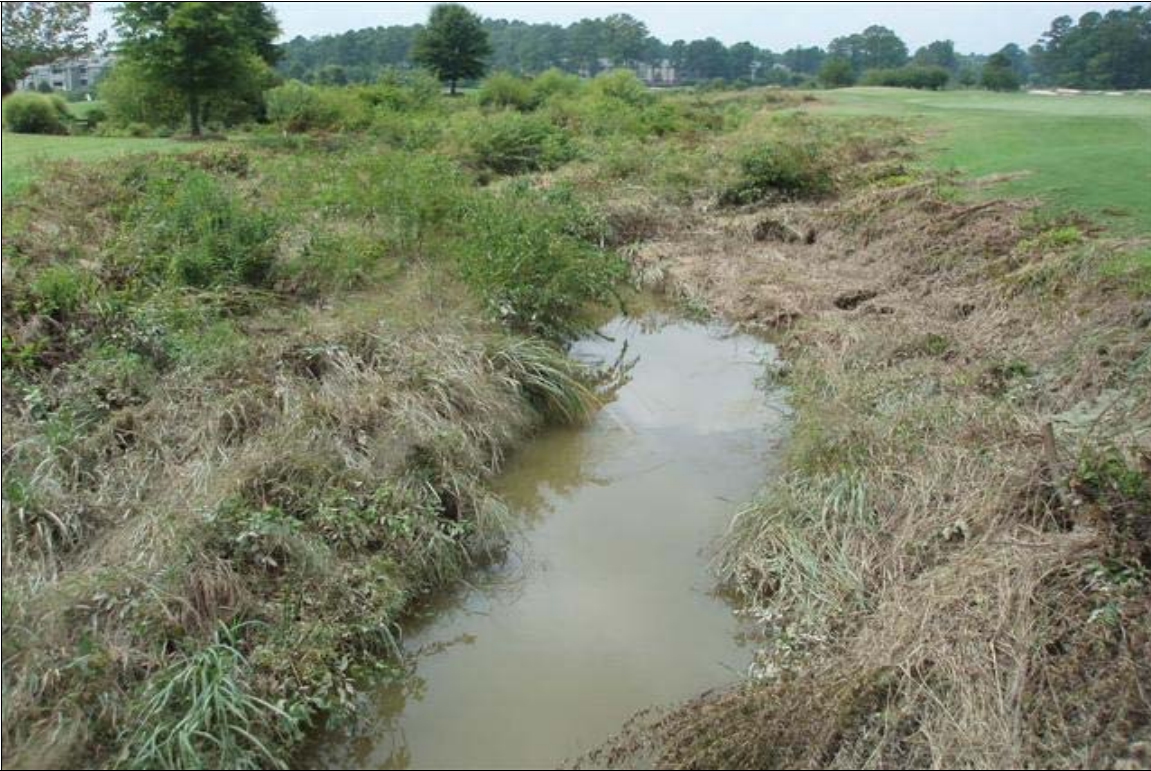
VP1 – Photo taken near station 48+00 looking upstream towards Veg Plots 5 and 6. Left bank vegetation has been cut for play over area. 9/2/08 - MY 04

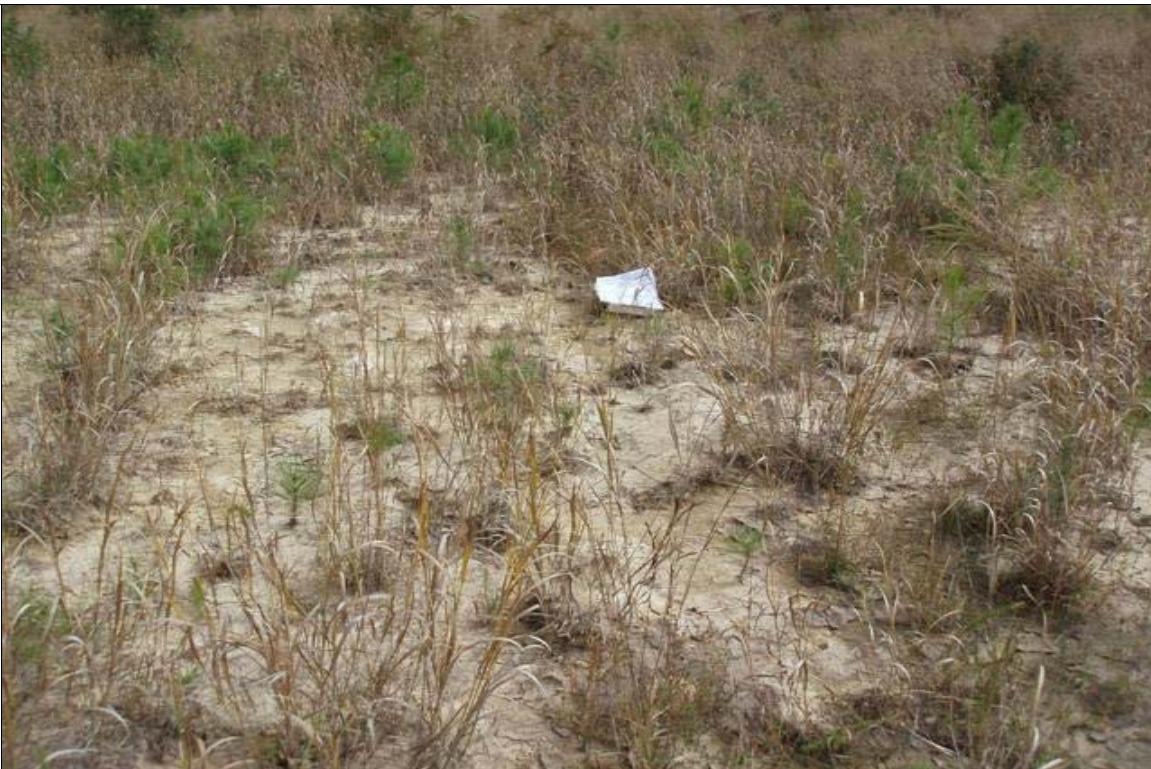
VP2 - Sparsely vegetated floodplain near Station 30+00. 10/27/08 - MY 04

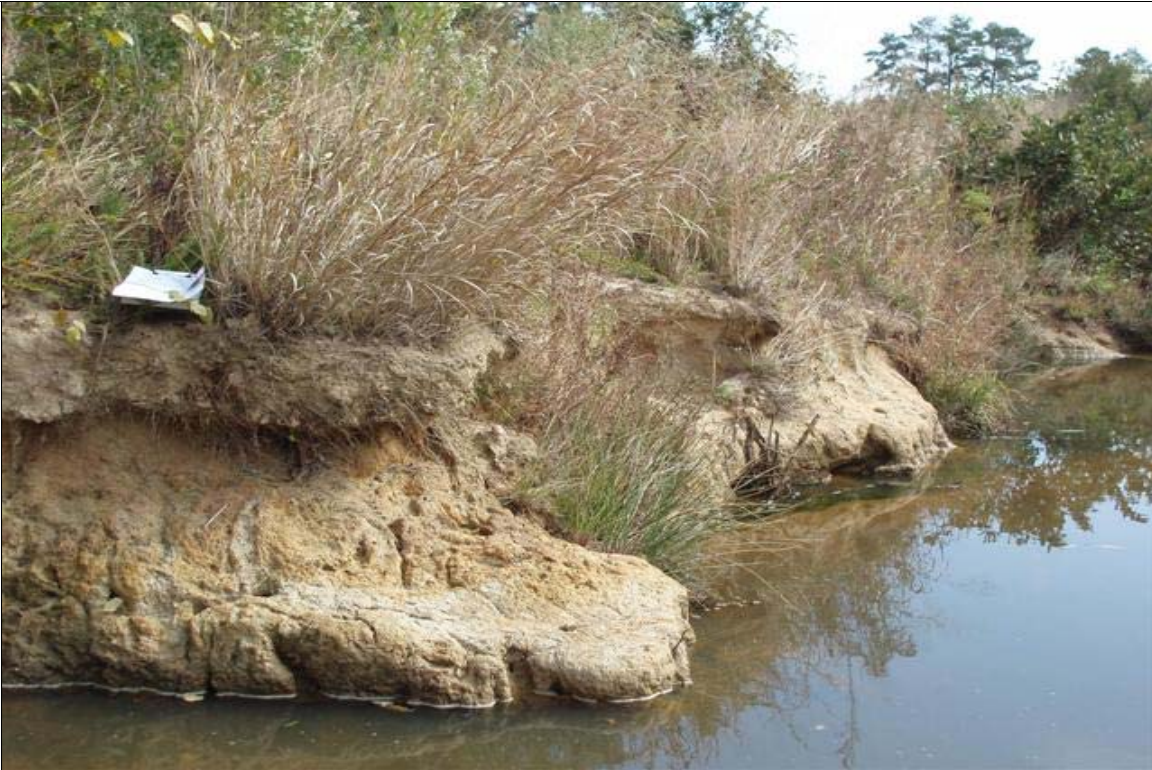
SP1 - Bank erosion. Photo taken near Station 18+60. 10/27/08 - MY 04.

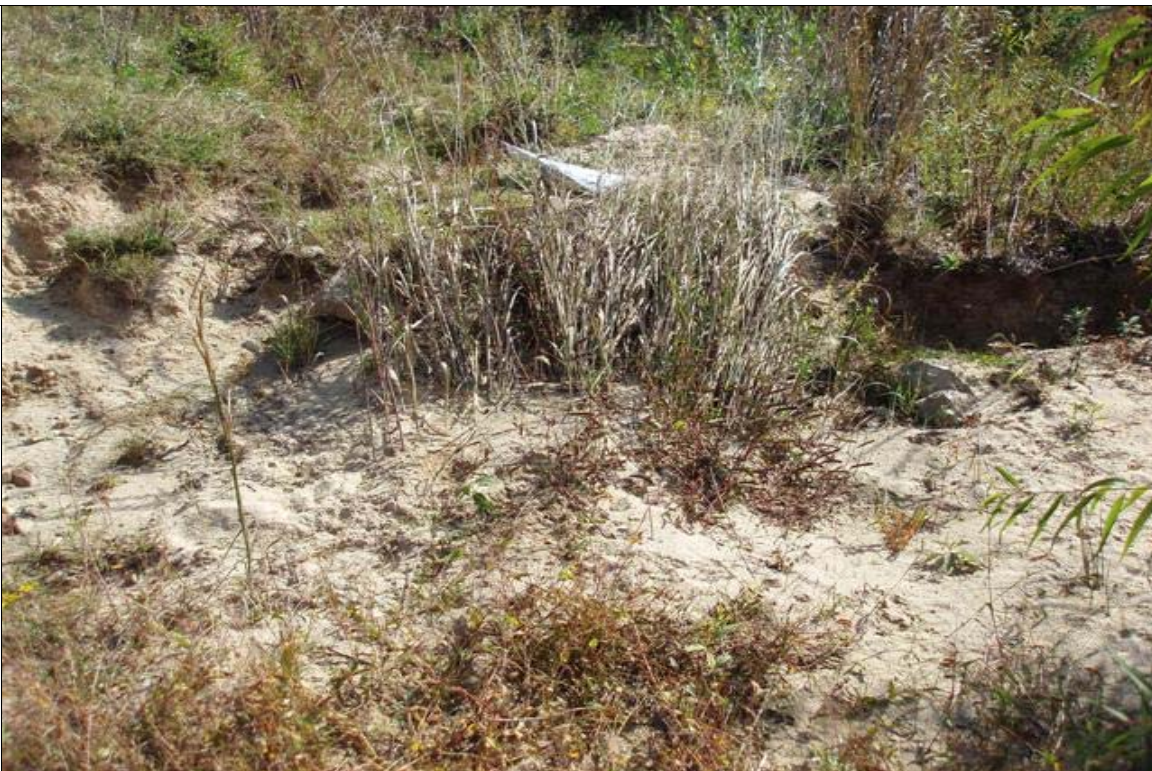
SP2 - Floodplain scour. Photo taken near Station 14+75. 10/27/08 - MY 04.

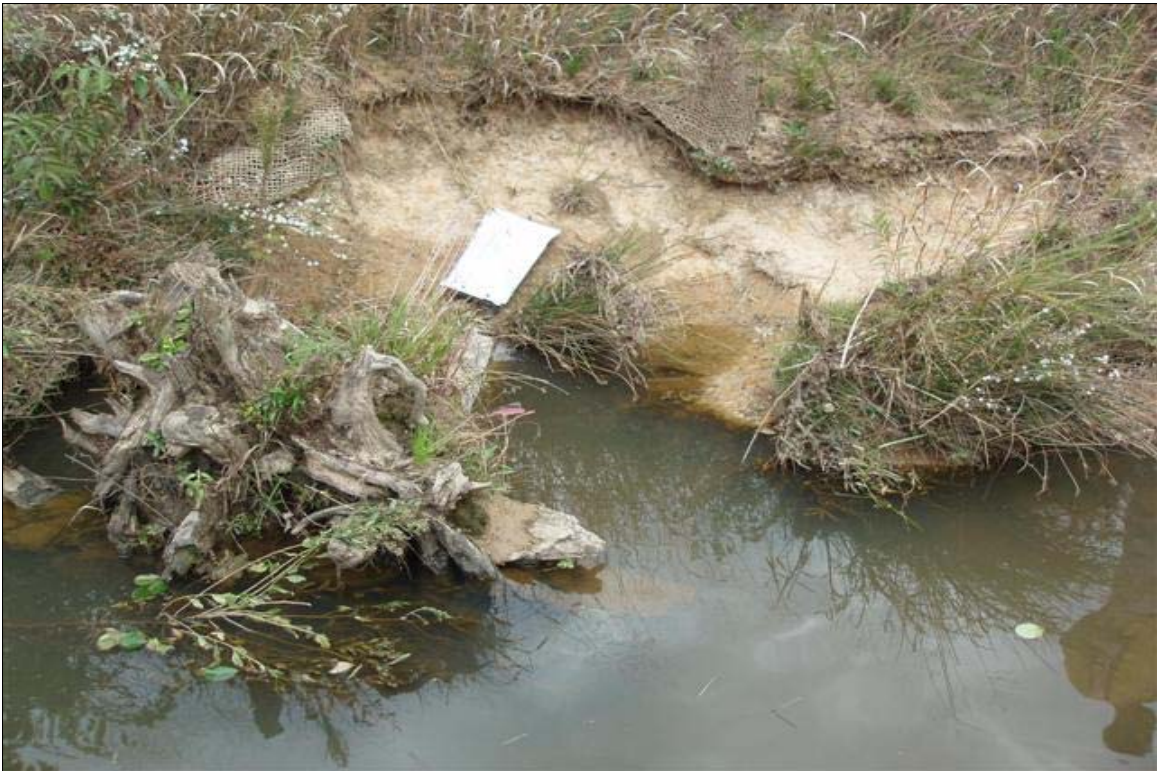
SP3 - Scour around rootwad. Photo taken near Station 37+50. 10/27/08 - MY 04.

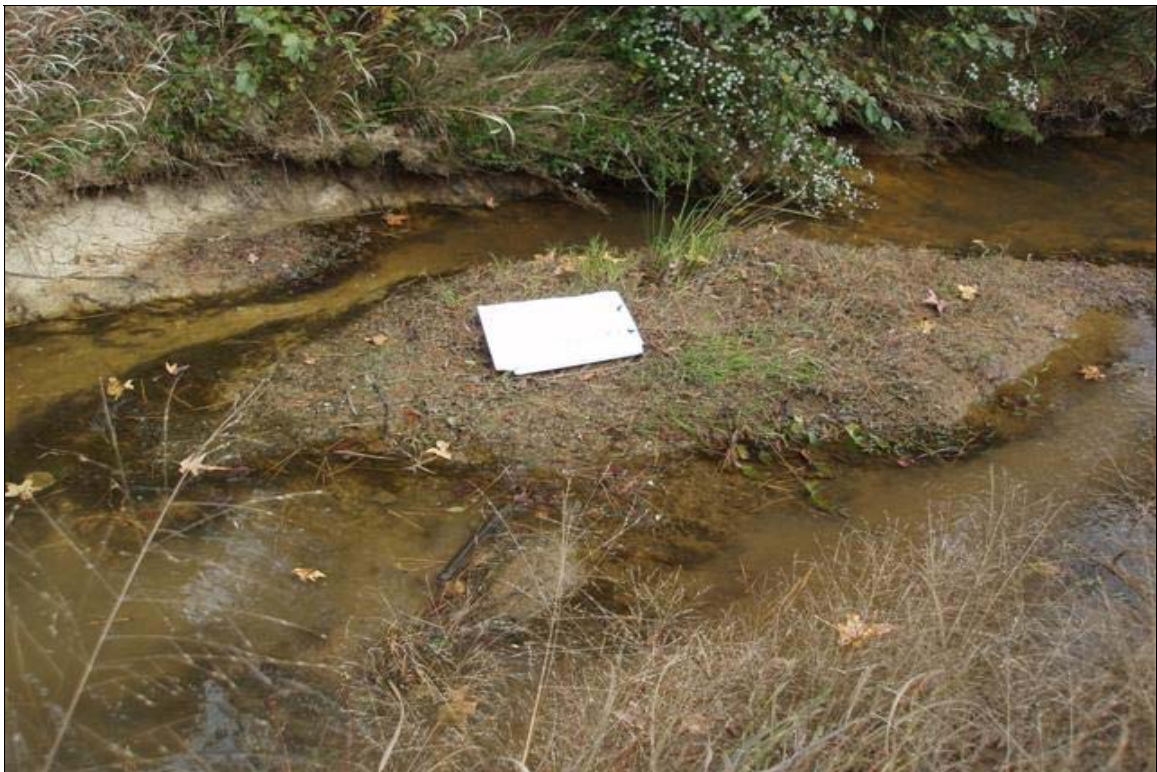
SP4 – Mid-channel bar. Photo taken near Station 32+000. 10/27/08 - MY 04.

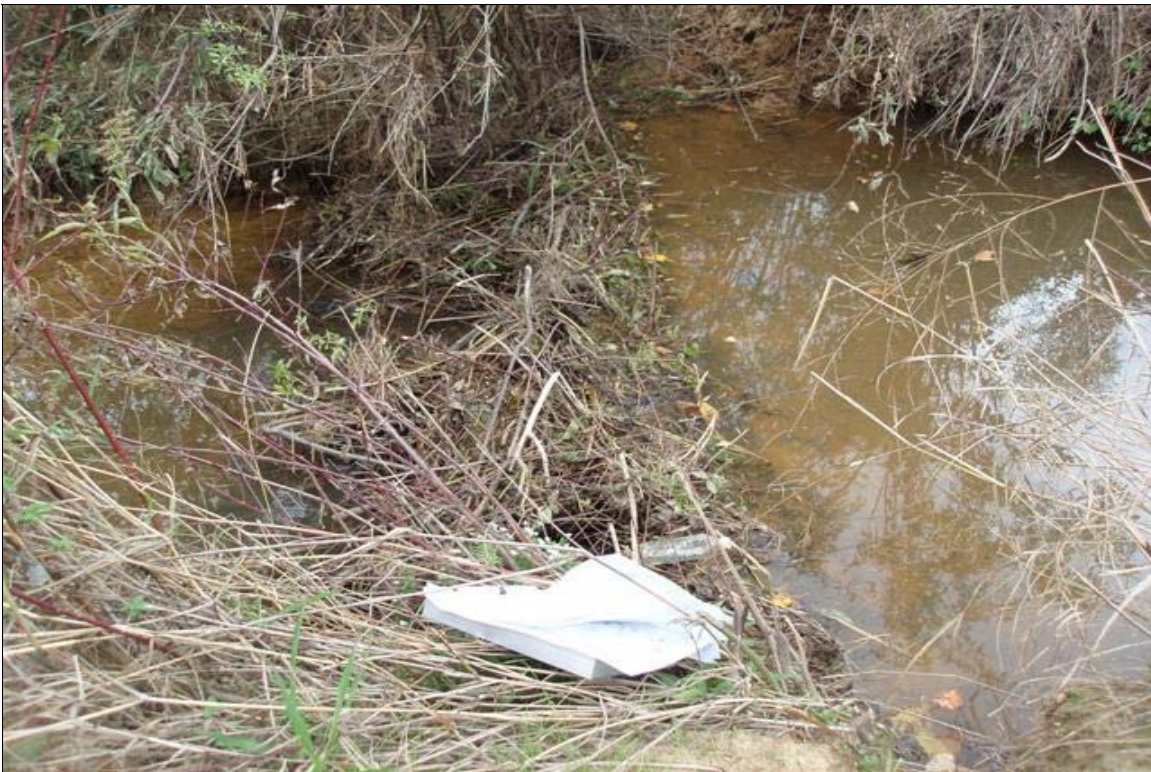
One new beaver dam has been built just downstream of the third bridge across the project stream. Four more beaver dams were being constructed, but have not begun to cause backwatering. The new beaver dam is ponding the lower portion of the stream, as described in the Current Conditions Plan View. EEP has informed KCI that the golf course has a private contractor for beaver control and is employed to address beaver or beaver dams as they are observed on site within the restoration reach. The beaver and dams noted in 2008 by KCI have since been removed.

SP5 –Beaver dam. Photo taken near Station 48+40. 10/27/08 - MY 04.

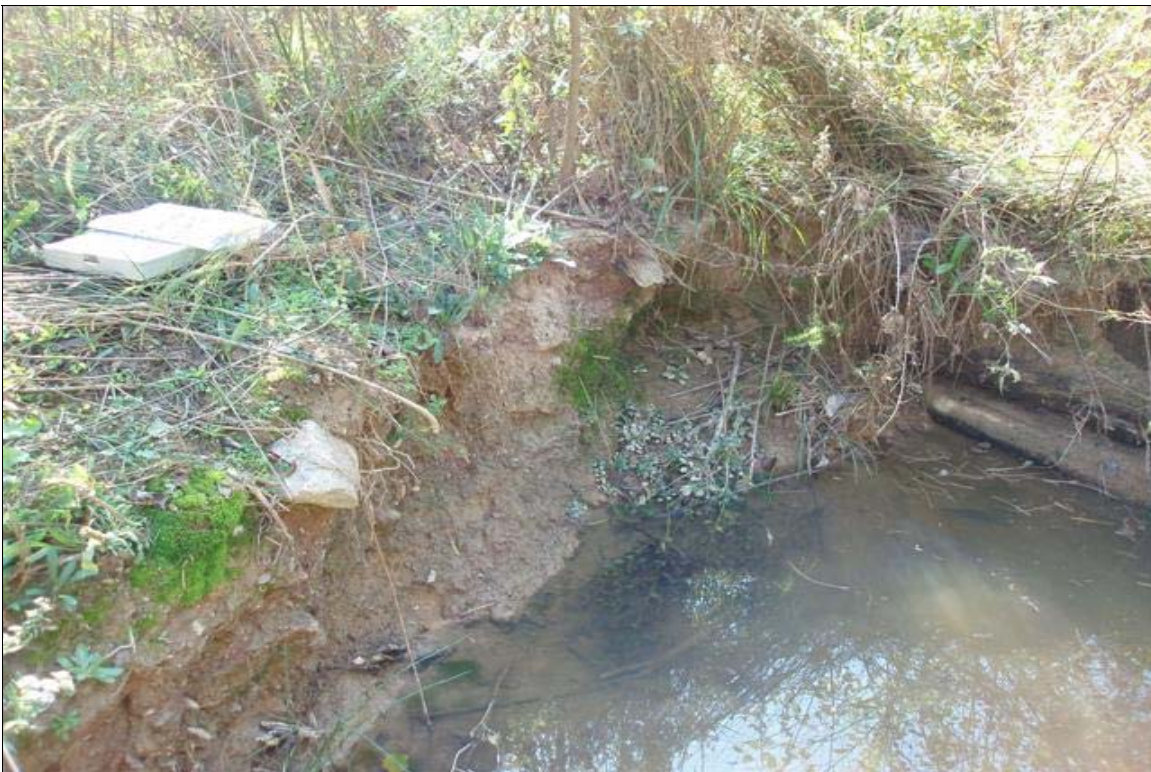
SP6 - Bank erosion. Photo taken near Station 2+00. 10/27/08 - MY 04.

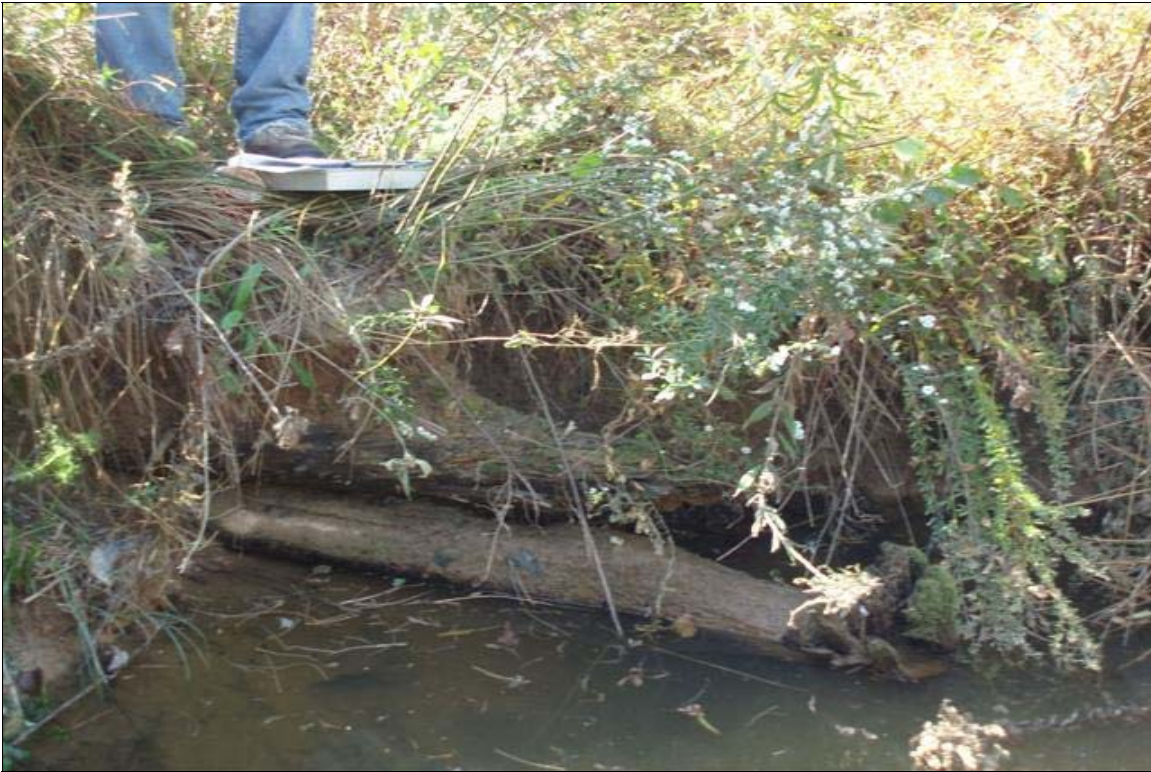
SP7 - Back scour around rootwad and bank erosion. Rootwad partially obscured by coir matting and vegetation. Photo taken near Station 02+10. 10/27/08 - MY 04.

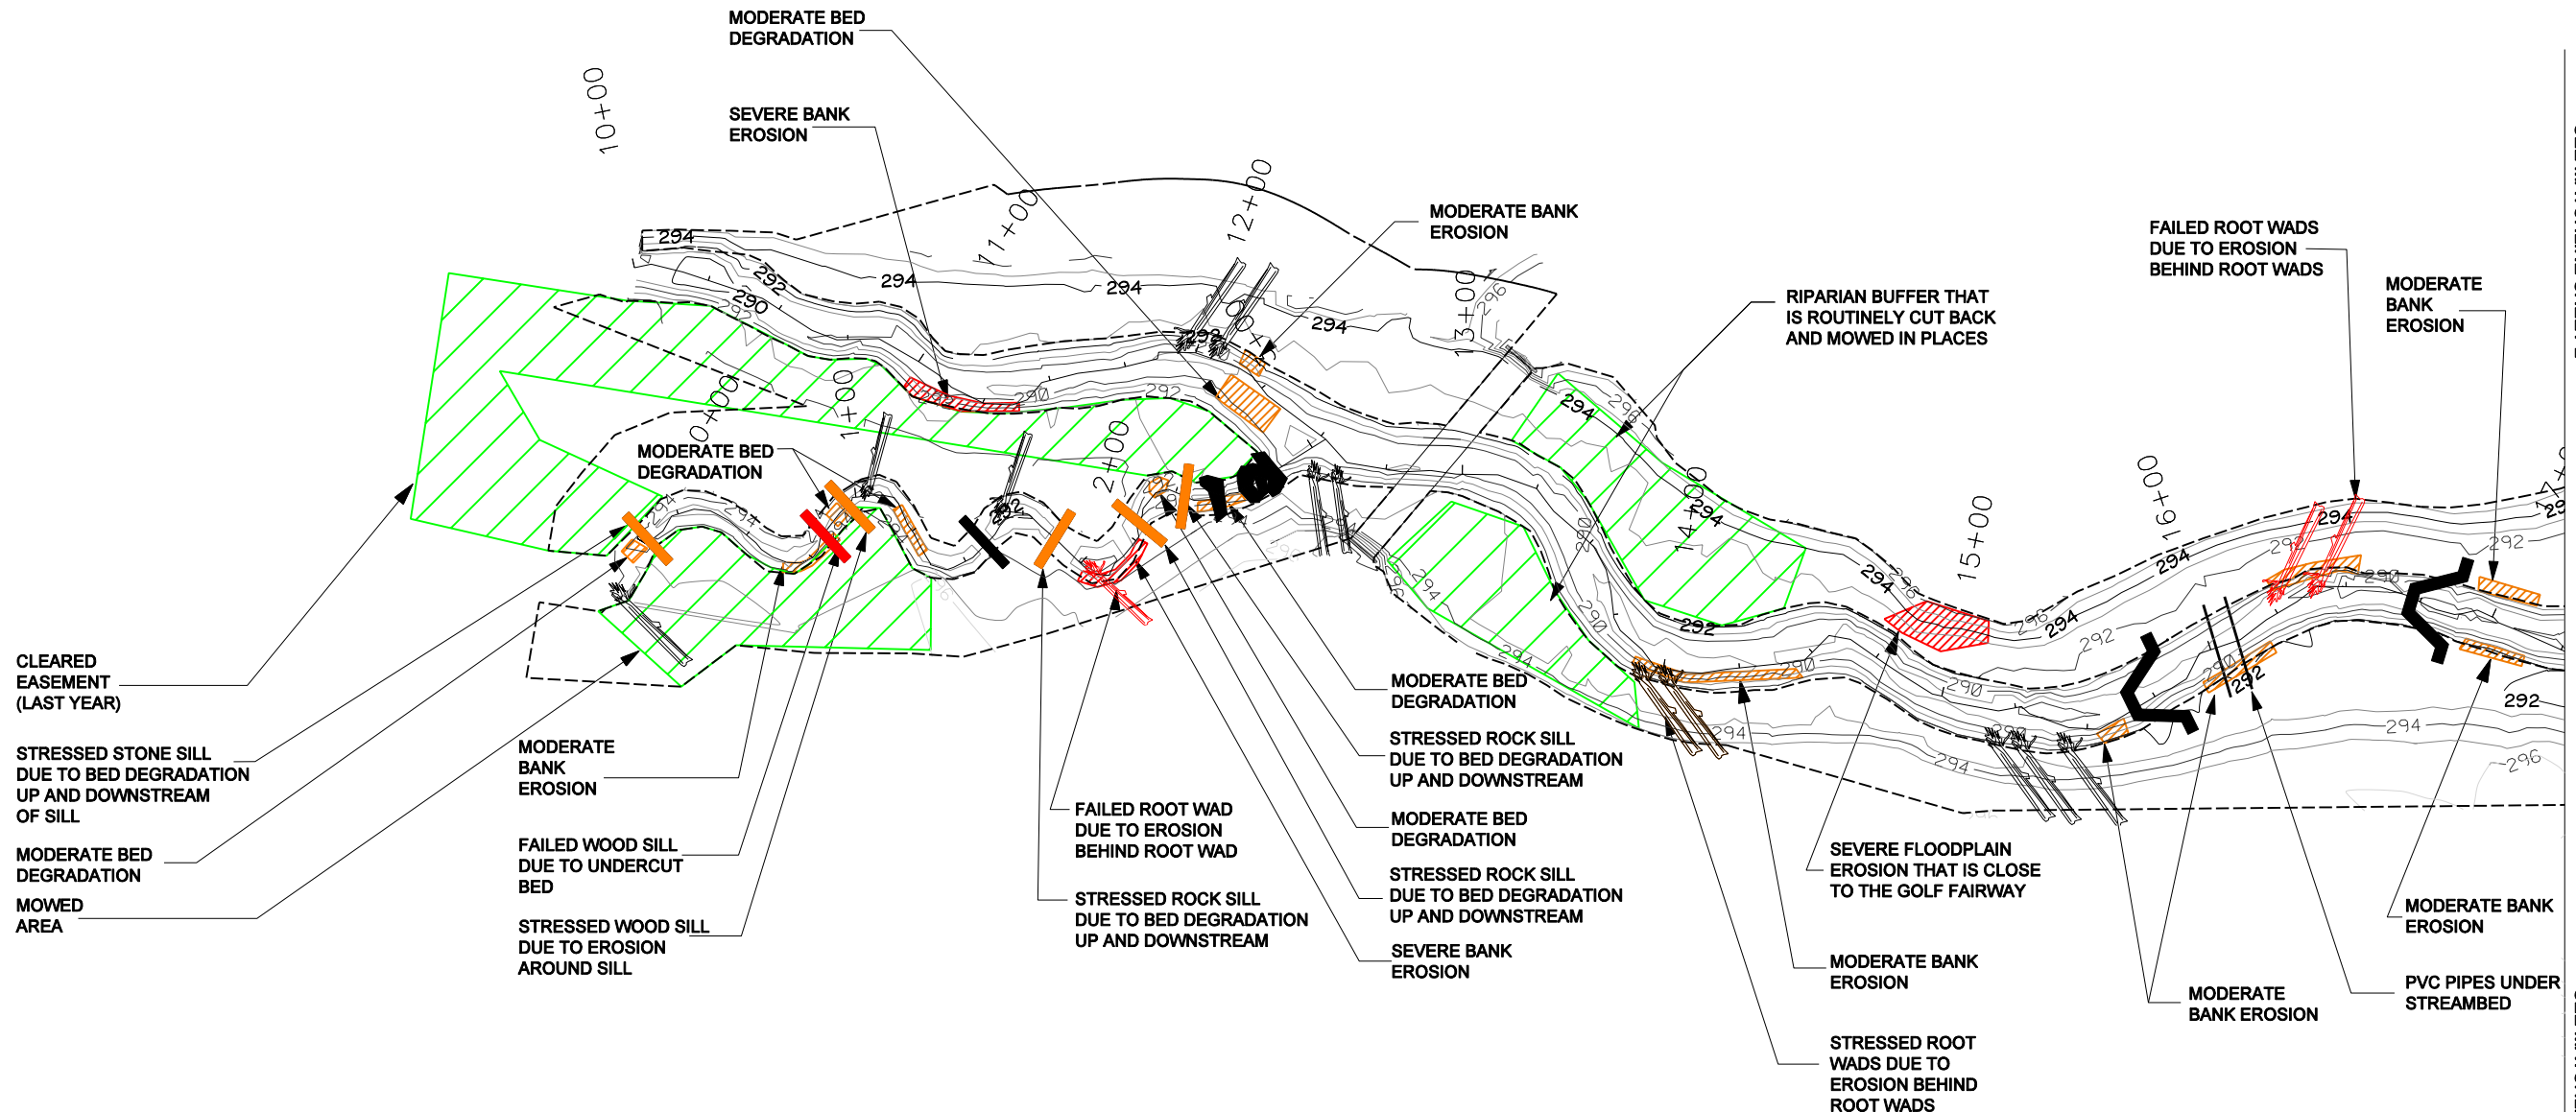
Current Conditions Plan View

CLEARED EASEMENT (LAST YEAR)

STRESSED STONE SILL DUE TO BED DEGRADATION UP AND DOWNSTREAM OF SILL

MODERATE BED DEGRADATION

FAILED WOOD SILL DUE TO UNDERCUT BED

FAILED ROOT WAD DUE TO EROSION BEHIND ROOT WAD

STRESSED ROCK SILL DUE TO BED DEGRADATION UP AND DOWNSTREAM

FAILED ROOT WADS DUE TO EROSION BEHIND ROOT WADS
