**Prestonwood Golf Course
(Hatchet's Grove)
Stream Restoration Monitoring Report
EEP Project # 289
Monitoring Year – 06**

**Data Collection: 2010
Construction Completed: May 2004
Submitted: December 2010**

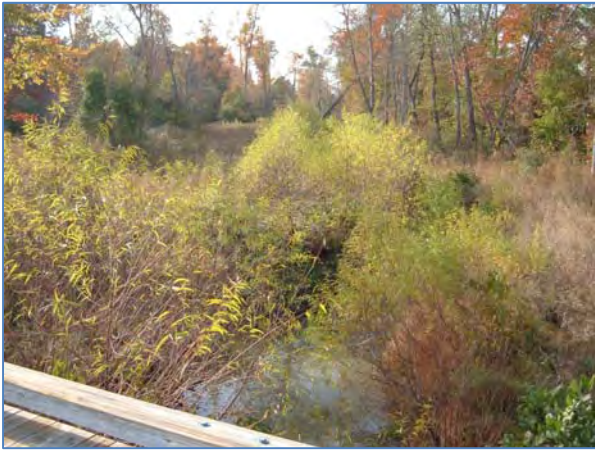
Photo Point 1 – Taken looking upstream from golf cart bridge at the upper 300 feet of the Hatchet’s Grove. 11/5/06 - MY 02

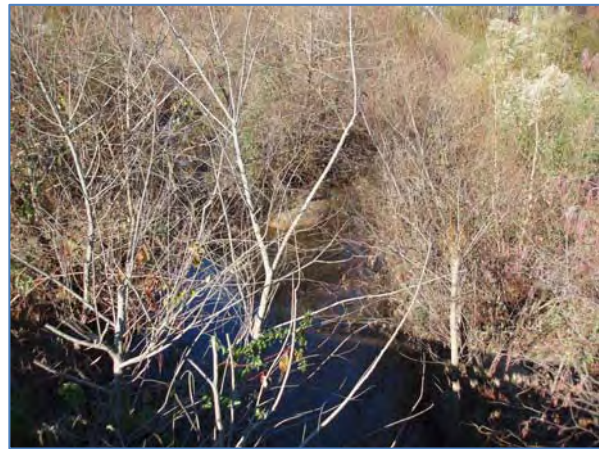
Photo Point 1 – Taken looking upstream from golf cart bridge at the upper 300 feet of the Hatchet’s Grove. 12/7/10 - MY 06

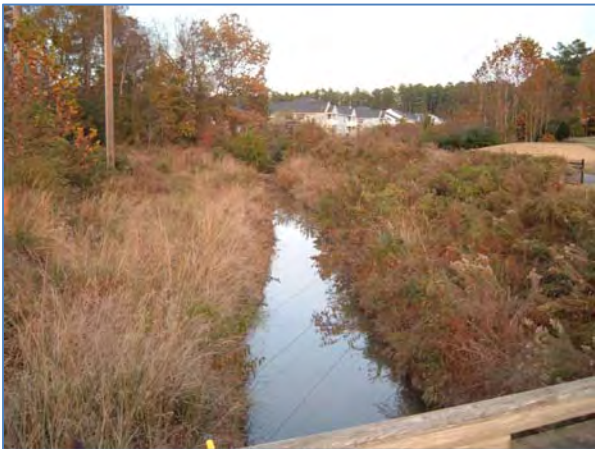
Photo Point 2 – Taken looking downstream from golf cart bridge at the lower 300 feet of the Hatchet’s Grove. 11/5/06 - MY 02

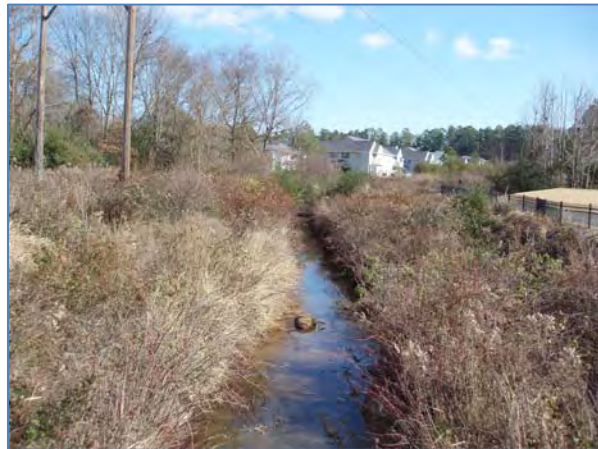
Photo Point 2 – Taken looking downstream from golf cart bridge at the lower 300 feet of the Hatchet’s Grove. 12/7/10 - MY 06
