STREAM MITIGATION AS-BUILT REPORT

Jefferson Pilot Guilford County, North Carolina

N.C. Wetlands Restoration Program
_____NCDENR_DWQ

June 2002

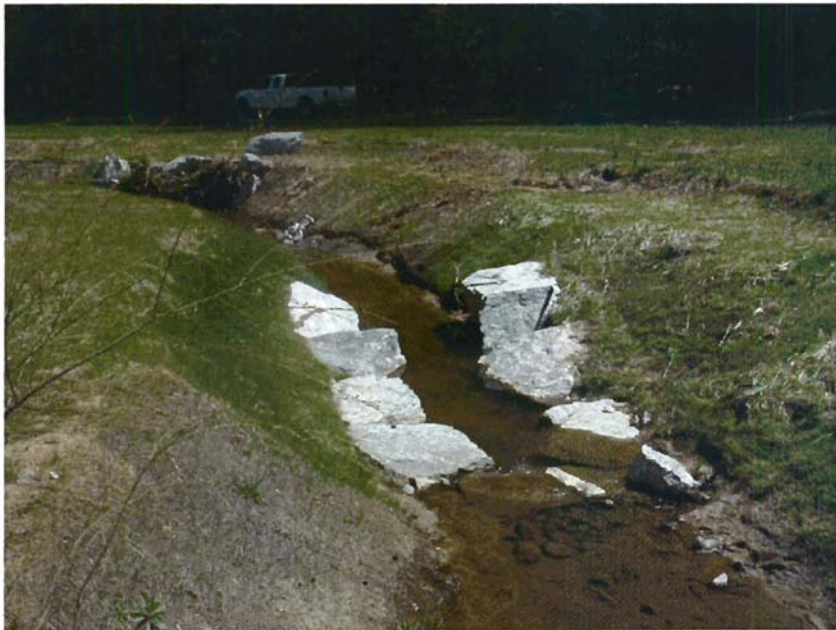
M3-DS: View from Meander 3 looking downstream towards a cross vane that was installed after the main construction period due to concerns with the grade downstream.

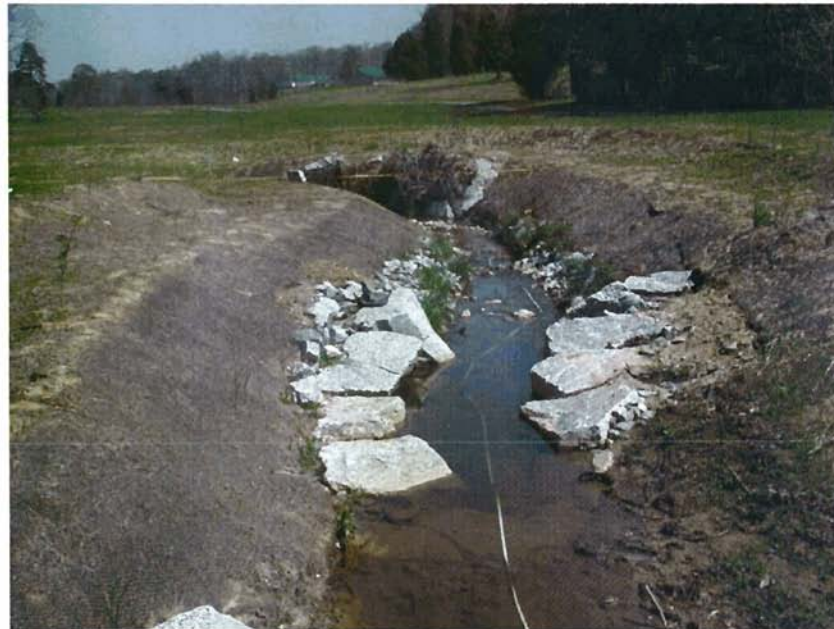
M5-DS: View from Meander 5 looking downstream towards Meander 6. Note the cross rock and the boulder adjacent to it on the right have settled since construction and are below the water surface.

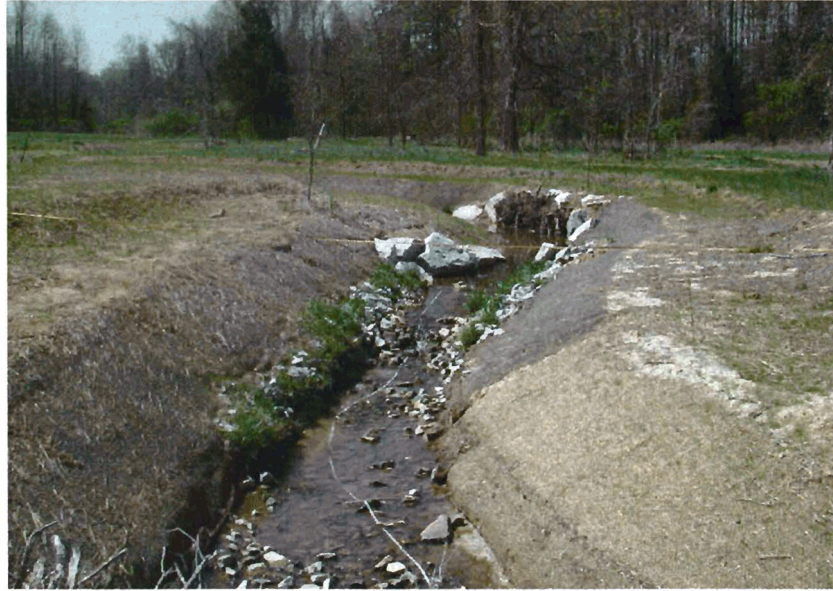
M6-US: View from Meander 6 looking upstream towards Meander 5. Note rip-rap was installed at the end of construction due to bed downcutting.

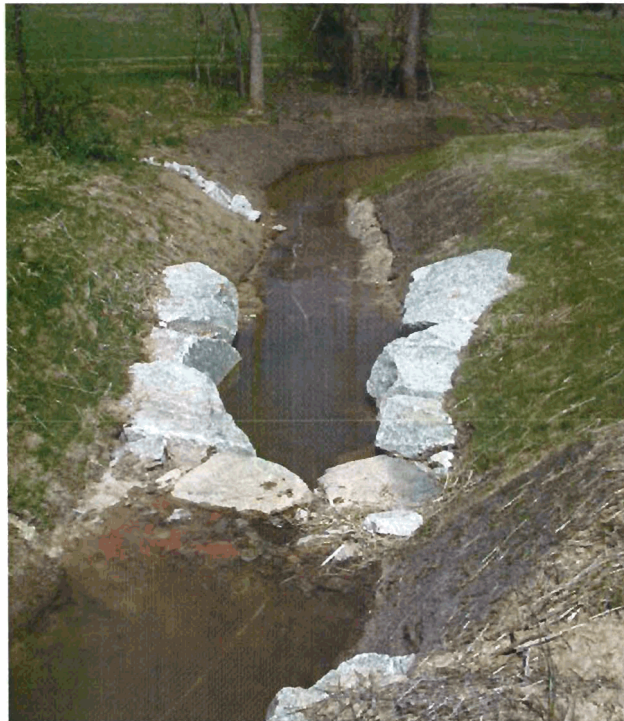
The longitudinal profile was modified from the design after the initial construction period due to bed degradation. During construction, loose clay soils were encountered in the streambed that became easily suspended once in contact with water. These soils washed away, contributing to the bed degradation. Two additional cross-vanes were installed in the stream to hold the grade immediately upstream. The longitudinal profile was taken after the degradation and after the addition of the two cross-vanes.

M6-DS: View from Meander 6 looking downstream. Note newly constructed cross-vane due to upstream degradation since the initial construction. Water is short cutting between the cross boulders on the right side.

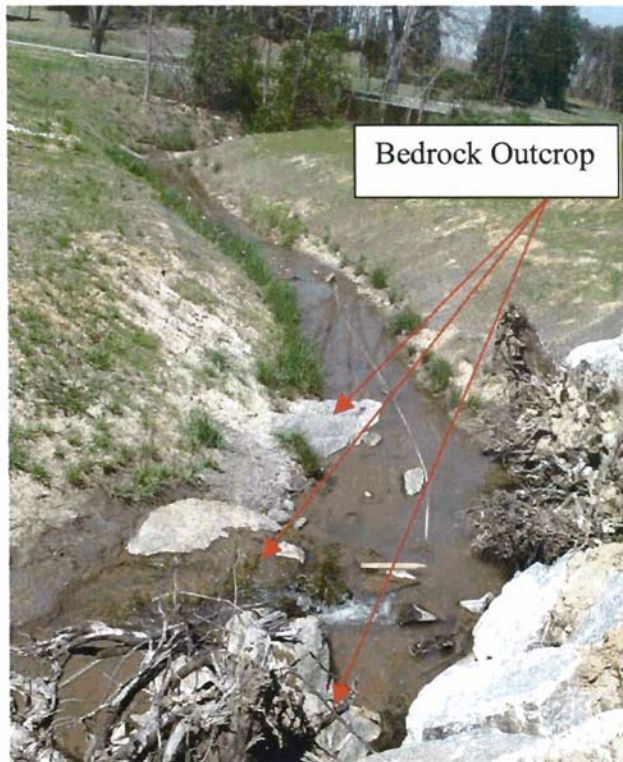
M10-DS: View from Meander 10 looking downstream. Note the bedrock in the bed of the channel exposed during construction.

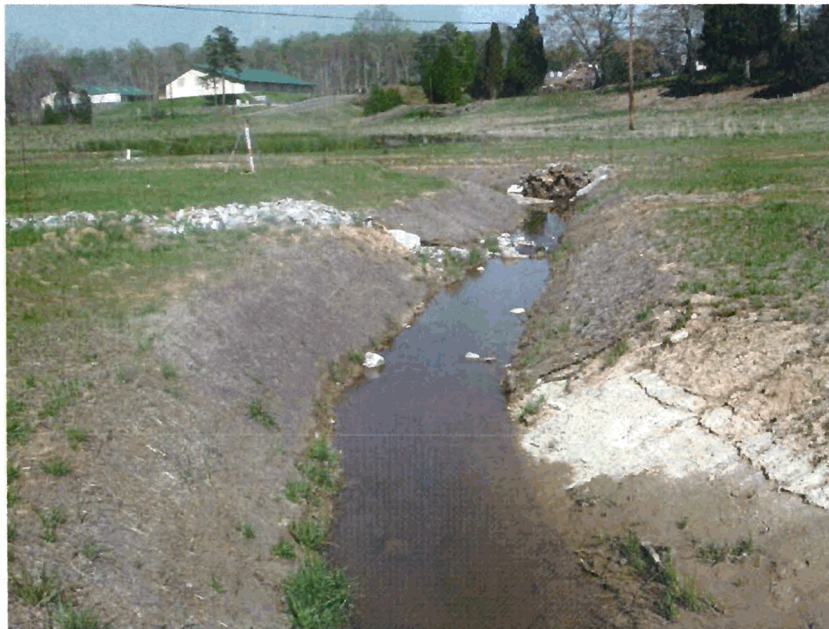
The step-pool outfall was designed to have a much longer step length and a wider tie-in with the main channel. The initial outfall was built according to the plans. However, erosion occurred during a rain event. Eddies that were formed at the tie-in caused this erosion. Therefore, the outfall was re-built on-site to help minimize the eddy effect.

M14-DS: View from Meander 14 looking downstream. Note stone step-pool outfall to connect roadway drainage to stream.

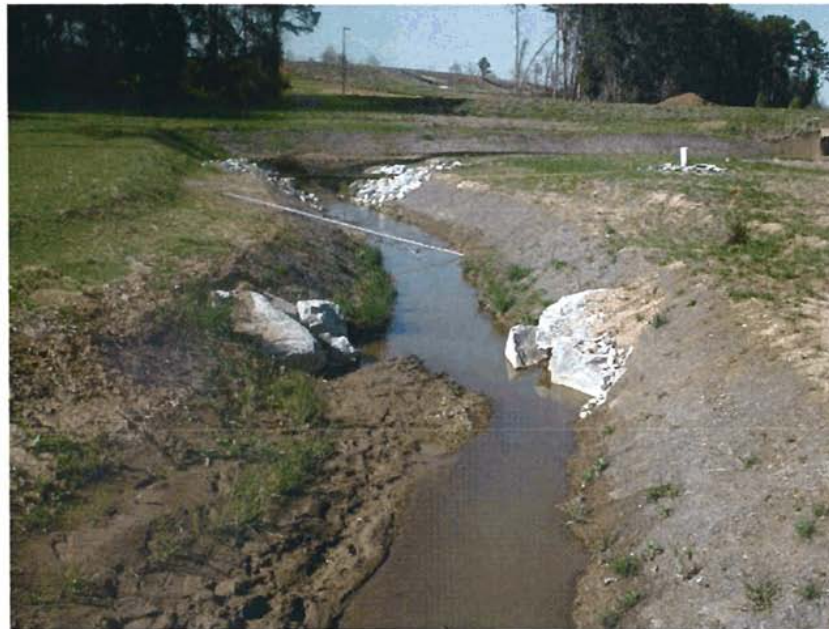
M15-DS: View from Meander 15 looking downstream. Note this cross-vane was moved upstream into the meander to avoid a gas line during construction. In effect, the upper portion of the cross vane has been covered up by the point bar since the cross vane slowed the water on the inside meander.

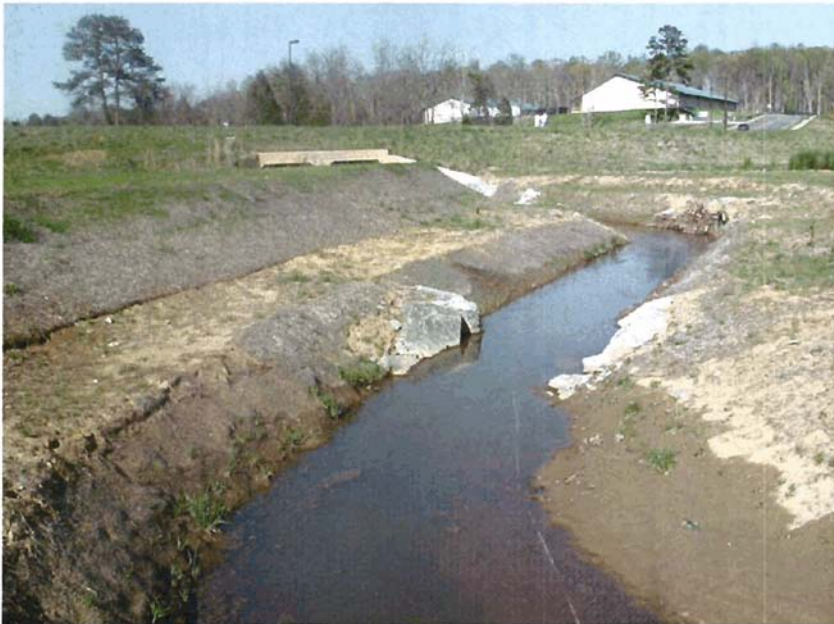
M16-DS: View from Meander 16 looking downstream. Cross-vane is drowned out due to backwater from the off-site lake downstream.

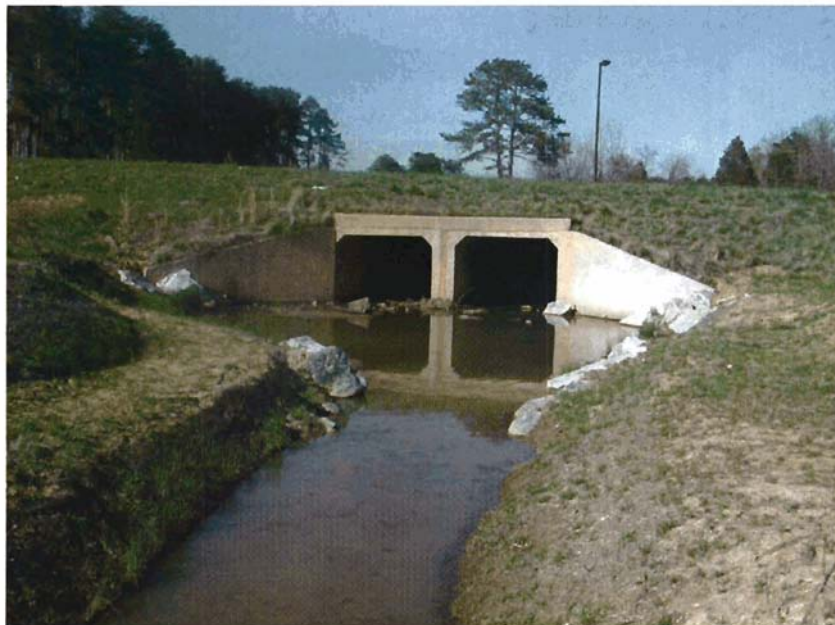
M17-DS: View from Meander 17 looking downstream towards the double 10' x 8' box culvert. Cross-vane is drowned out.

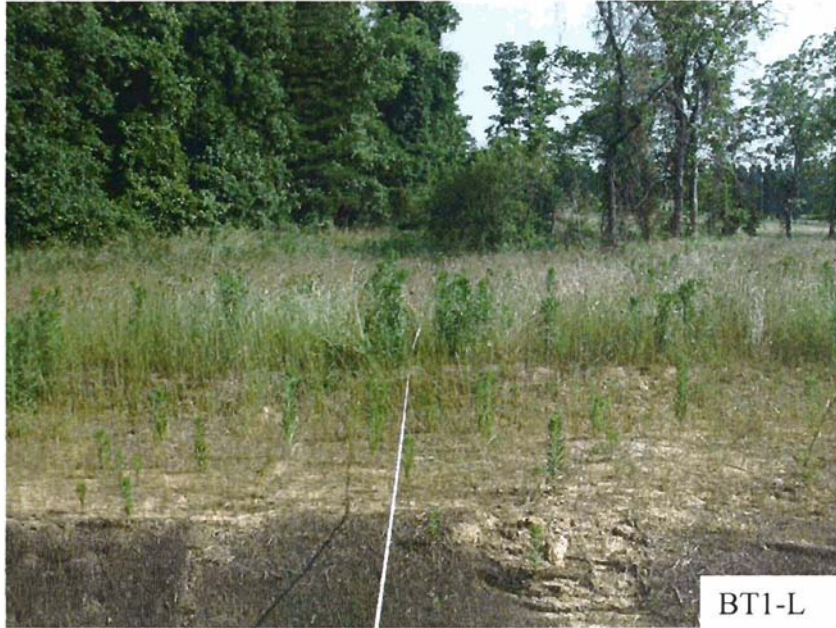
BT1-L

Transect 1 – Left bank. Shows build-out bench above coir matting with thin herbaceous vegetation

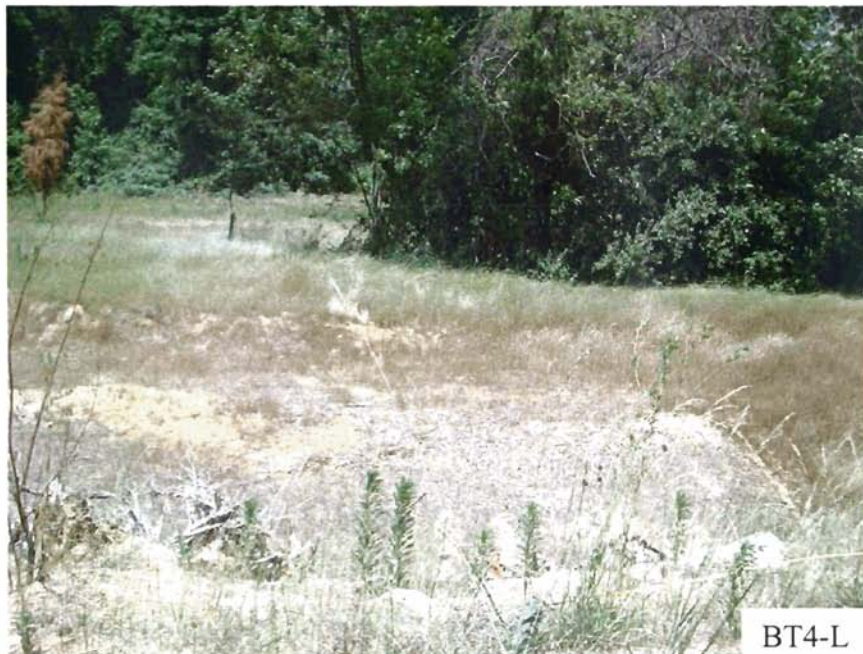
Transect 4 – Left bank. Looking at area disturbed by construction of new structure.

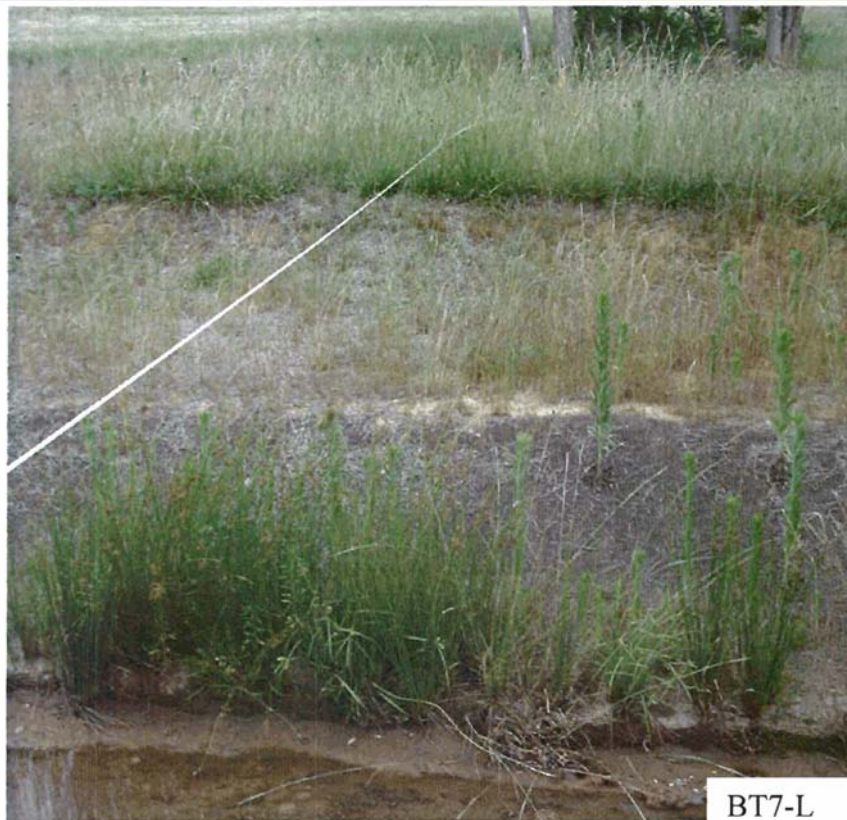
BT7-L

Transect 7 – Left bank in lower section below bridge. Shows significant elevation change between build-out bench and buffer elevation.
