# **YEAR ONE MONITORING REPORT**

## **Jefferson Pilot Stream Restoration Guilford County, North Carolina**

**N.C. Wetlands Restoration Program**  
\_\_\_\_\_NCDENR\_DWQ

**January 2003**

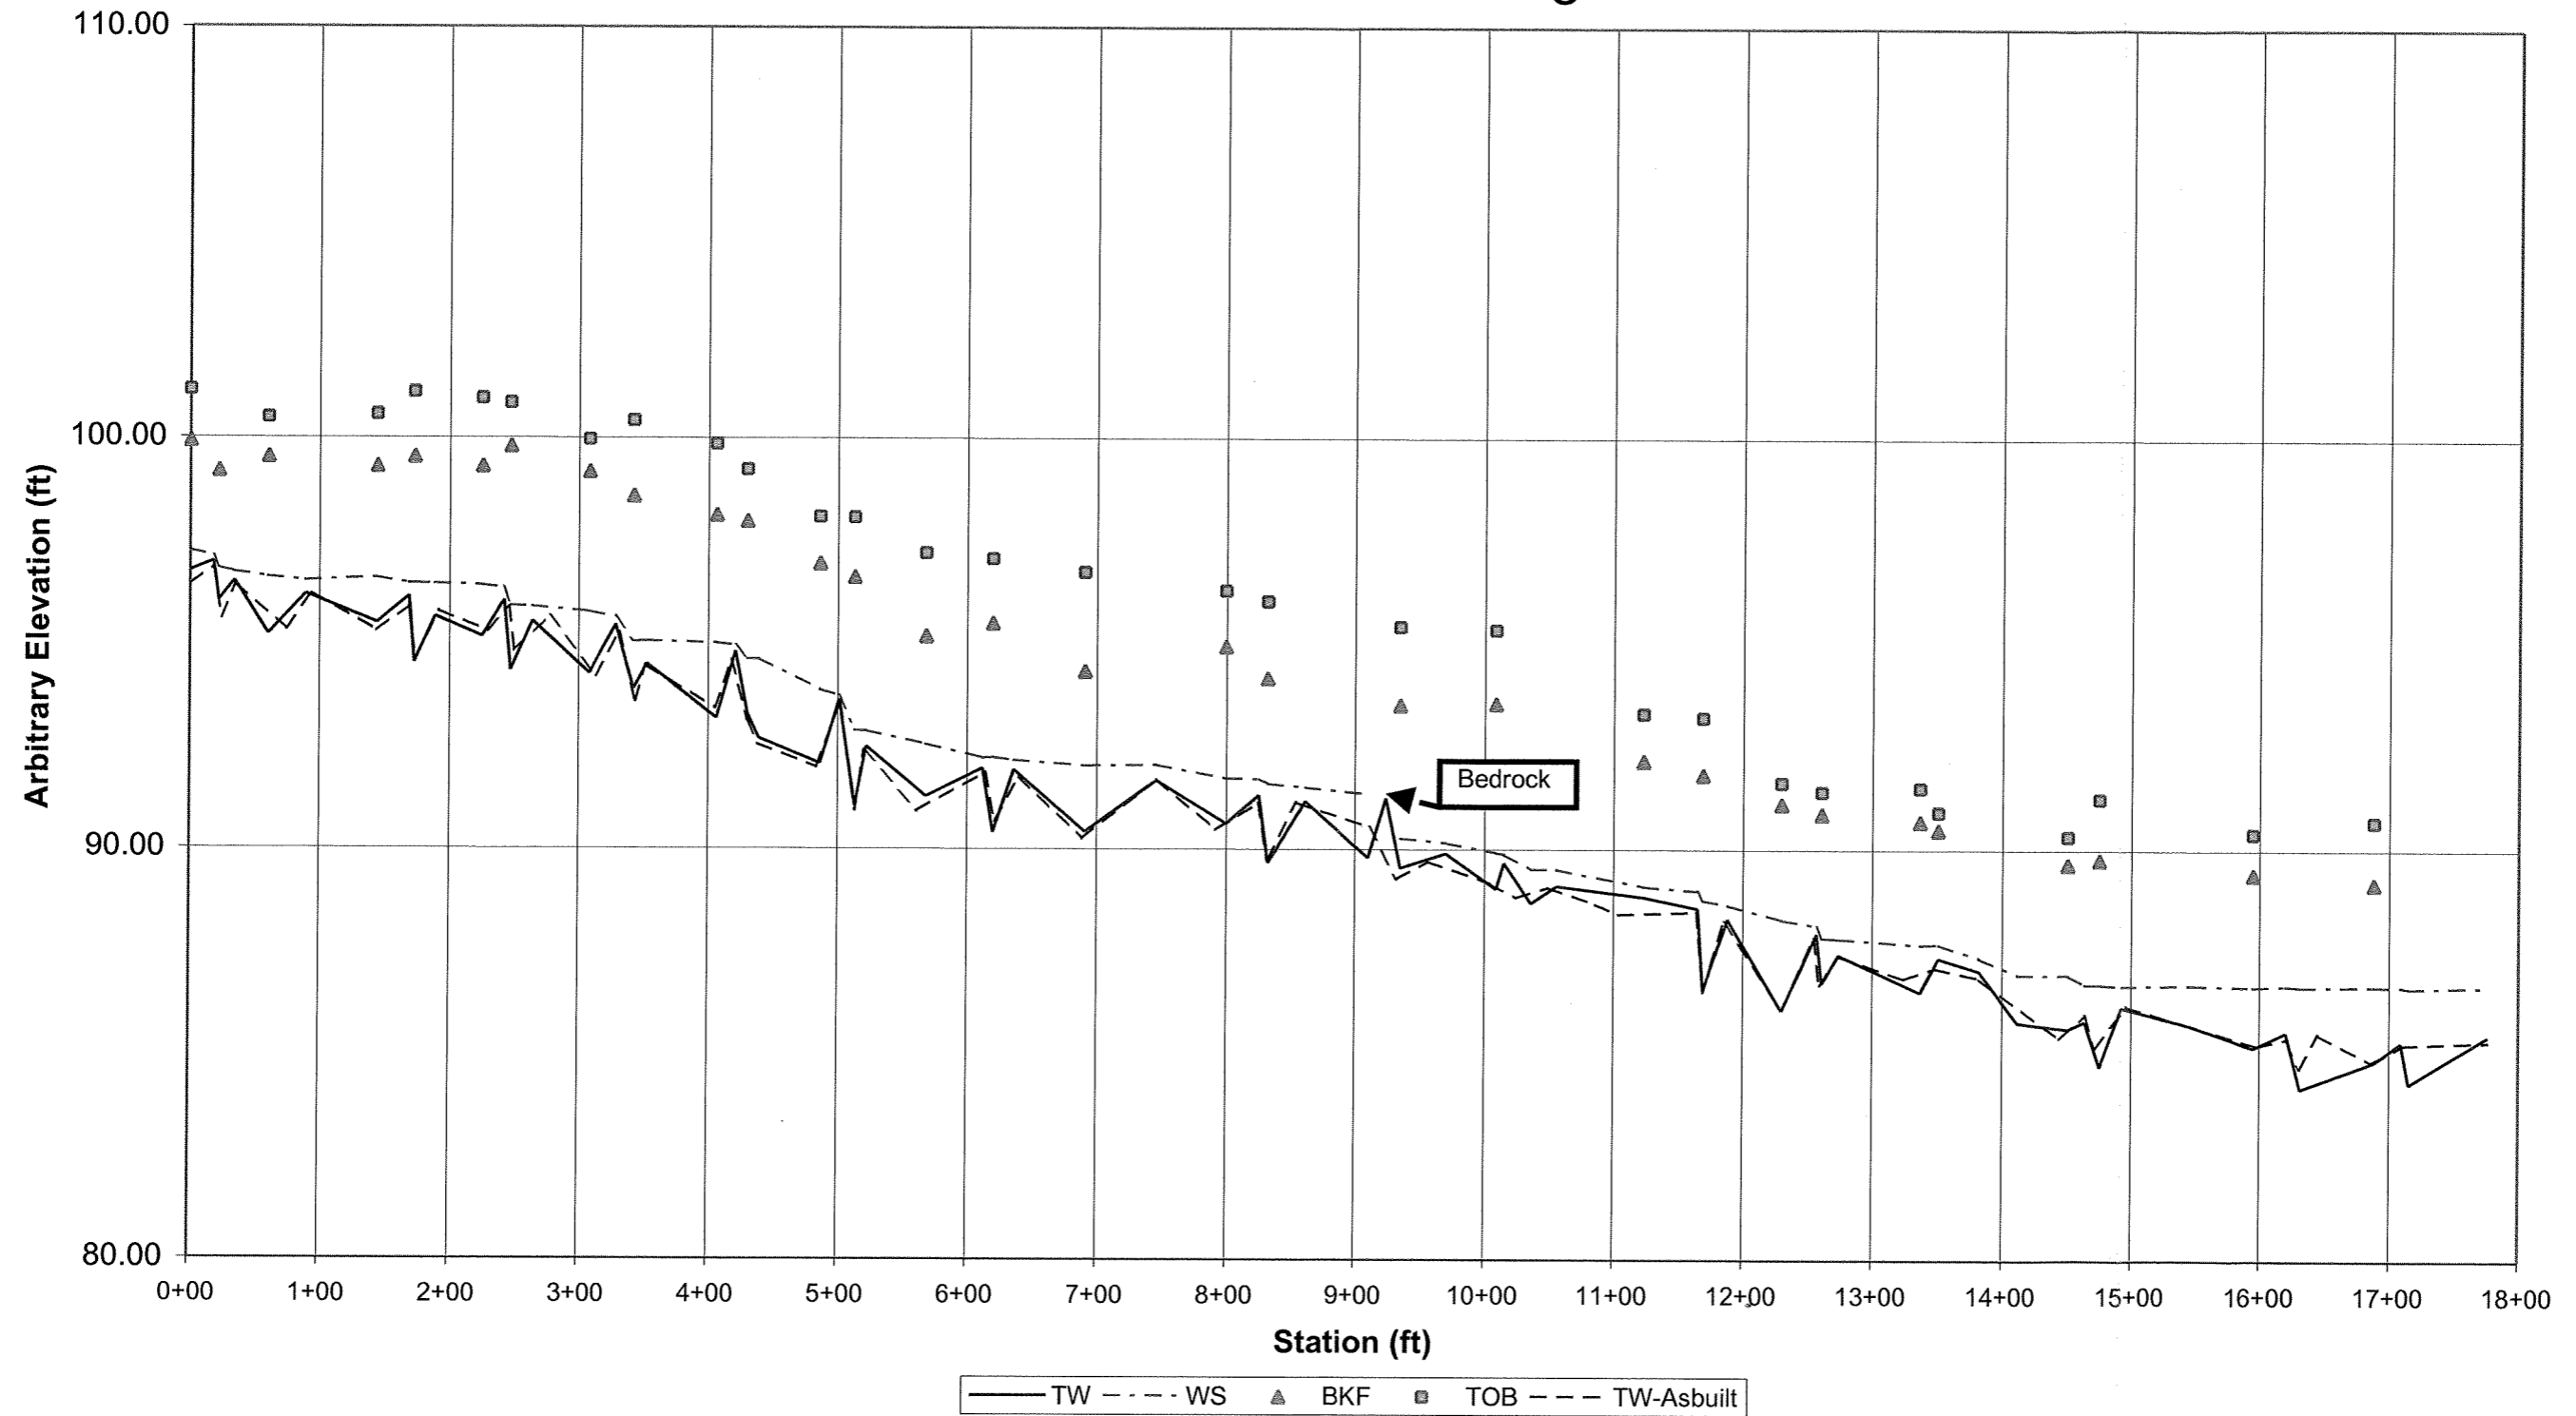
Figure 1: Longitudinal Profile  
Jefferson Pilot Stream Restoration  
Year 1 Monitoring

In general, the bed features have remained in about the same location since the as-built survey conducted on April 11, 2002. In a few places, the pool below the cross-vane appears to have moved slightly upstream or downstream. However, the stations on the head of cross-vane were typically different from the As-Built conditions survey to the Year One conditions. In order to determine if the pool below the cross-vane had moved, the difference between the cross-vane station and the station of the maximum pool below each cross-vane was summed and divided by the total number of cross-vanes for both the as-builts and the Year One surveys. On the As-built survey, the average distance from the top of the cross-vane to the max pool was 7.5' while it was 7.6' on the Year One survey, which is essentially the same.

The overall bed slope of the channel has remained the same from the As-Built to the Year One monitoring period at 0.0059 ft/ft. The water surface slope was 0.0062 ft/ft during the As-Built survey and 0.0064 ft/ft in the Year One survey, a minor difference.

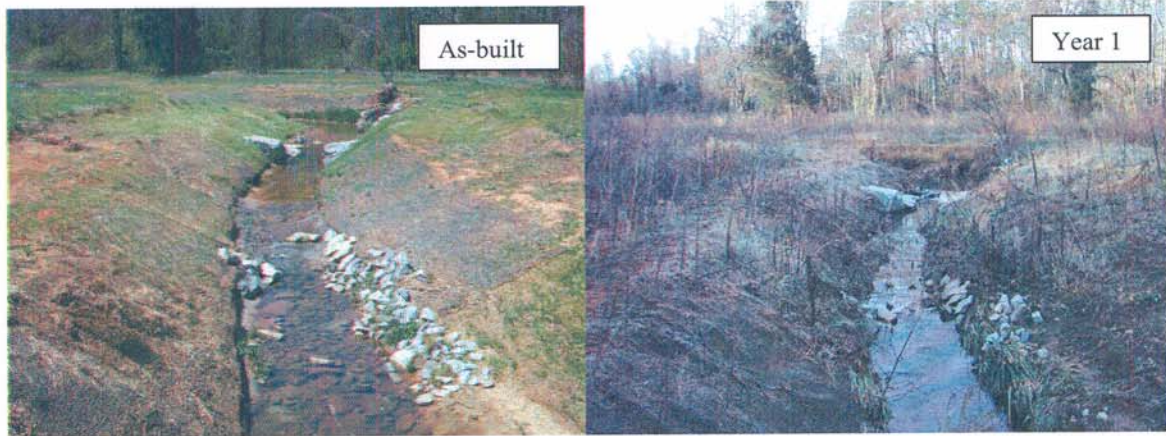
M3-DS: View from Meander 3 looking downstream towards a cross vane that was installed after the main construction period due to concerns with the grade downstream.

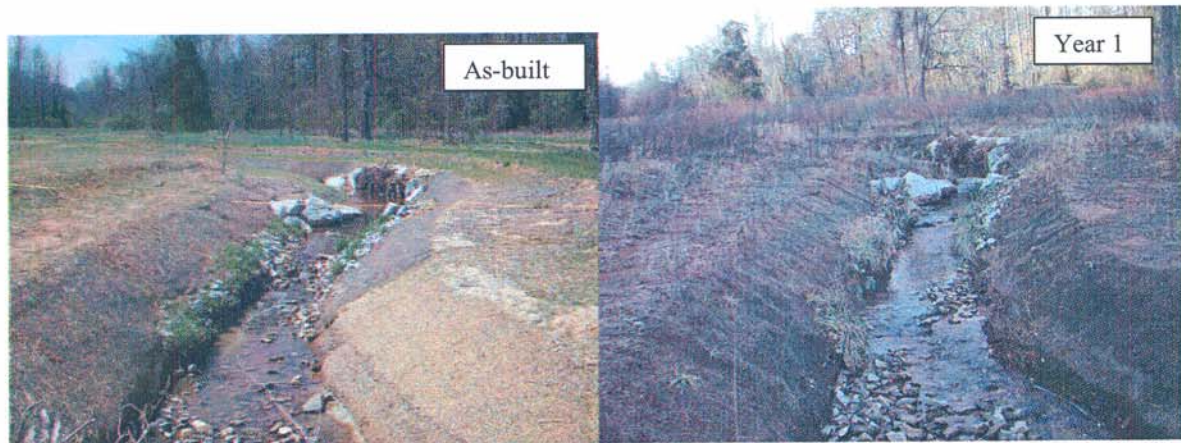
M6-US: View from Meander 6 looking upstream towards Meander 5. Note rip-rap was installed at the end of construction due to bed downcutting.

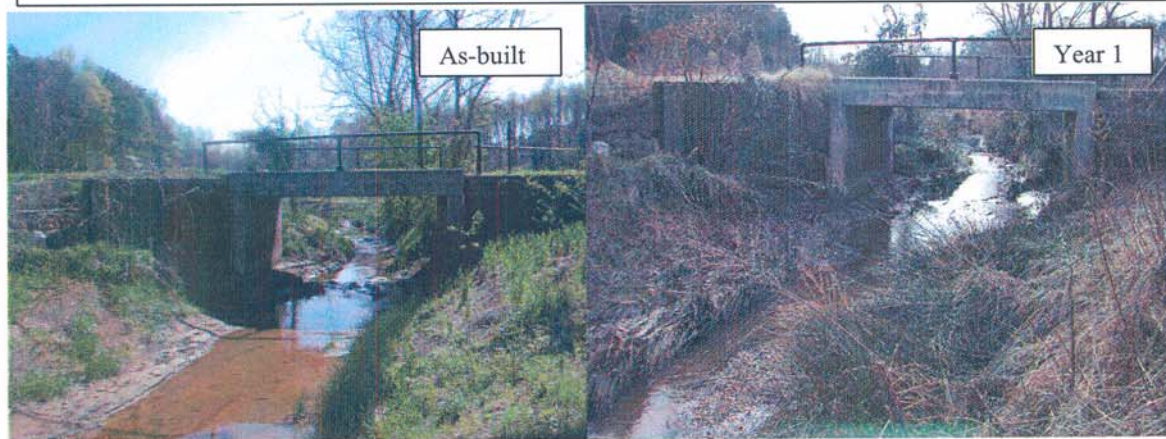
M12-US: View from Meander 12 looking upstream through the culvert. Note how the channel has narrowed and vegetated in the Year 1 photograph.

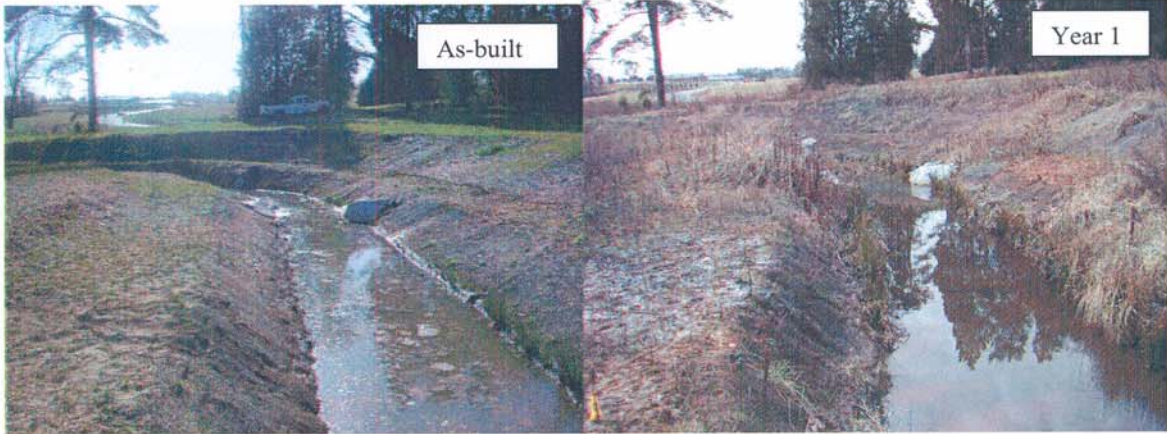
M16-DS: View from Meander 16 looking downstream. Cross-vane is drowned out due to backwater from the off-site lake downstream.

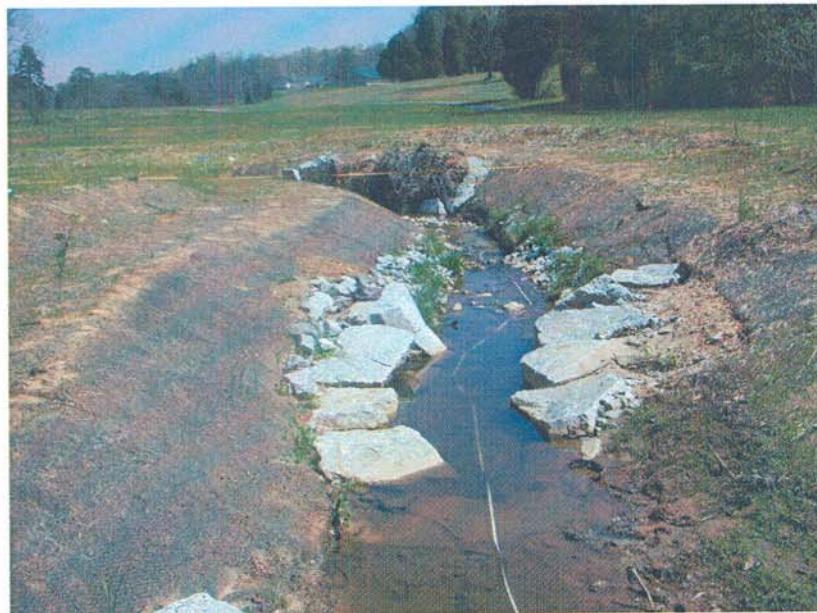
M5-DS: View from Meander 5 looking downstream towards Meander 6. Note the cross rock and the boulder adjacent to it on the right have settled since construction and are below the water surface.

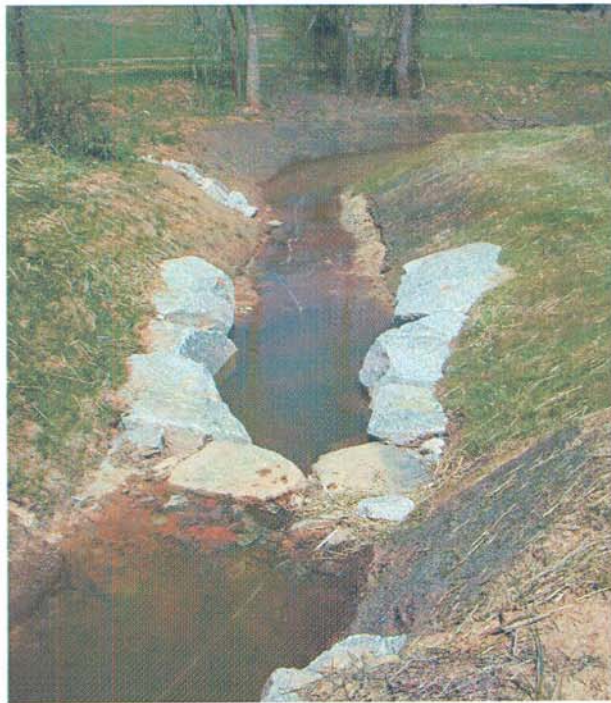
M6-DS: View from Meander 6 looking downstream. Note newly constructed cross-vane due to upstream degradation since the initial construction. Water is short cutting between the cross boulders on the right side.

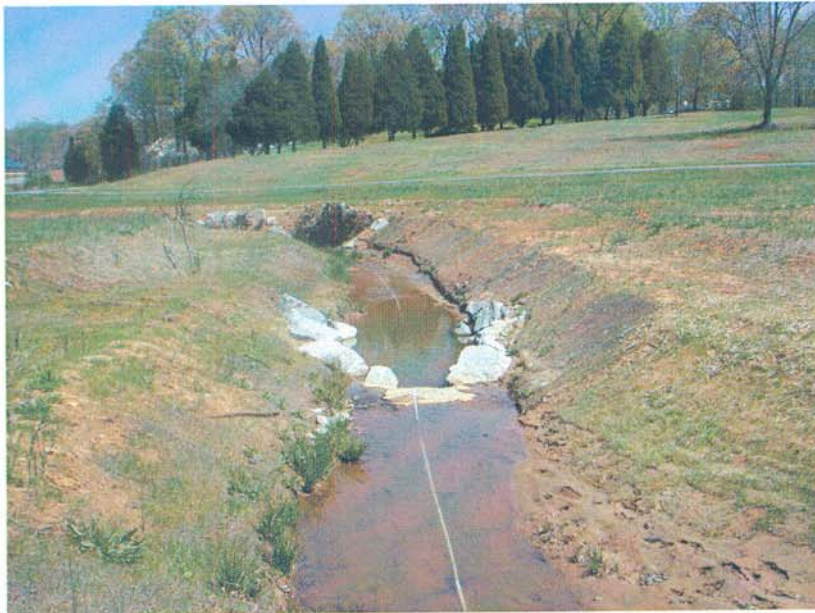
M9-DS: View from Meander 9 looking downstream. Note the point bar formation in the lower right corner of picture.

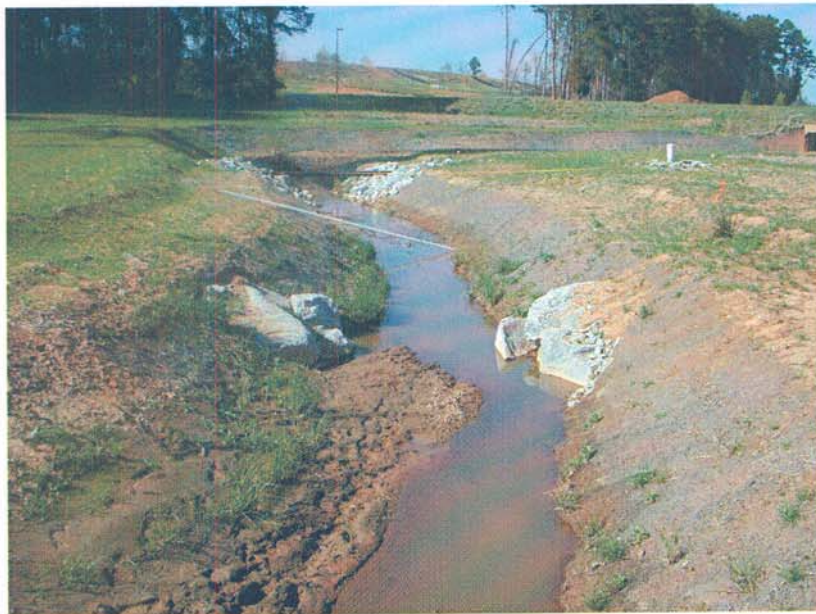
M15-DS: View from Meander 15 looking downstream. Note this cross-vane was moved upstream into the meander to avoid a gas line during construction. In effect, the upper portion of the cross vane has been covered up by the point bar since the cross vane slowed the water on the inside meander.

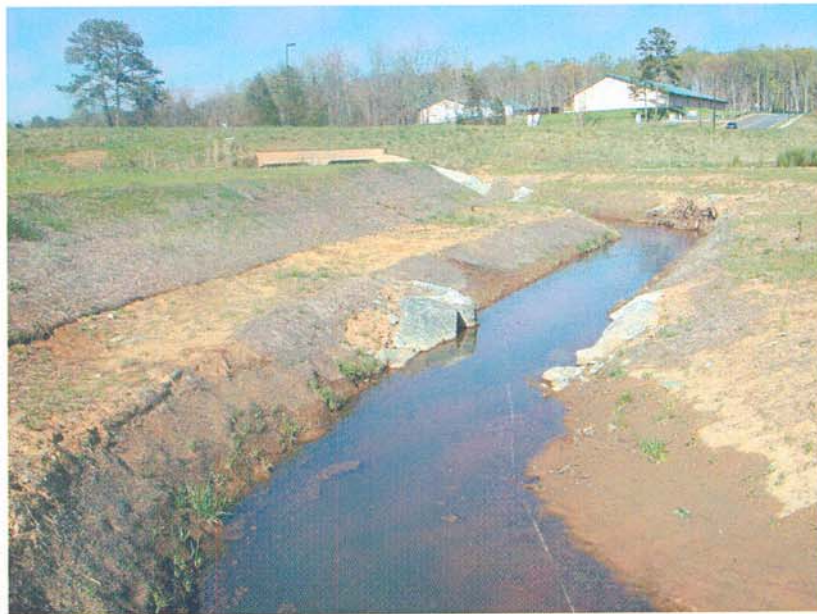
M16-DS: View from Meander 16 looking downstream. Cross-vane is drowned out due to backwater from the off-site lake downstream.

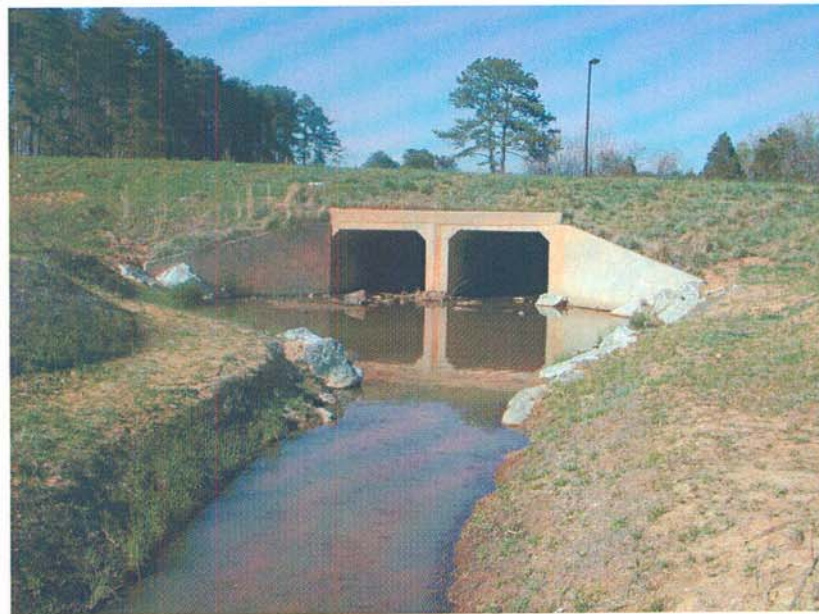
M17-DS: View from Meander 17 looking downstream towards the double 10' x 8' box culvert. Cross-vane is drowned out.

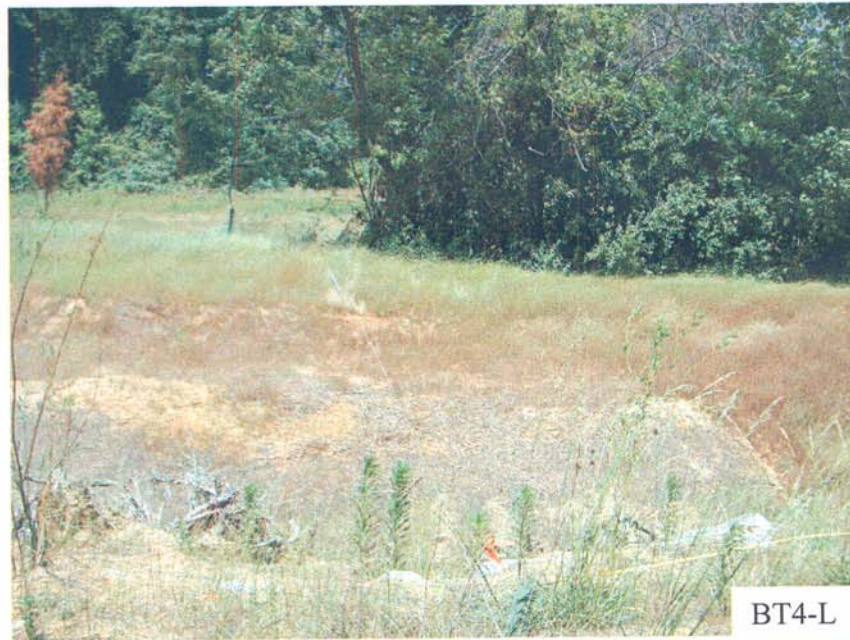
Transect 4 – Left bank. Looking at area disturbed by construction of new structure.

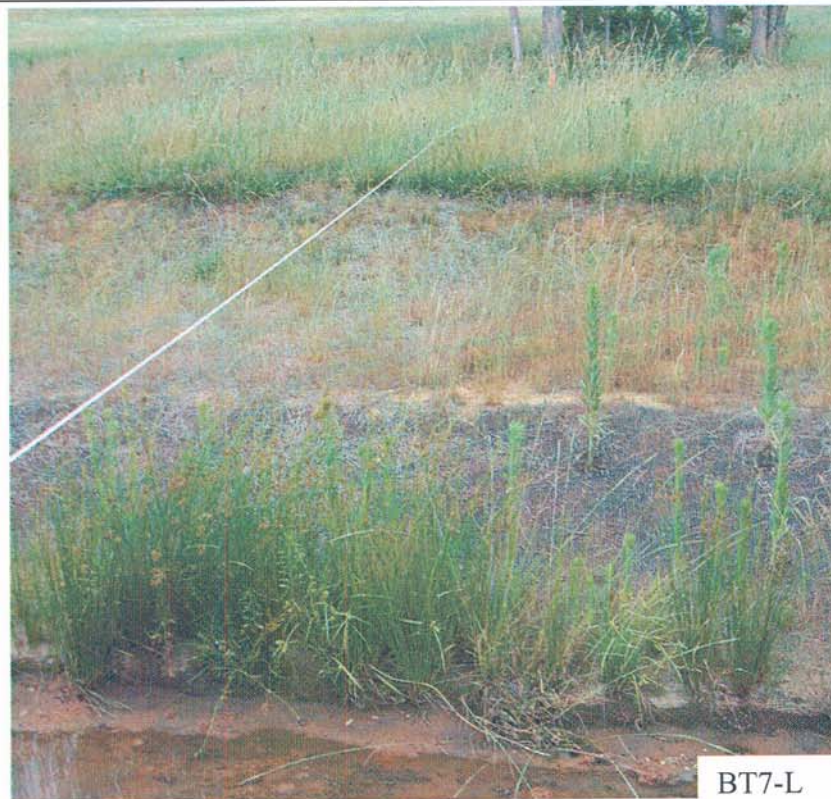
BT7-L

Transect 7 – Left bank in lower section below bridge. Shows significant elevation change between build-out bench and buffer elevation.
