Price Park Stream Restoration

2003 Annual Monitoring Report

Prepared by: Biological & Agricultural Engineering
Water Resources Research Institute
North Carolina State University
Campus Box 7625
Raleigh, NC 27695

March, 2004

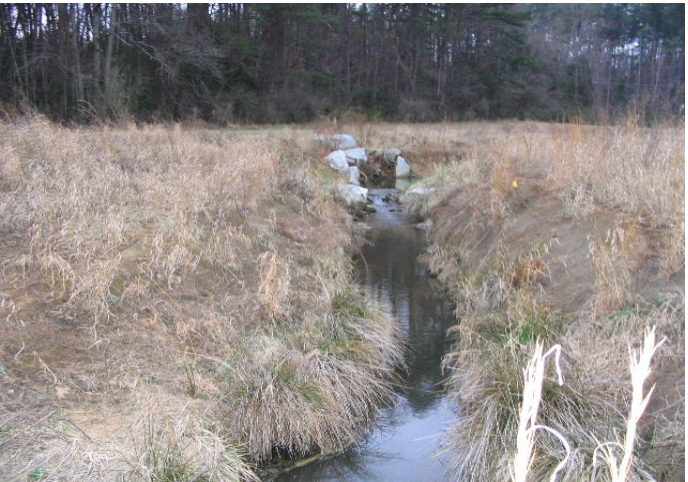
Photo of Cross-Section #1 - Looking Downstream

As-Built	2002	2003
Area	24.1	25.64	36.99
Width	13.3	14.8	15.0
Mean Depth	1.8	1.7	2.5
Max Depth	3.5	3.6	4.3

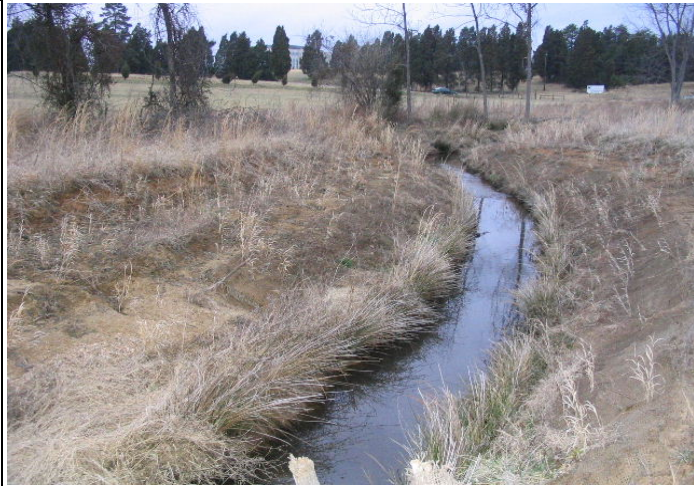
Photo of Cross-Section #2 - Looking Downstream

As-Built	2002	2003
Area	50.6	49.28	44.90
Width	22.2	21.0	21.2
Mean Dept	2.3	2.3	2.1
Max Depth	4.9	4.8	4.8

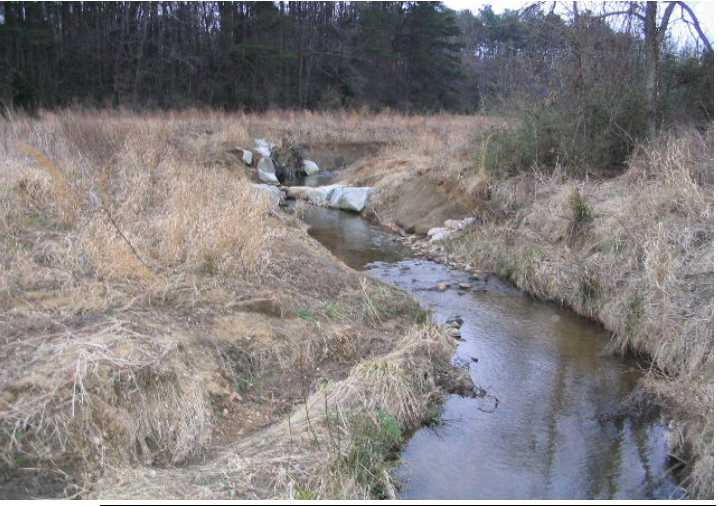
Photo of Cross-Section #3 - Looking Upstream

Channel cross-sections have remained mostly consistent since construction. There are areas of bank slumping as evident in cross-section #3. Most bank slumping appears to be the result of overland flow washing into the channel. Cross-section #1 continues to show signs of enlarging due to channel down cutting. Cross-section #2 (pool) is decreasing in area as a result of aggrading along the inside meander. Cross-section #4 have remained similar in area to as-built conditions.

As-Built	2002	2003
Area	31.9	28.41	31.86
Width	14.0	14.0	14.7
Mean Deptl	2.3	2.0	2.2
Max Depth	3.6	3.4	3.6

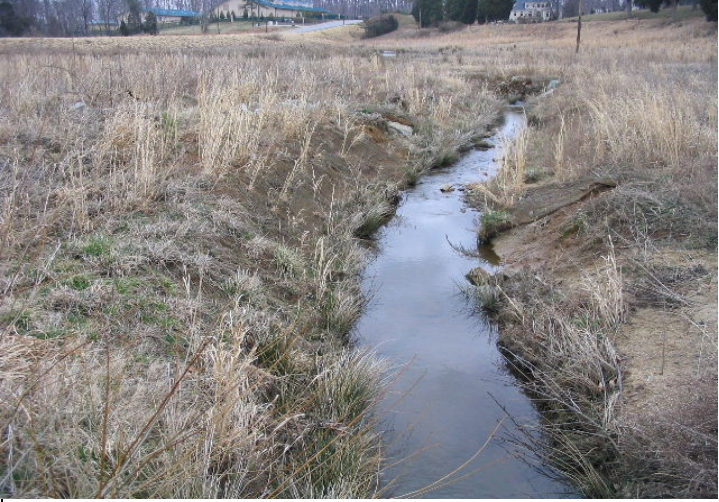
Photo of Cross-Section #4 - Looking Upstream

As-Built	2002	2003
Area	36.7	43.36	36.28
Width	17.2	19.1	17.2
Mean Depth	2.1	2.3	2.1
Max Depth	3.2	3.6	3.7

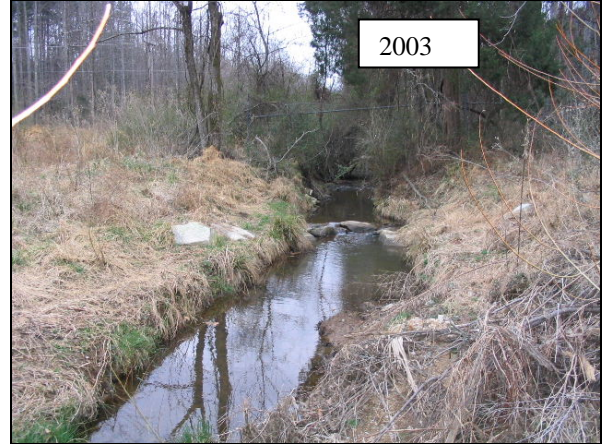
M1-US: Meander 1, looking in the upstream direction. Fenceline represents the beginning of the project and longitudinal profile. Note bar formation and vegetation establishment in this region.

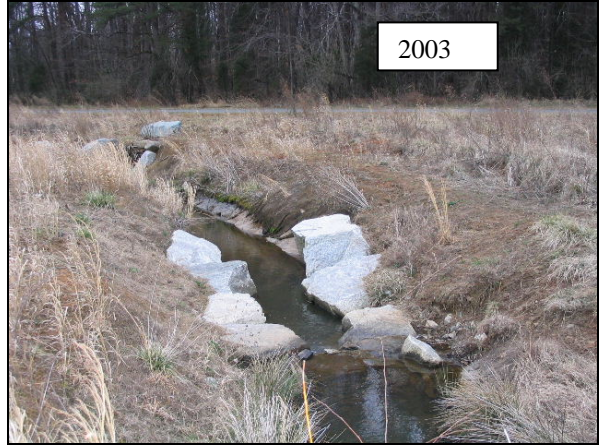
M3-DS: View from Meander 3 looking downstream towards a cross vane that was installed after the main construction period due to concerns with the grade downstream.

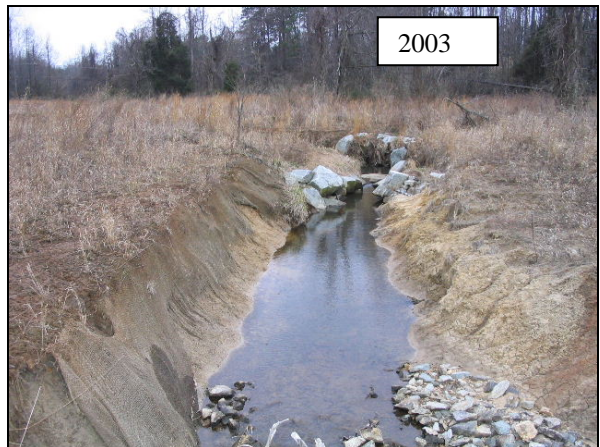
M6-US: View from Meander 6 looking upstream towards Meander 5. Note rip-rap was installed at the end of construction due to bed downcutting. 64

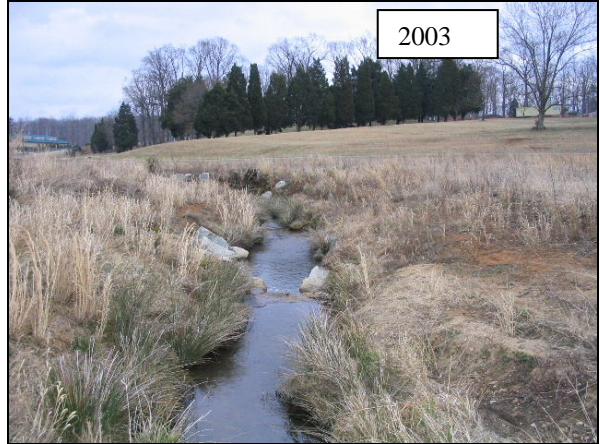
M9-DS: View from Meander 9 looking downstream. Note the point bar formation in the lower right corner of picture.71

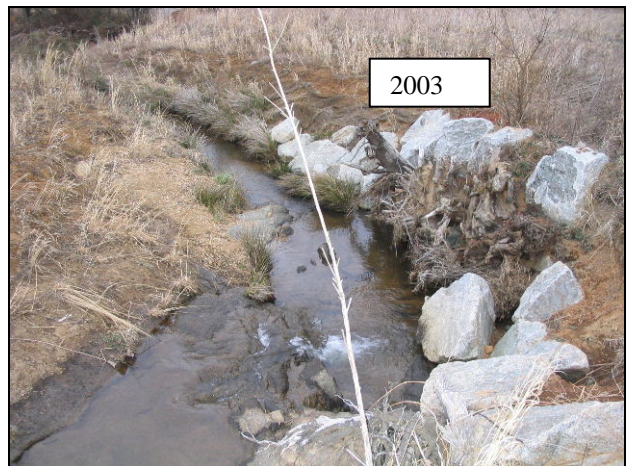
M10-DS: View from Meander 10 looking downstream. Note the bedrock in the bed of the channel exposed during construction.73

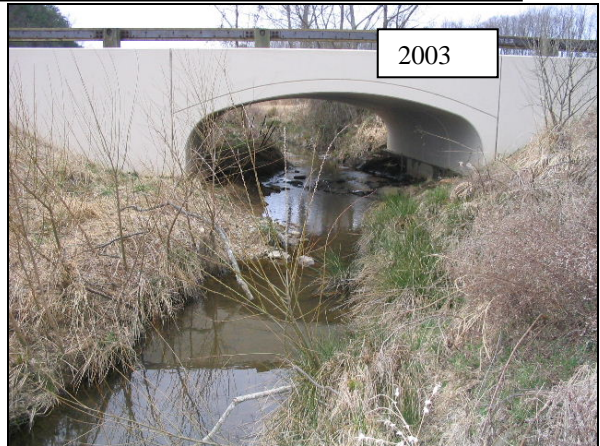
M12-US: View from Meander 12 looking upstream through the culvert. Note how the channel has narrowed and vegetated in the Year 1 photograph.76

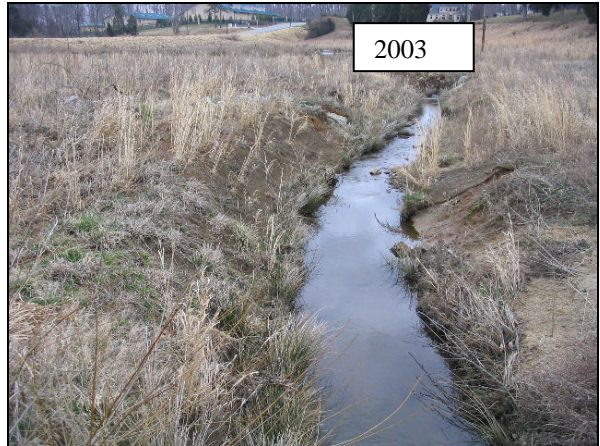
M14-DS: View from Meander 14 looking downstream. Note stone step-pool outfall to connecting roadway drainage to stream channel.82

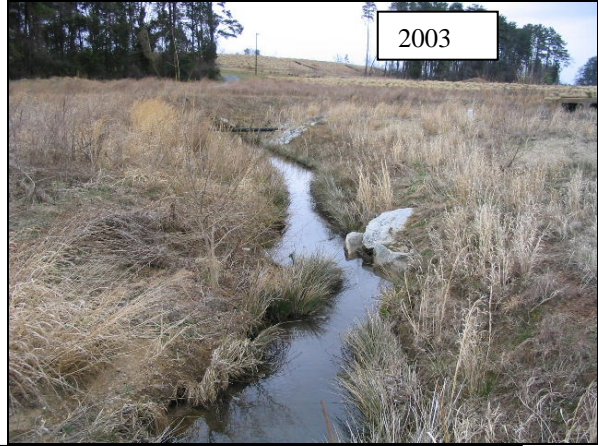
M15-DS: View from Meander 15 looking downstream. Note this cross-vane was moved upstream into the meander to avoid a gas line during construction. In effect, the upper portion of the cross vane has been covered up by the point bar.⁸⁴

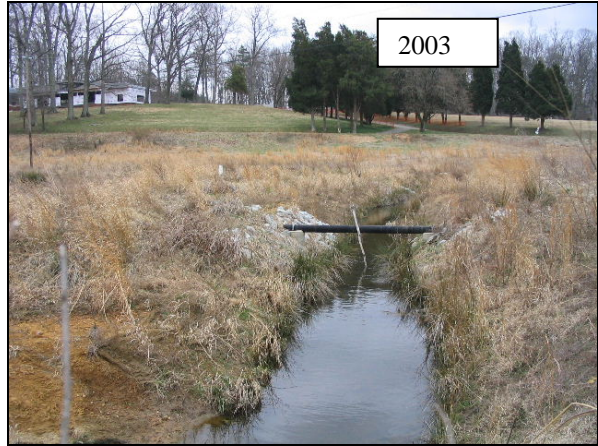
M16-US: View from Meander 16 looking upstream. The aerial sewer line was re-routed to make it perpendicular to the stream.⁸⁵

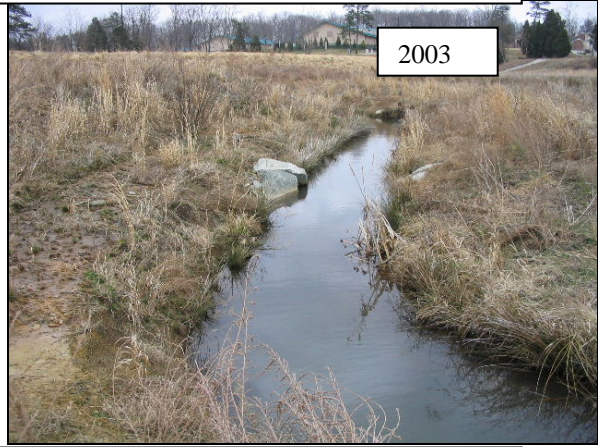
M16-DS: View from Meander 16 looking downstream. Cross-vane is drowned out due to backwater from the off-site lake downstream. ⁸⁶

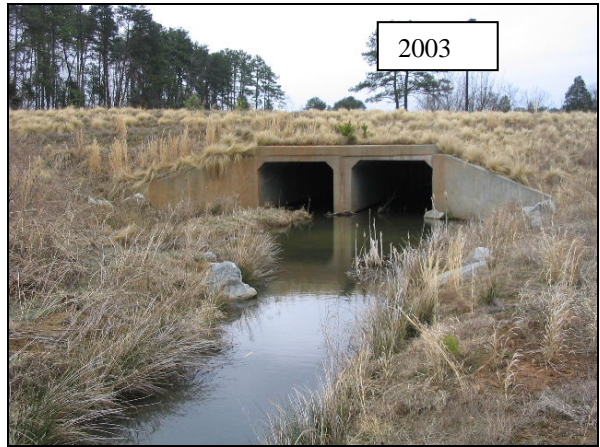
M17-DS: View from Meander 17 looking downstream towards the double 10' x 8' box culvert. Cross-vane is drowned out.88
