Price Park Stream Restoration

2004 Annual Monitoring Report

February, 2005

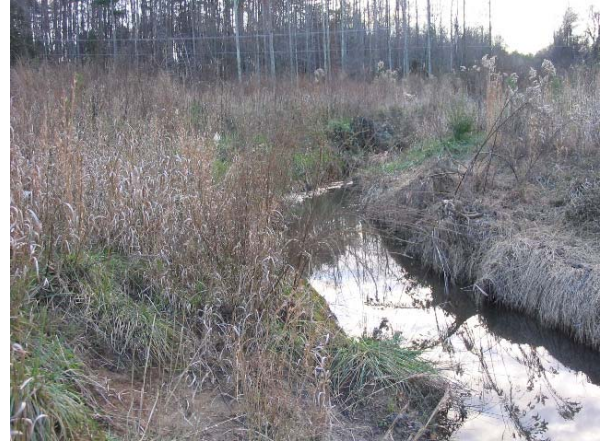
**Highlight Photo 1 - Station 16+00.
Floodplain Wetland off of right bank.
Not a concern area.**

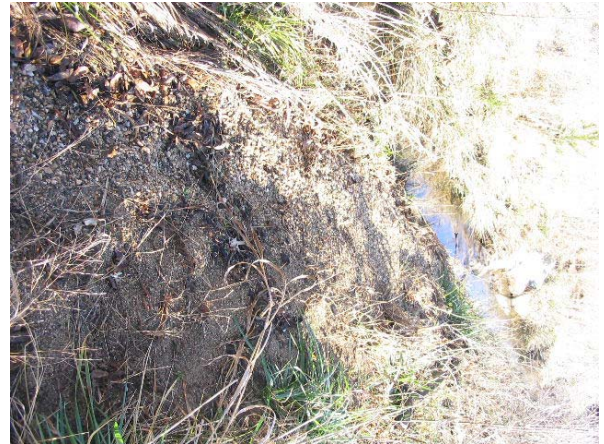
**Highlight Photo 2 – Station 5+50
Gravel depositing on point bar. Indication that
course gravel is moving through the system.**

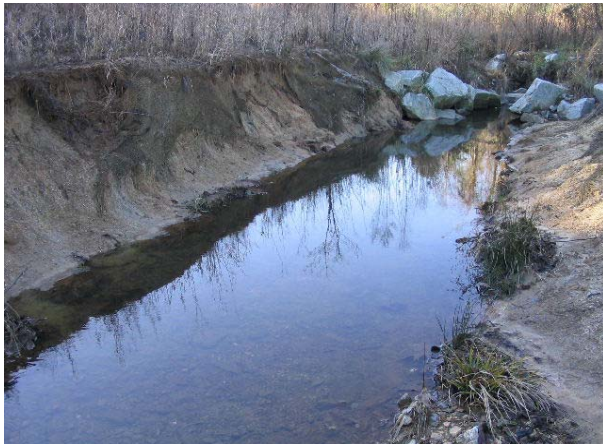
**Issue Photo 4 - Station 2+10. Cross vane with
footers undermined and boulders slumping**

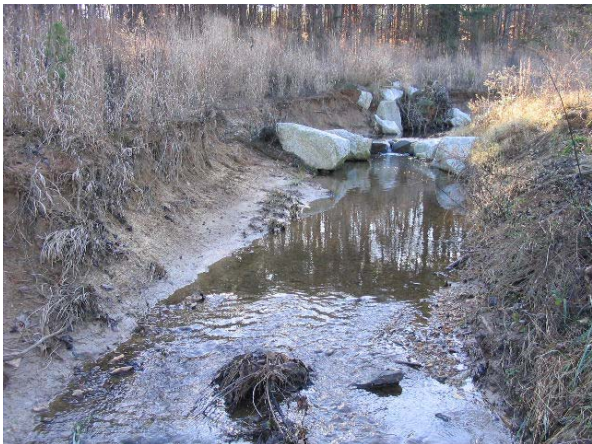
**Issue Photo 5 - Station 2+40
Eroding streambank, coir matting ripped,
and inadequate vegetation**

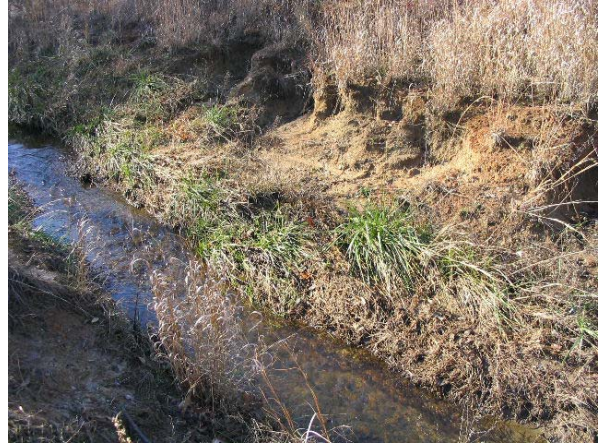
- Areas with bank erosion due to overland flow washing into the channel
 - Stations 3+90, 4+40, 12+20, 14+00 and 15+50
 - Station 12+20 has degraded to the point that the bank is not likely to heal with the addition of vegetation alone.

Issue Photo 7 - Station 3+90
Outside meander slump resulting from overland flow

- These areas should be examined closely to see if a structure is necessary to provide a stable method of allowing the water to enter the channel or if vegetation will be adequate.

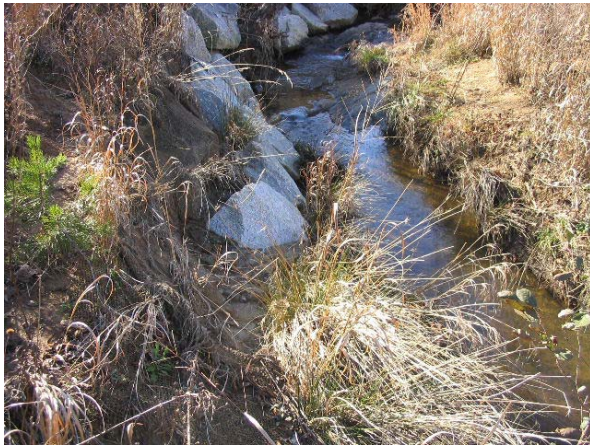
Issue Photo 8 - Station 4+40
Overland flow eroding channel bank

- Areas included are from stations 0+80 to 3+50 and small sections around stations 4+40, 14+00 and 15+50
 - These areas should be reseeded.
 - It will be required to prepare a seedbed in order establish herbaceous cover.

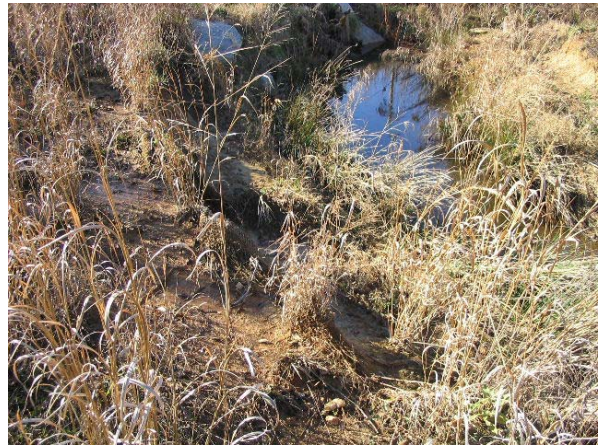
Issue Photo 9 - Station 6+80
Right bank scour and inadequate vegetation

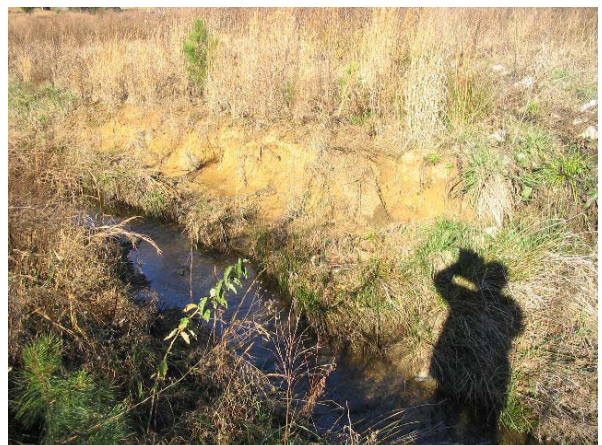
- Station 14+00 has degraded to the point that the bank is not likely to heal with the addition of vegetation alone.
- The lack of successful vegetation in the riparian buffer

Issue Photo 11 - Station 14+00
Right bank un-vegetated and scoured

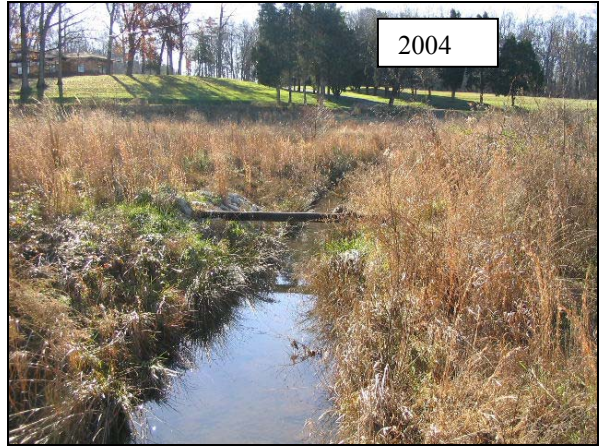
M16-DS: View from Meander 16 looking downstream. Cross-vane is drowned out due to backwater from the off-site lake downstream.⁸⁶

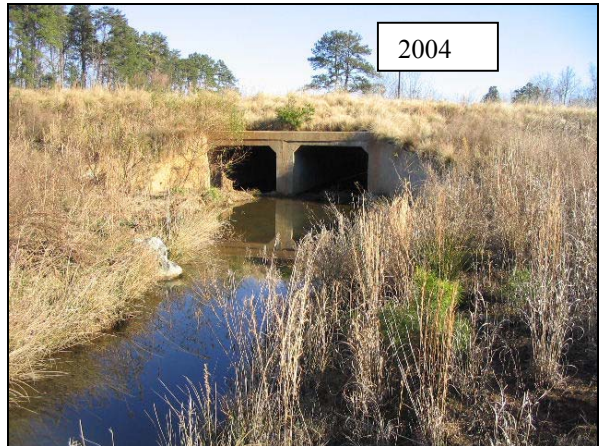
M17-DS: View from Meander 17 looking downstream towards the double 10' x 8' box culvert. Cross-vane is drowned out.88

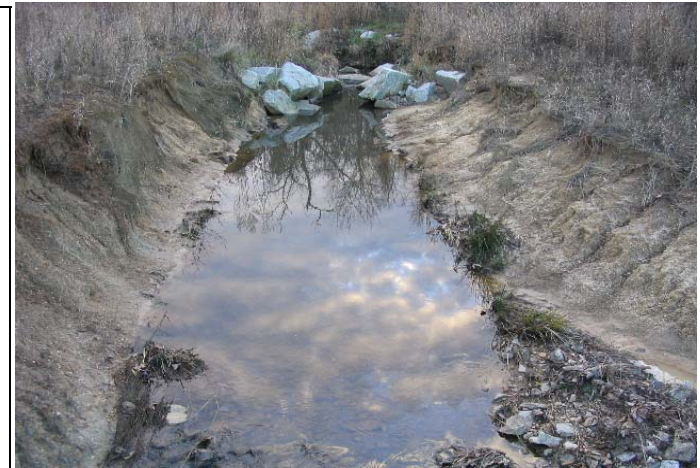
Photo of Cross-Section #1 - Looking Upstream

Channel substrate in cross section #4 (riffle) coarsened slightly over the past year. Cross-sections #2 (pool) and #3 (riffle) remained similar to last year's condition. Cross section #1 (riffle) had a decrease in coarseness over the past year.
