**Price Park  
Stream Restoration Monitoring Report  
EEP Project # 291  
Monitoring Year – 06  
2008**

**March 2009**

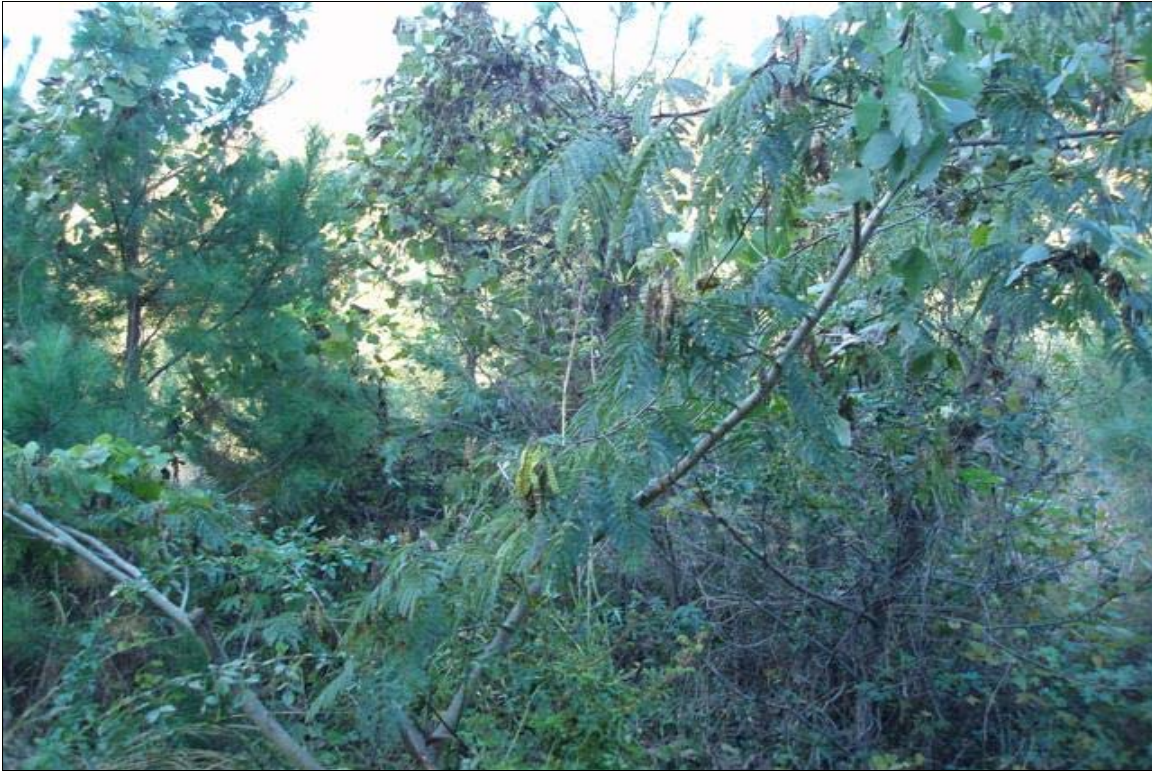
VP1 – Mimosa (*Albizia julibrissin*) and kudzu (*Pueraria montana*). Photo taken near Station 3+50. 10/29/08 - MY 06

The most prolific of the site's exotic invasive species is kudzu (*Pueraria montana*), which already covers a large part of the easement and should be controlled as soon as possible. The other invasive species that are present in the project area include: Japanese honeysuckle (*Lonicera japonica*), Chinese privet (*Ligustrum sinense*), multiflora rose (*Rosa multiflora*), elaeagnus (*Elaeagnus sp.*), mimosa (*Albizia julibrissin*), oriental bittersweet (*Celastrus orbiculatus*), Johnson grass (*Sorghum halepense*), lespedeza (*Lespedeza cuneata*), and microstegium (*Microstegium vimineum*). It is recommended that a site assessment for replanting be conducted and that an aggressive invasive species control program be implemented.

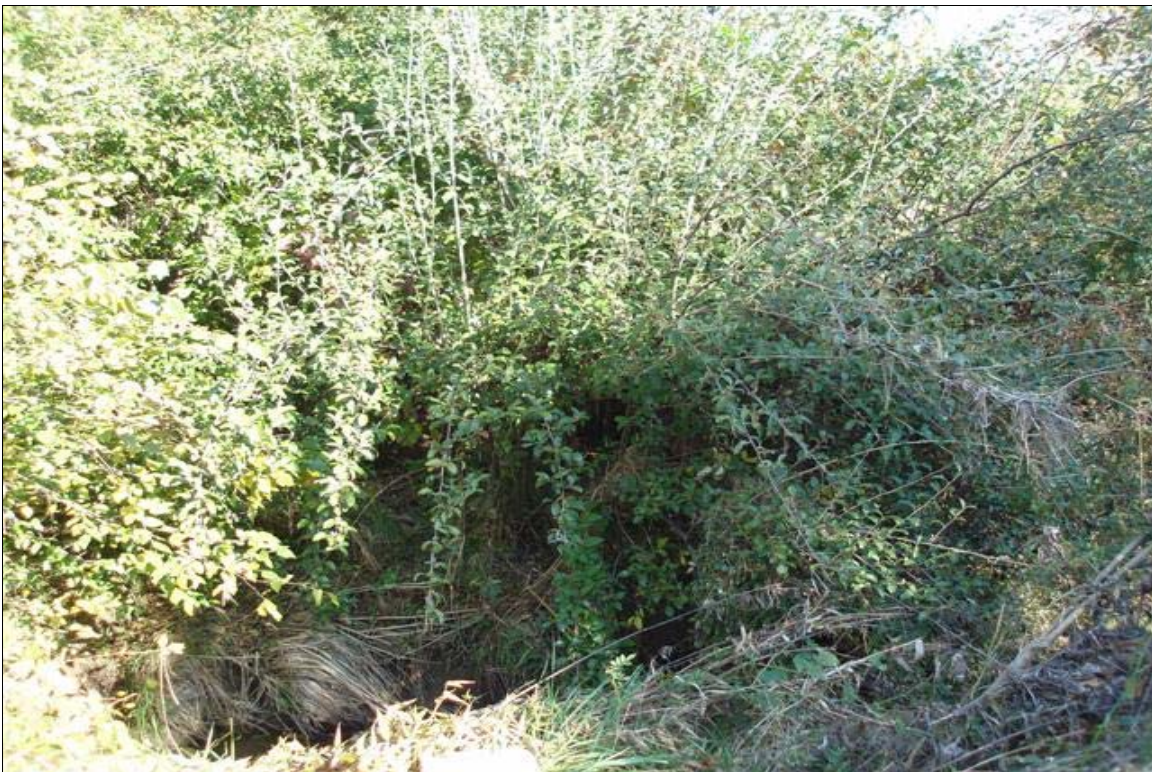
VP2 – Thorny olive (*Elaeagnus pungens*) along stream bank. Photo taken near Station 5+50. 10/29/08 - MY 06

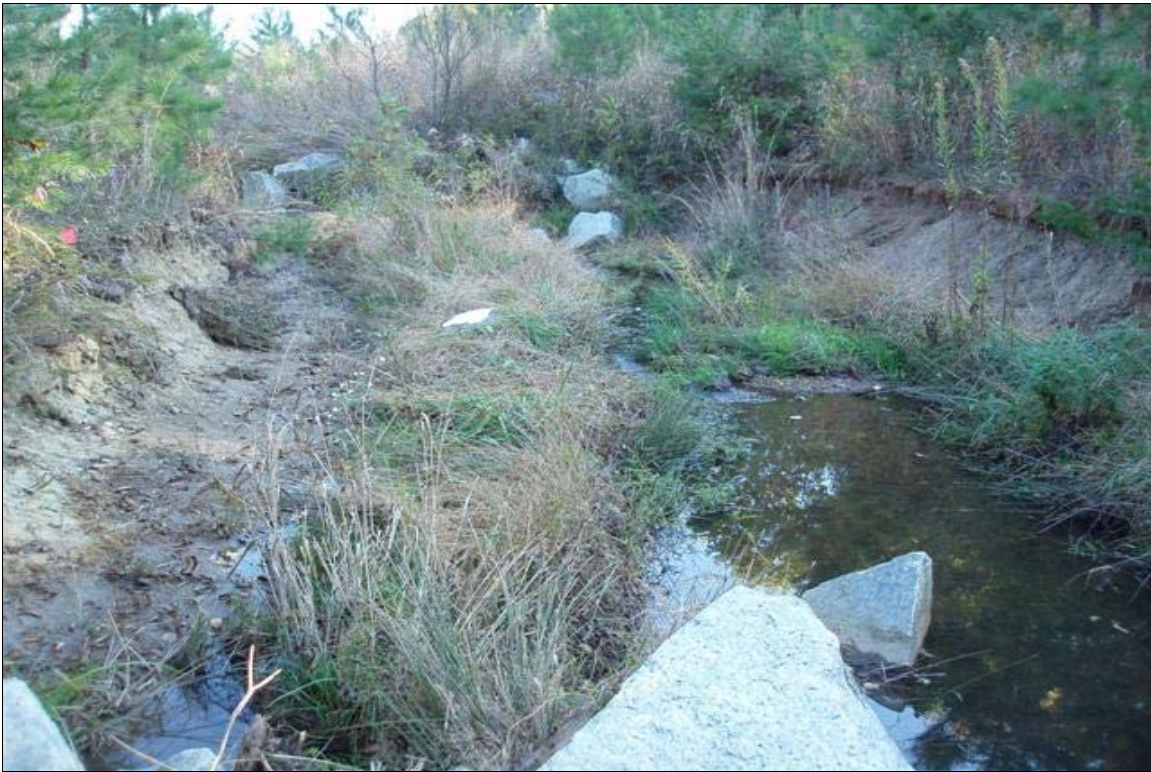
SP1 – Severe bank erosion. Photo taken near Station 4+00 (XS1). 10/29/08 - MY 06

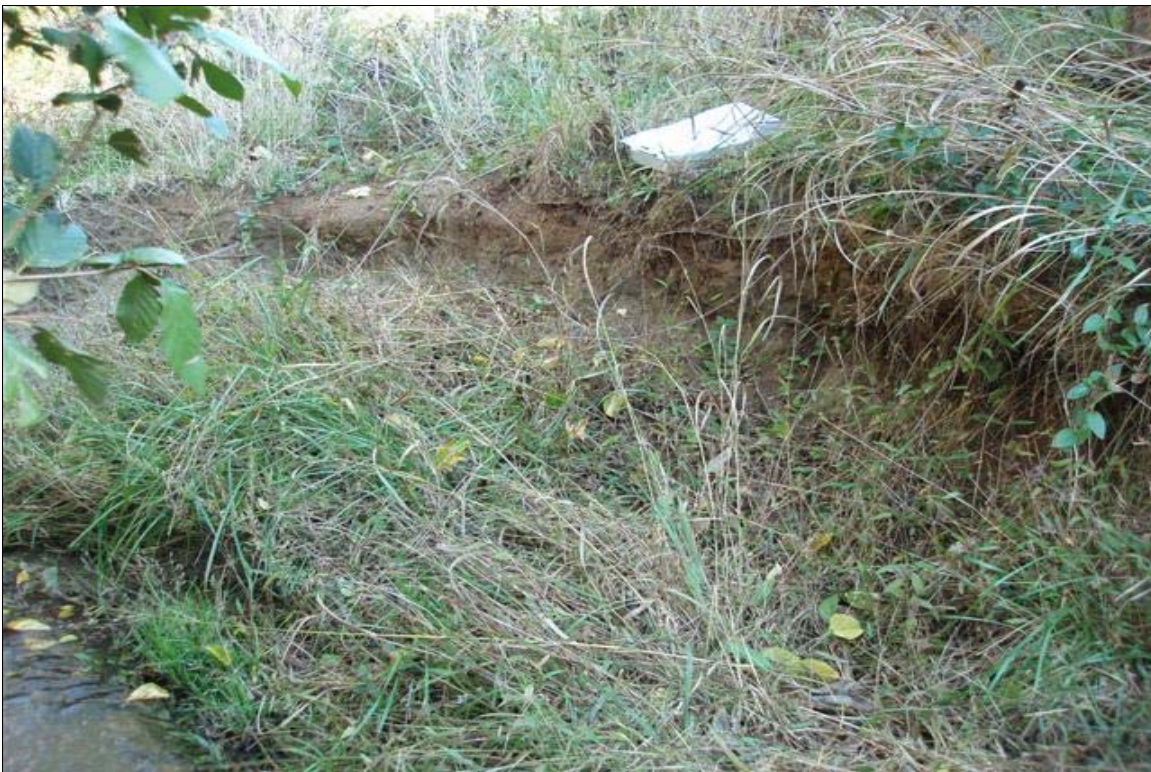
SP2 – Upper bank erosion. Photo taken near Station 5+00. 10/29/08 - MY 06

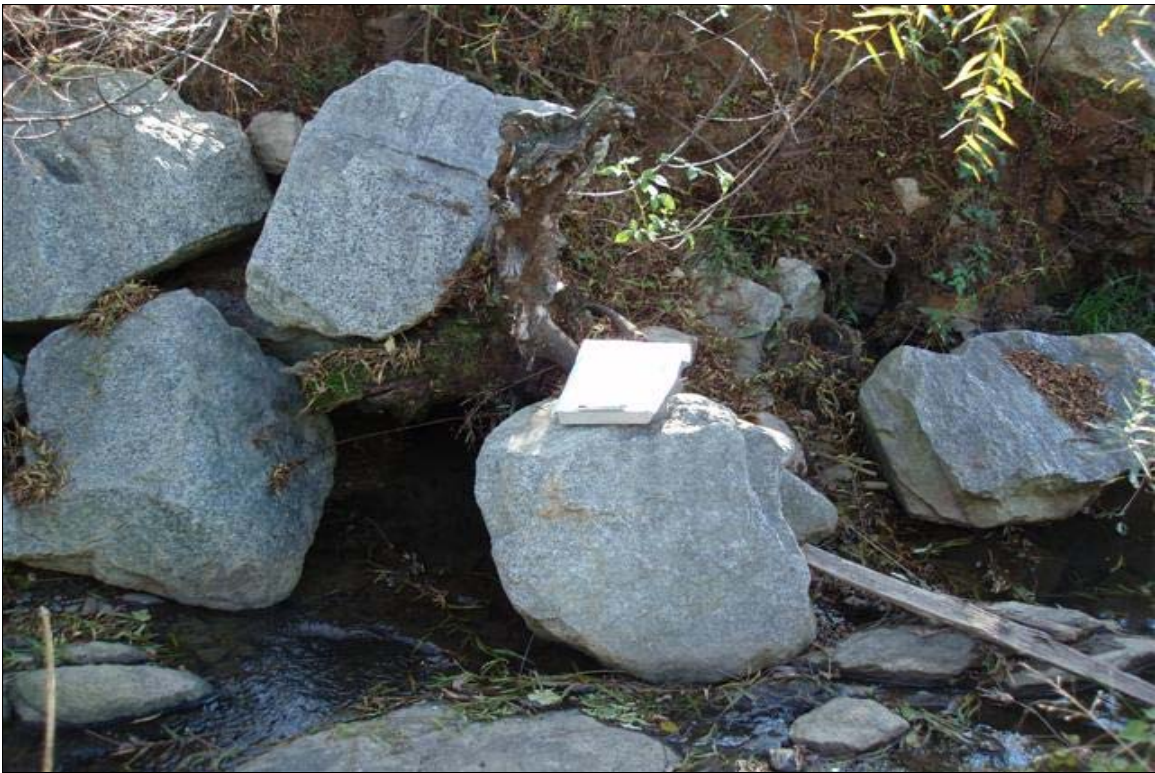
SP3 – Root wads completely above baseflow, rotting, and with scour behind. Photo taken near Station 9+00. 10/29/08 - MY 06

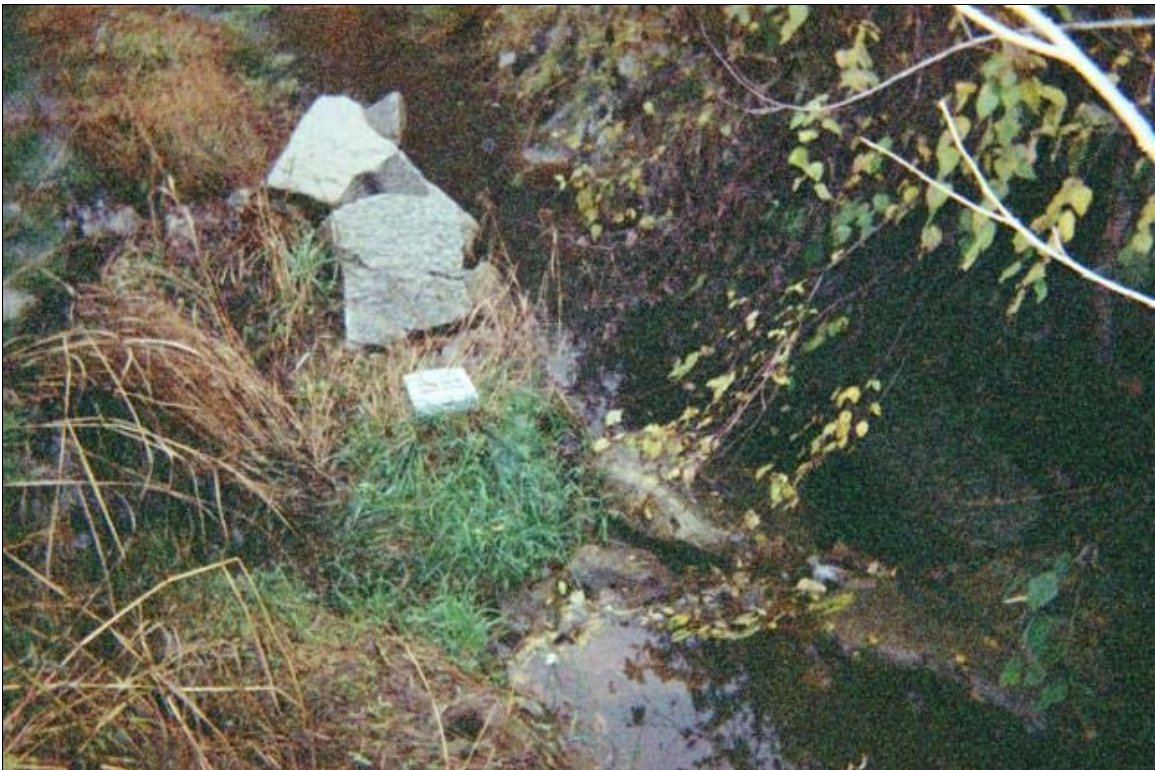
SP4 – Failed cross vane. Photo taken near Station 4+00. 11/5/08 - MY 06

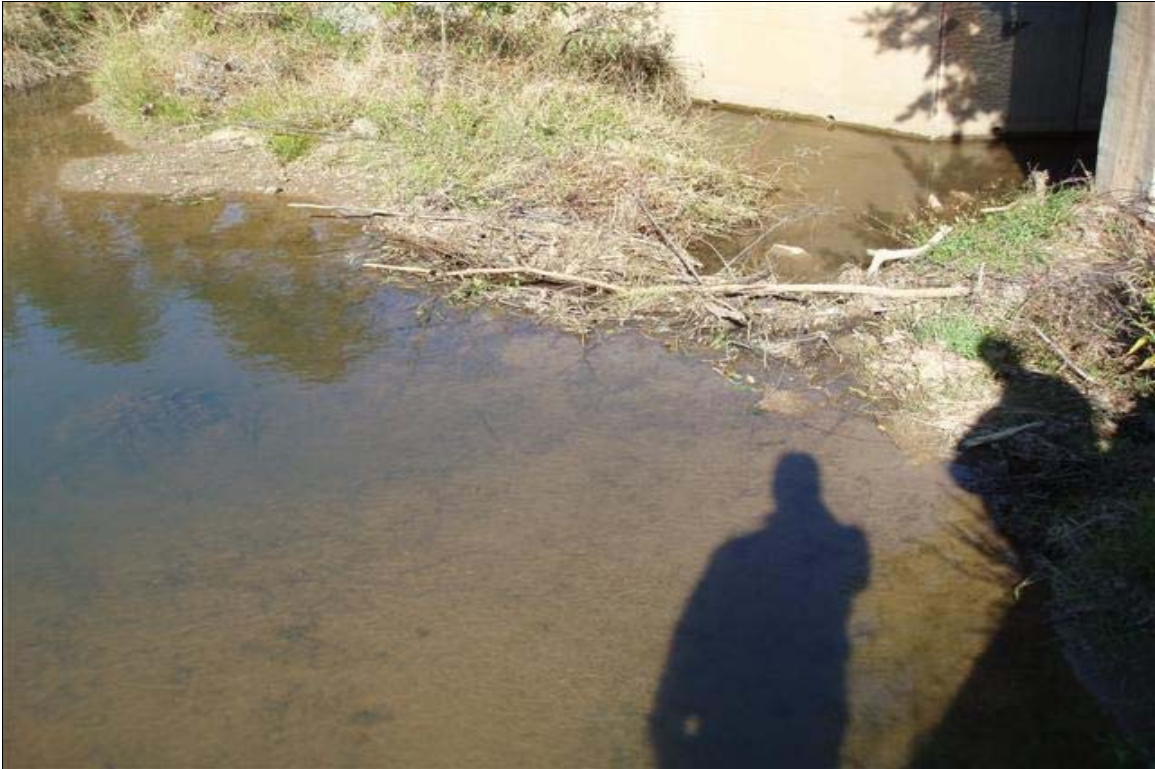
SP5 – Beaver dam causing backwater conditions to Station 13+60. Photo taken near Station 17+50. 10/29/08 - MY 06
