**Price Park  
Stream Restoration Monitoring Report  
EEP Project # 291  
Monitoring Year – 07  
2009**

**December 2009**

PRICE PARK  
UT TO HORSEPEN CREEK  
GUILFORD COUNTY, NORTH CAROLINA  
EEP PROJECT NUMBER 291 - MY07  
STATION 00+00 TO STATION 10+28

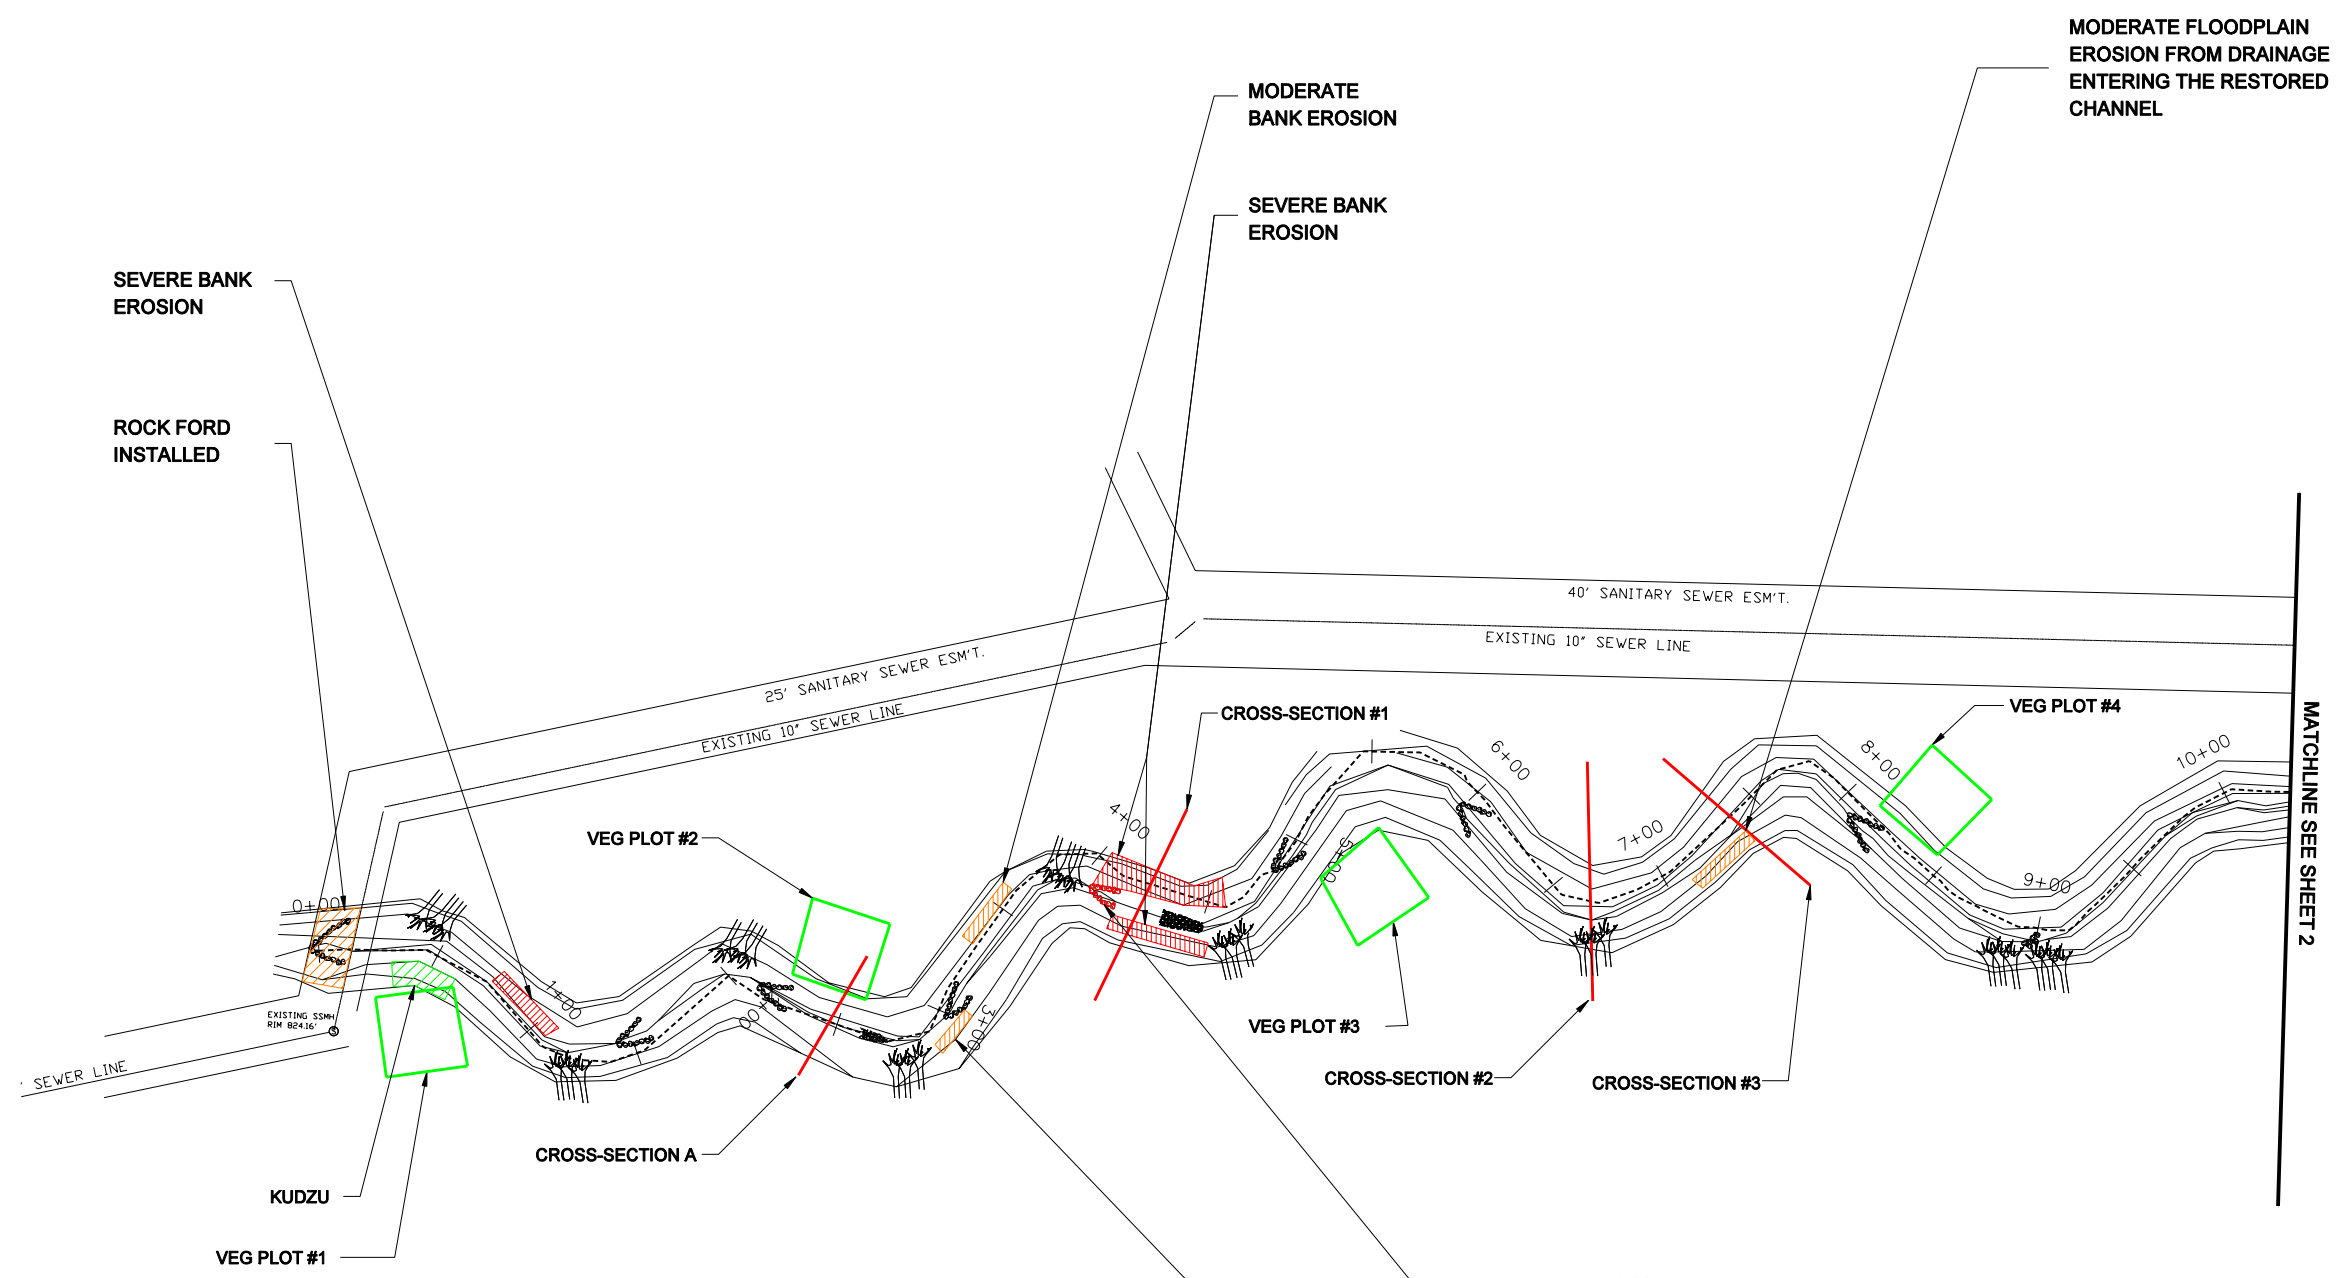
DATE: DECEMBER 2009  
SCALE: SEE SHEET  
CURRENT  
CONDITION  
PLAN VIEW  
SHEET 1 OF 2

Although the project channel exhibited some adjustments and several areas of instability at some point in its history, observations in measurement years 6 and 7 indicate that the majority of these have stabilized. Two areas of bank erosion rated as severe with one area at cross-section 1, near station 4+00 that included a complete structural failure of a cross-vane. This area covers the 50-foot riffle in this section and represents the one main area of instability. However, the rest are modest instances of prior erosion with 93 and 94% of the total bank footage exhibiting stability for measurement years 6 and 7, respectively.

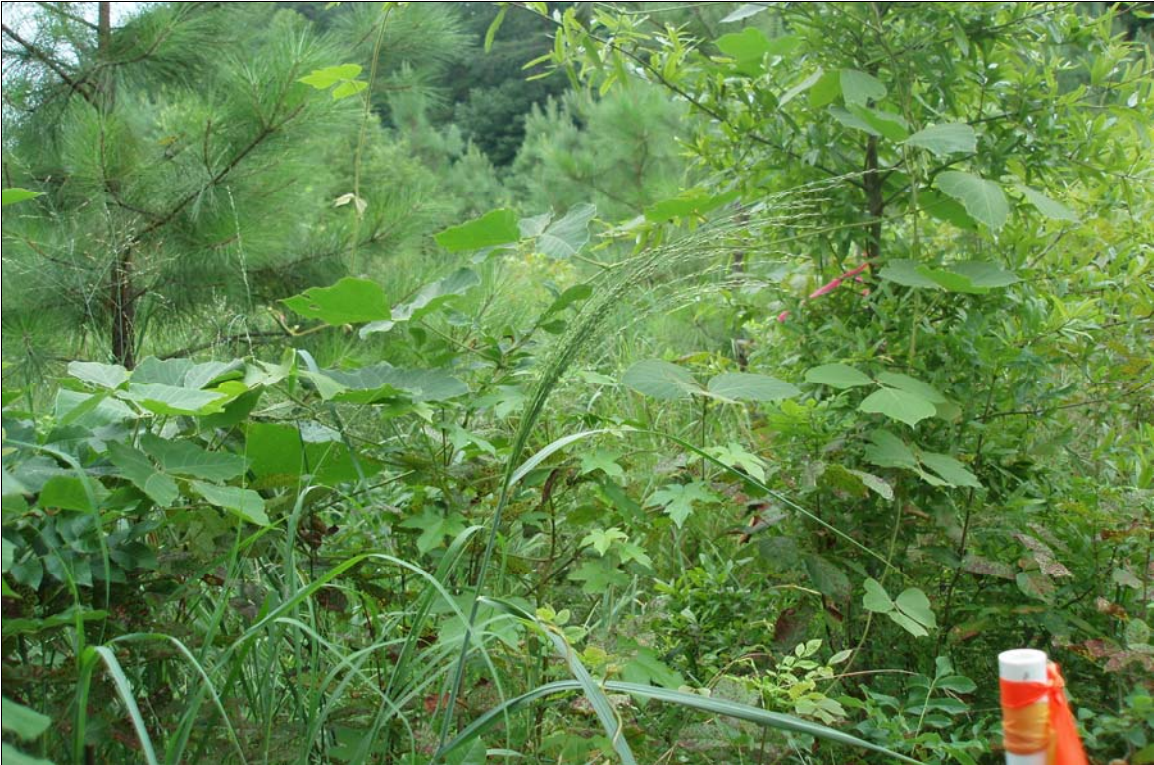
Vegetation Plot 1 – Taken looking southeast toward the center of the plot from the origin. 7/16/09 - MY 07

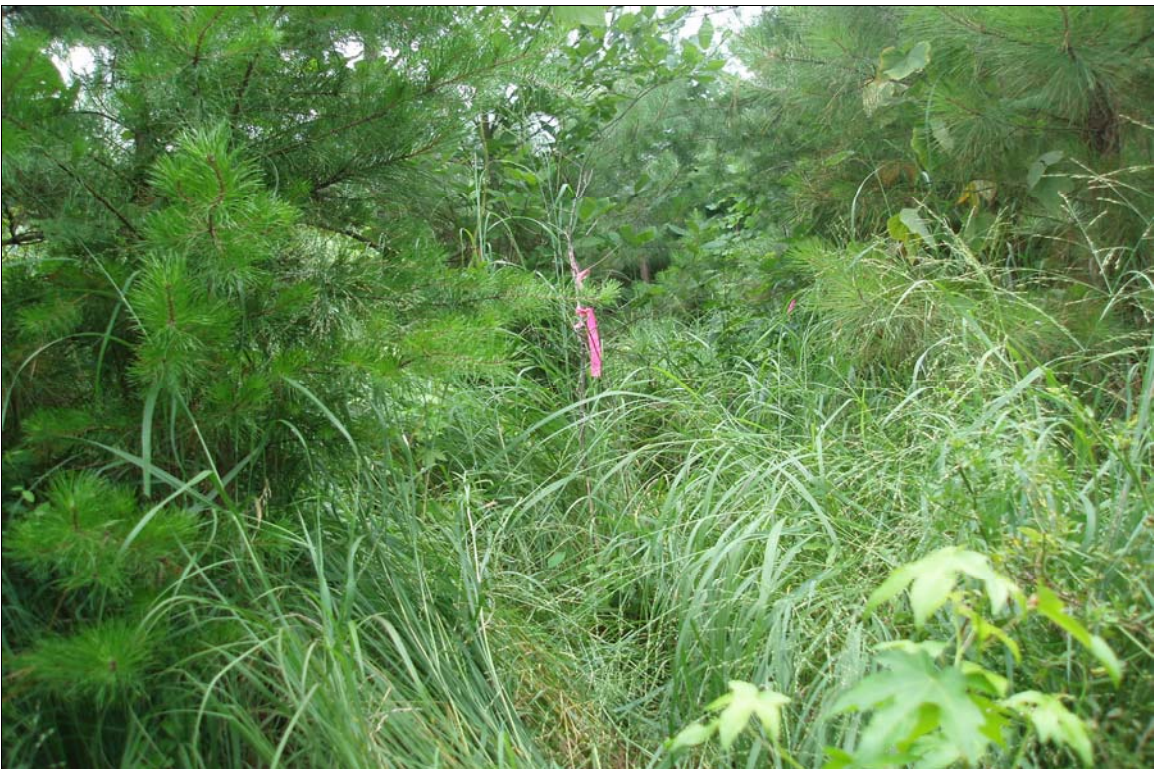
Vegetation Plot 2 – Taken looking northeast toward the center of the plot from the origin. 7/16/09 - MY 07

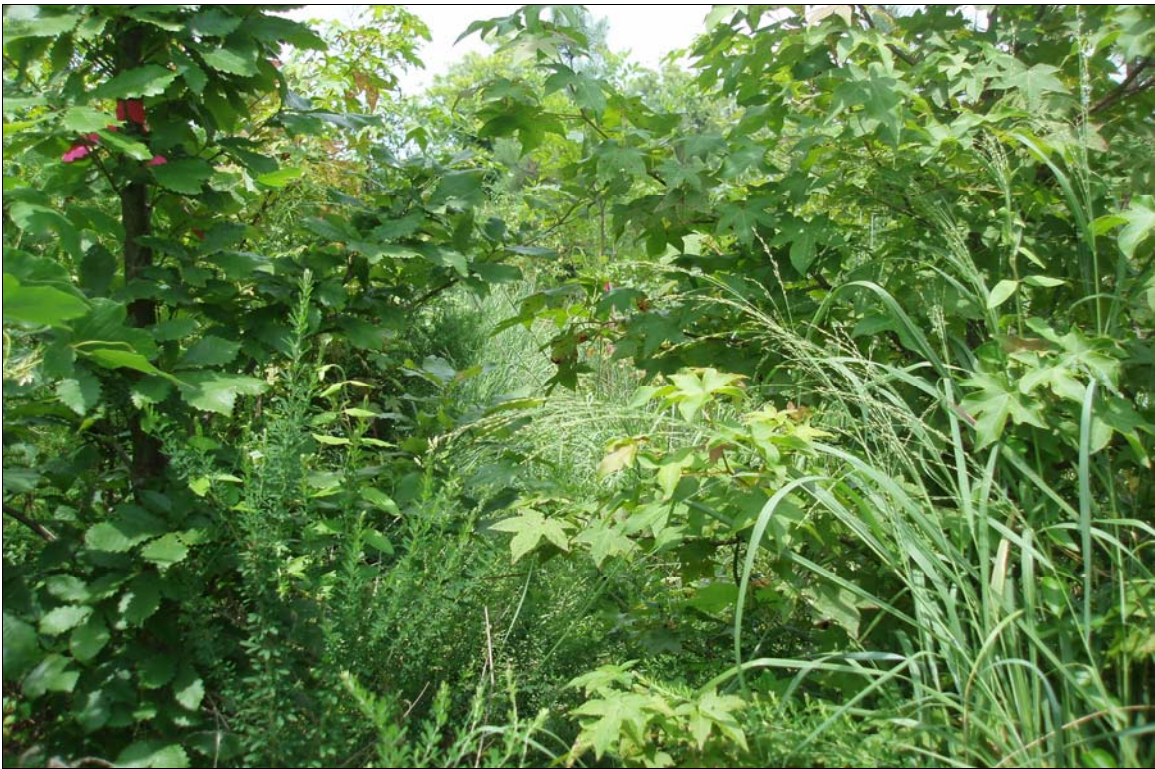
Vegetation Plot 3 – Taken looking east toward the center of the plot from the origin. 7/16/09 - MY 07

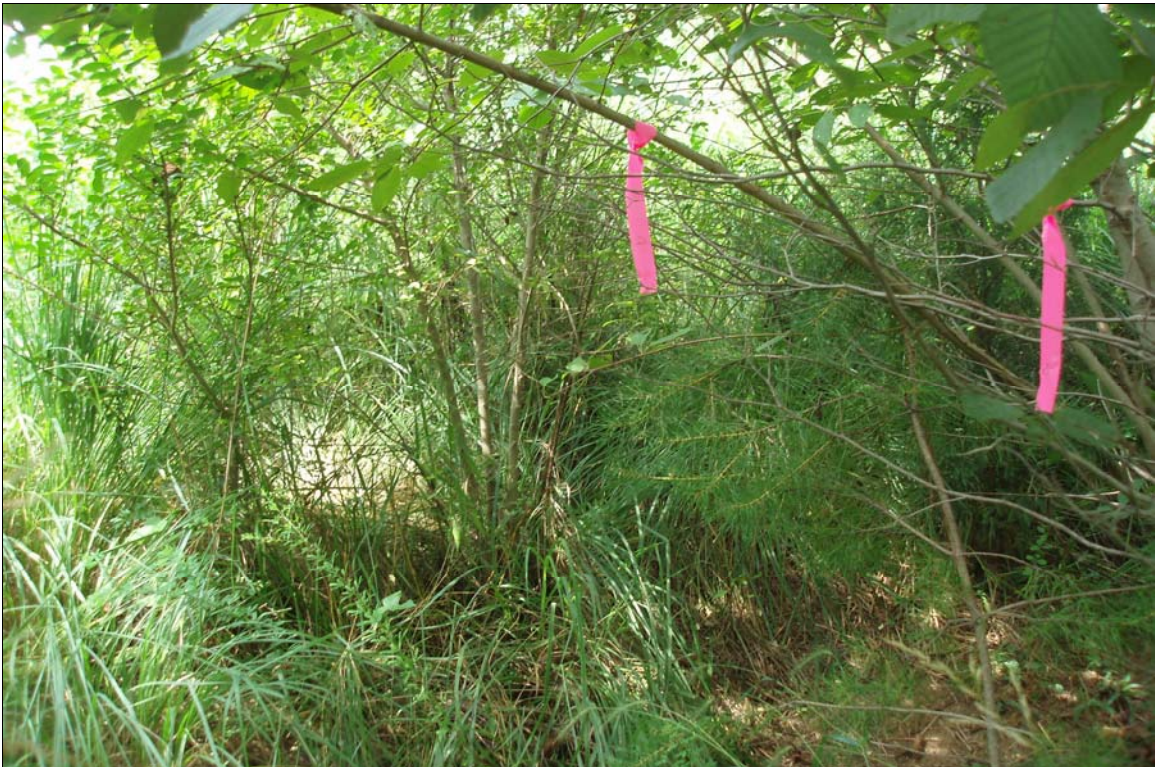
Vegetation Plot 4 – Taken looking east toward the center of the plot from the origin. 7/16/09 - MY 07

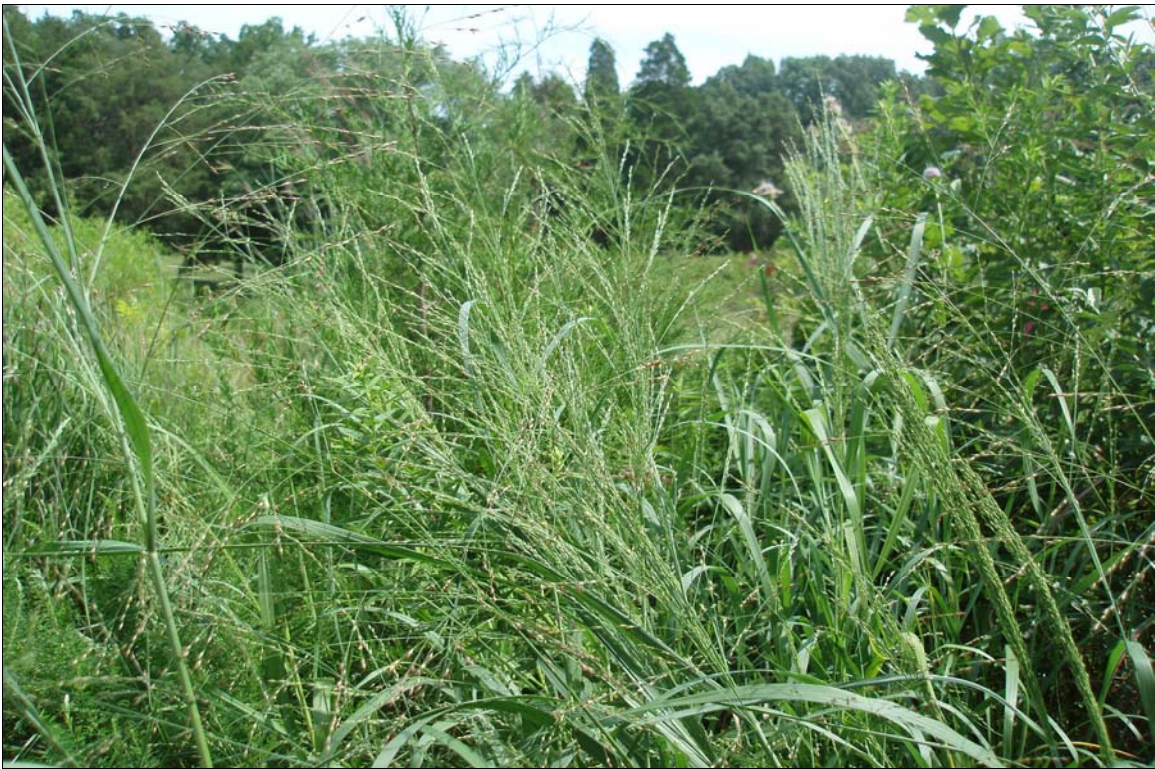
Vegetation Plot 5 – Taken looking south toward the center of the plot from the origin. 7/16/09 - MY 07

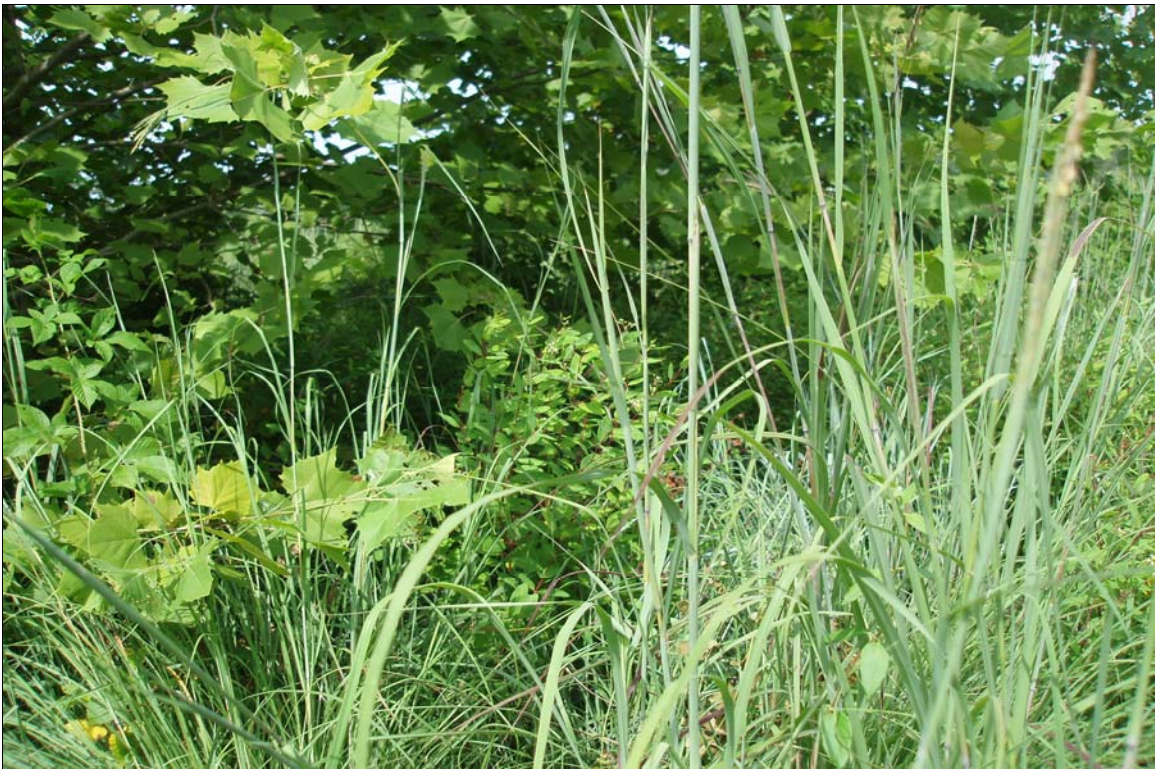
Vegetation Plot 6 – Taken looking east toward the center of the plot from the origin. 7/16/09 - MY 07

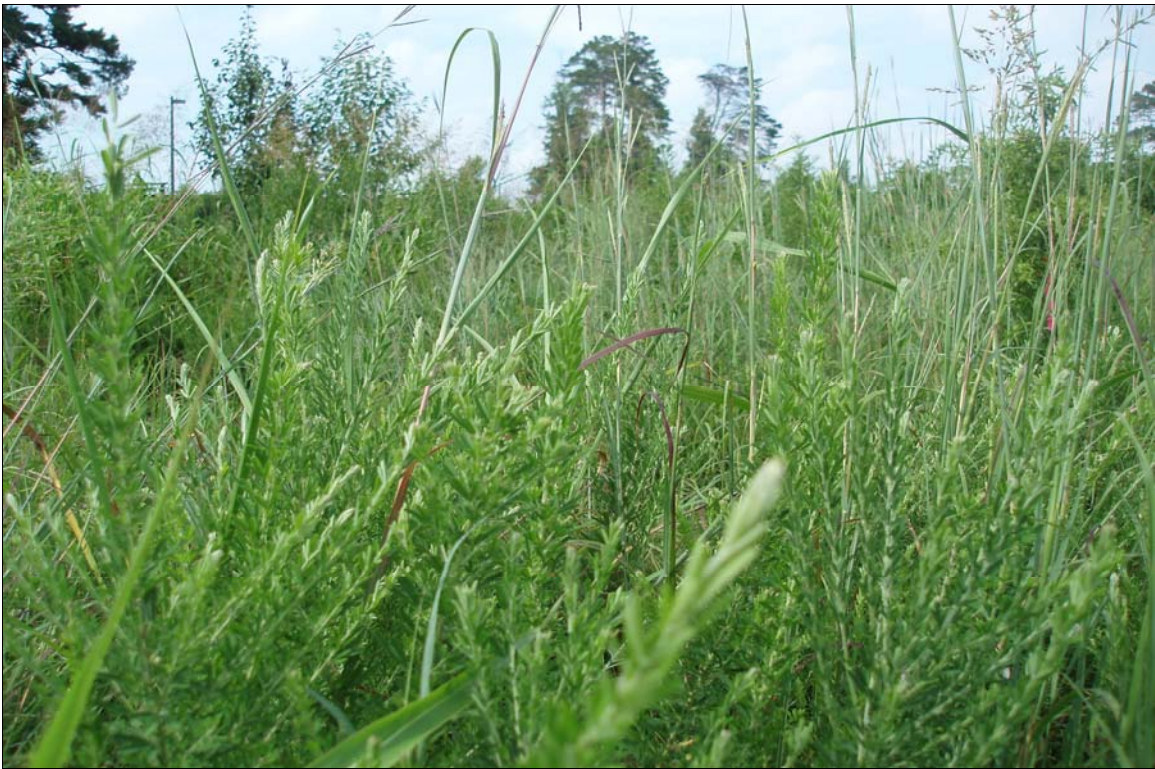
Vegetation Plot 7 – Taken looking northeast toward the center of the plot from the origin. 7/16/09 - MY 07

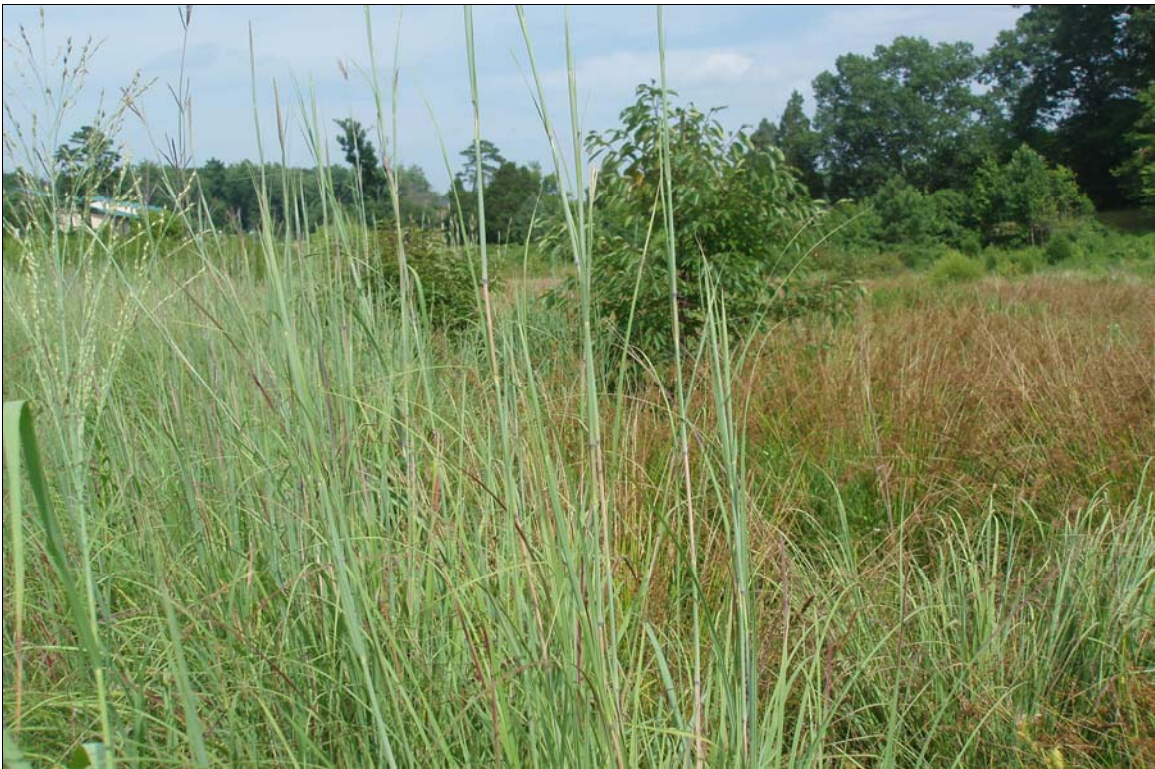
Vegetation Plot 8 – Taken looking south toward the center of the plot from the origin. 7/16/09 - MY 07
