Purlear Creek - Phase I Stream Restoration Annual Monitoring Report

Monitoring Year: 2005

NCEEP Project Number: 294

Prepared by: Biological & Agricultural Engineering, North Carolina State University
Campus Box 7625
Raleigh, NC 27695

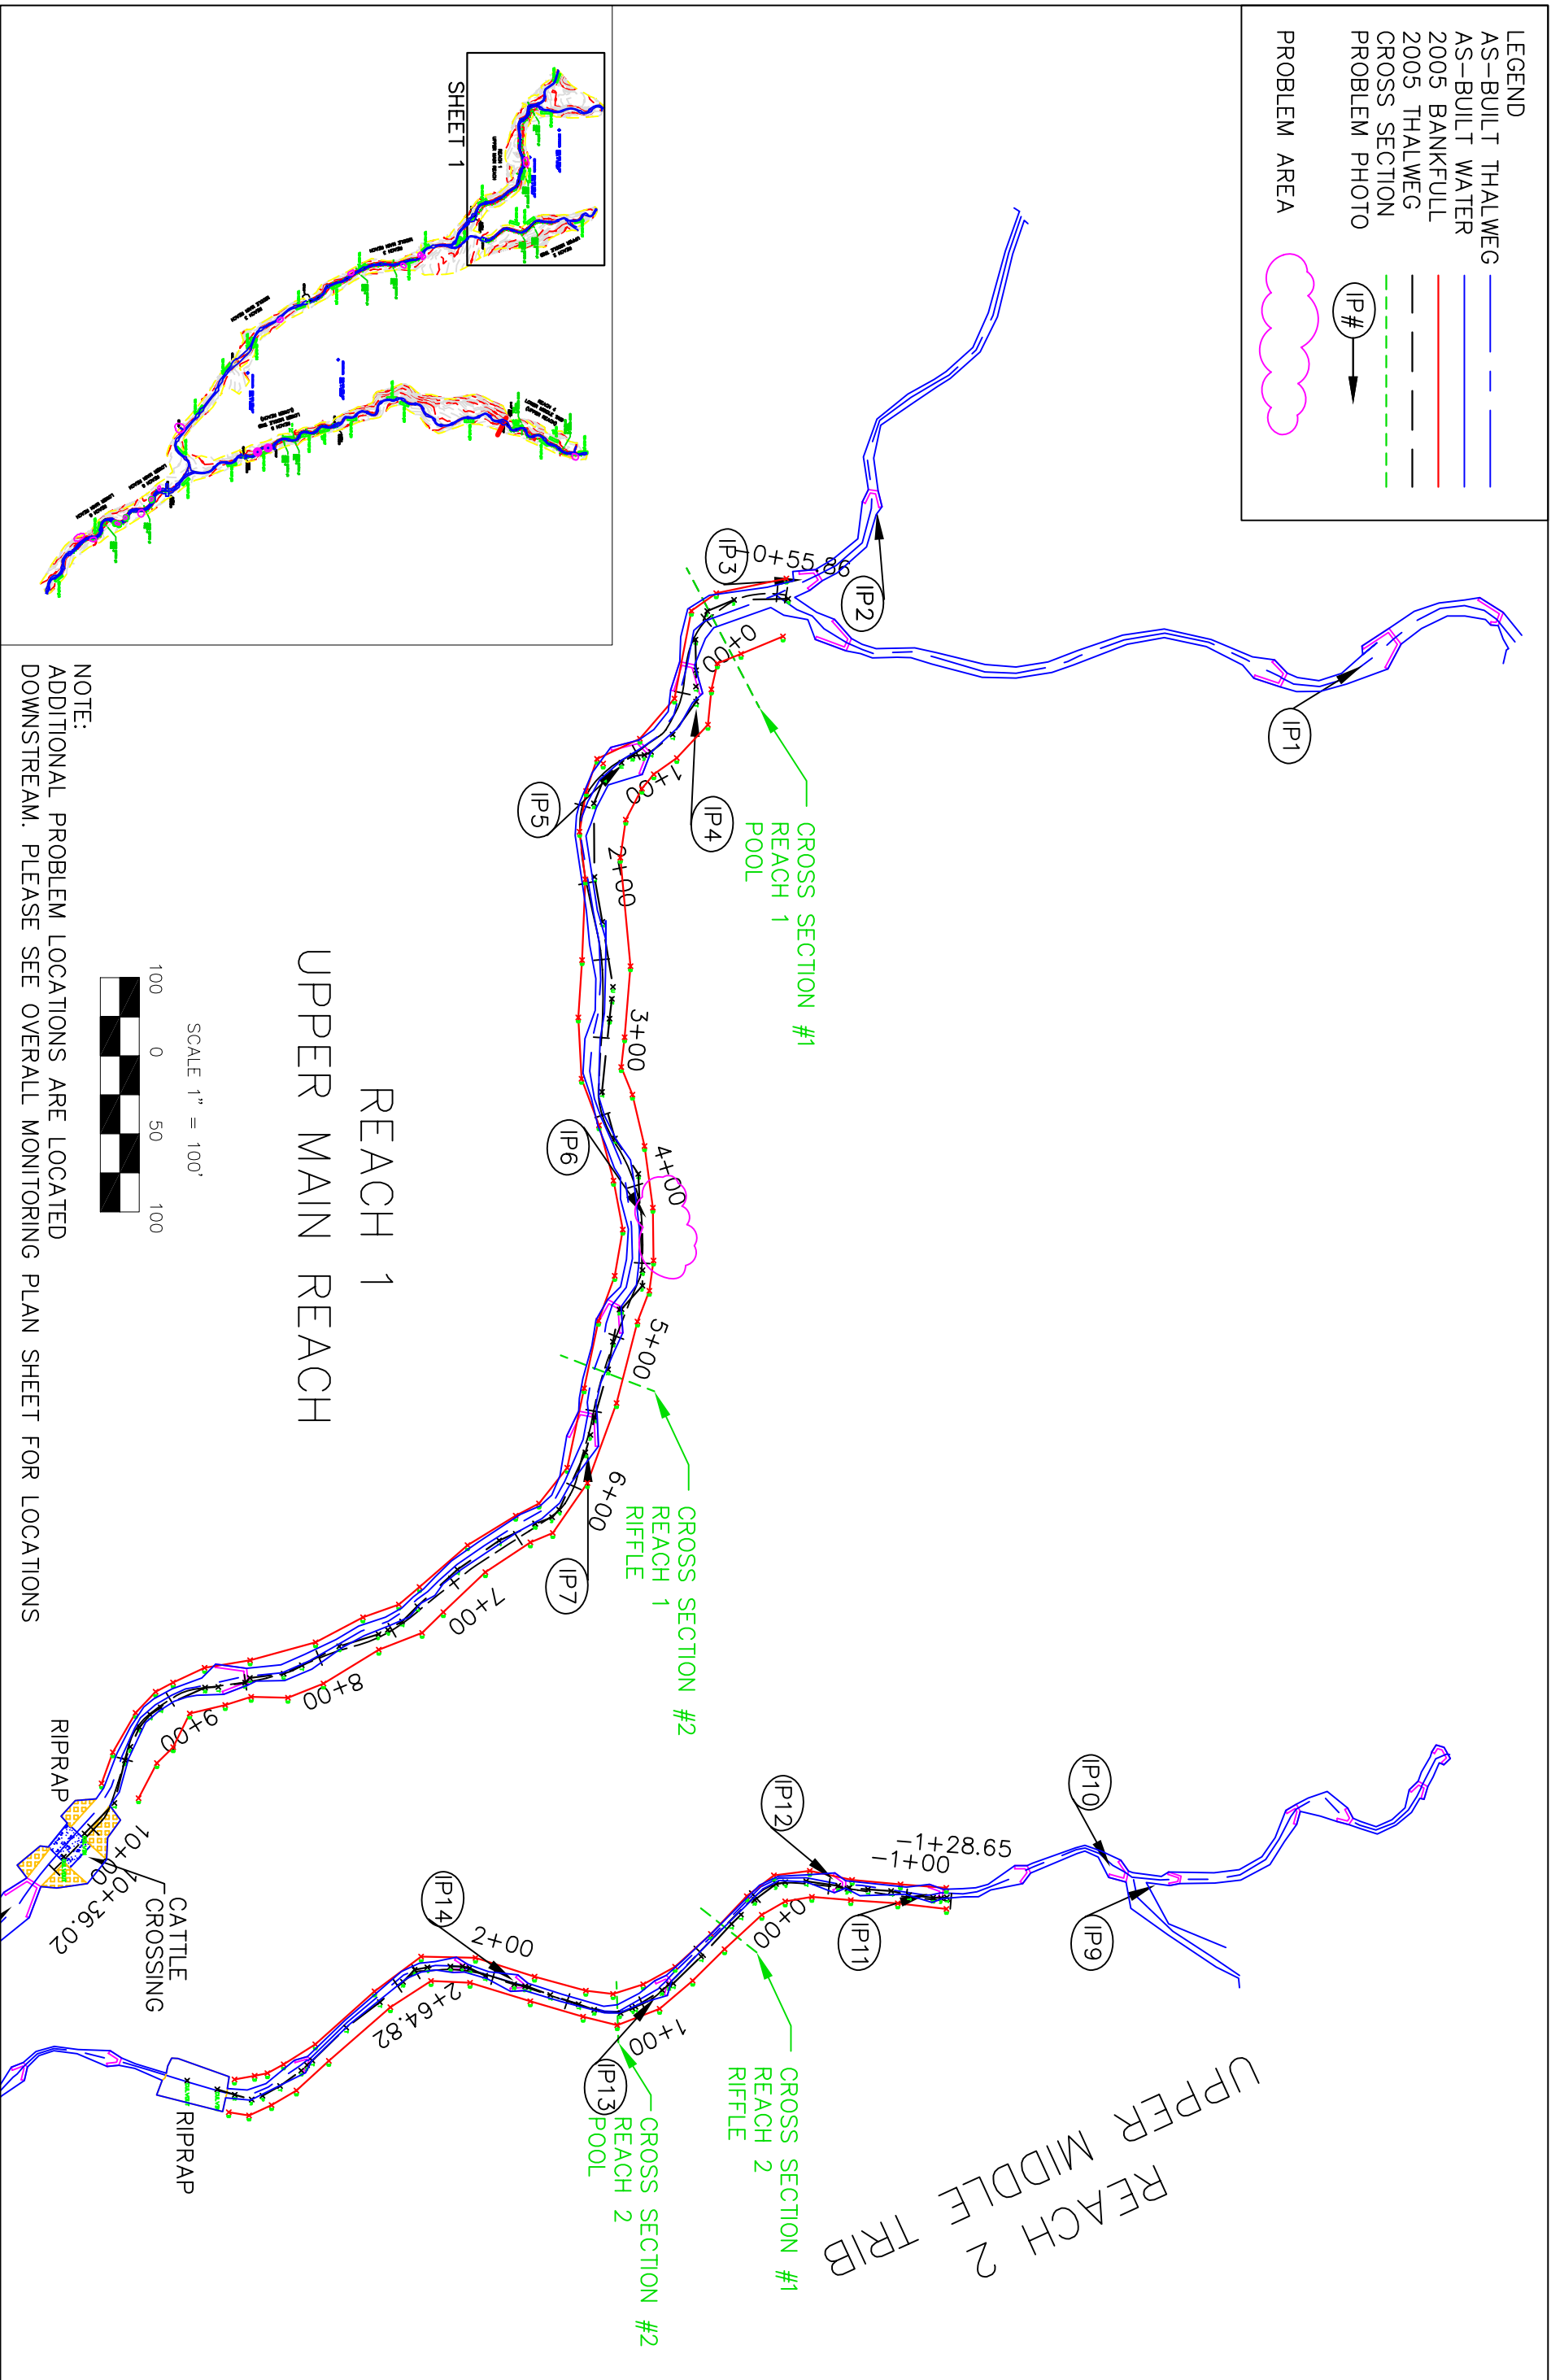
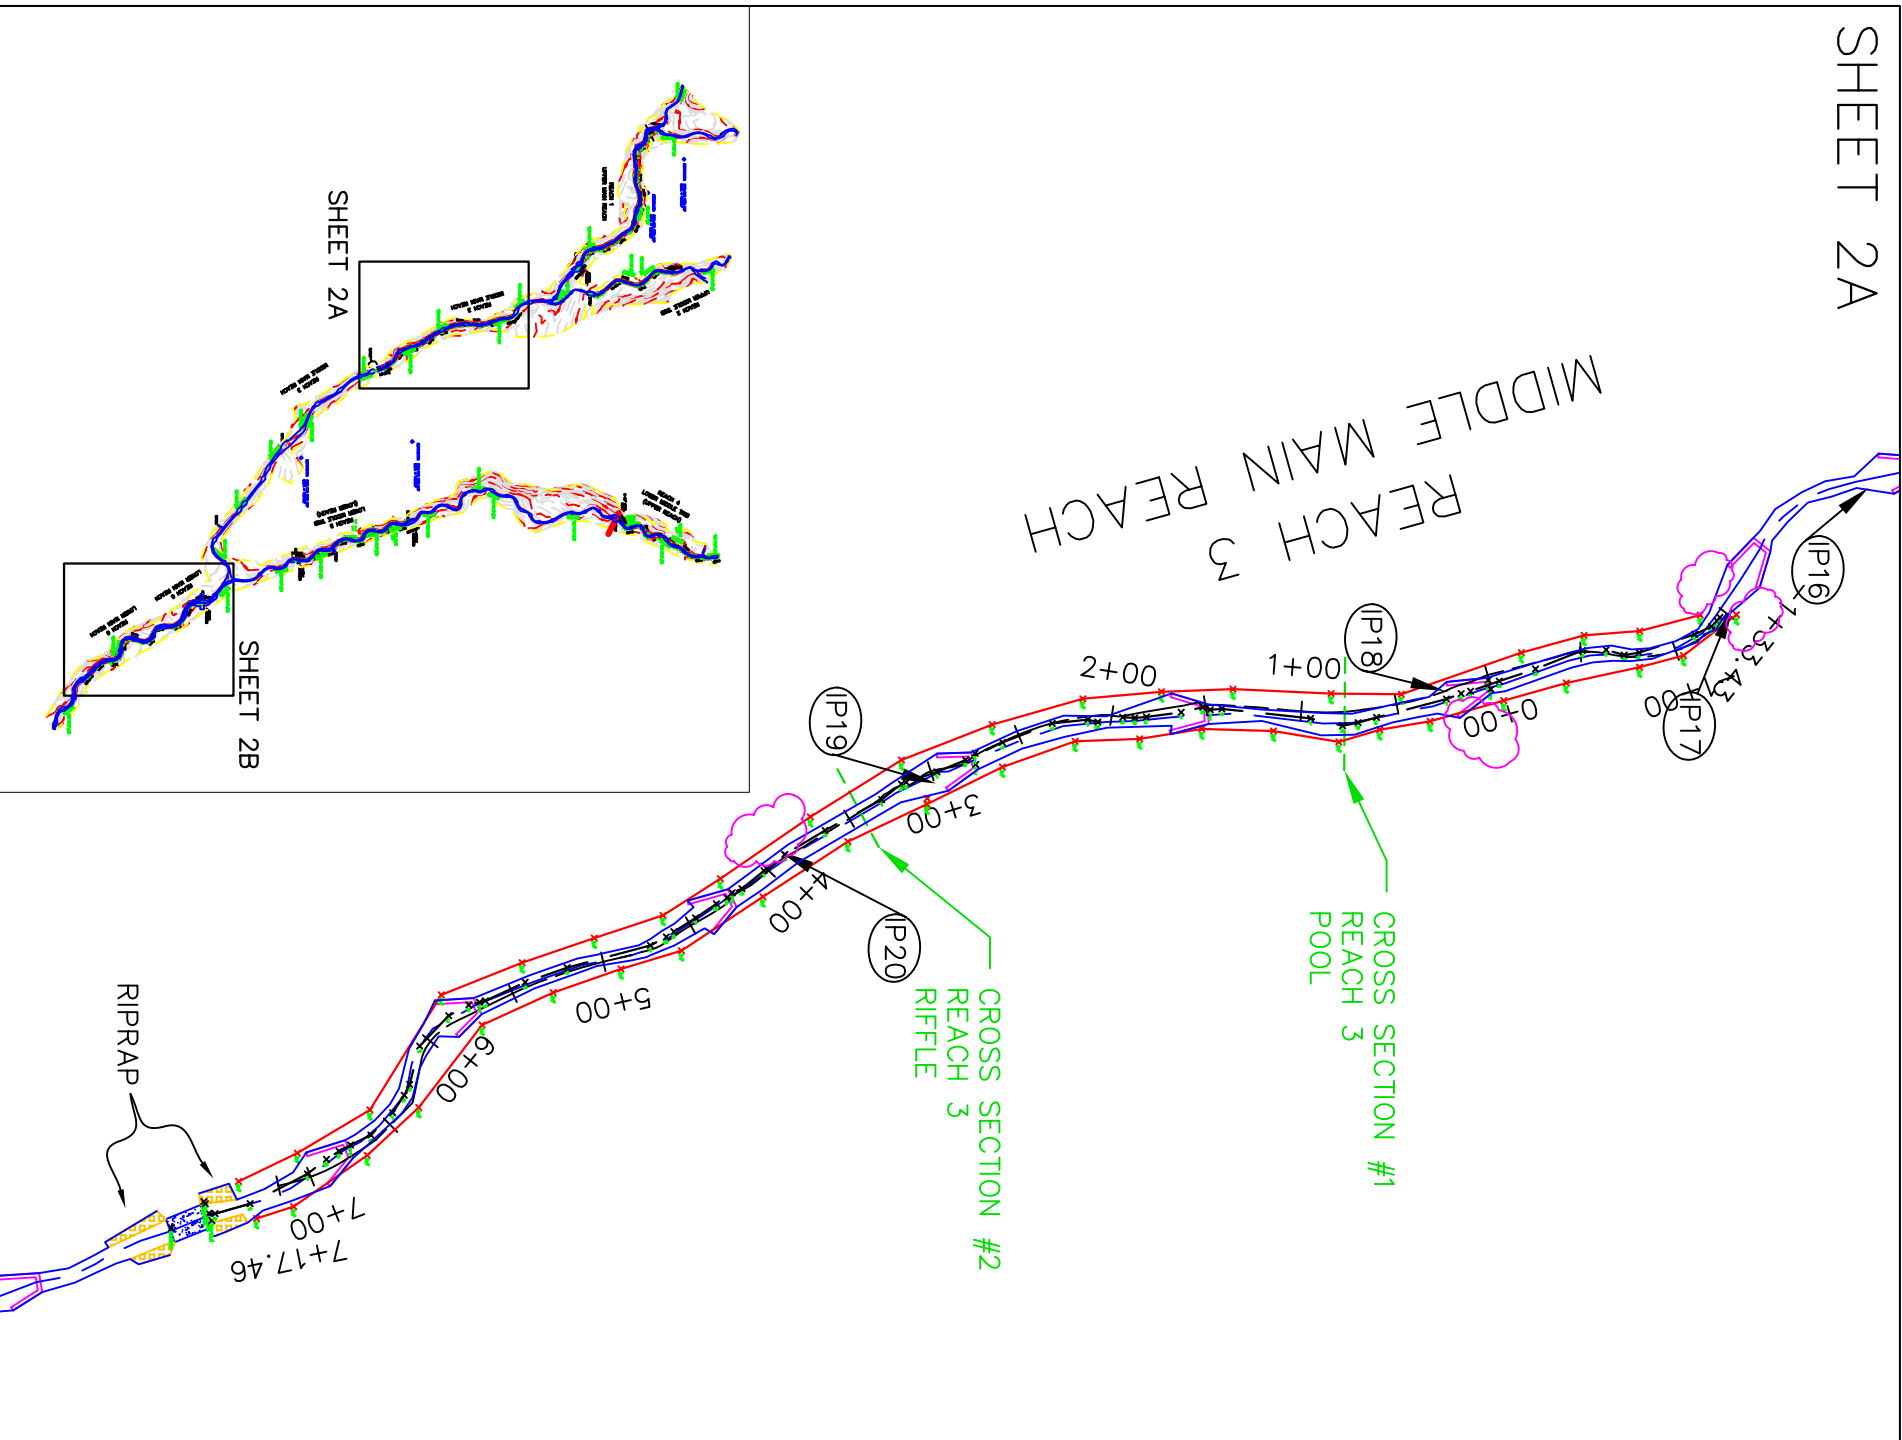
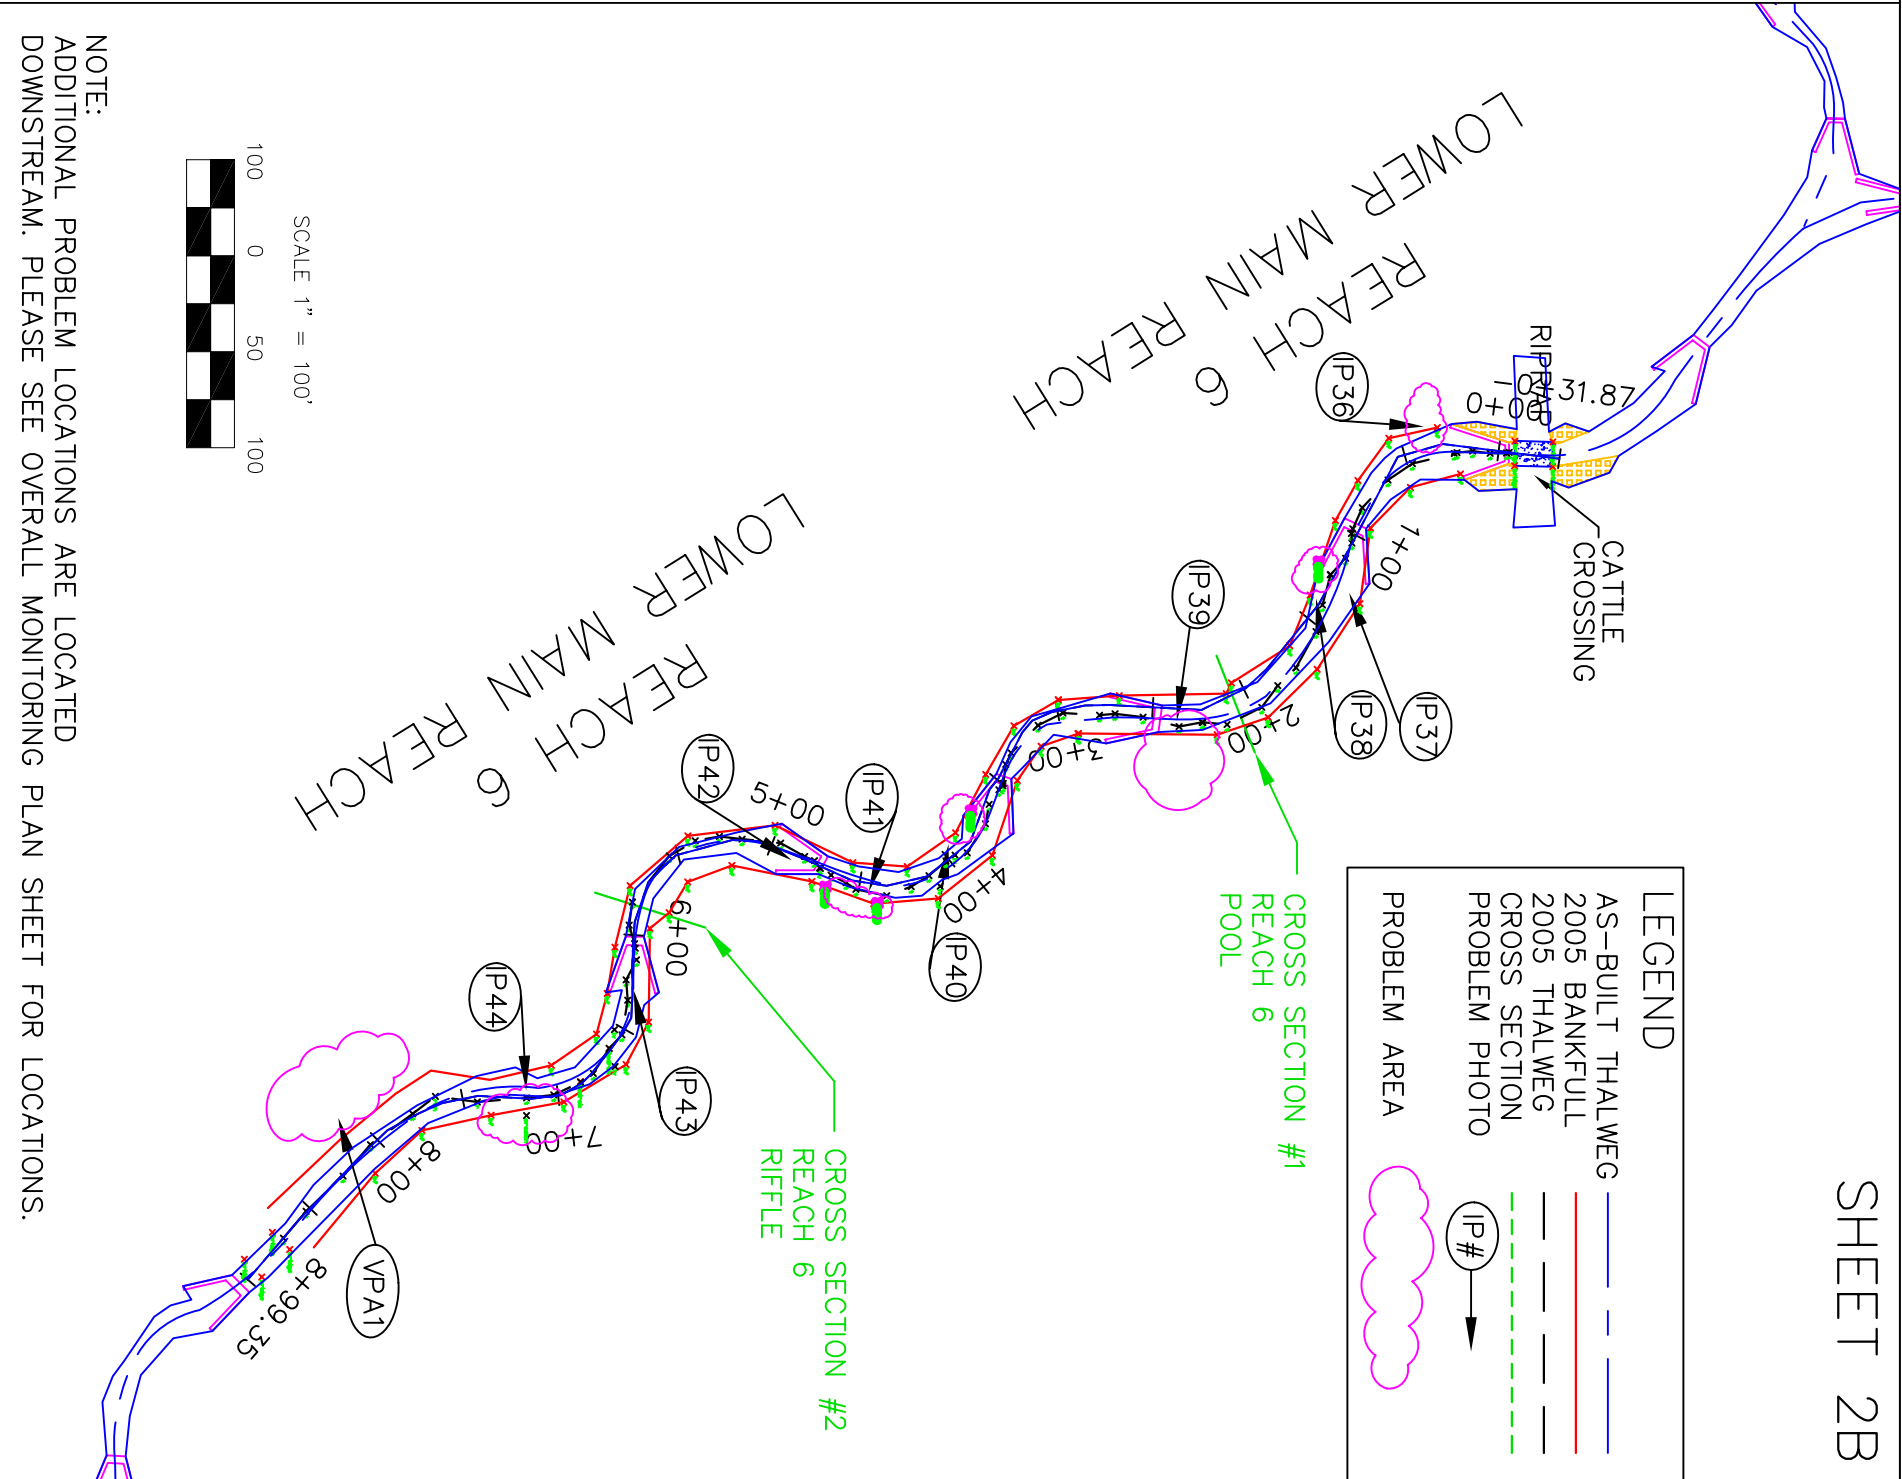
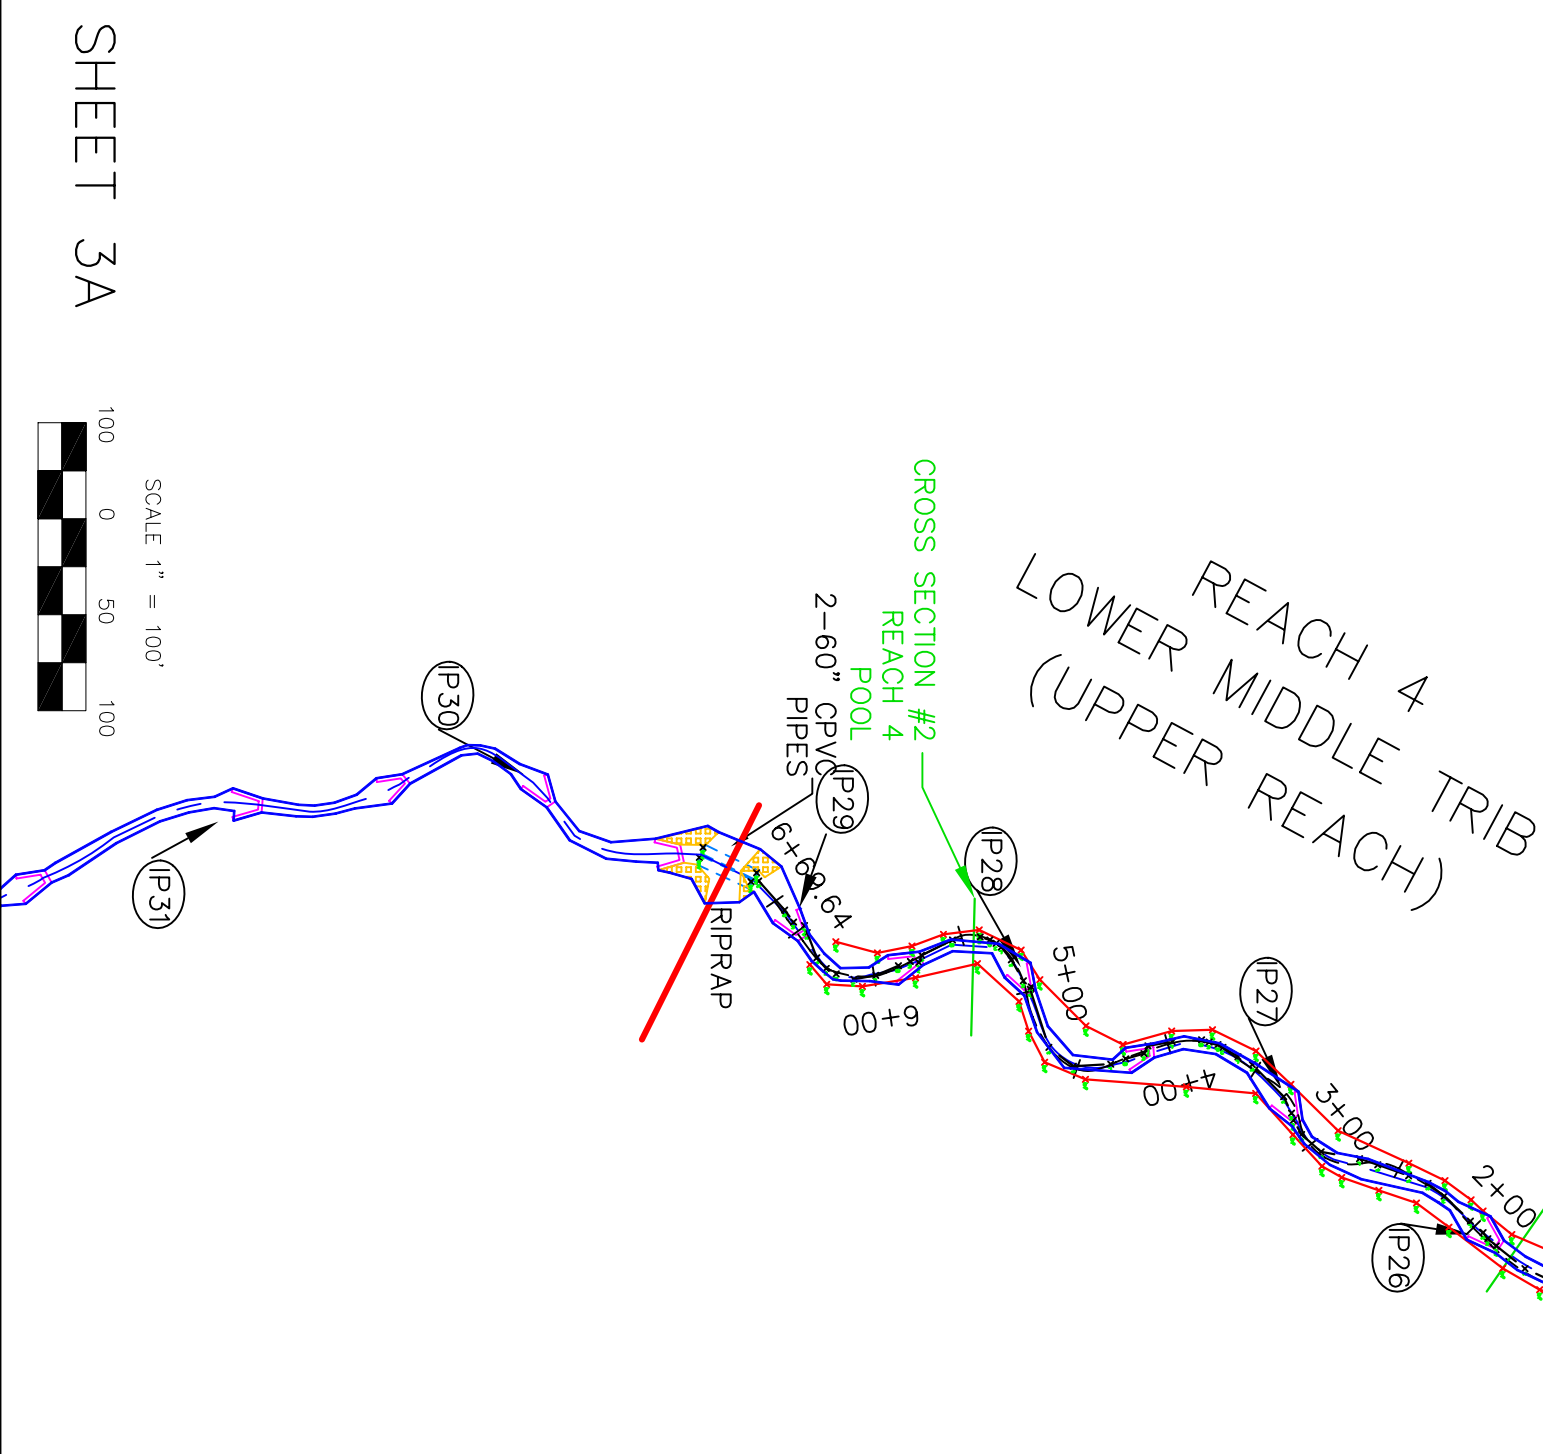
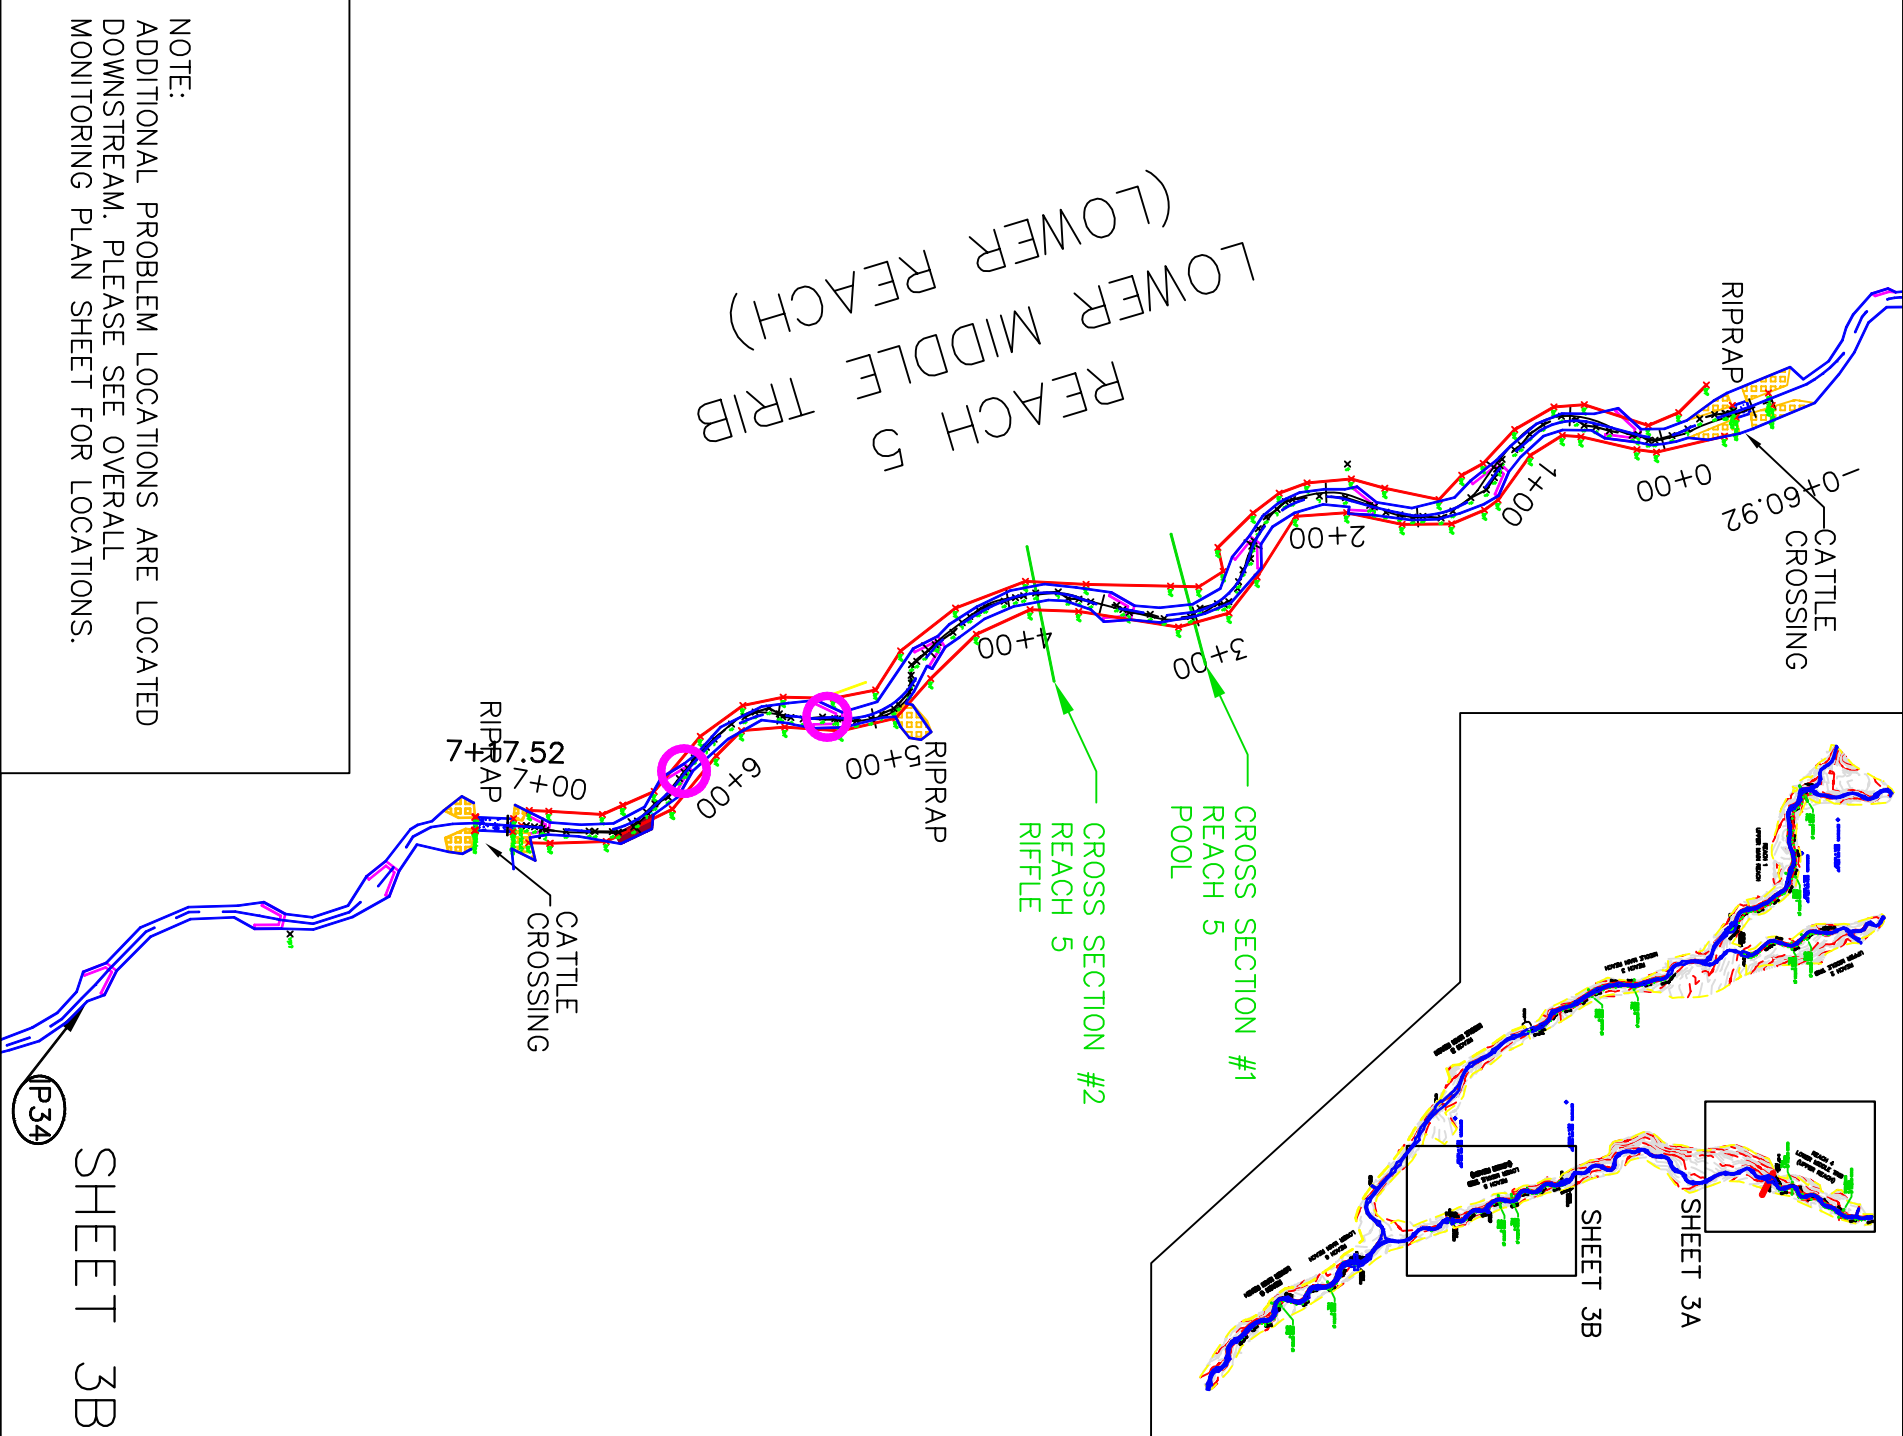
PROBLEM AREA

The primary area of concern is the grade drops at 33 of the cross vanes on the project. The grade drops of 0.5 feet or more are listed in the problem area table. No action is recommended at this time but these structures should be monitored closely in upcoming monitoring events. Other concern areas are primarily small erosional areas that appear to be localized. At four locations along the project, excess nutrients are entering the channel and bypassing the established buffer. Two locations are drain tiles recently installed and two are heavy use areas where topographic drainages exist.

Feature Issue	Reach	Problem/ Photo Number	Station Numbers	Suspected Cause
Bed Elevation Drop	Reach 1	IP1	Above Study Reach	Steep Channel Grade Drop Designed into Structure
		IP2	Above Study Reach	
		IP3	Above Study Reach	
		IP4	0+30	
		IP5	1+00	
		IP7	5+50	
		IP8	Below Study Reach	
		Reach 2	IP9	
	IP10		Above Study Reach	
	IP11		-1+30	
	IP12		-0+65	
	IP13		0+74	
	IP14		1+75	
	IP15		Below Study Reach	
	Reach 3	IP16	Above Study Reach	
		IP18	0+00	
		IP19	2+77	
		IP21	Below Study Reach	
		IP23	Below Study Reach	
	Reach 4	IP26	1+84	
		IP27	3+15	
		IP28	5+00	
		IP29	6+50	
	Reach 5	IP30	Above Study Reach	
IP31		Above Study Reach		
IP32		Above Study Reach		
IP33		Above Study Reach		
IP34		Below Study Reach		
Reach 6	IP35	Above Study Reach		
	IP37	1+00		
	IP40	3+50		
	IP42	4+70		
	IP43	6+00

No immediate action is recommended for problem areas.
