Purlear Creek - Phase I Stream Restoration Annual Monitoring Report

Monitoring Year: 2006

NCEEP Project Number: 294

PURLEAR CREEK - PHASE 1 STREAM RESTORATION 2006 MONITORING REPORT

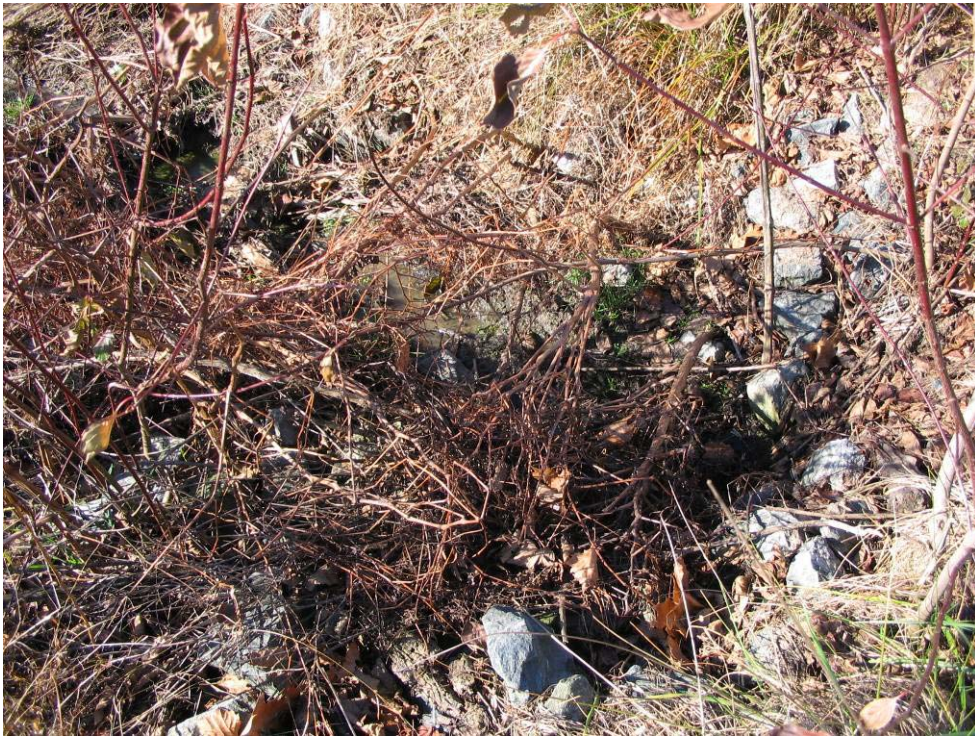
VPA-2, 27-Nov-06

Issue	UTM N	UTM E	Probable Cause	Photo #
Bare floodplain	4006028	473744	Head cut from pasture channel	VPA-1
Bare floodplain	4006168	473771	Head cut from pasture channel	VPA-2
Bare bank	4006343	473269	Constructed steep slope	VPA-3

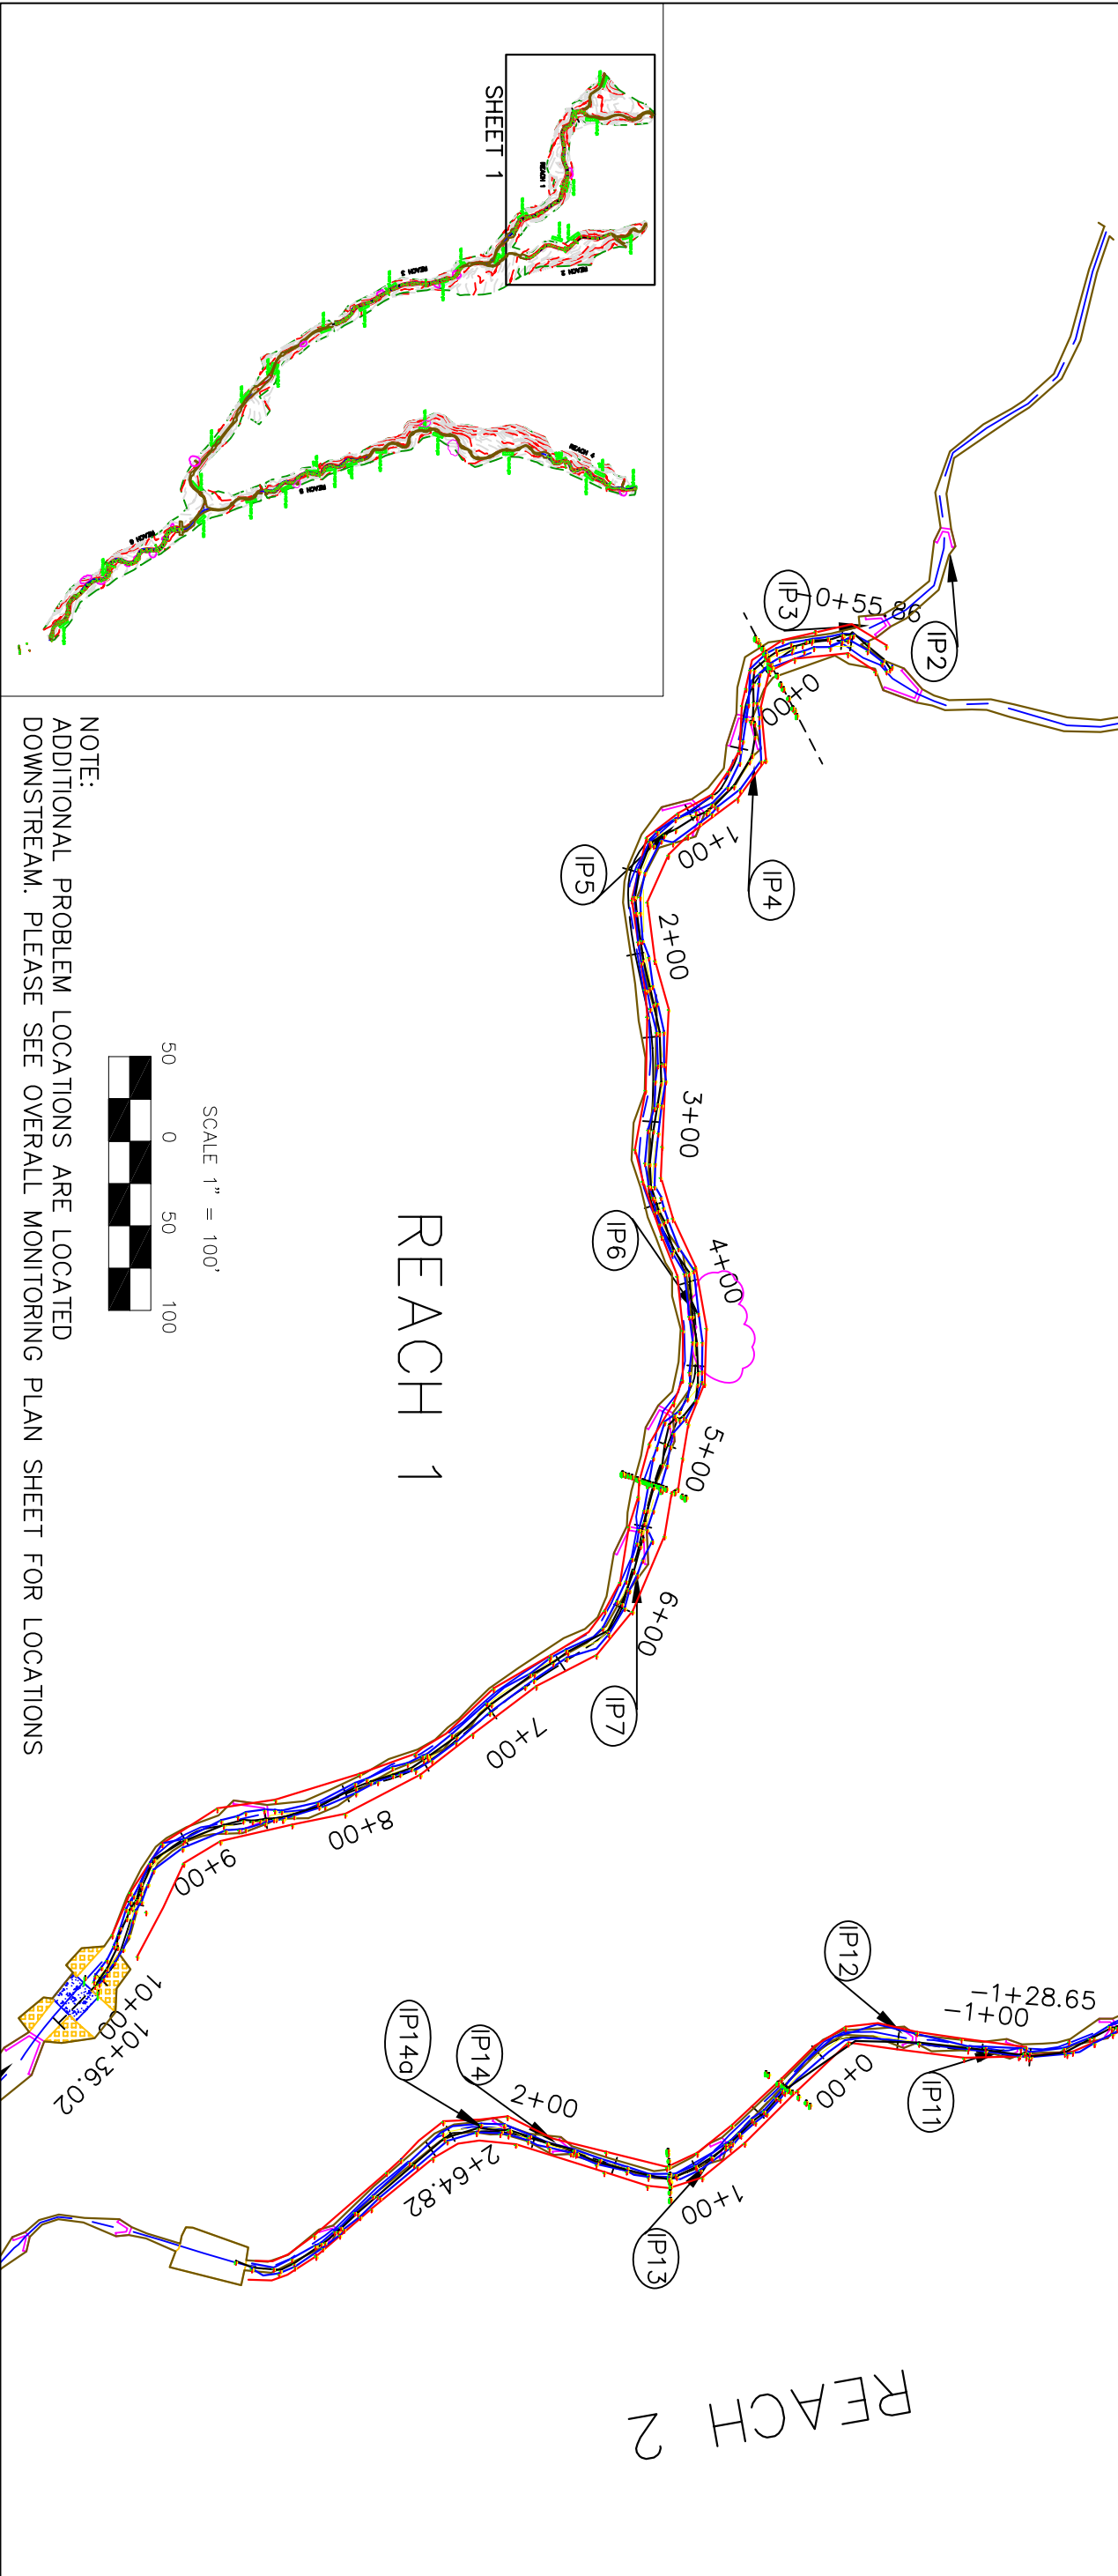
Feature Issue	Reach	Problem/ Photo	Station Numbers	Suspected Cause
Bed Elevation Drop	Reach 1	IP1	Above Study Reach	Steep Channel Grade Drop Designed into Structure
		IP2	Above Study Reach	
		IP3	Above Study Reach	
		IP4	0+30	
		IP5	1+00	
		IP7	5+50	
		IP8	Below Study Reach	
		IP9	Above Study Reach	
	Reach 2	IP11	-1+30	
		IP13	0+74	
		IP14	1+75	
	Reach 3	IP18	0+00	
		IP19	2+77	
		IP21	Below Study Reach	
	Reach 4	IP29	6+50	
	Reach 5	IP30	Above Study Reach	
		IP34	Below Study Reach	
	Reach 6	IP35	Above Study Reach	
IP37		1+00		
IP40		3+50		
IP42		4+70

Reach	Problem/ Photo Number	Feature Issue	Station Numbers	Suspected Cause
Reach 1	IP6	Bank Erosion	4+25	High shear stress, poor vegetation Note: Vegetation is establishing in this area, reducing future risk.
Reach 2	IP 14a	Large Drop and Piping	2+20	
Reach 3	IP17	Double Drop Vane w/ Bank Erosion	Above Study Reach	Constriction of Flow Note: Vegetation is establishing in this area, reducing future risk.
	IP 18	Slump Arm	0+00	Poor Soils, Lack of sufficient footers
	IP20	Erosion / Ground Hog	4+00	Ground Hogs
	IP24	Excess Nutrients through Buffer	Below Study Reach	Farmer Note: Area is significantly more well vegetated then last year.
Reach 6	IP36	Tile	Above Study Reach	Farmer Note: Could not field locate this pipe.
	IP39	Tile	2+10	Farmer Note: Could not field locate this pipe.
	IP40	Vane Undermine Rt.	3+50	Poor Soils, Lack of sufficient footers
	IP41	Bank Erosion	4+00	High shear stress, poor vegetation Note: Area is improving due to vegetation establishment.
