Purlear Creek - Phase I Stream Restoration Annual Monitoring Report

Monitoring Year: 2008

NCEEP Project Number: 294

PURLEAR CREEK - PHASE I STREAM RESTORATION 2008 MONITORING REPORT

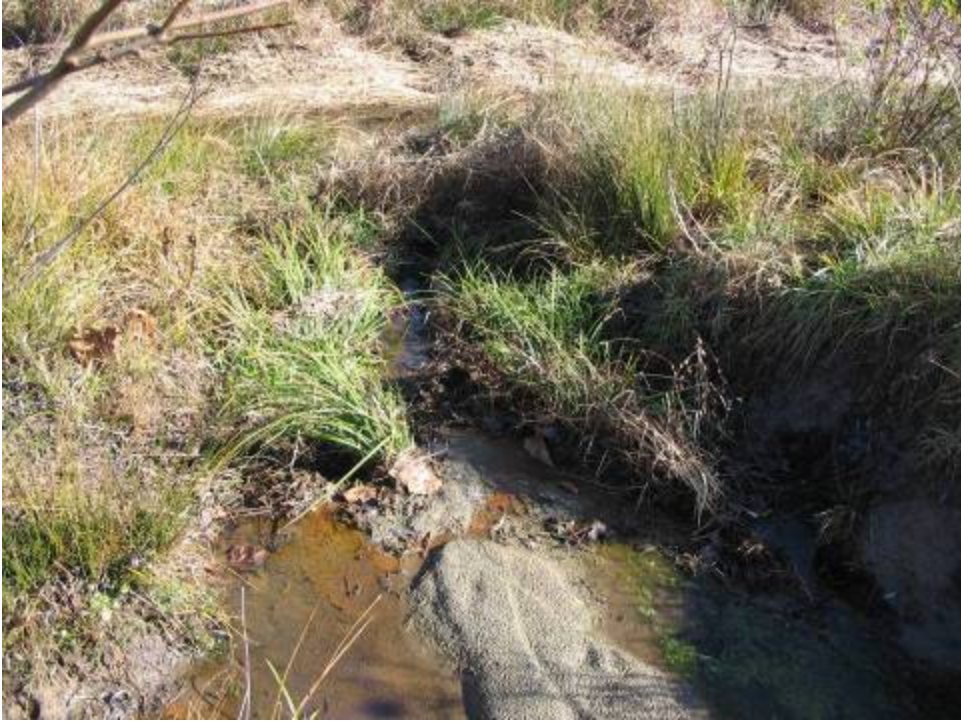
Issue	UTM N	UTM E	Probable Cause	Photo
Bare flood plain	4006028	0473744	Head cut from pasture channel	VPA-1
Bare flood plain	4006168	0473771	Head cut from pasture channel	VPA-2
Bare bank	4006343	0473269	Constructed steep slope	VPA-3
Kudzu Invasion	N 36.20173	W -81.29724	Animal dispersal	VPA-4

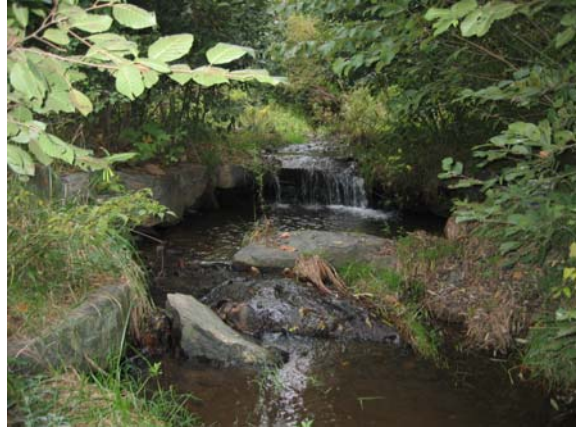
IP 1 Bed Elevation Drop and Loose Boulder (Upstream of Study Reach)

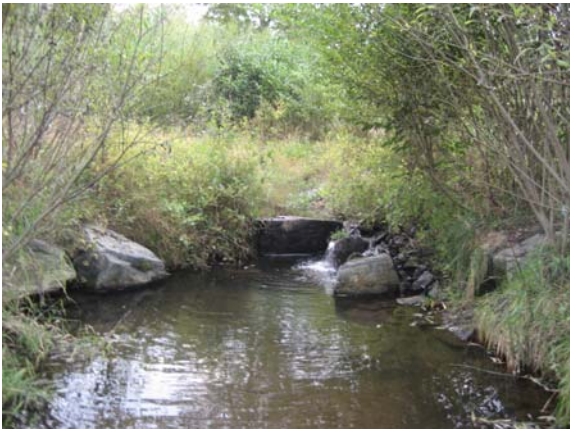
IP 5 Bed Elevation Drop and Piping at Left Arm (Station 0+89)

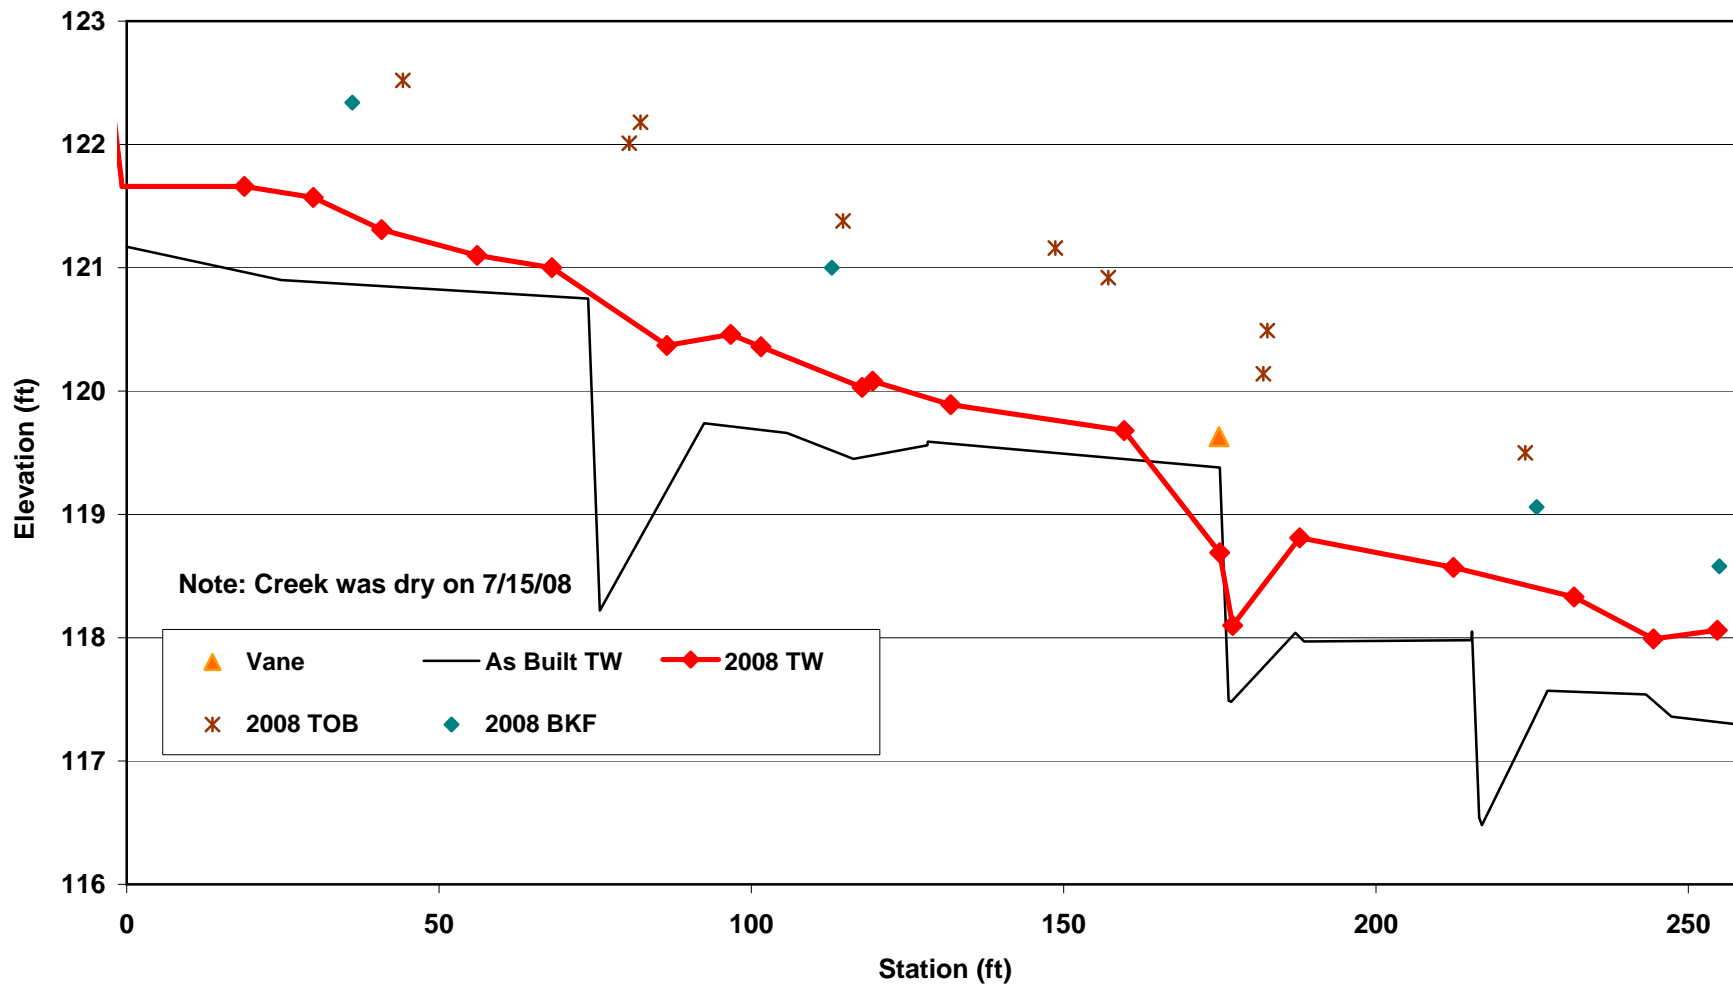
Purlear Creek Reach 2
MY-04 Monitoring - 2008
Survey Date: 7/15/08

Reach 2 was dry during the 2008 survey making it difficult to observe riffle and pool features. Some aggradation has occurred along the channel profile compared to the as built condition. This is illustrated in the profile and channel cross sections included in the appendix. The cause of the aggradation is likely from excess sediment from an upstream source. Dense vegetation is doing an excellent job of inducing aggradation along the channel banks. There are no signs of erosion on the streambanks.
